**MARYLAND HISTORICAL TRUST
NR-ELIGIBILITY REVIEW FORM**

Property Name: Hereford United Methodist Church Inventory Number: BA-1549

Maryland Inventory of Historic Properties Form

INVENTORY FORM FOR STATE HISTORIC SITES SURVEY

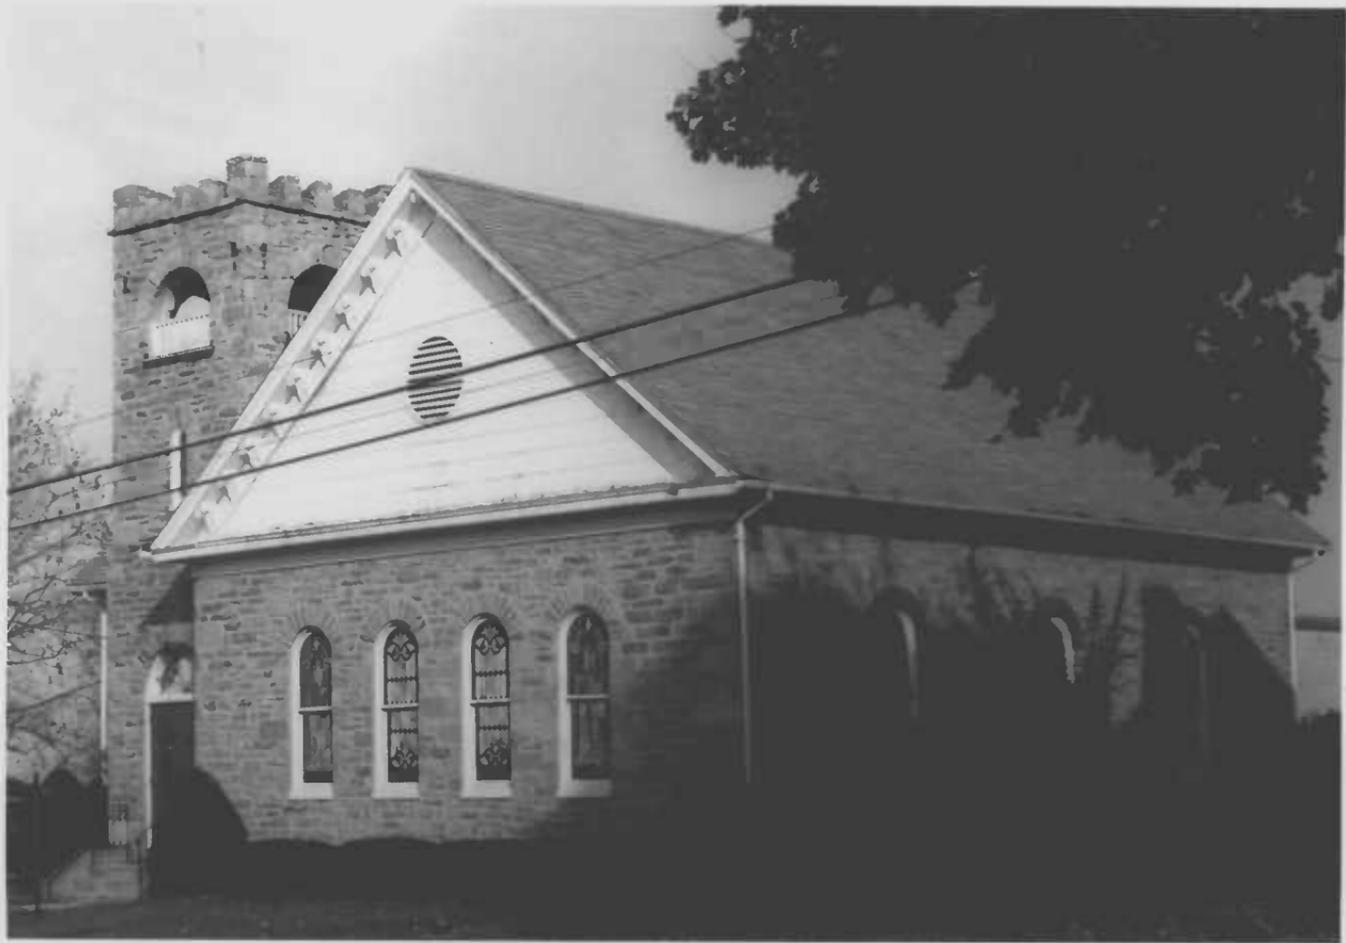
HEREFORD UNITED METH. CH. BA 1549
Baltimore County, Maryland
J. McGrain, October 1979
Neg. located at MHT
Main (west) and south facades

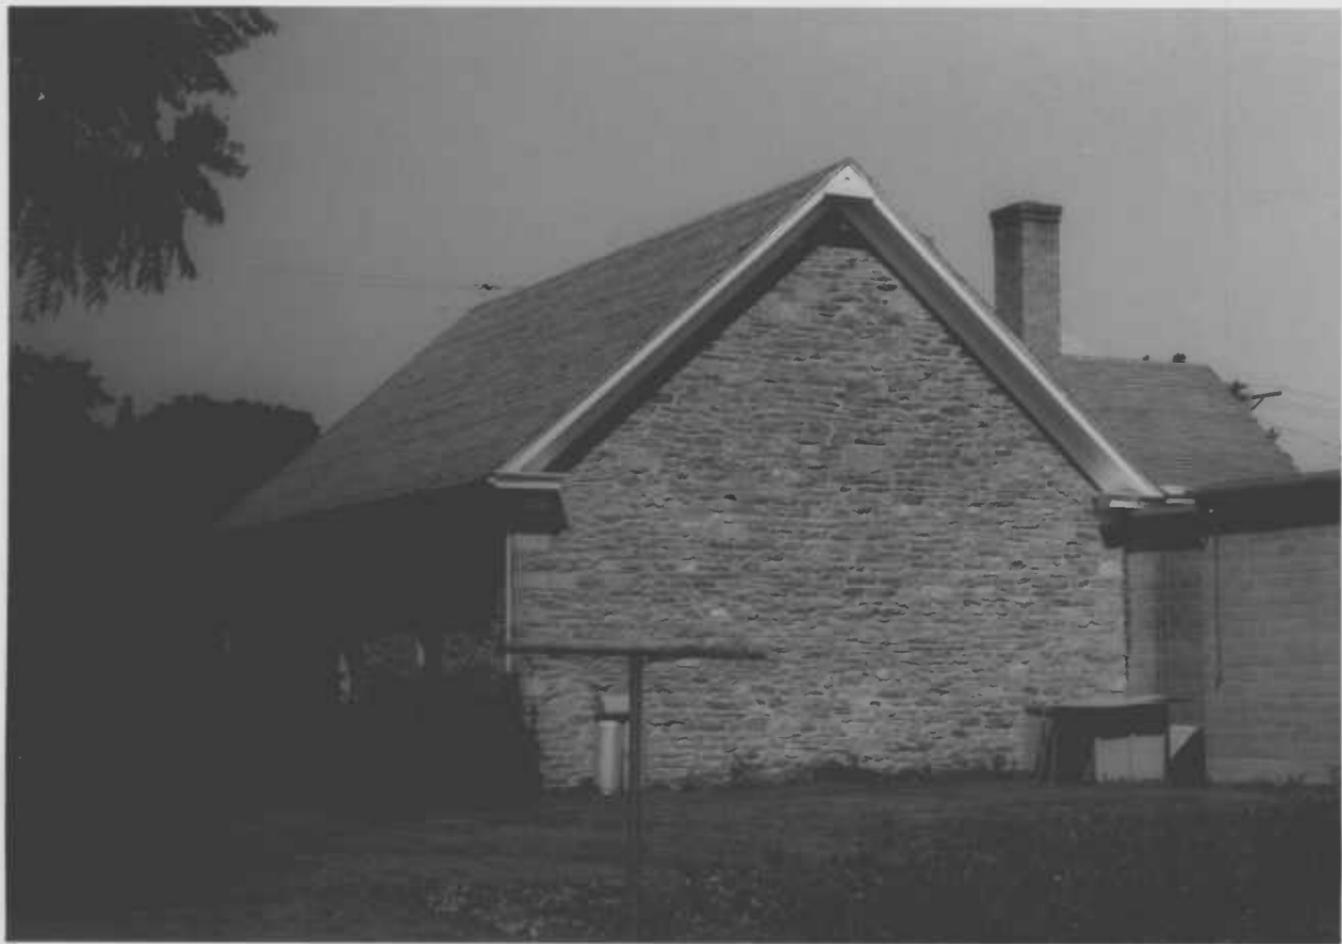
HEREFORD U.M. CHURCH BA-1549
Baltimore County, Maryland
J. McGrain July 1981
Neg. located at MHT
Rear (e) of church from east
