Brooklandville Tenant Houses
Brooklandville
Maryland
Private

INVENTORY FORM FOR STATE HISTORIC SITES SURVEY

BROOKLANDVILLE TENANT HOUSES #1, #2, & #3

The BROOKLANDWOOD TENANT HOUSES are three structures remotely located and separately deeded from Brooklandwood (mansion). Closely oriented to a driveway leading north off Green Spring Valley Road, the three structures face east. For convenience in description, the southerly structure, closest to the Green Spring Valley Road, here is called BROOKLANDWOOD TENANT HOUSE NUMBER 1; the middle structure is called NUMBER 2 and the northerly structure is called NUMBER 3.

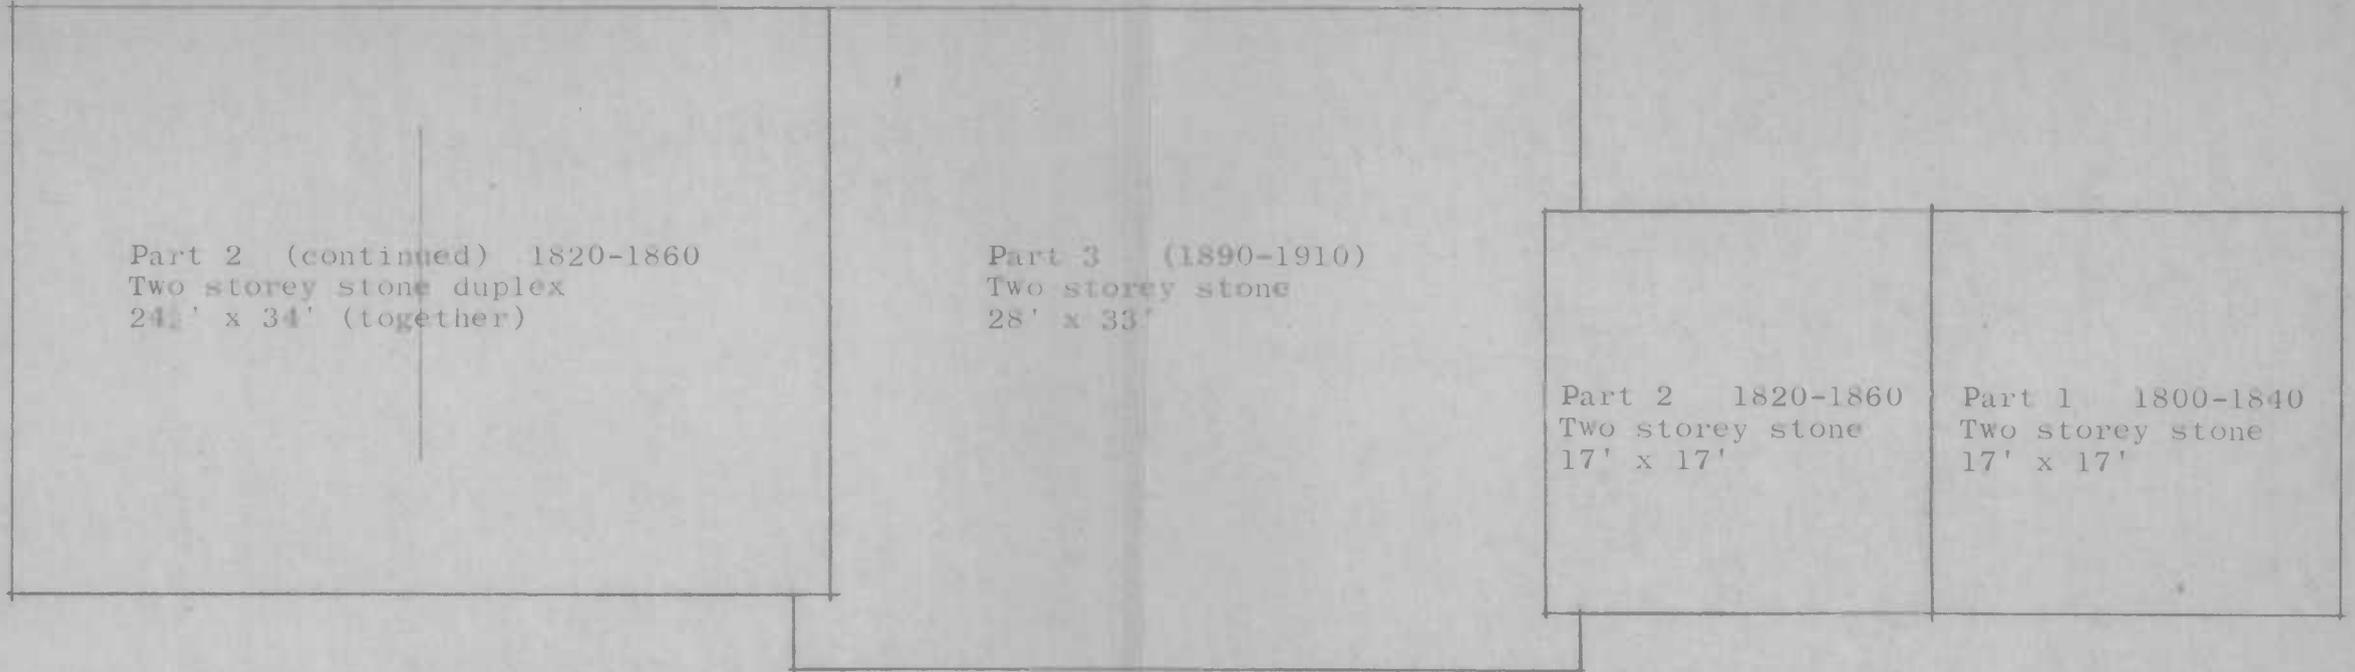
BROOKLANDWOOD TENANT HOUSE NUMBER 1

Part 2 (continued) 1820-1860
Two storey stone duplex
24 1/2' x 34' (together)

Part 3 (1890-1910)
Two storey stone
28' x 33'

Part 2 1820-1860
Two storey stone
17' x 17'

Part 1 1800-1840
Two storey stone
17' x 17'

TENANT HOUSE NUMBER 1 - 1594 (BA)

Part 1 (1800-1820)

In the east or principal front of this oldest section the southerly bay originally had a door, now converted to a window. The original window opening in the northerly bay retains a 6/6 window of original size with thick frame. A stone jack arch is above each opening. Access to the cellar under Part 1 is through hatch doors beneath the original window. A brick chimney stack is flush with the original south gable of this part. A single room is in each storey, both extensively but simply refinished in modern times. A fireplace in the first storey is closed but one in the second storey is open; neither has an old mantel or surround. The enclosed and winding staircase is in the alcove west of the chimney. The second storey ceiling joists are the collar beams. The attic space is inaccessible. In the cellar an arch is beneath the fireplace of the first storey.

Part 2 approximately doubled the length of Part 1 and a similar duplex some thirty feet south was erected in the same period. Each duplex is now a single modern residence. Entrances are in each end bay of the principal or east front and 6/6 windows with narrow frames and exposed wooden lintels are in the middle bays. A massive brick chimney rises through the roof ridge within the southerly bay of the northerly unit. A small gabled porch shelters each entrance. Interior finishes are modern, quite simple and compatible with the original. The southerly duplex was not accessible for interior inspection. No portion of Part 2 has a cellar.

Part 3 joined the two earlier parts to form a single three-part structure. Three bays in width with gabled roof to the front its eaves are higher than those of the earlier flanking wings and its design makes it the principal or dominant element of the three-part structure. Double doors are in the middle bay of the first storey and double 2/2 windows are in flanking bays of both storeys; by contrast a single 2/2 window is in the middle bay of the second storey. All windows have segmental arches above. A single 2/2 window is in the stocced gable. A one-storey porch shelters the east front.

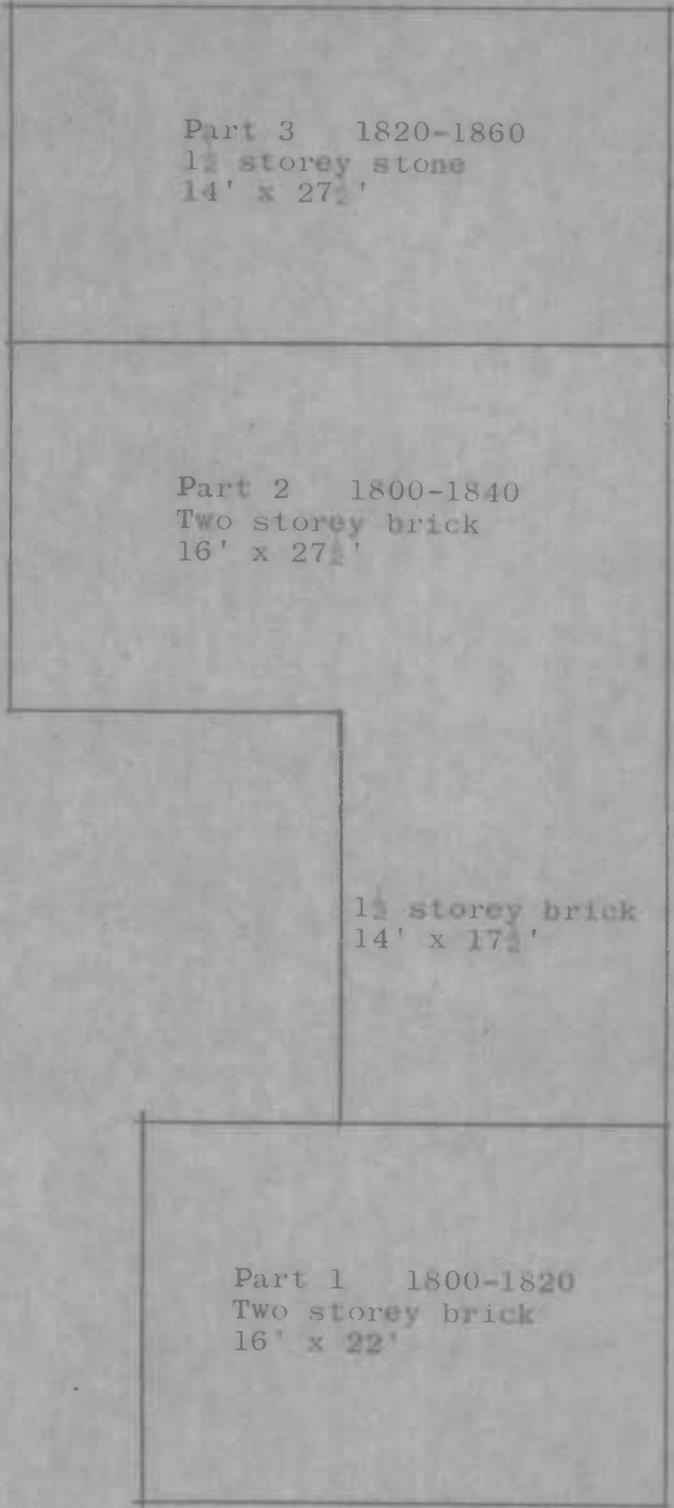
BROOKLANDWOOD TENANT HOUSE NUMBER 2

Part 3 1820-1860
1 1/2 storey stone
14' x 27 1/2'

Part 2 1800-1840
Two storey brick
16' x 27 1/2'

1 1/2 storey brick
14' x 17 1/2'

Part 1 1800-1820
Two storey brick
16' x 22'

TENANT HOUSE NUMBER 2 - 1595 (BA)

This section is two storeys in height, three bays in width, with a gabled roof and an interior brick chimney flush with the north gable. The walls are laid in common bond, every sixth course headers. The principal entrance is centered in the east front and 9/6 windows are in flanking bays; 6/6 windows are in each bay of the second storey. A single similar window is centered in each storey of the south end and a small 4-light casement is in the attic. In the north end is a single 6/4 window in the first storey, west of the chimney, its height matching that of typical windows, its width one light less. Windows retain original wide frames joined by pegged mortise-and-tenon and some retain driven pentels for original shutters. Lintels are not visible and there are no arches above openings. The beaded fascia is probably original but it has been lengthened to create a wide rake eave at the south gable.

The orientation of the principal section of Part 2 matches that of Part 1 and like Part 1, its brick walls are laid in common bond with every sixth course headers. The hyphen roof is a single pitch, its ridge, level with adjacent eaves, above its north wall which is flush with the north end walls of Parts 1 and 2 and it falls to a low south eave to include a porch between the two taller sections east and west. Within the porch the taller westerly portion of Part 1 has a 6/6 window in the south bay, a door in the middle bay, adjacent to the hyphen. Both units are modern and a door was originally in the south bay. A 6/6 window with wide pegged frame is centered in the south and north gables; a similar window with a narrower frame is above and a single 6-light sash is in the attic. A 6/6 window with narrow frame is in the westerly bay of the hyphen and a door is in the easterly bay, now closed with wood. A 4-light casement is above each in the second storey. A modern steel flue rises flush with the north gable, east of the ridge.

Part 3 is a shed addition across the entire rear or west facade of Part 2, its walls of rubble stone. Its roof is a continuation of the roof of Part 2 and it sweeps to a picturesquely low eave with two small shed dormers each containing 3/3 windows. A single 6/6 window is in the northerly bay. Interior finishes are all modern.

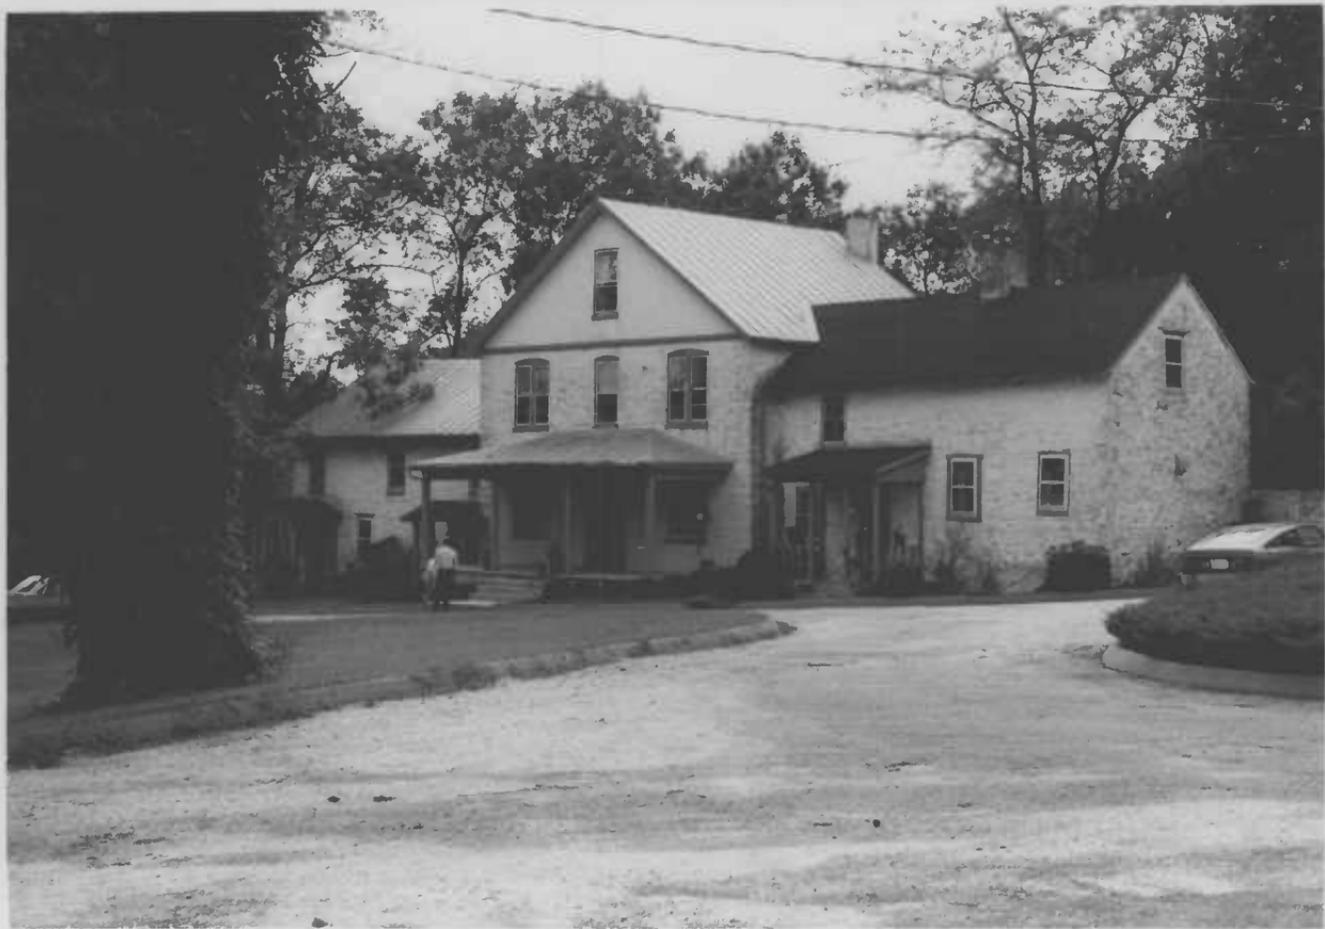
BA 1594 #/ *1-11-1979*
Brooklandvil *JTW 9/13/79*
le Tenant Hs *4-10*

GSVHD
Gr. Spn. Vly.
JTW
9-13-79
Md. Hist. Tr.
from NE

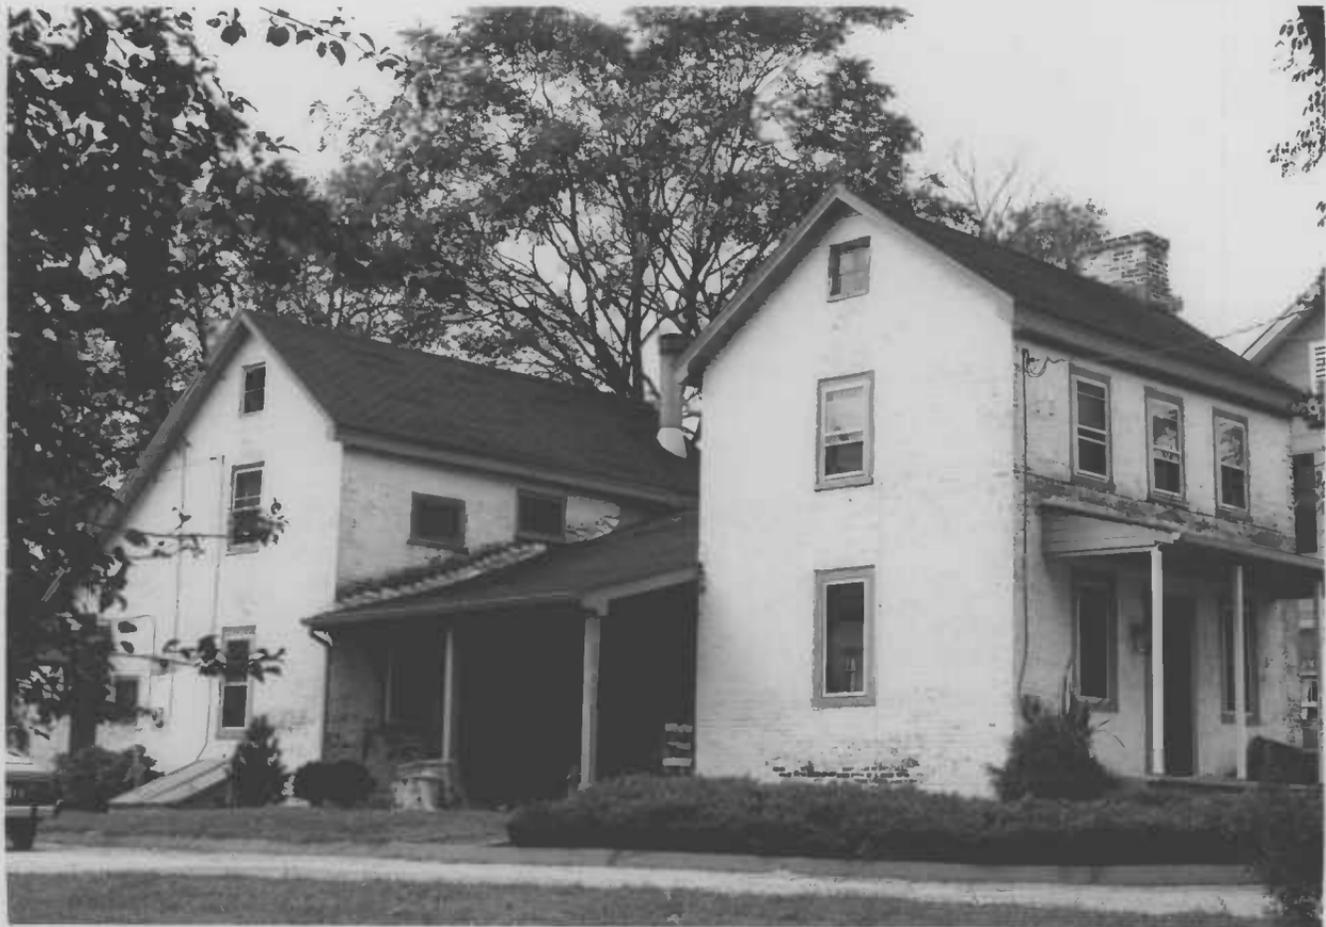
BA 1595#2
Brooklandvi
lle Tenant
House

from SE

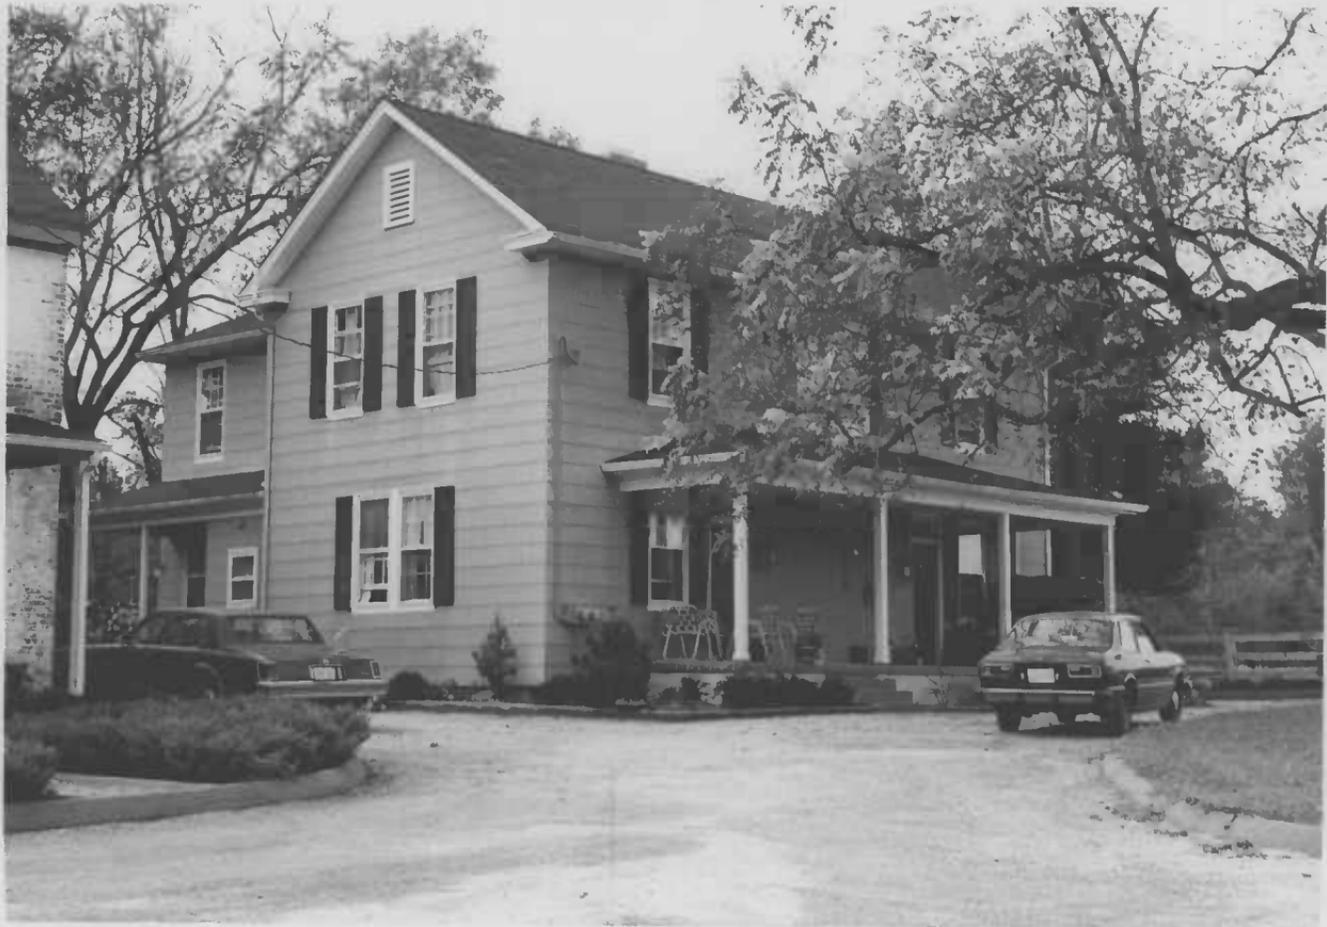
BA 1596#3
Brookland-
ville Tenant
House
GSVHD
Gr. Sp. Vly. Rd

JTW
8-13-79
Md. Hist. Tr.
from SE

Of frame construction, four bays in length, two storeys in height, NUMBER 3 is a very typical late nineteenth century tenant house. A one-storey porch shelters the principal or east front. The end bays each have a 6/6 window in each storey with narrow frame and louvred blinds. The principal entrance is in the northerly middle bay and a similar doorway adjacent to the south is now eliminated. A doubled window is centered above the entrances. A service wing, also two storeys in height, extends to the rear (west), a porch in the angle between it and the main section. The interior was not inspected.
