CAPSULE

1113 W. Lake Avenue

INVENTORY FORM FOR STATE HISTORIC SITES SURVEY

BA-1782

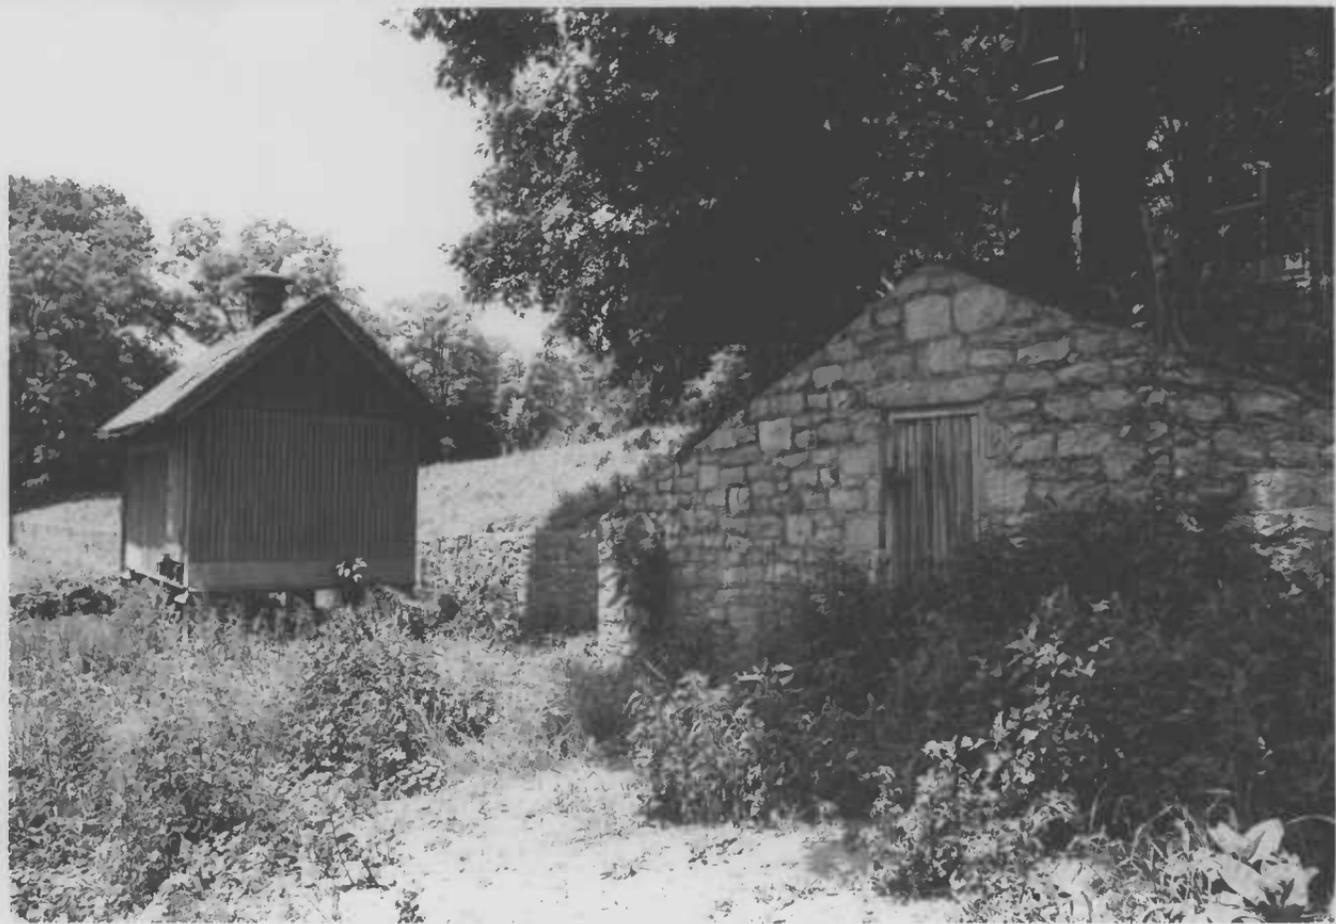
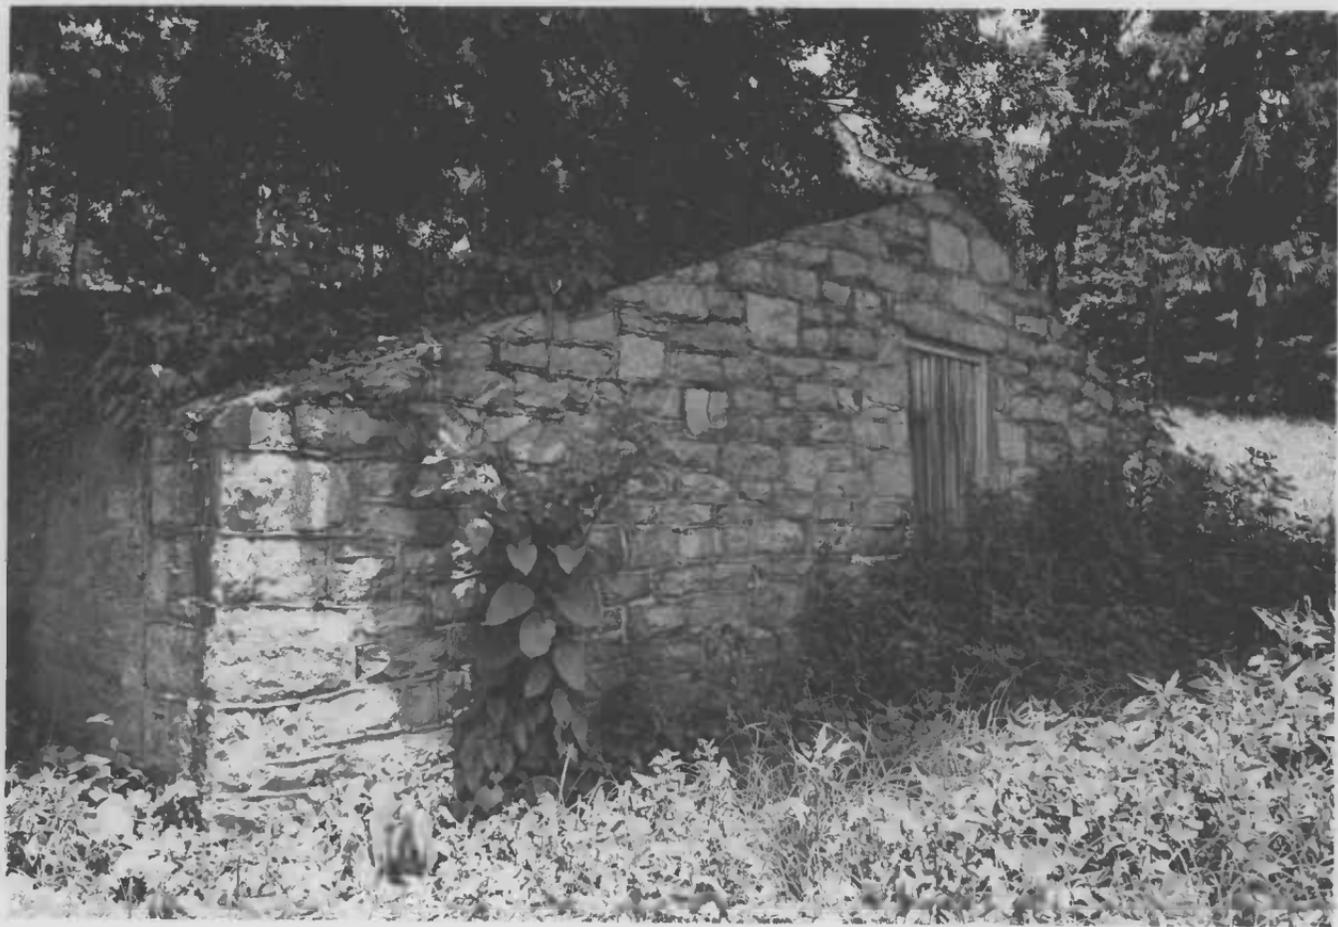
STORAGE CELLAR-
1113 W. LAKE AVE.

The next house East of this property is a classic frame picturesque dwelling a la Downing or Vaux which is perceived as being post-bellum. It is surrounded by stone walls and a stone outbuilding which may have been original to # 1113 W. Lake Avenue. This may not have been the case, however, it was observed that approximately 50 yards East of the stone dwelling there is a stone construction built into the side of the same hill. Access was not gained. A round metal ventilator protrudes from an earth mound whose south side has a triangular shaped stone wall.

The wall is 2 feet thick. It is 5 feet high on its southeast corner. It is gabled and measures 9 feet 6 inches at the midpoint. The total length is 28 feet. A centrally located 3' x 6½' door provides access.

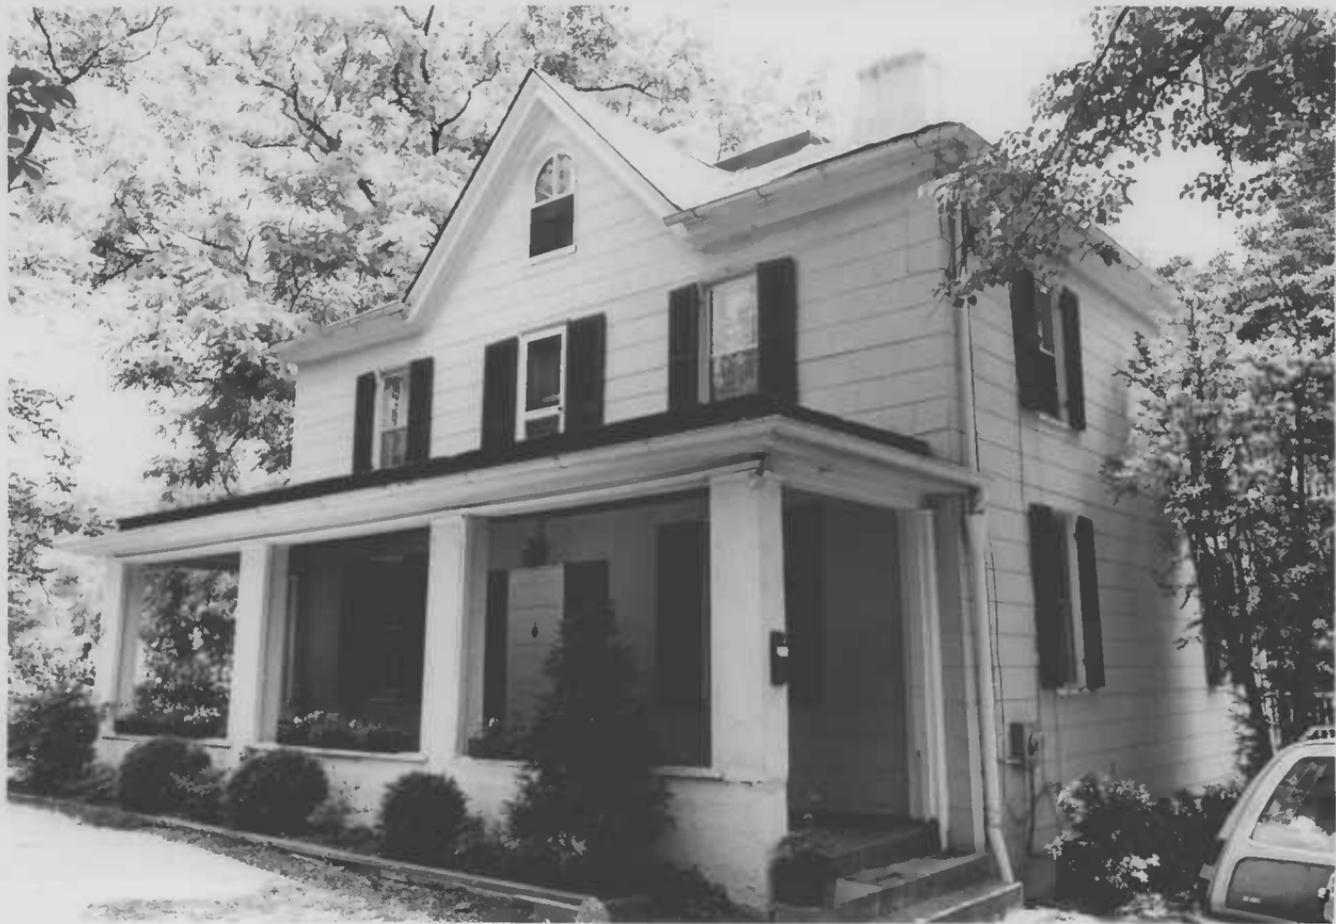
N. W. CORNER

Modern siding obscures the fact that this is a stone building that is two stories in the front (North), three in the rear and is three bays wide and two long bays deep. The high basement is a sloping hillside site results in a foundation that is 2 feet high on the northwest corner and 7 feet high on the southwest corner. The nearly square block is capped by a shallow pitch hipped roof. Two interior chimneys exit at the ridge.

The main or north facade is characterized by a steeply pitched cross-gable (possible addition) and the centralized tri-partite division. There are centrally located doors on both the first and second levels suggesting the possibility of an earlier second story porch or gallery. The present single story supported by four square columns and two pilasters covers the entire first level. It has been much altered. The most decorative feature of this facade is the round arch 2/2 sash window which vents the cross gable dormer. The other windows are fitted with louvered shutters.

The west facade has a slightly elongated appearance due to the interior arrangement of the chimneys. The outer bays are vented by 6/6 sash windows on the two principal levels with the basement being vented with similarly placed 2-light casements. That of the north bay has been altered.

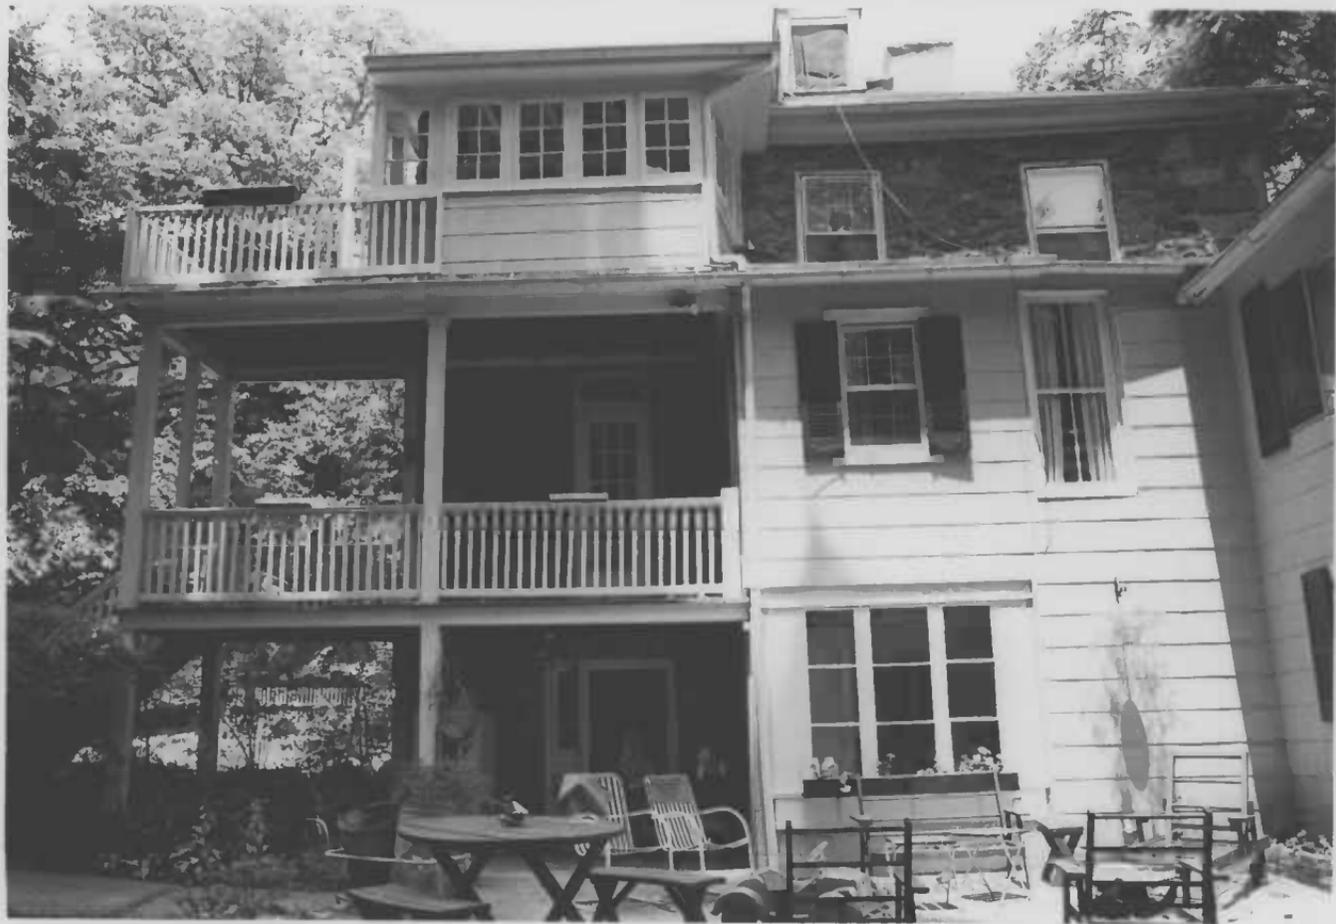
1113 W. LAKE AVE.
S. FACADE

The south facade is the most difficult to describe but is the most interesting in terms of original appearance. It is on this side of the building that one can see the walls are constructed of random sized fieldstones with an attempt at coursing and the use of massive stones as quoins. This facade is a full three stories with entrances on the bottom level. There are full galleries or porches on all three levels with various portions being either enclosed or open.

It is curious how unlike this facade is from its counterpart on the north side. Not only is there a taller massing, but a different plan as well. The entrances of both levels are on the west side rather than in the middle and instead of the Victorian cross-gable dormer there is a centrally placed pedimented dormer decorated with a "broken pediment." The result is that this side of the building is distinctly Federal

in appearance while the opposite is Victorian.

On the first level within the enclosed area one can see that the exterior stone wall has been stuccoed and painted white. Evidences of whitewash are found in the upper portions of the south wall as well suggesting that the building may once have been painted white.

Portions of a large ovolo cornice moulding survive on the north, south and east sides but stop after wrapping around the southeast and southwest corners. That this facade was left undecorated suggests that when the moulding was applied this was indeed the "back" of the building.
