INVENTORY FORM FOR STATE HISTORIC SITES SURVEY

17 Linden Terrace

BA-2157

PHOTOGRAPHS: 17 Linden Terrace

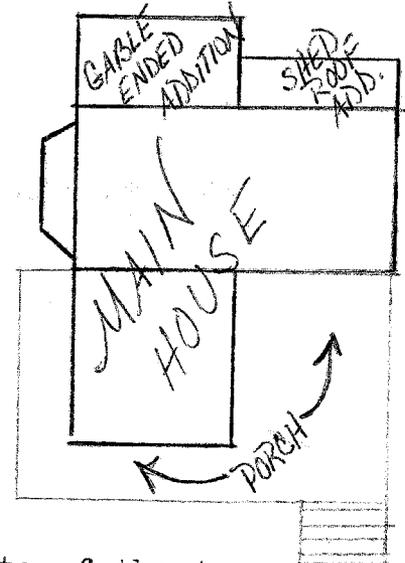
The north facade, as indicated on the sketch to the right, reflects the structural changes brought about by two probable additions in the rear of the house. A one story shed roof lean-to is located on the right or west side of the north facade. A small two story gable ended addition appears on the left east side. The shed roof addition contains a glass paneled door with a 2/2 sash window to the left. Above the shed roof is a 2/2 sash window. A door opening has also been cut into the north-south wing addition above the shed roof. A casement window has been added to the first floor of the north-south wing. An arched window appears in the attic of the wing. It seems possible that this was originally a sash window like those found on the other facades.

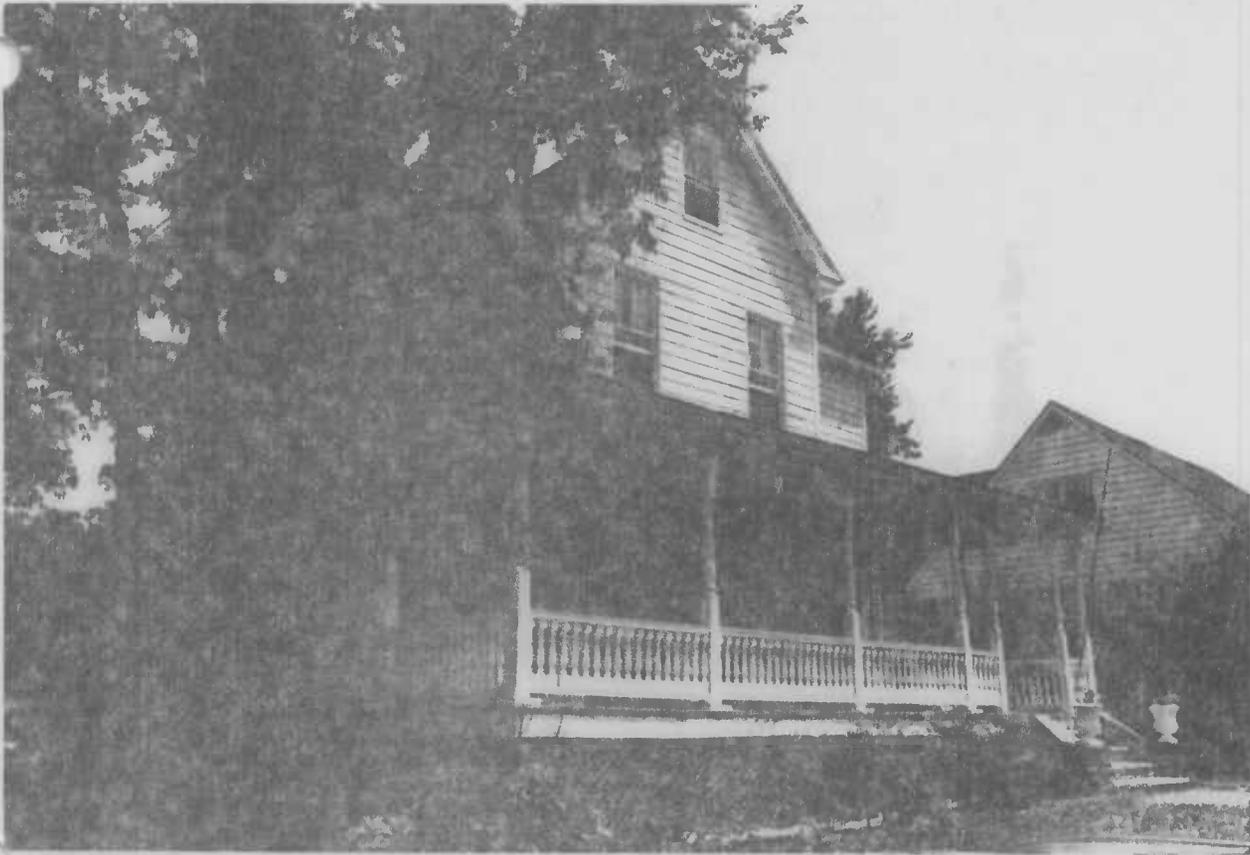
ABOVE: South-west Facade

The most striking feature on the main or south facade is the L-shape or wrap-around porch which surrounds the entire south and half of the west facades. Five stone steps lead to the porch which rests upon stone porch piers and is floored with tongue and groove boards. The original turned ballusters support a handrail while a lattice-like porch base surrounds the porch. Thirteen turned posts with knobs support the tongue and groove ceiling and the slightly hipped porch roof. Two metal brackets (recently added) adorn the posts on each side of the steps.

The fenestration on the west facade consists of the two story bay window and a 2/2 sash window with red louvered shutters. (The shutters on all the other windows were removed while renovation work was being done). A modern brick chimney flue also appears on this facade.

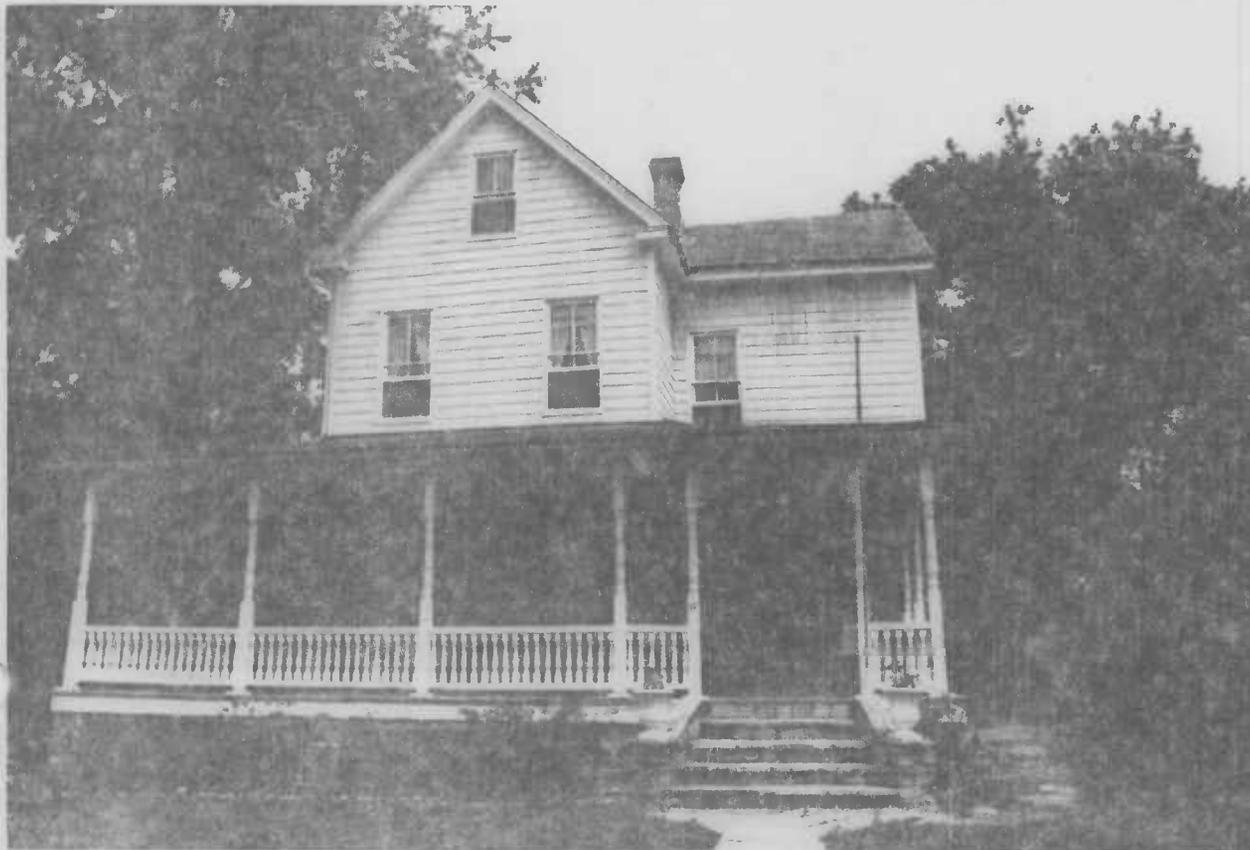
BELOW: South (Main) Facade

The entrance has recently been altered as was the window immediately to the right. A double door of lower inset square panels and upper rectangular arched panels is located at the top of the steps. Non-functional wood corbels decorate the door. A gothic arched stained glass window now appears to the right of the door where previously a double hung sash window stood. Two additional 2/2 sash windows appear on the first floor south facade. Three 2/2 sash windows are located on the second floor. The attic contains one 2/2 sash window.
