INVENTORY FORM FOR STATE HISTORIC SITES SURVEY

35 Willow Avenue

BA-2162

PHOTOGRAPHS: 35 Willow Avenue

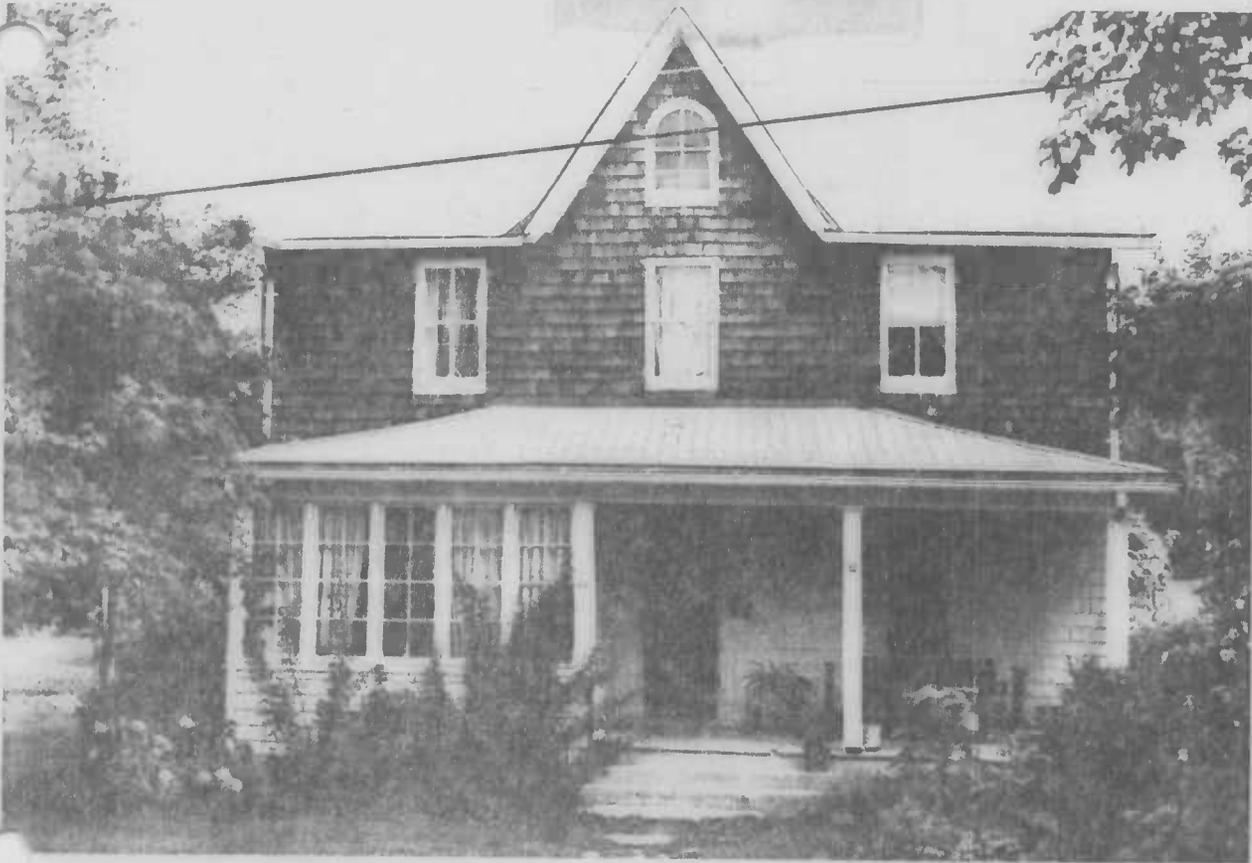
Three concrete steps lead to the front porch which has been enclosed on the west or right side. Two wood Doric columns support the porch roof on the remaining open section. Tongue and groove boards floor the porch. The main entrance is centrally located and consists of a wood door constructed of eight small rectangular inset wood panels. A small rectangular glass transom hangs above the door. To the right of the door is a floor length 4/4 sash window with plain white trim. To the left of the door is the enclosed section of porch which shows five rectangular casement windows on the main facade and three on the east and west sides. These casement windows contain eight lights each and are encased in plain white trim. Above the porch on the second floor are three 2/2 sash windows with plain white trim. The attic contains an arched 2/2 sash window.

ABOVE: South (Main) Facade

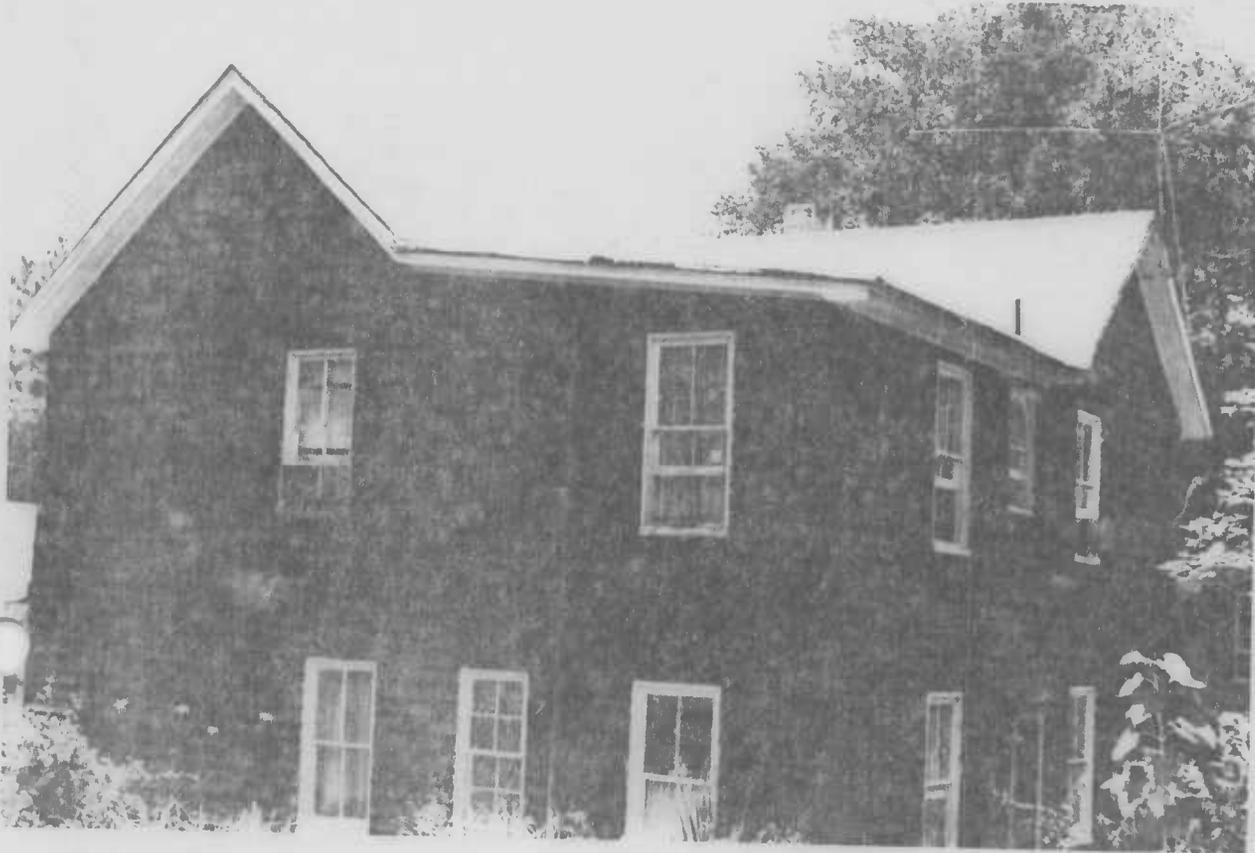
The north facade shows the rear of the addition as well as the rear of the north-south original wing. The addition contains a 2/2 sash window and a wood paneled door on the first floor. The door provides a rear entrance to the structure and is constructed of four inset wood panels. To the right of the door, in the original section of the house, is a 2/2 sash window on the first floor. The second floor displays two 2/2 sash windows in the addition and one 2/2 sash window in the original section.

The west facade contains a side entrance to the house. This door consists of two rectangular wood panels on the lower half with four panes of glass in the upper half. A casement style cellar window flanks each side of the door. First floor fenestration consists of a [2/2 sash window] on each side of the side entrance. Two [2/2 sash windows] appear on the second floor.

BELOW: North-west Corner
