INVENTORY FORM FOR STATE HISTORIC SITES SURVEY

24 Willow Avenue

Towson

BA-2165

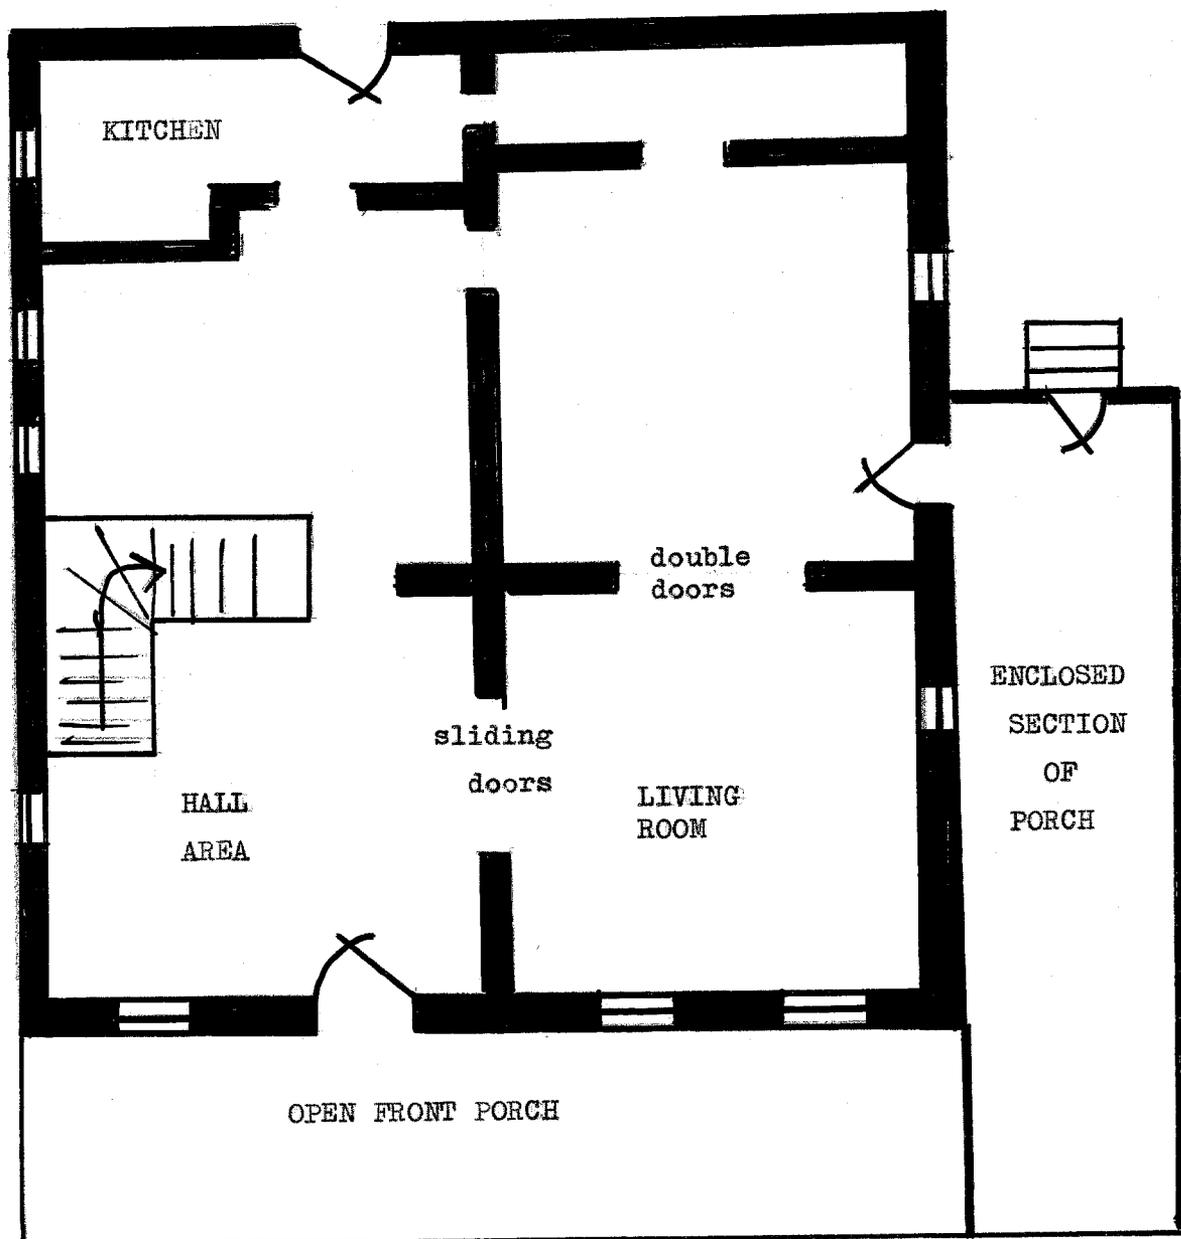
The interior of the house, opposed to the exterior, has remained relatively unchanged. All of the original mouldings and doors survive. A balustraded railing appears on the stairs and sliding double doors lead into the living room. A rough sketch of the floorplan appears below.

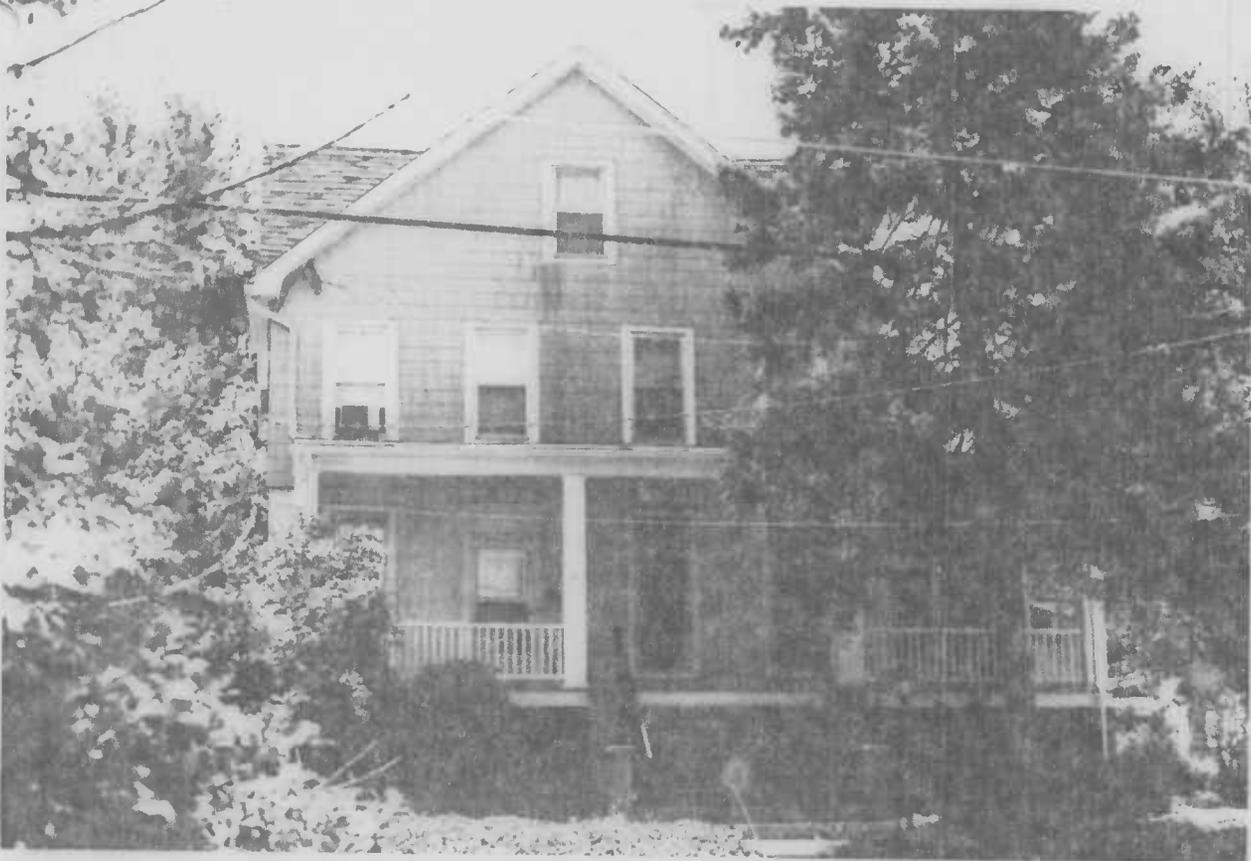
ABOVE: North (Main) Facade

The main facade is four bays wide. The entrance is located slightly off center to the left. It consists of a modern storm door opening onto a wood paneled interior door. The transom has been enclosed with a piece of wood. To the left of the door is a 1/1 floor length window with white trim. To the right of the door are two additional 1/1 floor length windows. The second floor contains four regular size 1/1 sash windows. A smaller 1/1 sash window appears on the attic floor.

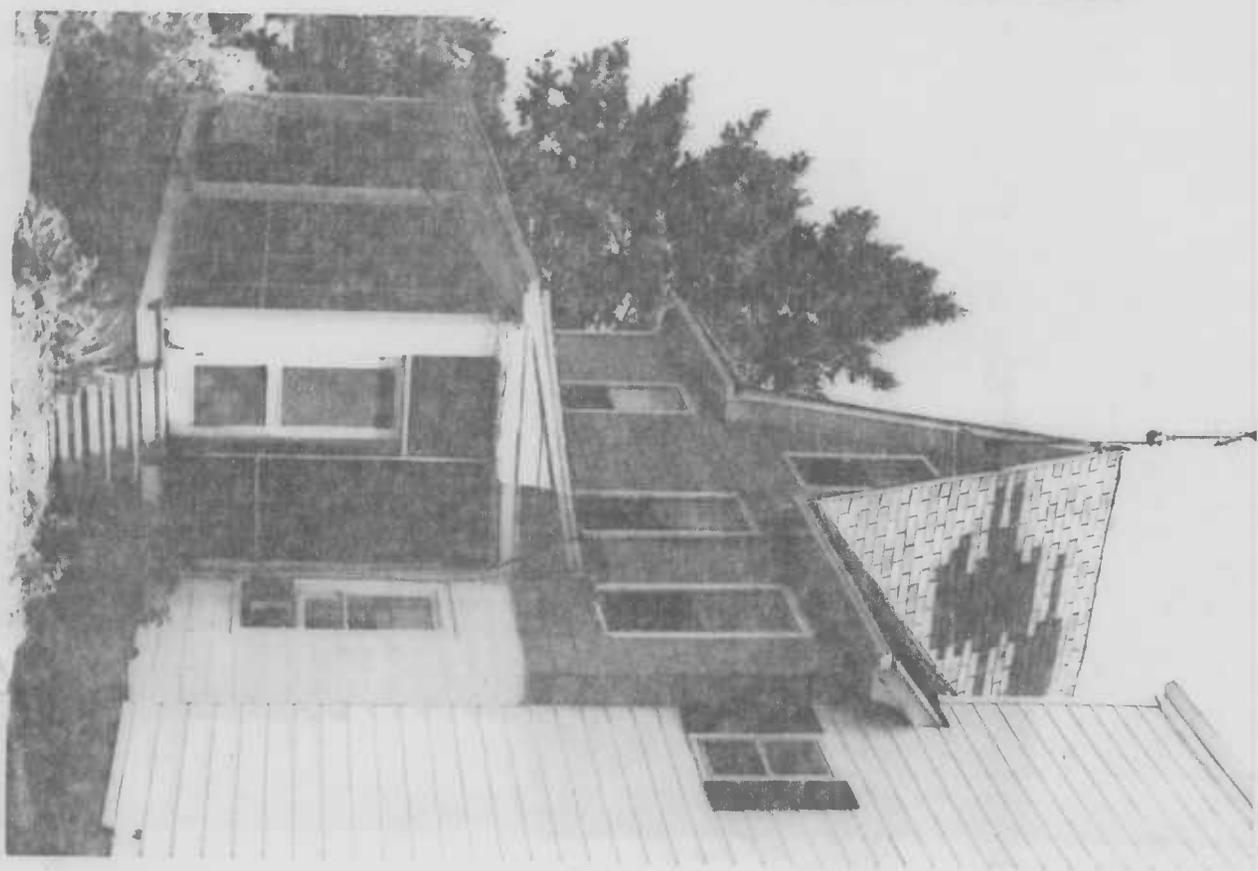
BELOW: West Facade

The west facade is dominated by the steep cross gable and the enclosed side porch. The first floor shows two 1/1 sash windows and a wood paneled door with transom. The second floor contains three 1/1 sash windows. The attic displays a similar 1/1 sash window.
