HISTORIC PRESERVATION CERTIFICATION

APPLICATION — PART 1

1. NAME OF PROPERTY: Blacksmith's House
Address of property: Street 10113 Falls Road
City Brooklandville County Baltimore County State Maryland Zip Code 21022
Name of historic district in which property is located Rockland National Register District

The Blacksmith's House, Rockland, Brooklandville, Maryland

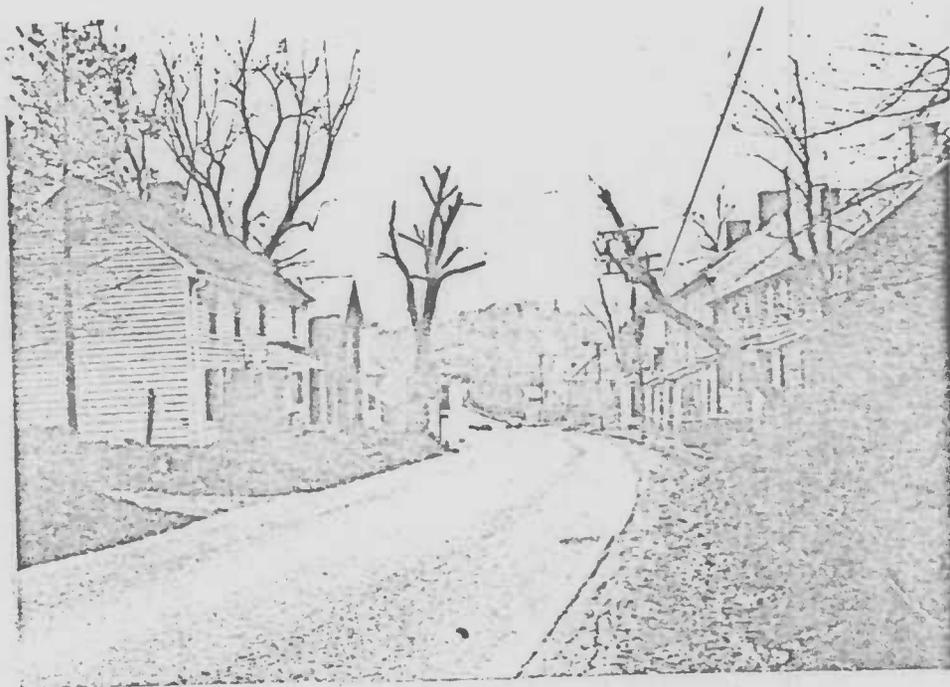
Blacksmith House, from the North, looking South along Falls Road.

The dark shingled Blacksmith's house can be seen on the left of the photograph, south of the "log House" Note the way the building fills in the road frontage between the log house and the blacksmith's shop, barely seen to the south of the subject property. Note the impact of the gable roof on the northern half of the Blacksmith's house, relating to the gable roof of the log house (a 90° shift). The same relationship exists on the right side of the road with the stone row gable to the north of the 90° shifted general store gable. (seen in photo above.)

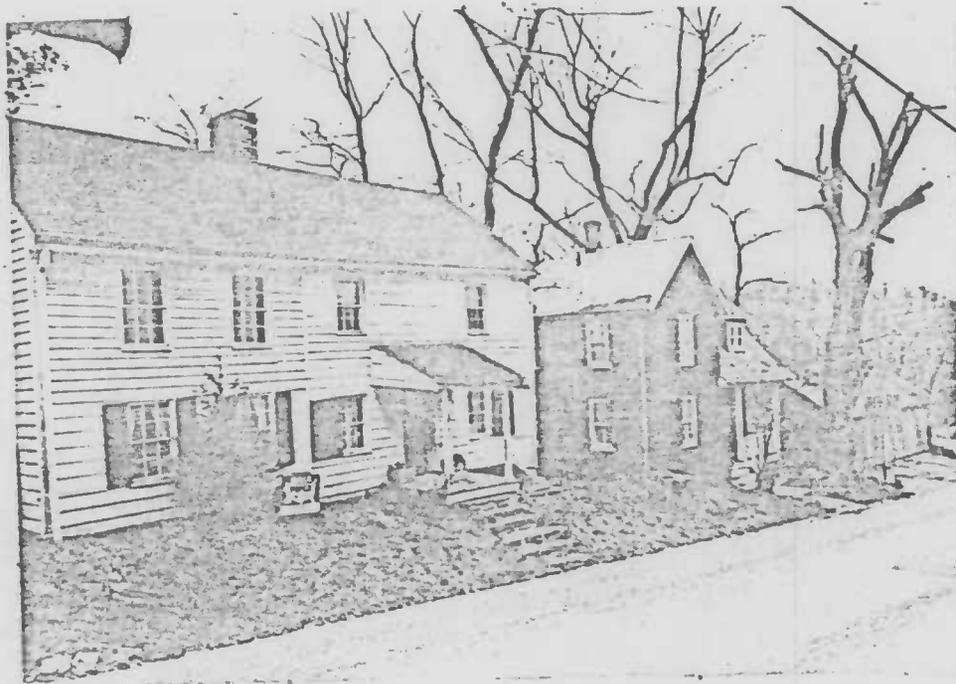
Blacksmith's House looking from the Northwest.

The fronts of the houses line up along the road edge. Note that the site sketch in the National Register submission inaccurately shows this house out of line with its neighbors. This is not the case. The site slopes down between the log house and the blacksmith's shop. The roof lines of the house help emphasize this stepping with the south gable parallel and the north gable perpendicular to the shed of the shop below.
