CAR-8
Round Barn
Mt. Zion
Private

INVENTORY FORM FOR STATE HISTORIC SITES SURVEY

Round Barn

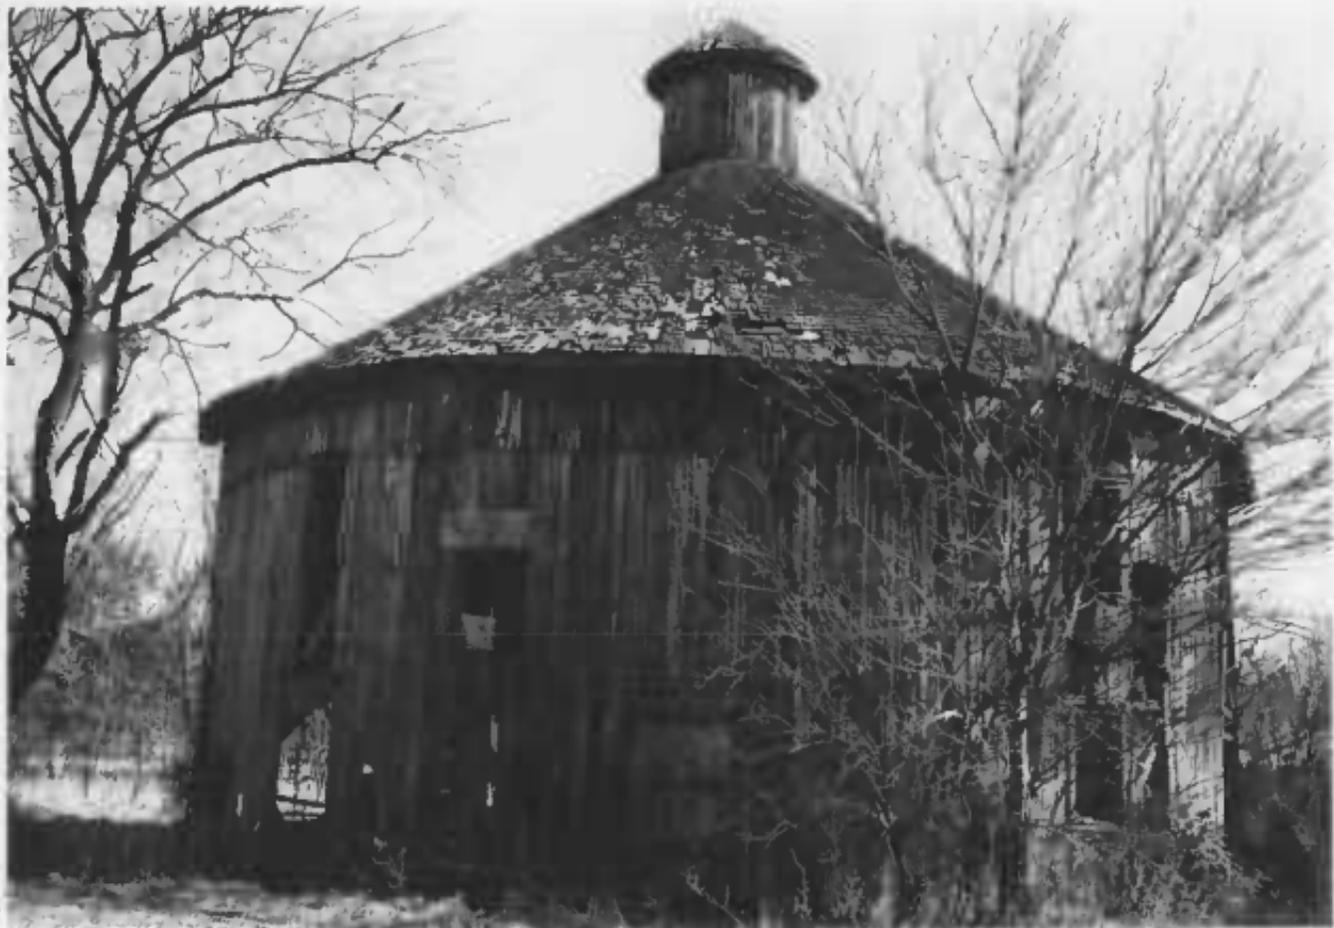
A two story frame structure, the Round Barn has a shingled conical-shaped roof with a central cupola. The framing system has twenty posts around the circumference of the barn, with a central row of four posts flanked by a pair of posts on each side. The roof frame has a central post to which all of the rafters are connected and extend, teepee-fashion, to the sills where their shaped ends slightly protrude. The exterior cladding of the barn is vertical siding of beaded tongue and groove boards. The siding is attached with nails and bolts, and has an ornamental sawtooth overlay on the upper sections of the barn and cupola. The whole structure is constructed around a concrete foundation.

The north side of the structure has a large wagon door, while two other doorways existed, one each on the south and southeast sides. Several windows are scattered around the barn on the first and second floors. Access to the second floor from the interior was by vertical ladders built on the side walls. The barn seems to have been mainly a storage area, and there appears no functional reason for its being round.
