1. STATE COUNTY TOWN STREET NO.	Maryland Cecil VICINITY St. Augustine	HISTORIC AMERICAN BUILDINGS SURVEY INVENTORY CE - 63
ORIGINAL OWNER ORIGINAL USE PRESENT OWNER PRESENT USE WALL CONSTRUCTION NO. OF STORIES	--- Dwelling Mr + Mrs. R.C. Dupont Jr. Dwelling Brick 2- 1	2. NAME "OLD BRICK HOUSE" late 18 th Century DATE OR PERIOD Early 19th Century STYLE Federal ARCHITECT BUILDER
4. NOTABLE FEATURES, HISTORICAL SIGNIFICANCE AND DESCRIPTION		3. FOR LIBRARY OF CONGRESS USE

Old Brick House

CE - 63

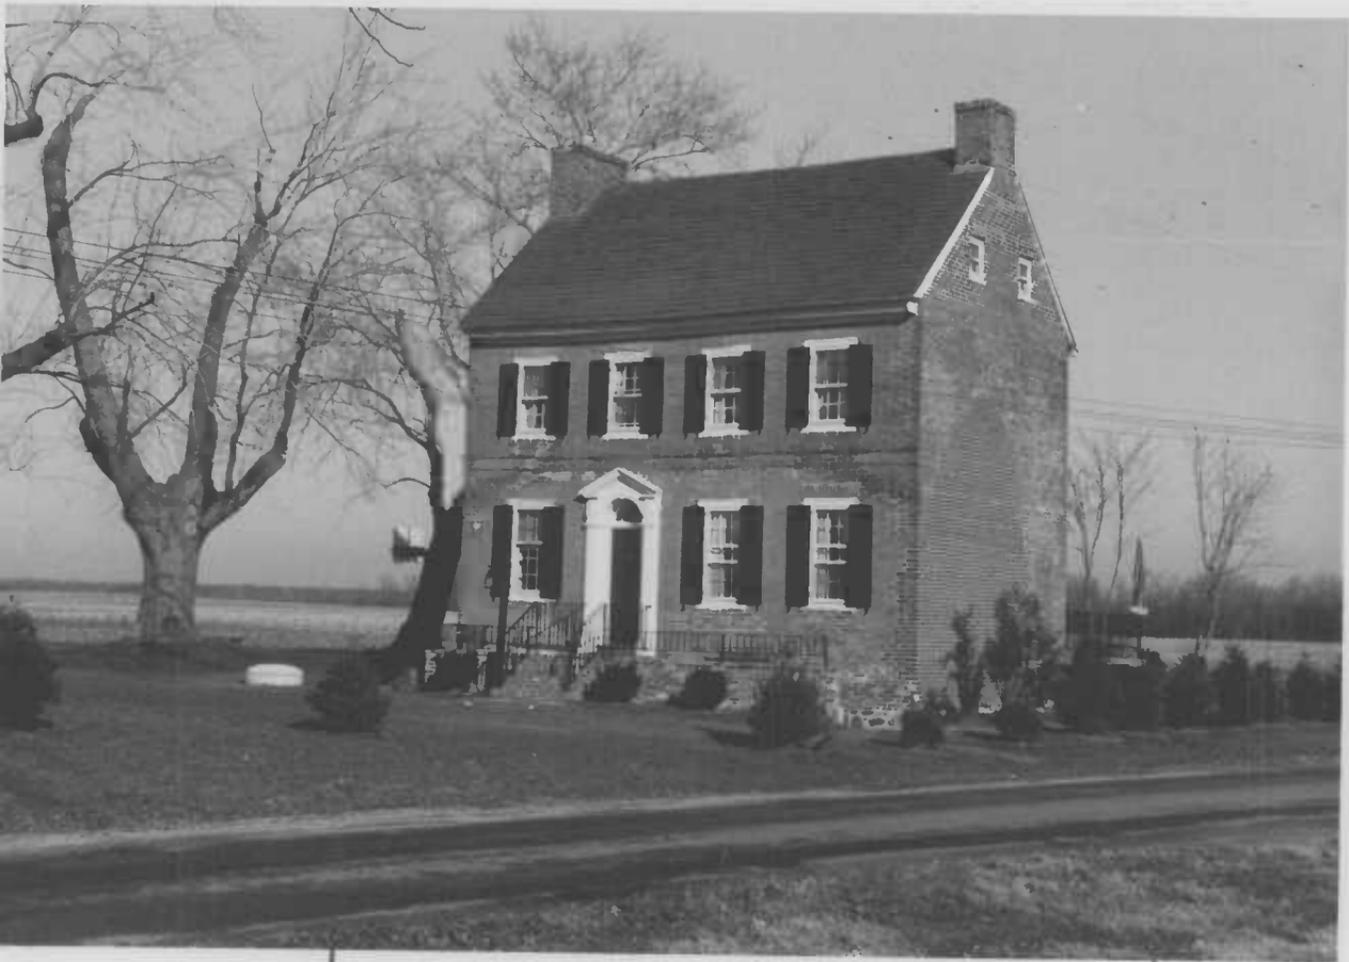
This 2-1/2 story dwelling has a gently sloping A-roof and is four bays wide and one room deep. It has Flemish bond brick construction on the front and common bond sides and rear. The first floor windows are 6/9 while those on the second floor are 6/6. The front door occupies the second bay from the left. There are flat brick arches over all the windows. The door is topped by a Federal fanlight and is molded nicely. Between the first and second stories on the front of the house is a four string belt-course. The top row of bricks in the belt course protrudes slightly. There is an enclosed chimney at each end of the house. A tiny corner staircase winds up from the basement to the attic of the house.

South Elevation
