INVENTORY FORM FOR STATE HISTORIC SITES SURVEY Magi No. 0812205404

Beaven Log House

Rowland Road east of Liberty Grove road

Port Deposit VICINITY OF

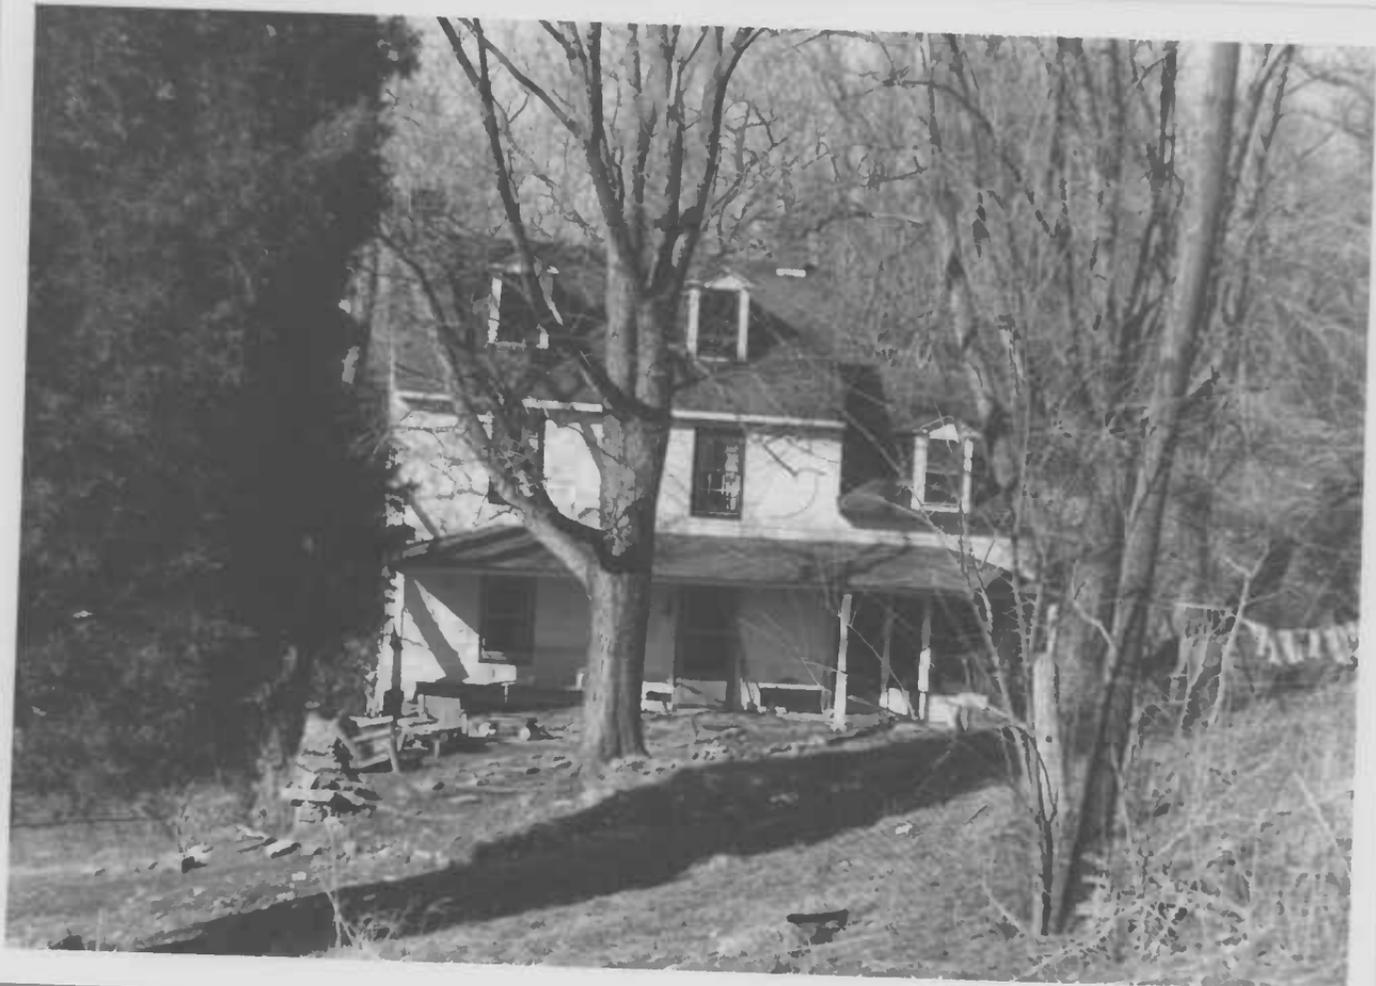
SOUTH ELEV.

The south facade of the log section is two bays across with an entrance in the eastern bay. The door has been replaced. 6/6 sash windows occupy the other openings. A corner bead on the surround serves as decorative window trim. Two identical sash light the second floor. A hip roofed porch covers the first floor and is supported by partially chamfered posts. A boxed cornice stretches across at the base of the roof and two gabled 6/6 sash dormers light the attic. The south side of the stone wing is two bays across with an entrance in the western of the two openings. A three sided bay window occupies the other bay and the shed roof porch covers the first floor of the wing. The south roof slope of the 1 1/2 story wing has a single 6/6 sash dormer.

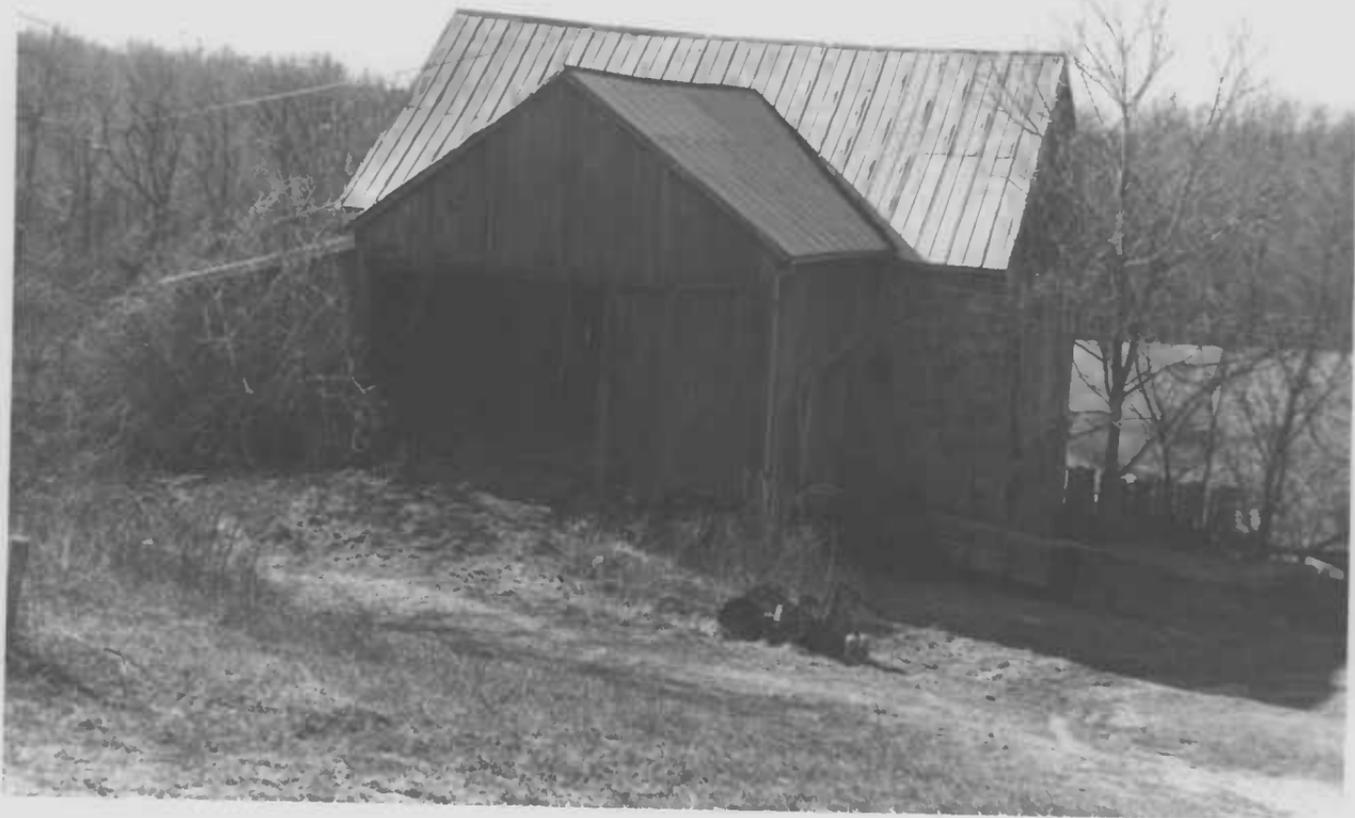
NORTH ELEV. OF BARN

A two story timber frame ^{and stone} barn stands to the south and west of the house and rests on a fieldstone foundation. It is set into a bank with a projecting entrance bay on the east side. The stone is nicely shaped and laid in courses. A later shed addition to house a dairy is attached to the south side and a shed addition off the back end.
