CHAS-18  
CHRIST CHURCH (William and Mary Parish)  
Wayside  
Private

INVENTORY FORM FOR STATE HISTORIC SITES SURVEY

CHRIST CHURCH (William and Mary Parish)

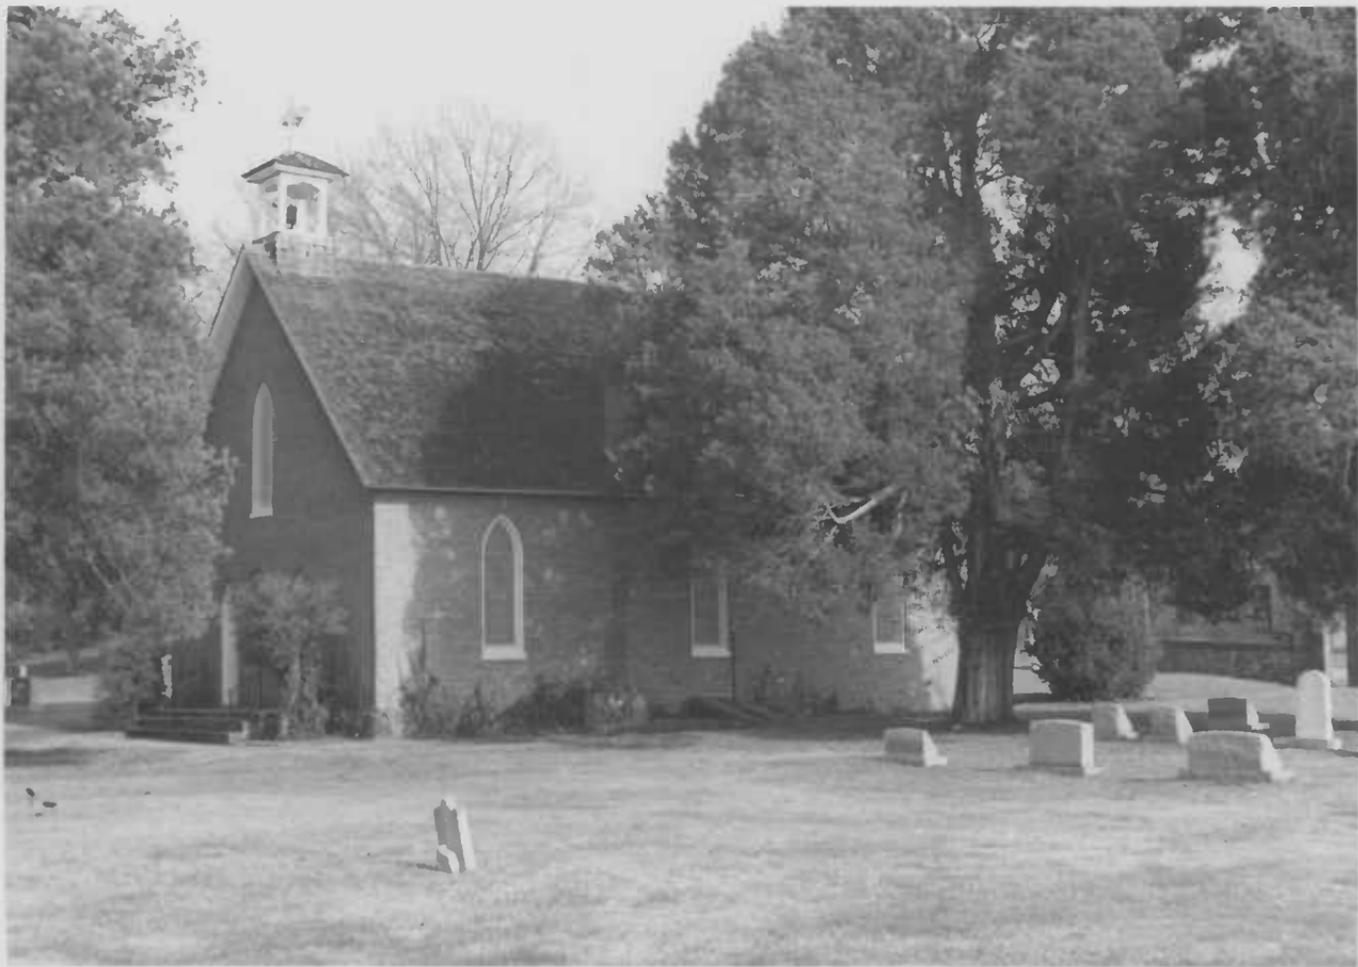
CHAS-18

View From E. JRRivoire, 1978

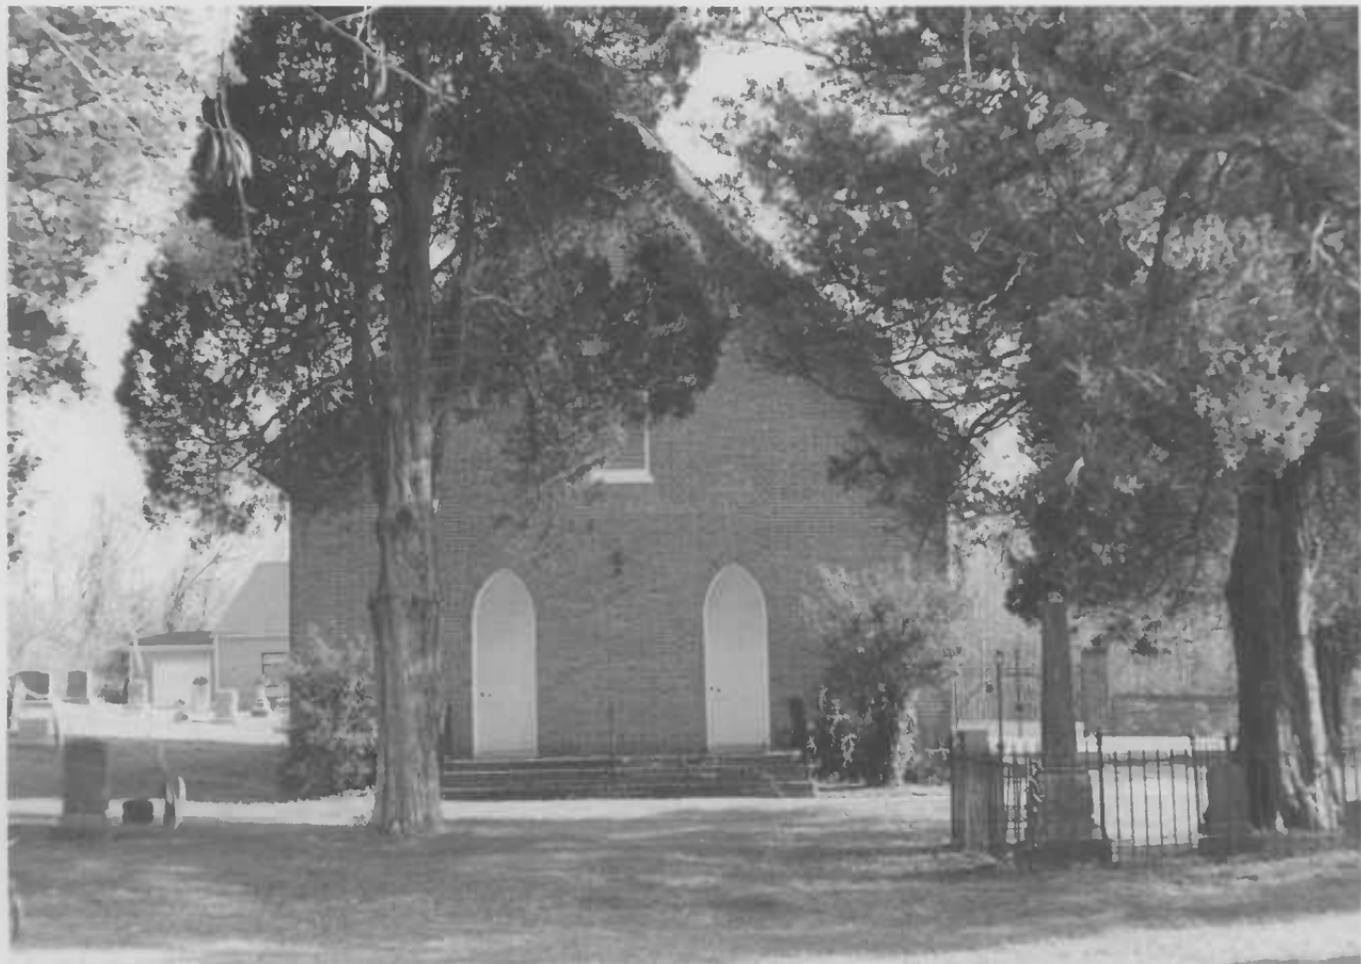
CHAS-18

A one-story, rectangular, Flemish bond brick structure with chamfered watertable, Christ Church is the smallest of the county's five eighteenth century Episcopal churches. The principal facade is at the south end and has two lancet arched entrance doors with a lancet arched window centered in the gable above. To the right of the left hand door is a seam marking the right side of an earlier door opening. Above both doors are areas of reworked brick that suggest the possibility that there were once two small gable windows that were later removed and replaced by the existing window. Both doors are of a single leaf design of four panels and are framed by paneled reveals. The window is of leaded stained glass fronted by a painted wire screen.

South Front JRRivoire, 1978
