CH-54
Marshall Hall
Marshall Hall Road (MD 227)
Bryans Road
Federal

c. 1725; c. 1760

UNITED STATES DEPARTMENT OF THE INTERIOR
NATIONAL PARK SERVICENATIONAL REGISTER OF HISTORIC PLACES
INVENTORY -- NOMINATION FORM

MARSHALL HALL

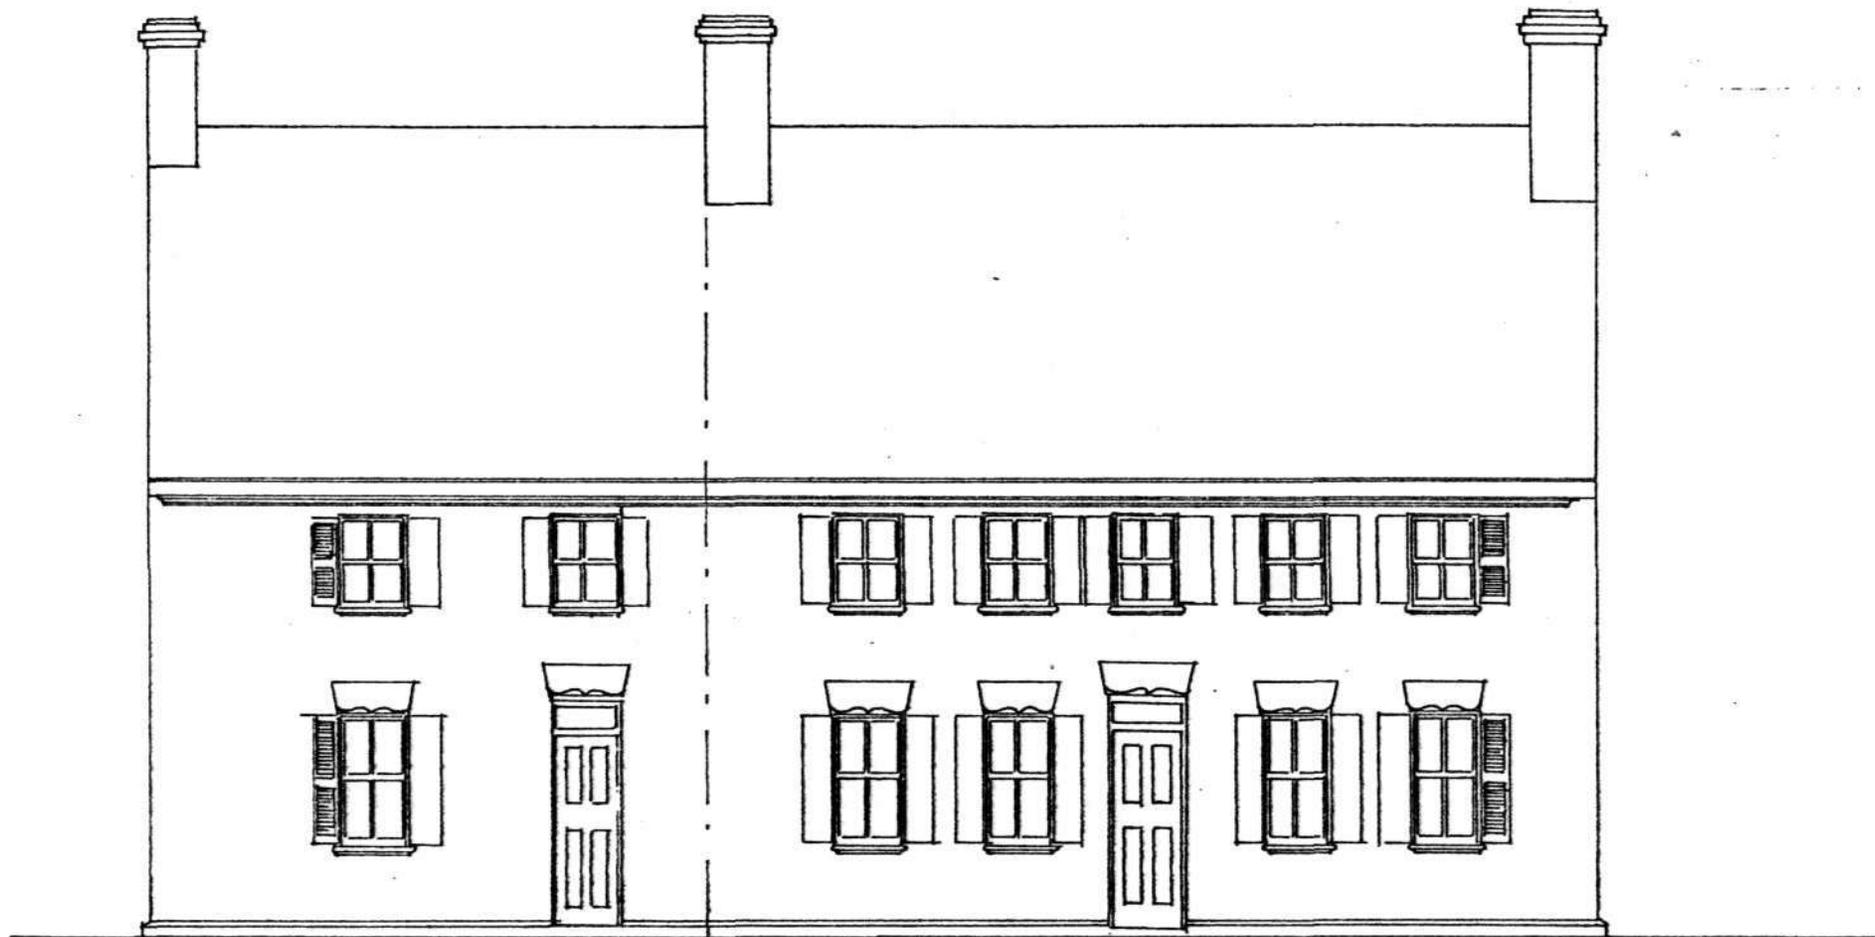
FIGURE 1

• Marshall Hall 'Mansion'
North Elevation, Front
scale: $\frac{1}{8}$ in. = 1 ft.

The river front (north facade) of the 60 X 30 foot house is seven bays in length (see Figure 1). The first five bays from the west end constitute the original house of circa 1725; the two easternmost bays date from an extension of the house made in about 1760. On the first floor the original five bays consist of a center door flanked by two windows on each side. These windows and the door have splayed brick arches of rubbed and gauged brick, the bases of which are molded in a double-ogee pattern creating a highly decorative effect.² The five similarly spaced windows above have flat unornamented heads that are flush with the base of the roof cornice. All the windows have sash of two-over-two panes that are of Victorian vintage, although the windows themselves occupy the original locations. The doorway frames a modern door and transom and is now slightly narrower than it was originally.

The two first and second floor bays of the addition (a window and a door on the first floor and two windows above) also occupy the original locations and have two-over-two Victorian sash. The doorway frames a modern door and transom; the original width, however, is retained. An interesting feature on this elevation of the addition is the manner in which the bases of the window and door heads of the first floor were crudely chiseled out in an attempt to repeat the decorated flat arches of the four windows and door of the original house.

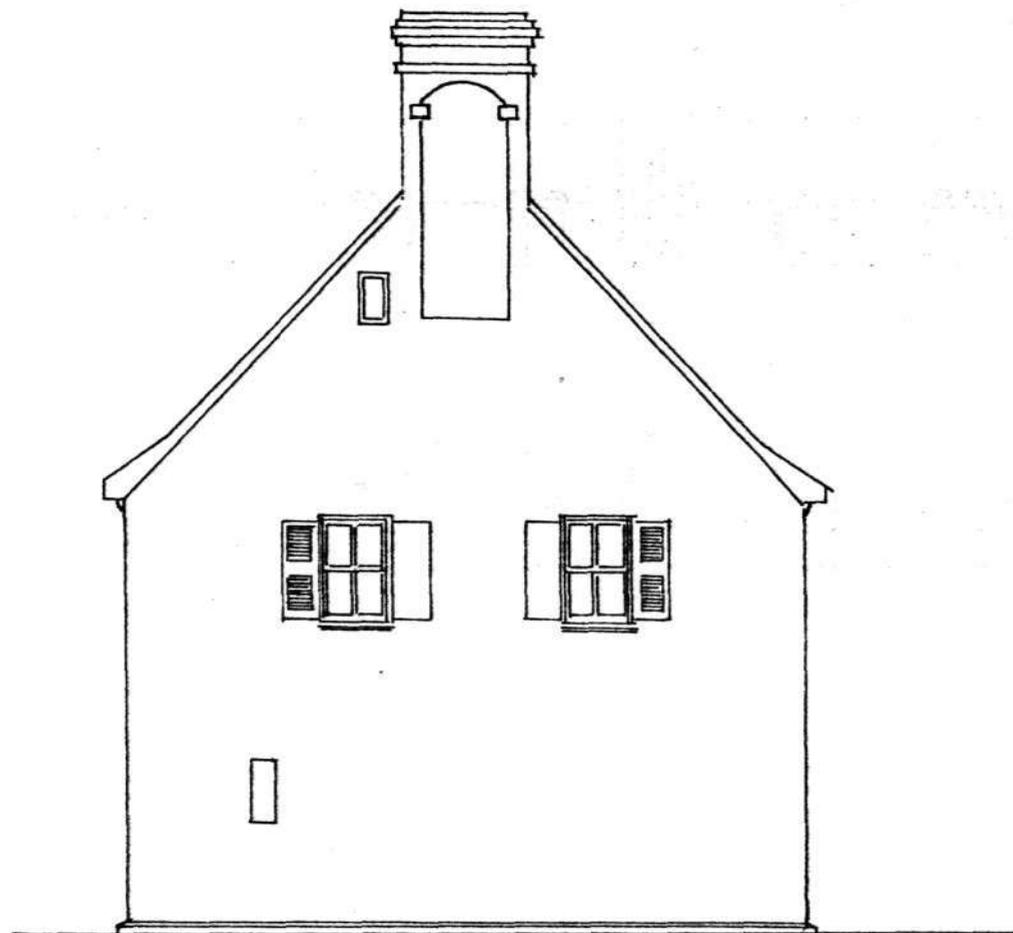
Marshall Hall "Mansion"
West End Elevation
scale: $\frac{1}{8}$ in. = 1 ft.

Before renovation of the house in 1966, the west end displayed a large flush chimney decorated on its outside face by an arched blind panel extending up from about the middle of the gable to just below the corbeled chimney cap (see Figure 2).³ In 1966 the chimney stack was rebuilt above the gable peak and, though the panel was rebuilt, the arch was not. When first built, the west end was broken only by a very narrow closet window near the north end of the first floor and an even smaller louvered vent near the top of the gable. Of these two openings, only the attic vent remains, the closet window having been bricked up at an unknown date. At the present time, there are two second floor windows that replaced doors introduced when a veranda was added to the house in the late nineteenth century. The east end of the house is now devoid of any openings as the two windows originally near the north end of the first floor were later bricked up.

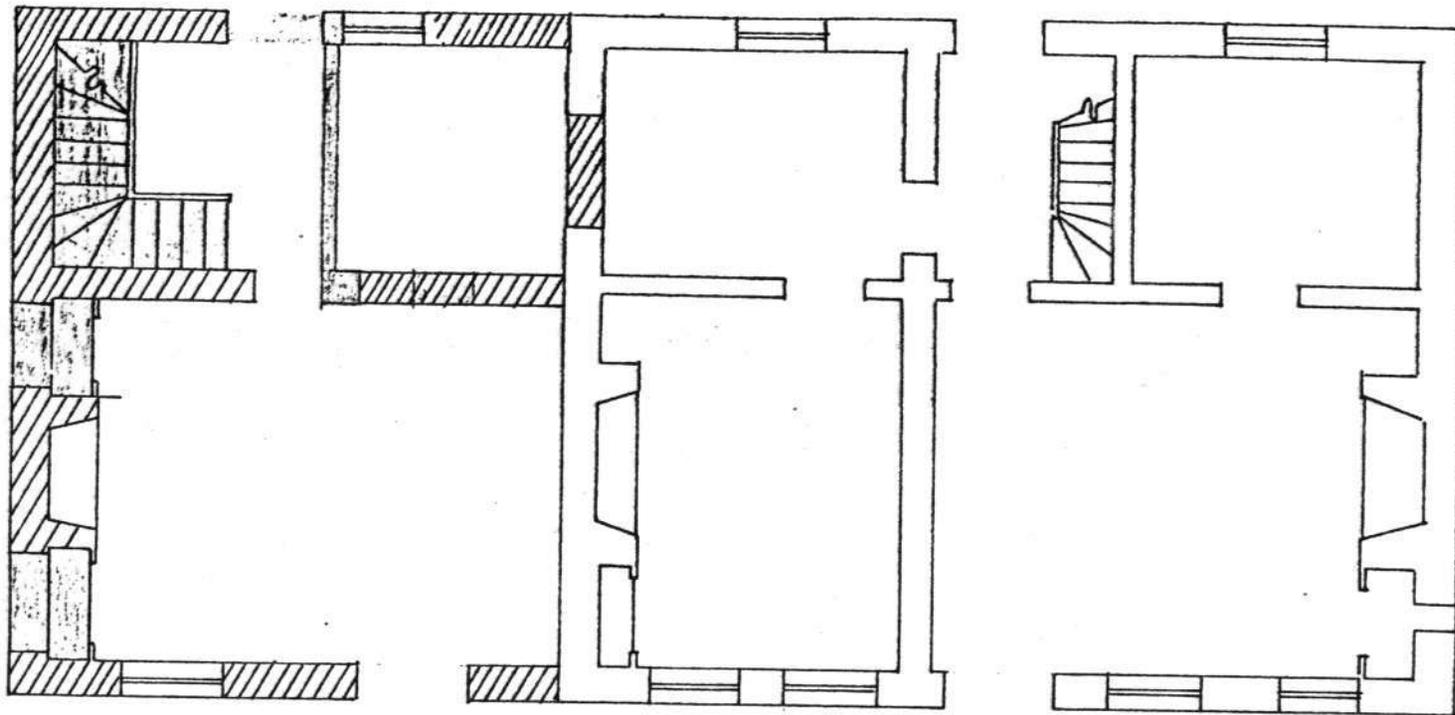
FIGURE 3

✧ Marshall Hall "Mansion"
GROUND LEVEL FLOOR PLAN ✧

In 1966 the interior of Marshall Hall was renovated for conversion to offices. The basic plan was retained (see Figure 3), as

The ground floor room configuration of the older, circa 1725 house consisted of four rooms with a short, centered, rear stair hall, a plan characteristic of Charles County architecture throughout the eighteenth century.⁴ The front entrance door opened into the largest (northwest) of the four rooms, which had walls completely covered with fielded panels, as well as heavily molded baseboards, chairrails and ceiling cornices, paneled window and door reveals, and a plastered ceiling. On the west wall was an expansive fireplace with rounded back, framed by a wide bolection molding. This fireplace was made smaller in size in the late nineteenth century and a new, Victorian-style mantel installed within the area framed by the earlier bolection molding. Flanking the fireplace on the north side is a shallow closet with paneled door and shelved interior. The closet was once lighted by a small window in its west wall which has since been bricked up and plastered over.

The initial plan of the addition included a large, full width front room that from all available evidence served as a kitchen (see Figure 3). The rear section of the first floor was a recessed porch, open to the outside by a wide arched doorway. The only early features known are that the north kitchen room had plastered walls, exposed beaded ceiling joists, a large fireplace on its east wall flanked by a window on each side, a door and window in its north wall, and a door and window on the south side. The kitchen floor might have been wood, as it is today, but it was probably paved with brick, as was the porch floor. In about 1800 the kitchen was remodeled to serve as an additional living area by plastering over the ceiling and installing new baseboards, chair-rails and a ceiling cornice. The fireplace was made smaller and a Federal-style mantel provided. The two windows flanking the fireplace were bricked up and two cupboards, each with two sets of paneled double doors, were installed in these areas. The porch was divided into two rooms and the former arched doorway filled in and a single door and window installed in its place. It is believed that the existing stair on the east wall of the southeast rear room was provided at this time, probably replacing a stair in the former kitchen room.

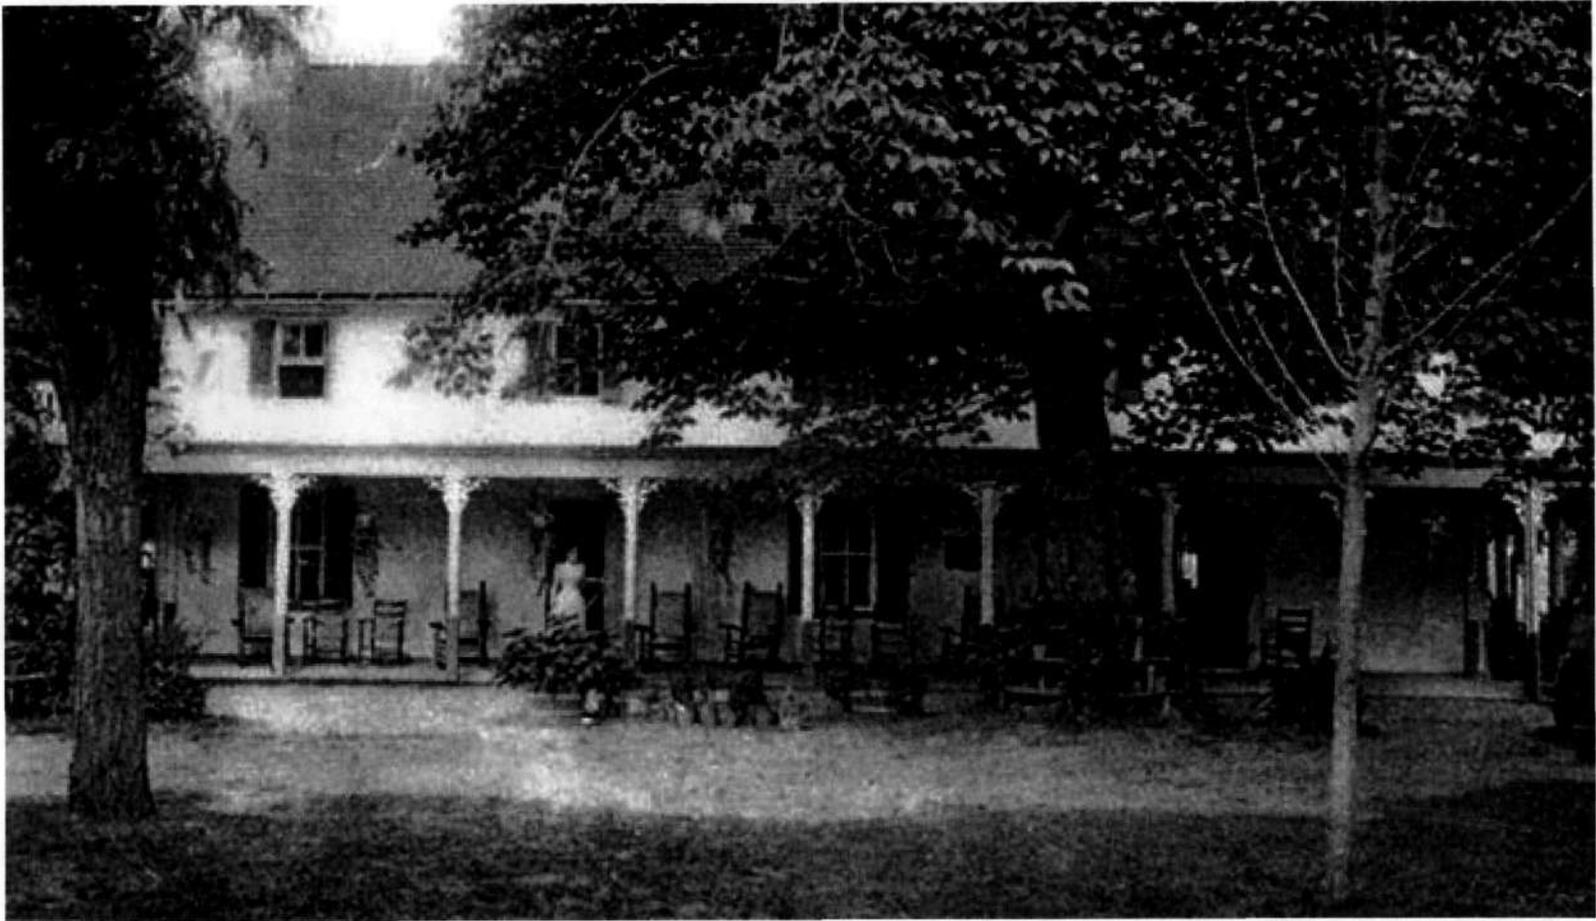
CH-54
Marshall Hall
c. 1900
South elevation

the older part, are unornamented and flush with the roof cornice. All windows on this elevation also held 2/2 Victorian sash. A photograph taken c. 1900 shows a Victorian porch with elaborate brackets spanning this entire elevation. Before renovation in 1966, the west gable end displayed a large flush chimney decorated on its outside face by an arched blind panel extending up from about the middle of the gable to just below the corbeled chimney cap. In 1966 the chimney stack was rebuilt above the gable peak, and though the panel was rebuilt, the arch was not. A closet window in this gable end was bricked up at an unknown date, as were two window openings on the east end of the house. Two windows pierce the second floor of the west gable end. The roof of the building flared at the eaves. Photographs from the 1950s and 60s show a modillioned cornice with ogee crown and bed moldings decorating the front and rear elevations, but this was removed in 1966. The basic interior plan was retained, along with a substantial amount of interior fabric. In 1976, the National Park Service bought the property, and planned to restore the building. On October 17, 1981 the house was completely gutted by an arson fire, leaving only the brick walls standing. The 60' x 30' walls were stabilized and fenced off until the building suffered yet another accident on January 12, 2003, when a large truck drove straight through the center of the building and out the other side. The bays destroyed on the south facade were the entrance bay and the bay to its east, and on the north facade, the entrance bay and the two to its east. Effectively, the central third of the building was completely destroyed.

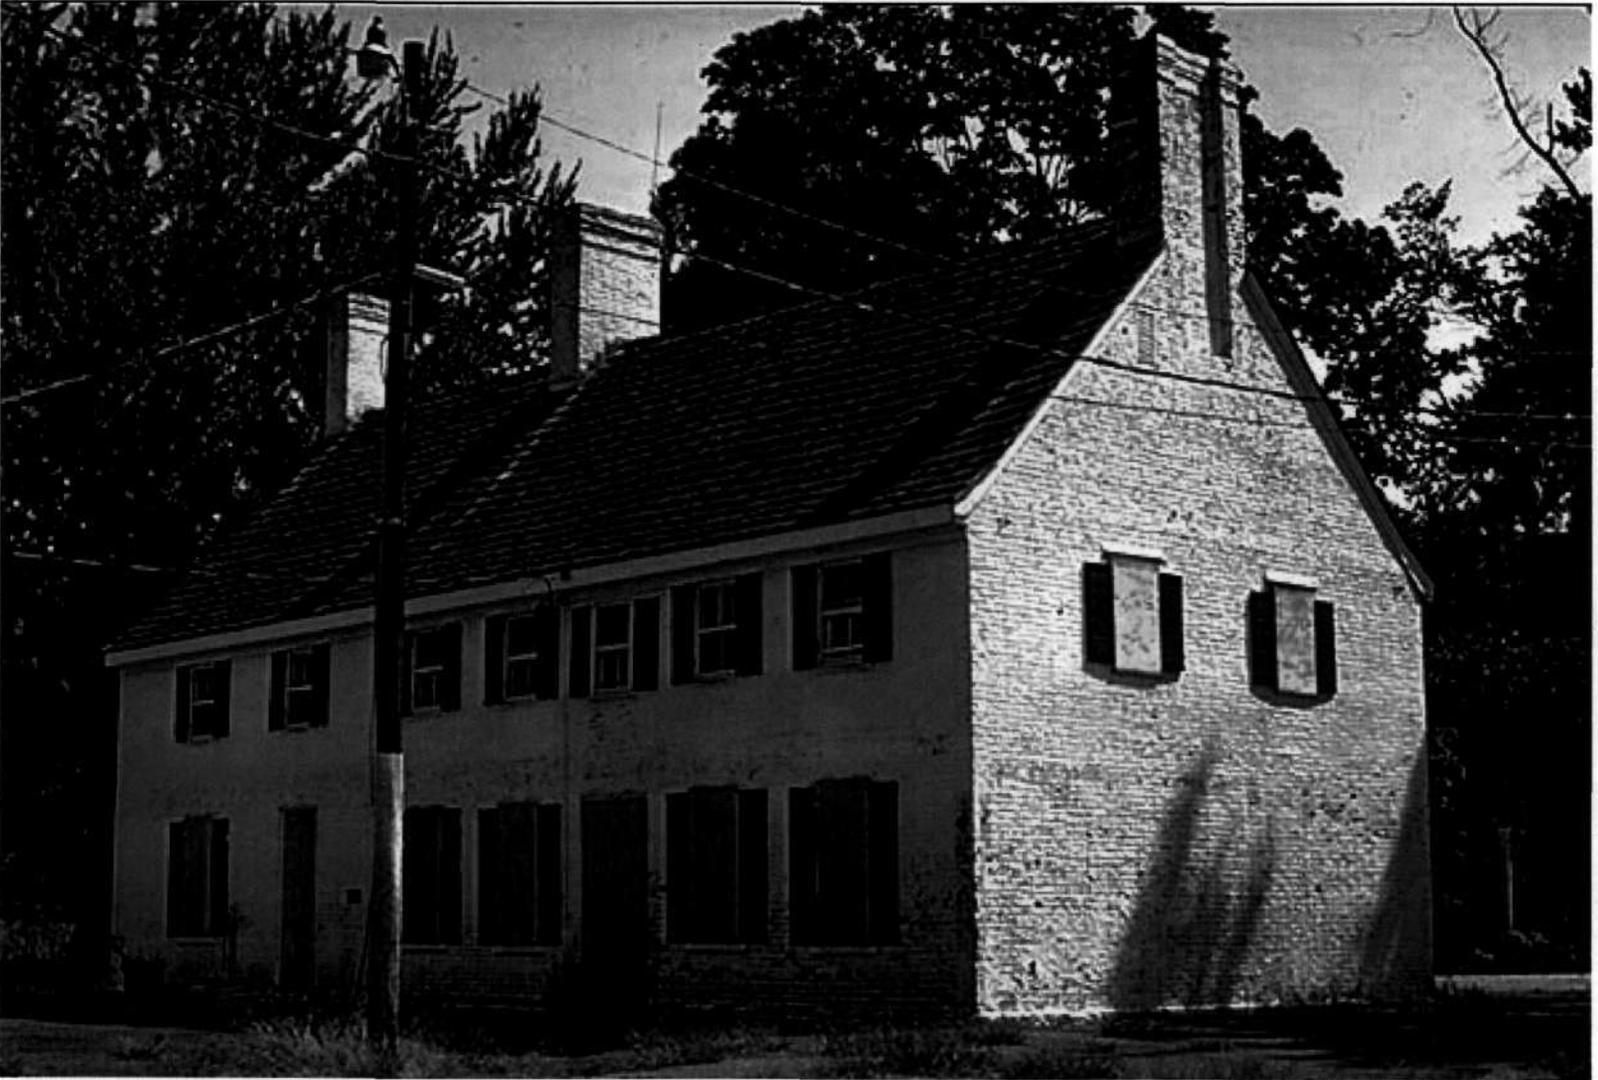
CH-54
Marshall Hall
c. 1980
North and West elevations

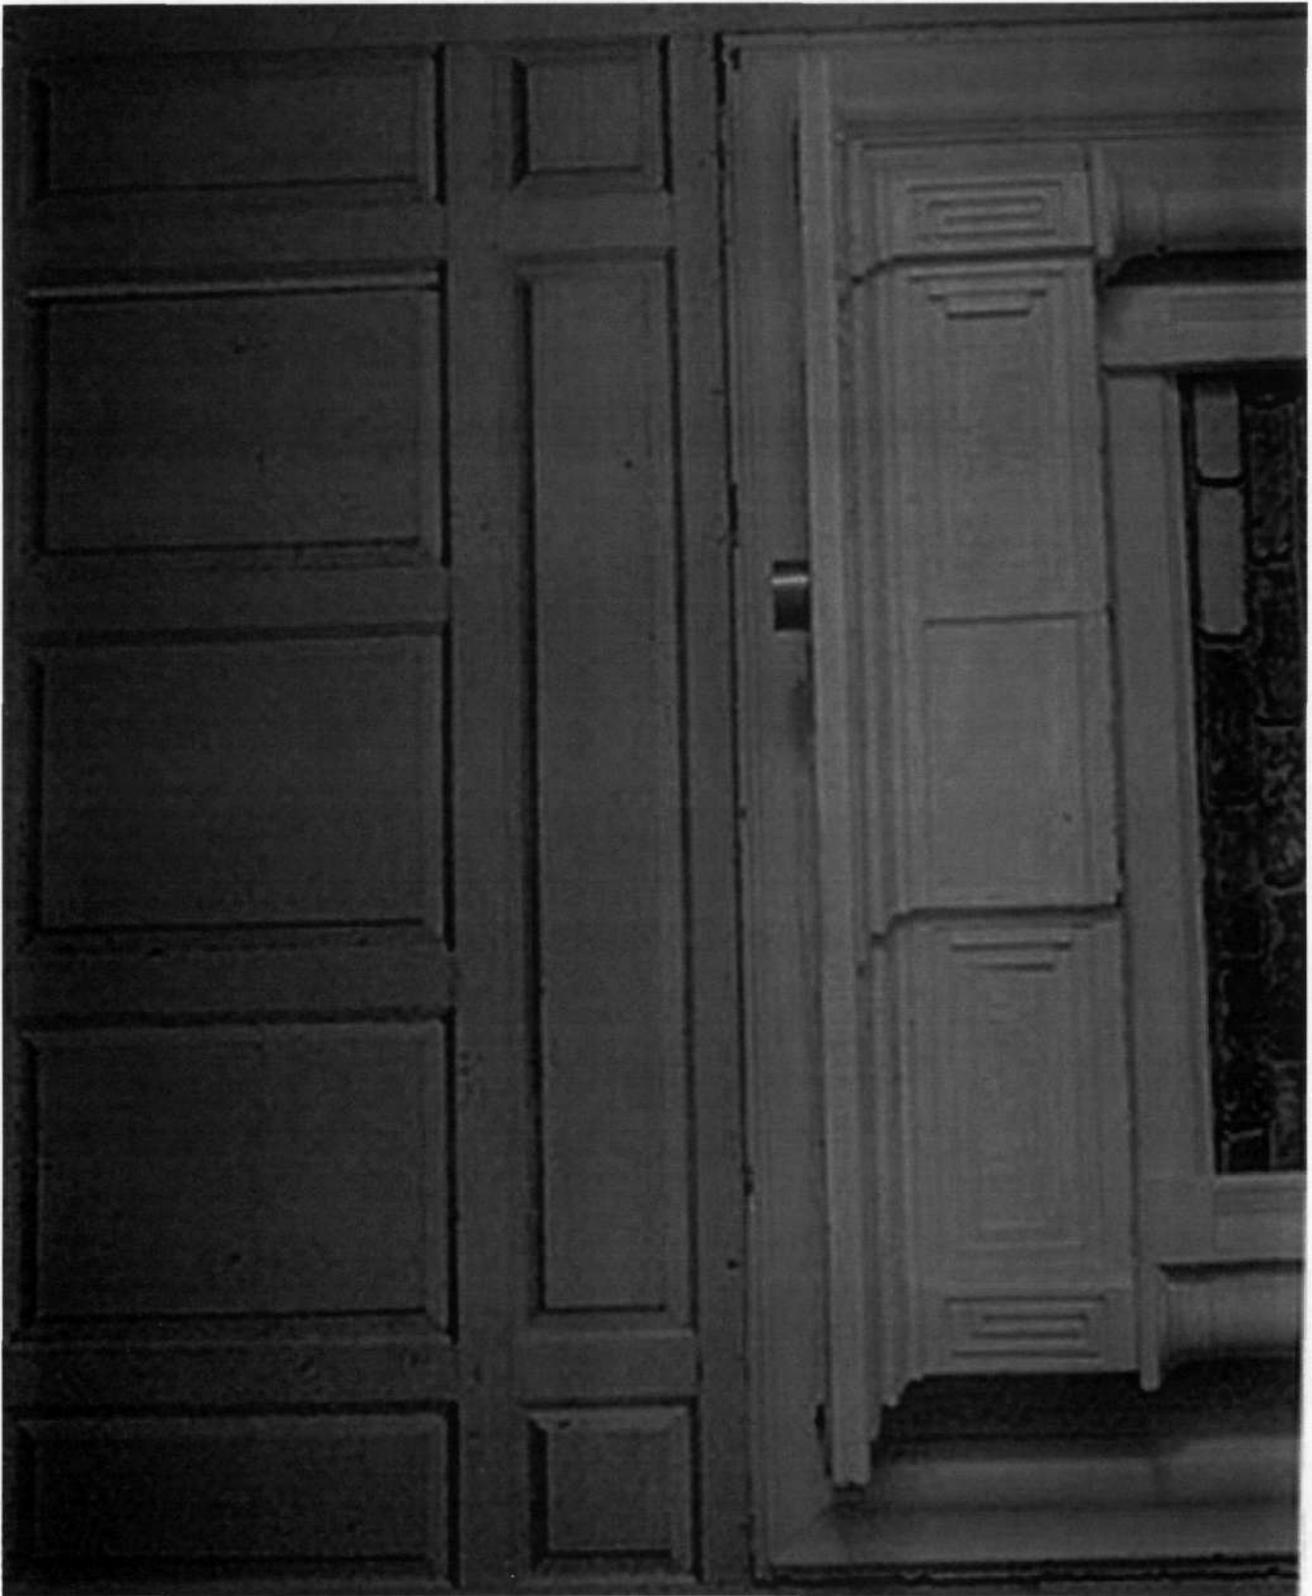
CH-54
Marshall Hall
Interior pāneling
c. 1980
