Sunnyside Farm
CH-214
Bryantown vic.
Private

Maryland Inventory of Historic Properties Form

Inventory No. CH-214

historic Sunnyside Farm

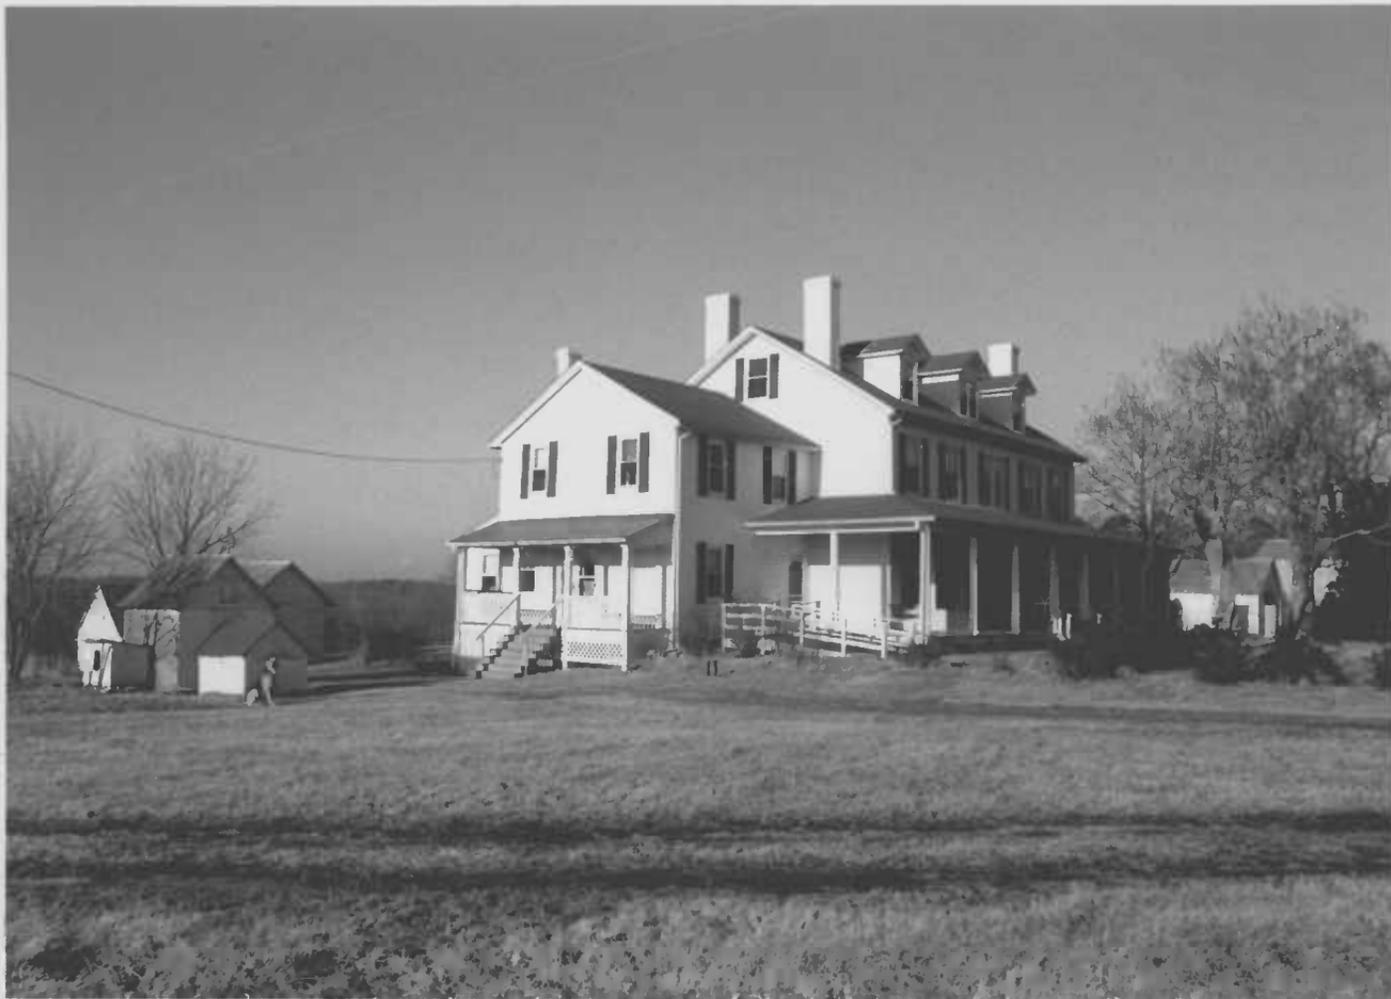
1 OF 13

LOOKING WEST

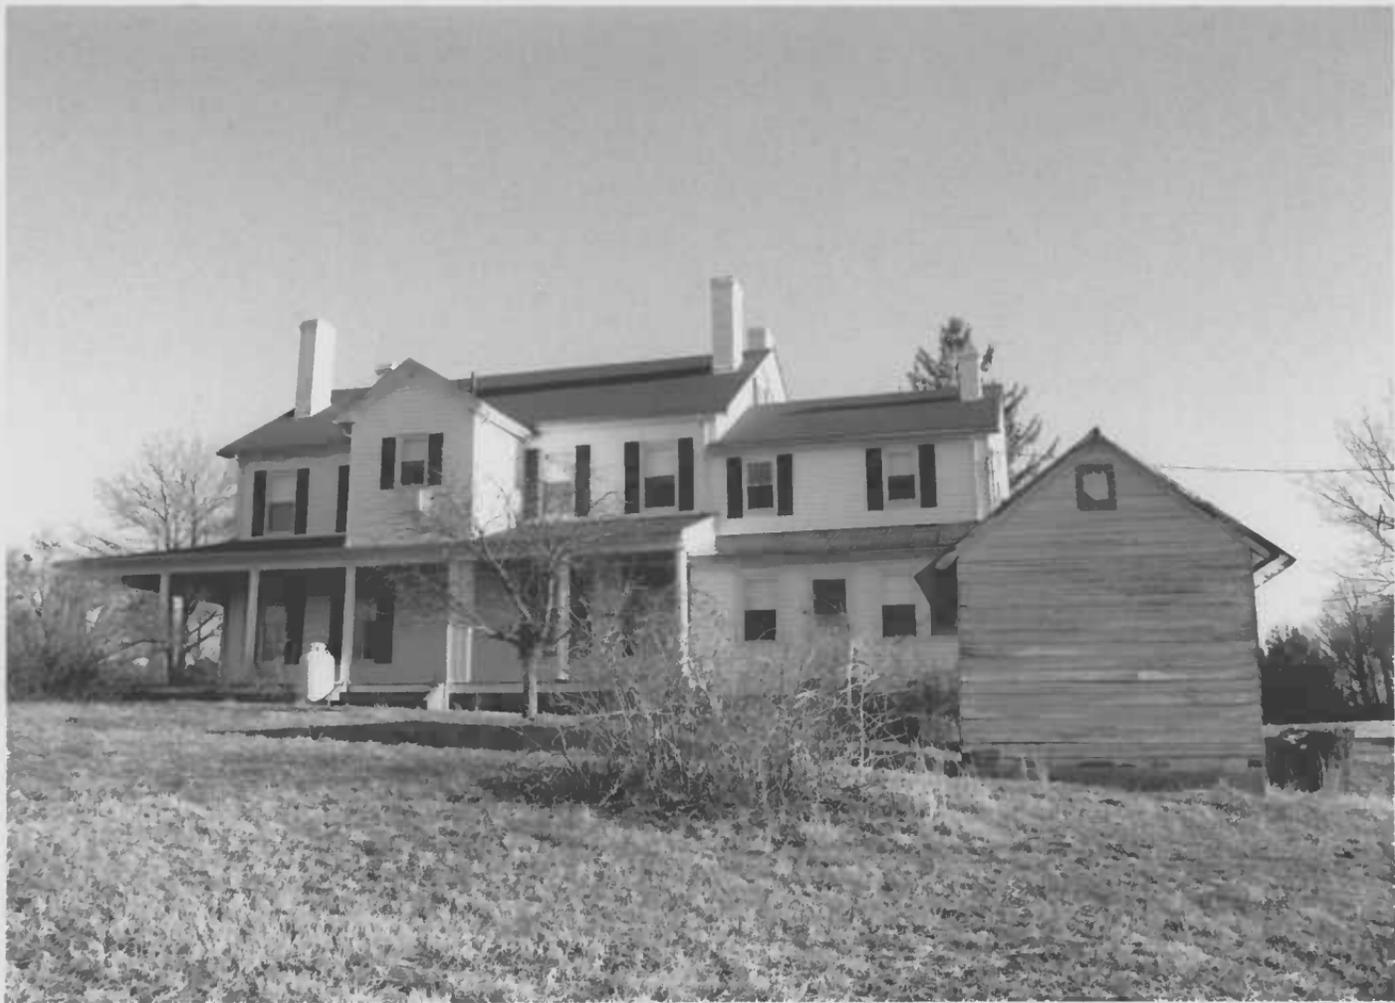
ZOF13

LOOKING SOUTH

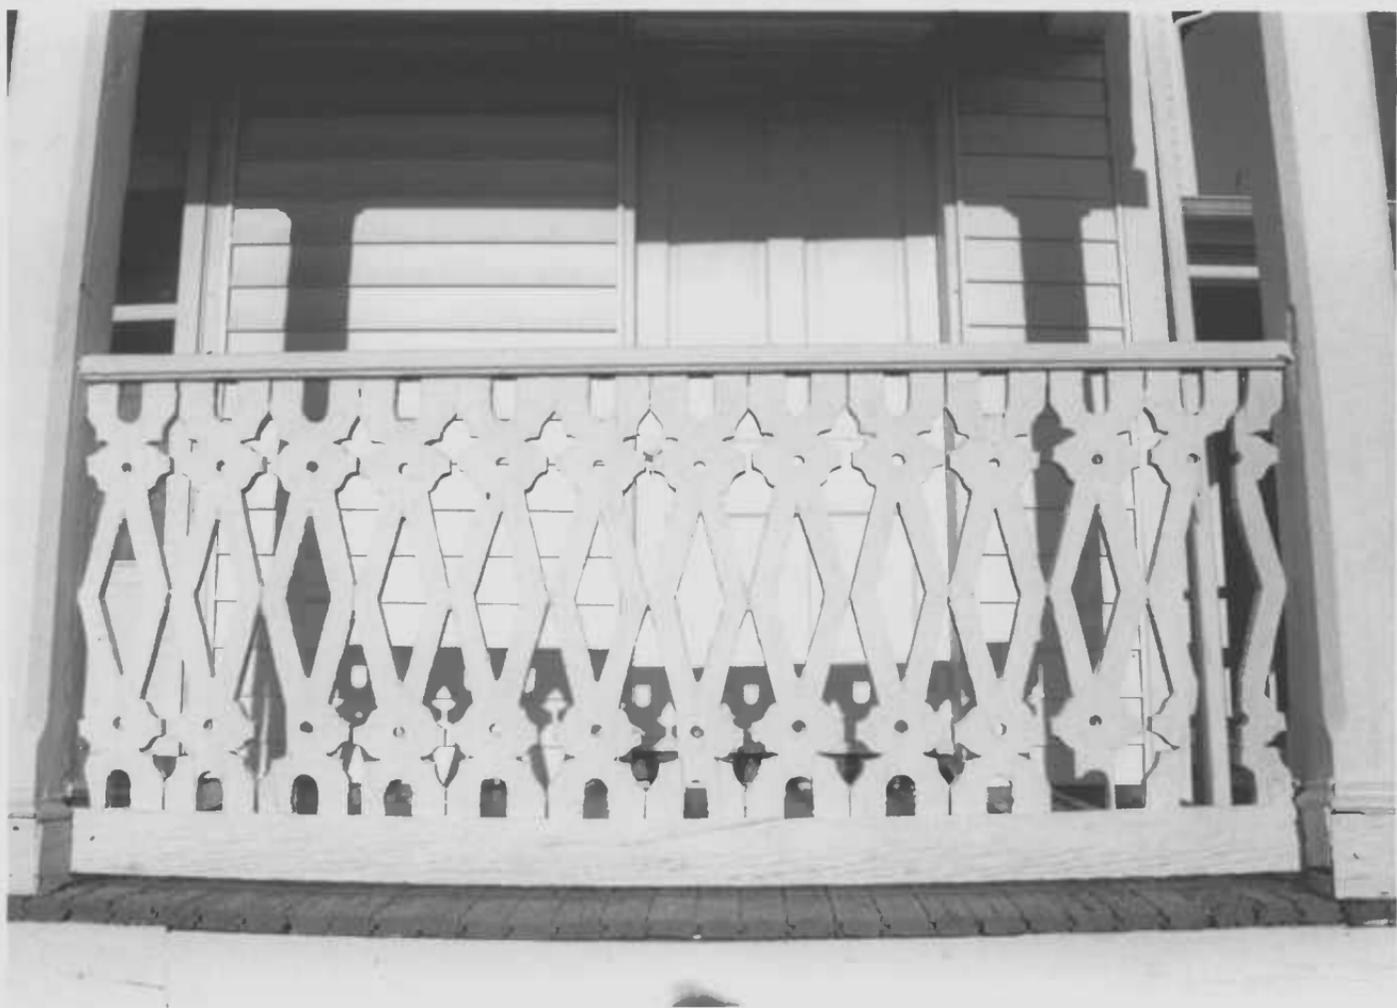
3 OF 13

A historic photograph reveals the earlier and likely original appearance of the dwelling which had double galleries on the front elevation with scrollsawn railings and decorative brackets. Part of this railing survives on the small kitchen porch at the northwest corner of the dwelling.

RAIL DETAIL, KITCHEN PORCH

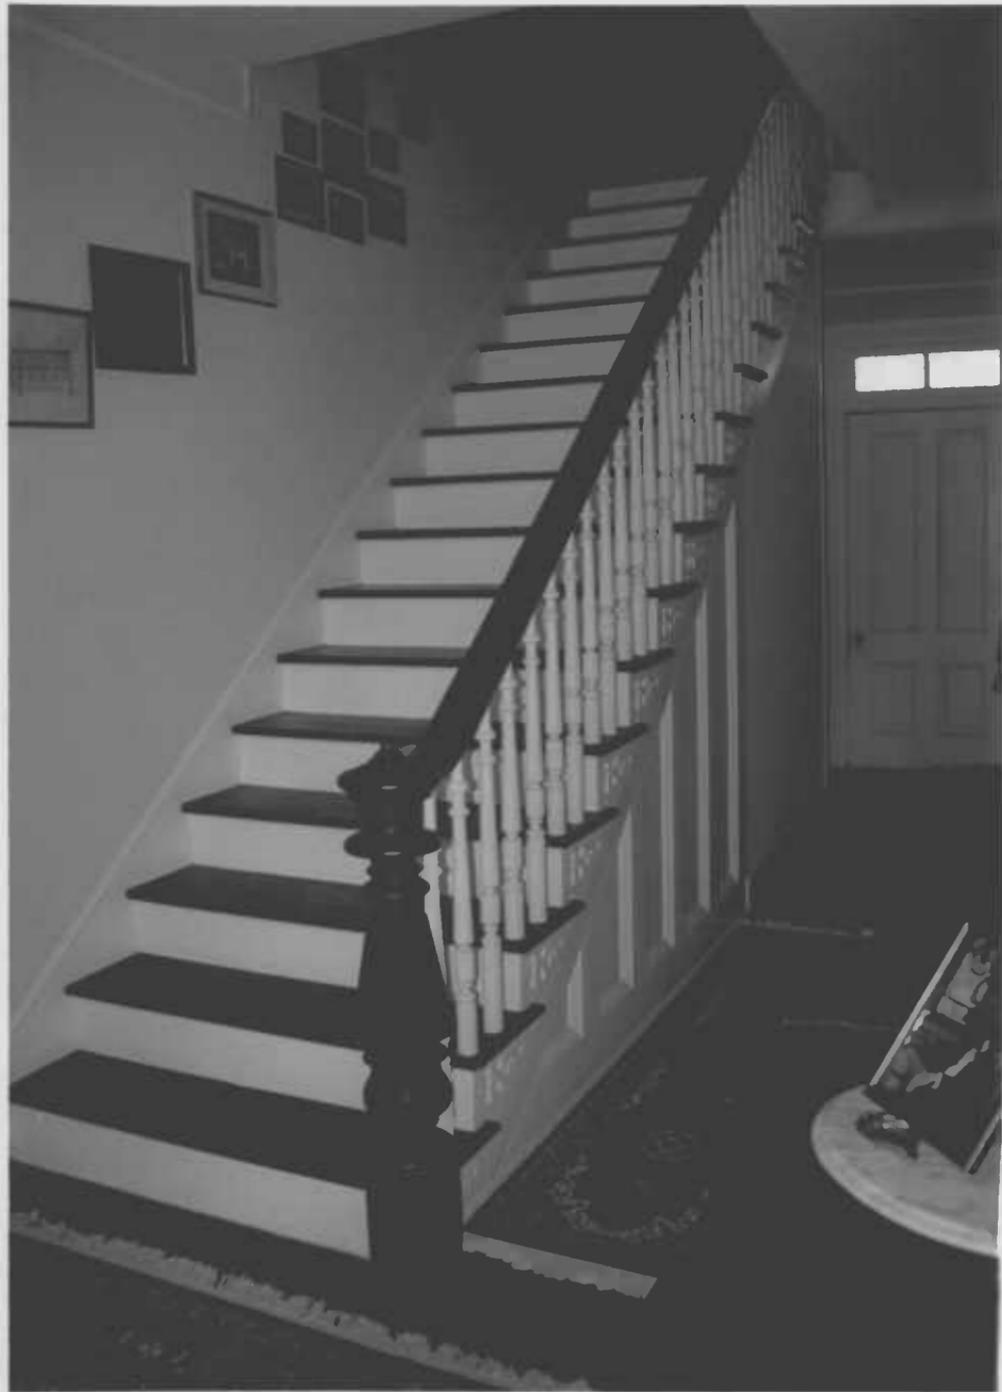
4 of 13

The interior includes characteristics commonly found on a center-passage double-pile plan including a center hall with a staircase and exterior doors at either end. Double parlors are found to the east of the hall. To the west is a set of rooms including the dining room conveniently located next to the kitchen wing. The hall retains its original newel, stair paneling and turned balusters. Flooring in the hall consists of 2 1/4 inch plank and probably dates to the c. 1920 renovation. The double parlors on the north side are divided by large tuck away paneled doors. These two rooms also feature original lighting fixtures from the time the home was first electrified. Currently an early 20th century door divides the two rooms on the north end, suggesting that the partition wall is a later alteration. It may have originally consisted of either one large dining room, or a tuck away door similar to that found on the opposite side of the hall. A small bathroom has been added under the stair at the rear of the hall.

MAIN STAIR, LOOKING NORTH

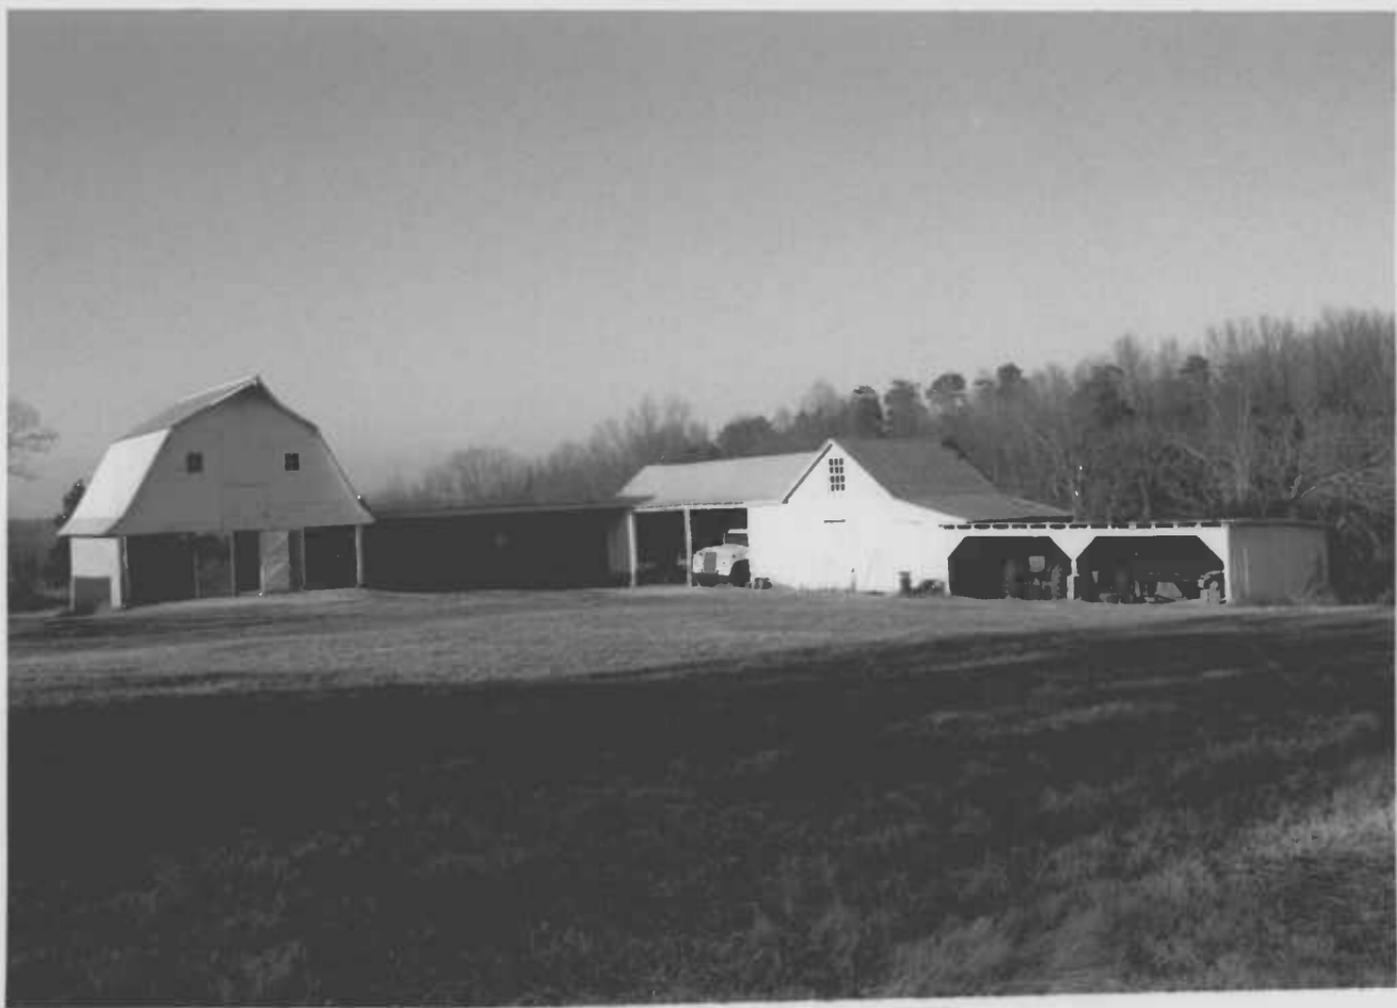
6 OF 13

The carriage house is a single bay, front gable, frame structure resting near the dwelling house. Next to the carriage house begins a connected structure that joins the stable, equipment shed, granary and workshop. The stable is a concrete block gambrel roof structure with a handful of stalls to the left, an open area to the right, and a center isle down the middle. Connected to the stable is a shed roof equipment shed that is in the form of an L. At the end of the L is a front gable granary with a center 6/6 light window in the attic story. Attached to the granary is a small room used as a workshop.

FARMYARD, LOOKING EAST

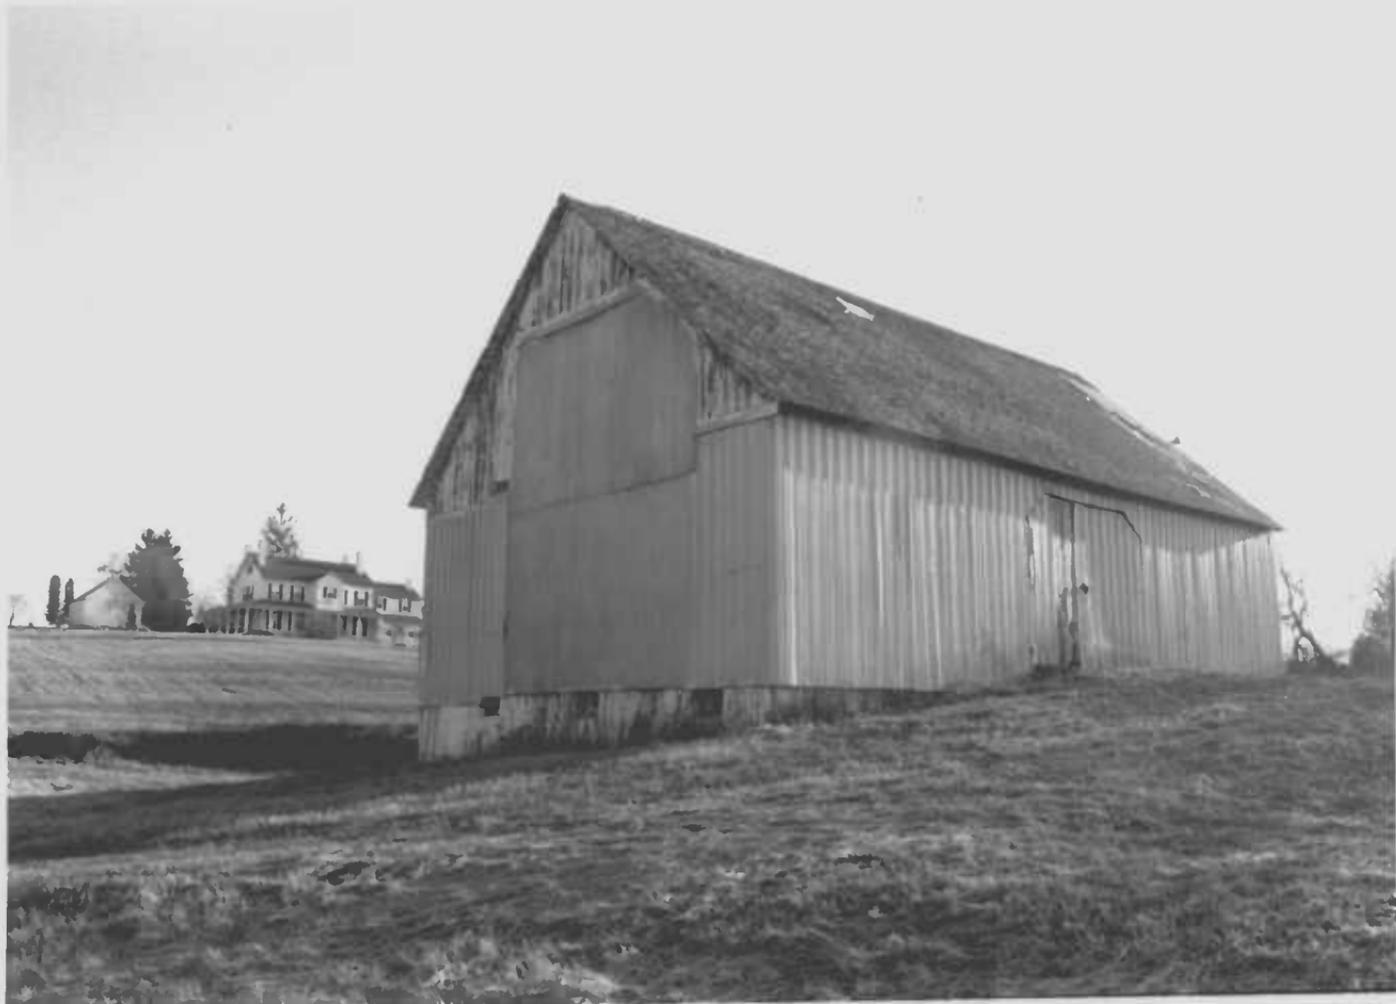
7 OF 13

Behind the dwelling is a large c. 1920 bank barn consisting of a frame structure resting on a concrete block and poured concrete foundation. Used as a dairy barn, the bottom section is accessible on the southwest elevation and includes a center isle flanked by a feeding area to the left and a milking area to the right. All columns are white-washed. The upper loft is accessed through either a loft stair in the rear or by a earthen ramp on the northeast wall. The loft is an airy open room with a wooden floor. The roof features a pulley system to assist in processing hay.

BANK BARN, LOOKING WEST

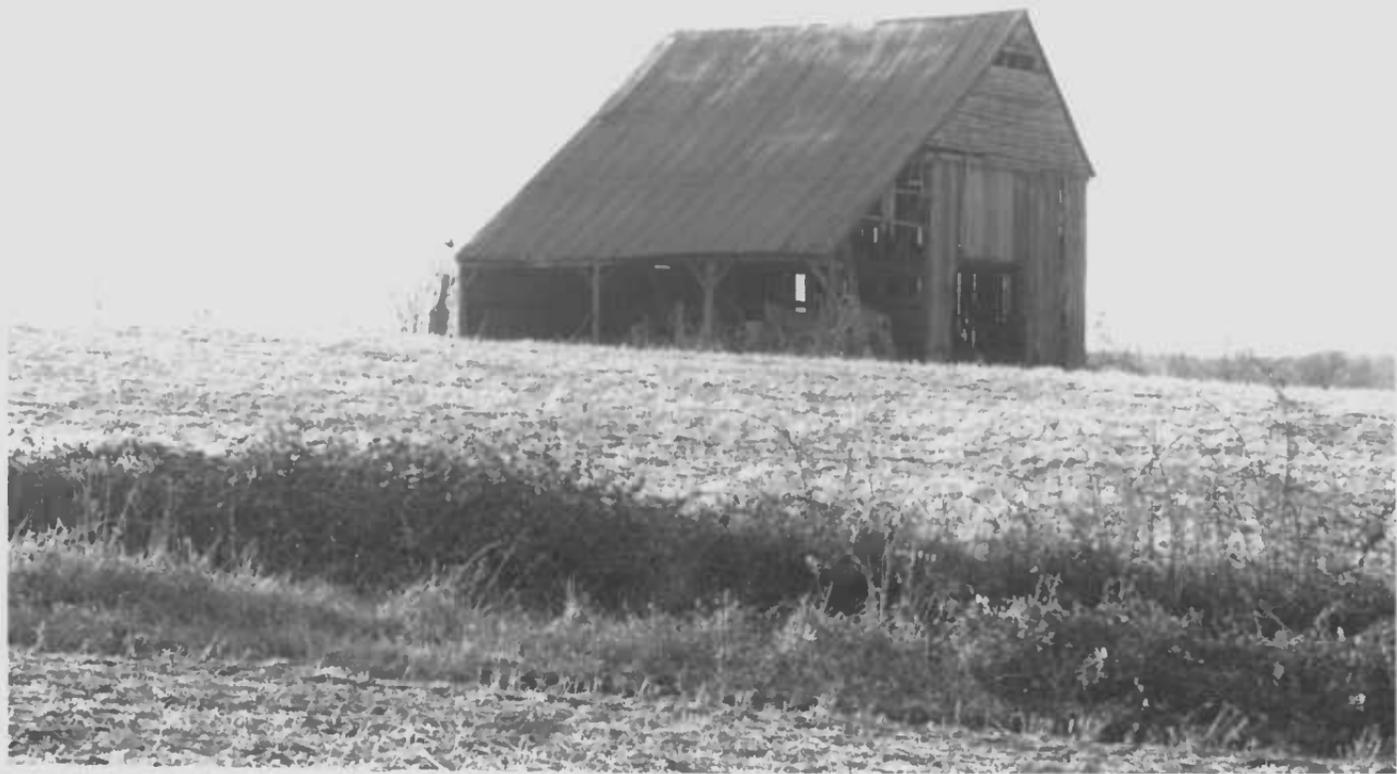
8 of 13

This building appears to date from the middle of the 19th century. It is rectangular in form with a three bay shed extending from the southwest wall. The plate has a regular number of empty mortises suggesting the earlier presence of additional studs needed for horizontal clapboard siding. Some original riven clapboards are visible on the southwest wall under the shed addition and under the east gable. Doors on the gable ends have been altered to accommodate machinery. According to the Edelen Family, an additional structure was once attached to the west end, but was torn down around 1985. At one point used as a stripping shed, this addition is said to have included hand-hewn post and beam construction.

TOBACCO BARN, LOOKING NORTH

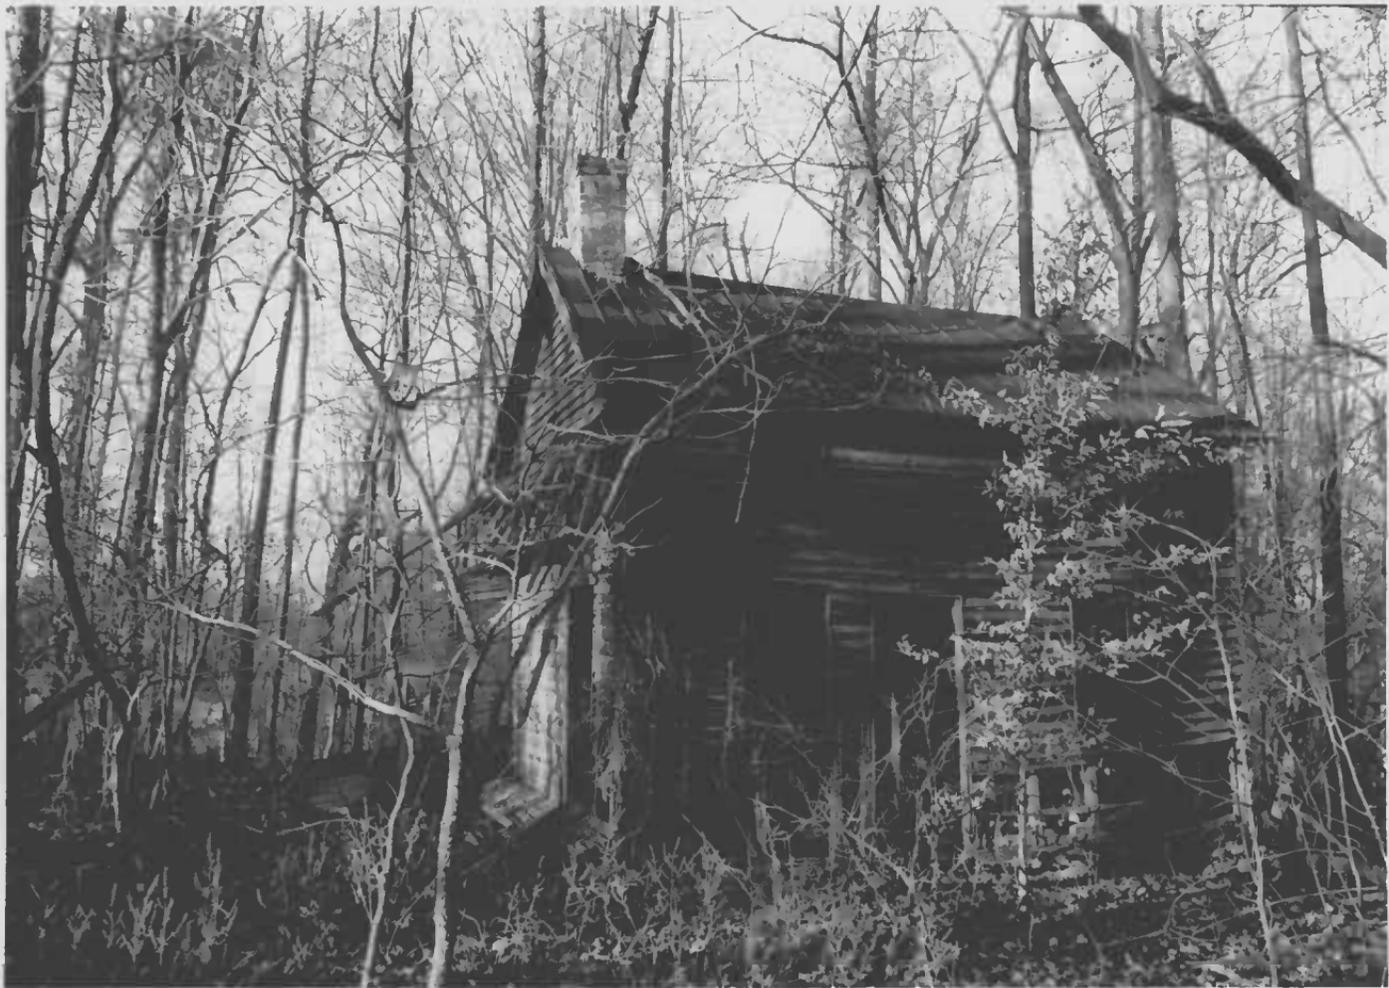
9 OF 13

Near the south field barn complex is a small tenant house constructed c.1875. It is a modest frame structure with a hall and parlor plan. The building, now ruinous, stands on a brick and stone rubble pier foundation. Weatherboard siding covers the frame and a single stove chimney projects from the metal roof. Although much of this siding was replaced early in the 20th century, the northwest wall which was eventually enclosed under a shed addition, includes original siding attached with cut nails. Missing siding reveals that the endposts were braced downward.

The front elevation faces southwest and includes four windows - two first floor and two above. Remnants of the original windows suggest they were 6/6 sash. The original doorway stands between the first floor windows. Moving clockwise, the gable elevation includes a single doorway. The rear elevation differs from the front, including only two first floor windows. The opposite gable end is without fenestration.

TENANT HOUSE, LOOKING ~~HOUSE~~ EAST

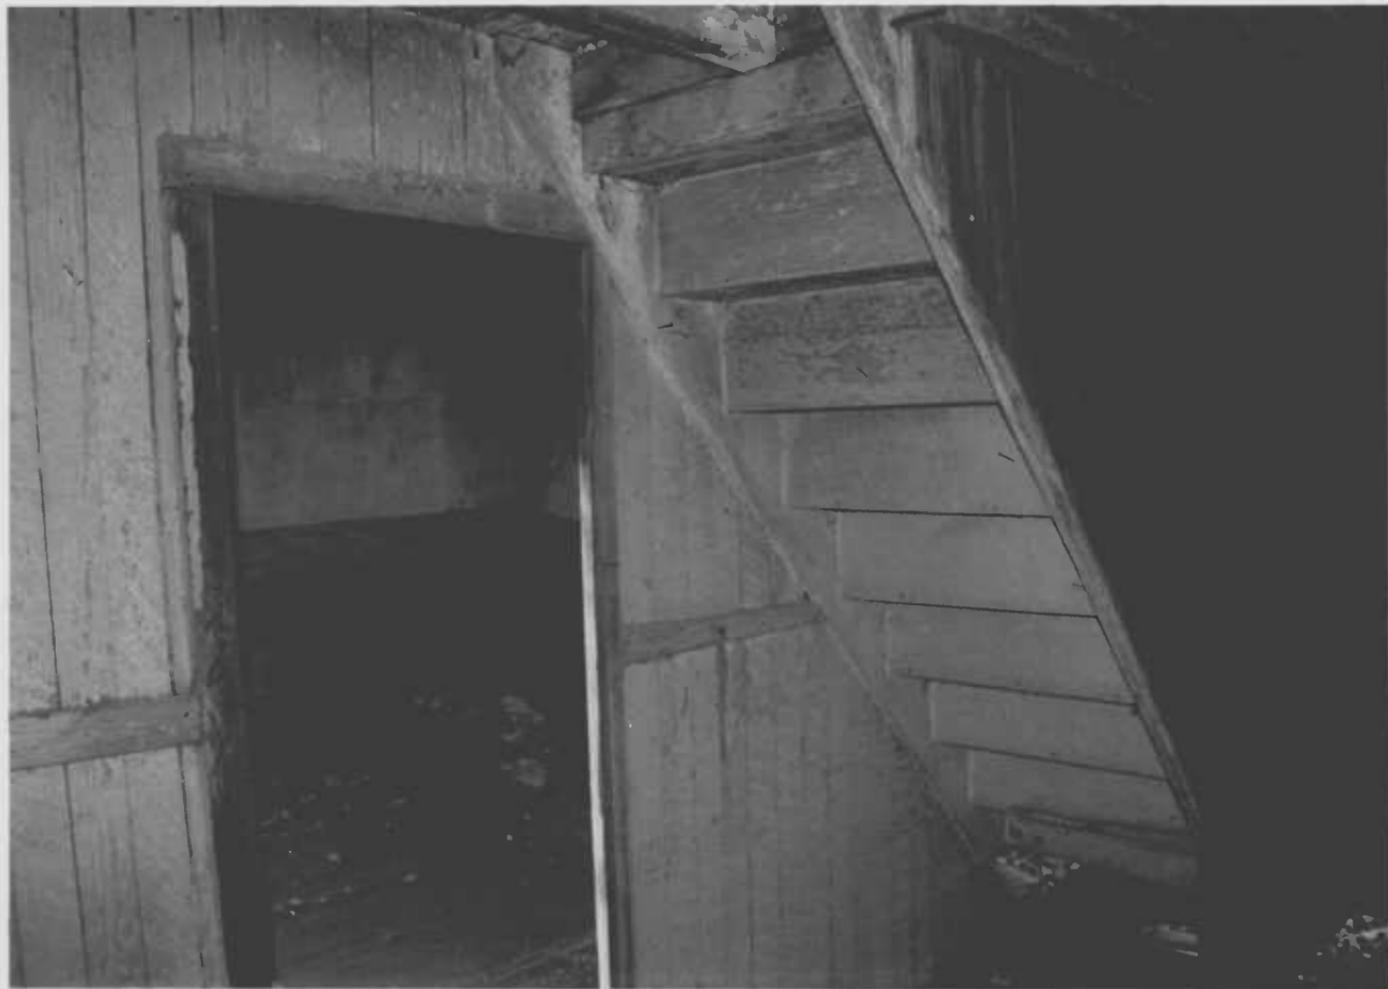
10 OF 13

The interior consists of two rooms below and one large room above. The main entrance opens into the larger of the two rooms which is plastered from the ceiling to approximately three feet from the floor. Below the plaster line the walls are formed using narrow planks laid horizontally. A small enclosed stair is located in the rear of the structure dividing the two downstairs rooms from one another. The opposite room is smaller and unplastered. The walls are covered with vertical planking. Ceiling joists are exposed and whitewashed.

TENANT HOUSE, INTERIOR, LOOKING NORTH

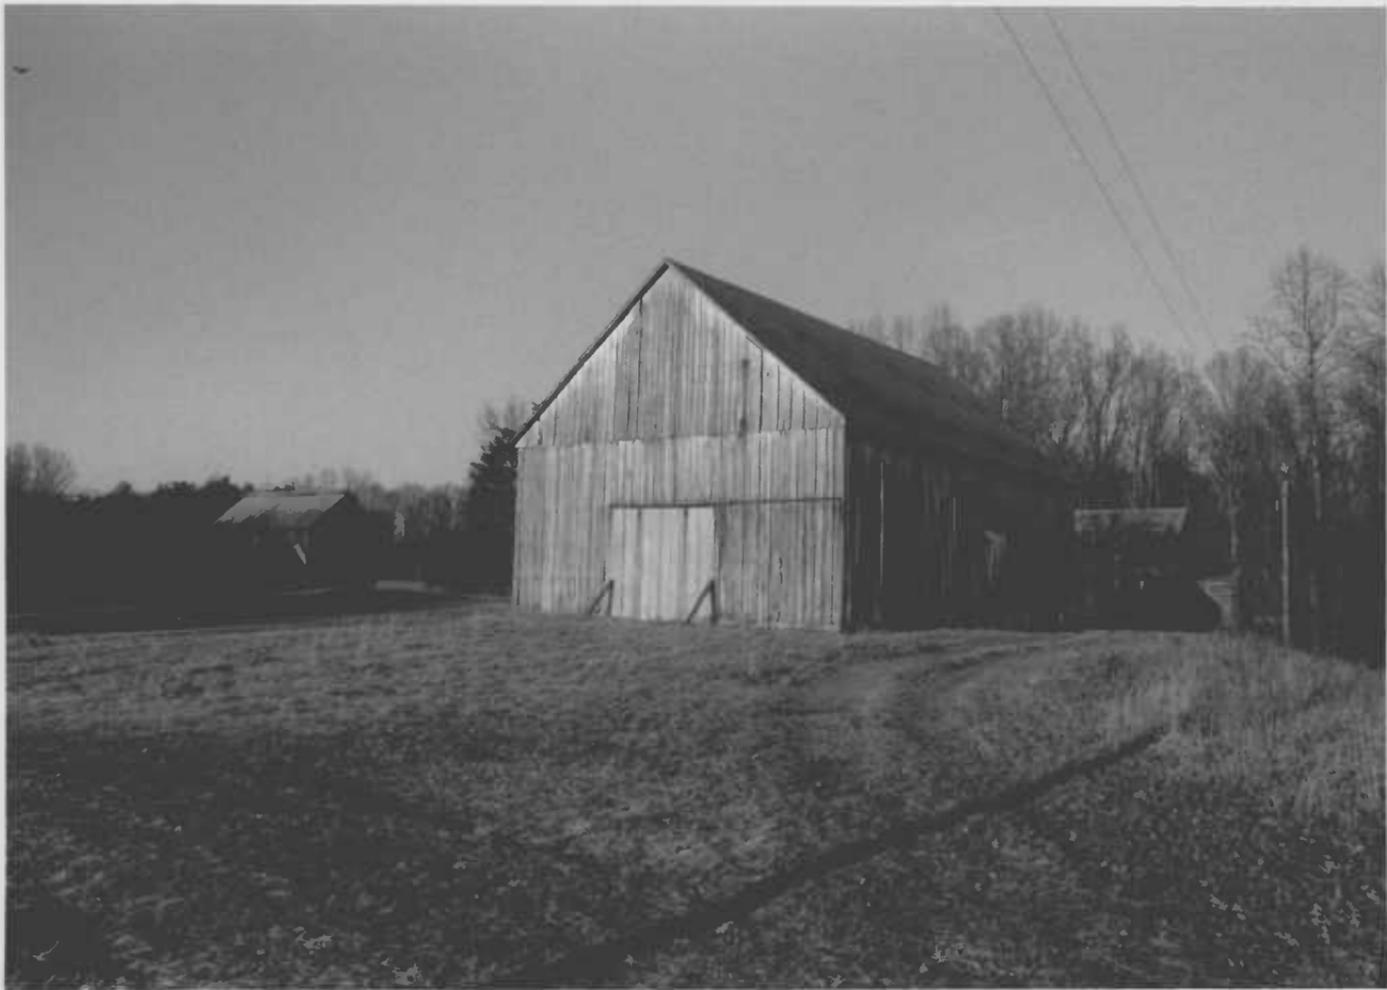
11 OF 13

The most substantial of the three barns, this structure includes a concrete foundation, metal roof and wooden frame. A large center isle with doors on either end allows tractors to drive through. Tier pole placement is very uniform throughout this barn. Posts on either side of the isles are fitted with slats for holding additional poles. In this way the isle space could be used as drying space when necessary. Ventilation is provided through hinged boards fastened by iron hooks on the exterior.

SOUTH BARN COMPLEX, LOOKING EAST

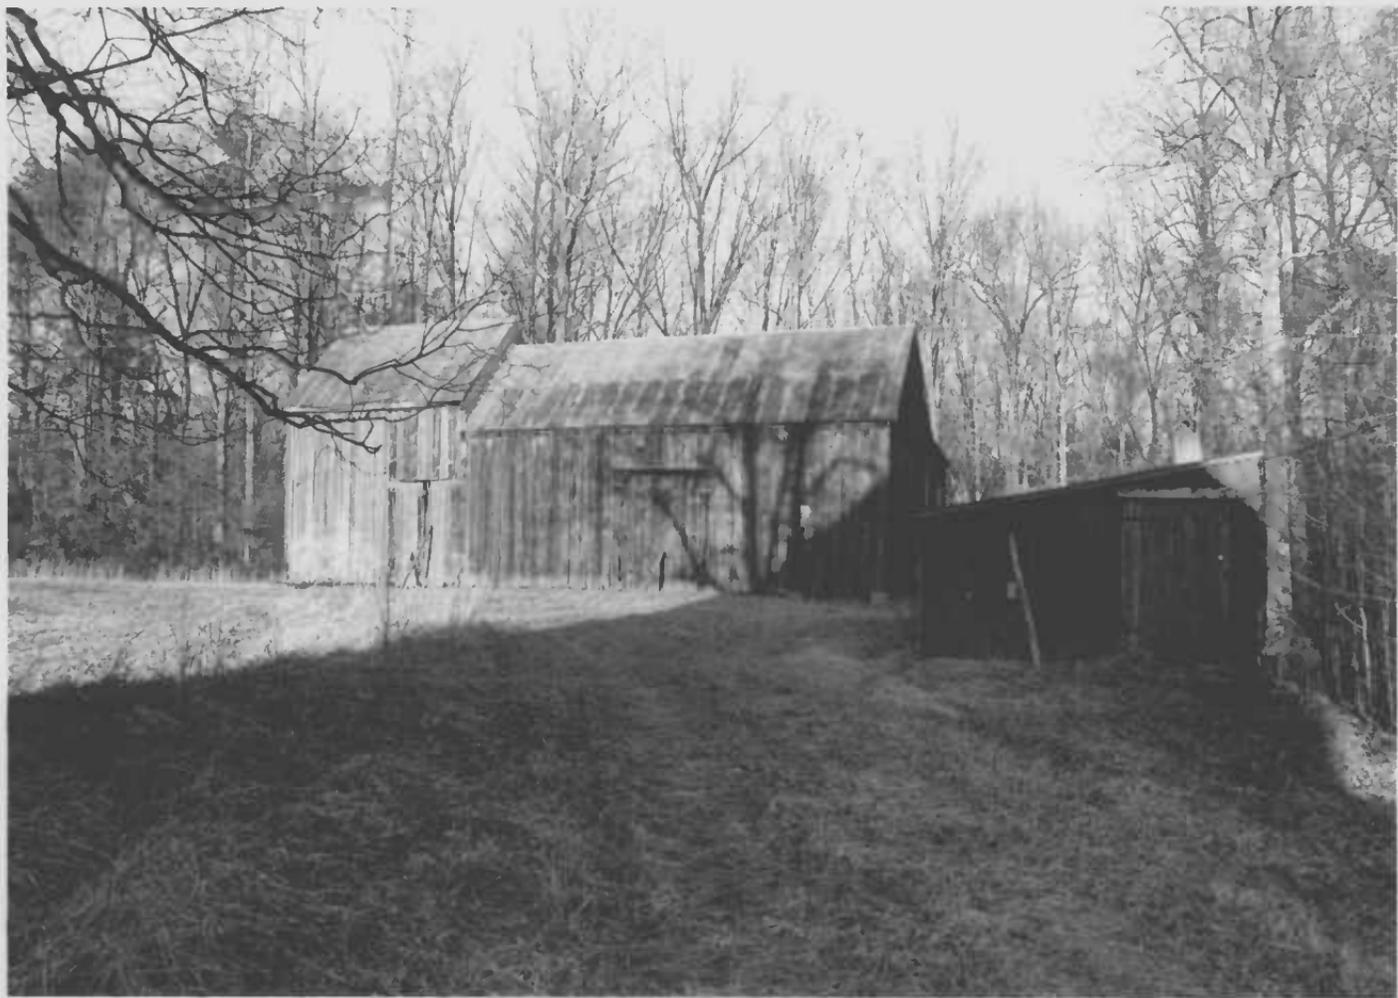
12 OF 13

probably was not originally built for such a purpose. Constructed in three sections, the long rectangular end was constructed first, followed by a narrow high barn. Finally, a shed addition extending across the entire rear elevation was constructed. Slats for tier poles are hastily fastened to the interior posts and poles rest on the existing structural horizontal timbers along the exterior walls. The unusual height of the narrow second section suggests this structure may have been used for grain storage or processing.

BARN, LOOKING EAST

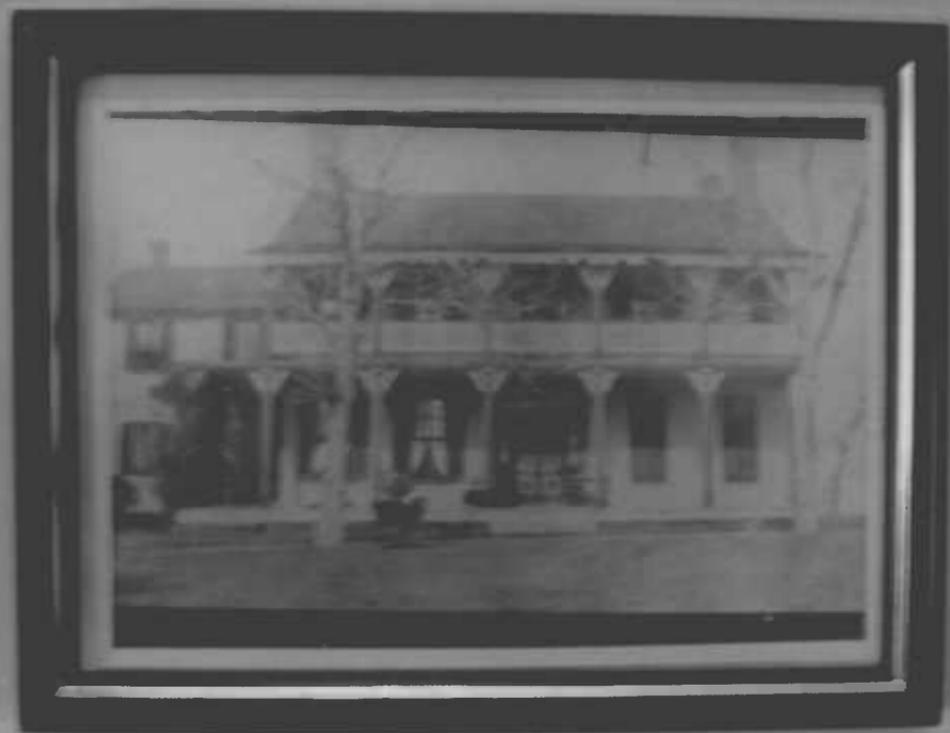
13 of 13

HISTORIC PHOTO, FRONT ELEVATION c. 1915

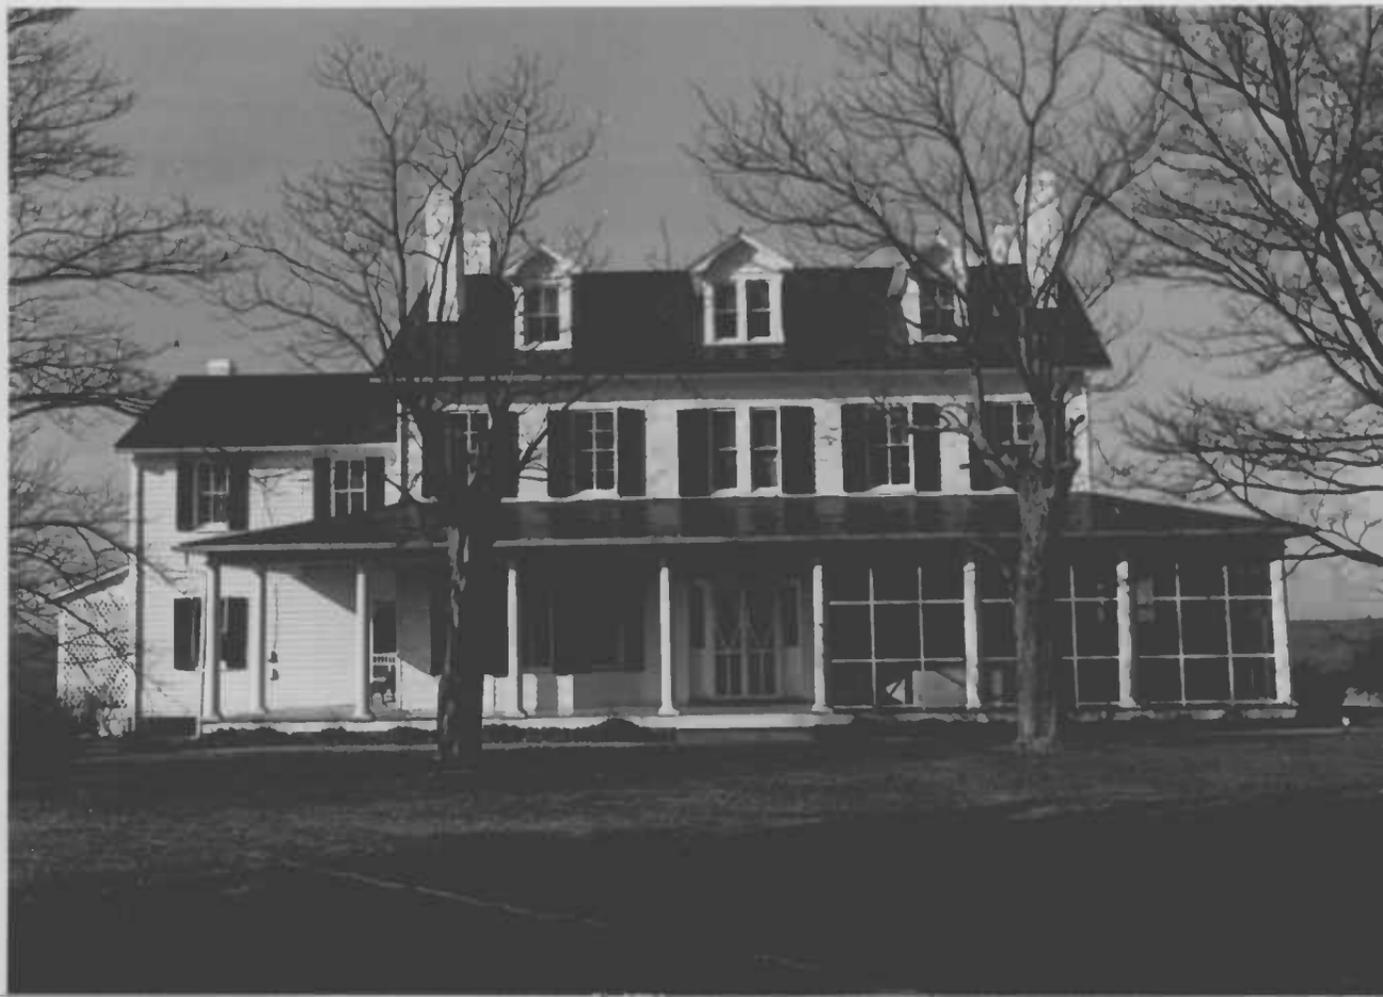
CH-214

Facing south on Langley Road, Sunnyside is a 2 1/2-story, five bay wide frame house, with three gabled dormers on the roof. Two large interior chimneys with corbeled caps rise from each end of the roof (four total). First floor windows have 2/2 sash, and 2nd floor windows appear to have 4/4 sash, except for the center window, which is split into two 1/1 windows. The same is true for the center dormer. The other two dormers have 2/2 sash. All windows on the first two floors of the main block have shutters. A two bay, two story frame addition to the west side of the house has a door in its easternmost first floor bay. All windows on the wing appear to be 2/2 and are shuttered. The wing has a small lean-to shed against the west wall. A large wraparound 1-story porch with Tuscan columns surrounds the south and east sides of the house. The east side and half of the south side of this porch are now screened. The front door has sidelights and a transom, and appears to have a double screened door with muntins. Two large trees stand symmetrically placed in front of the house.
