CARR-316

WILLIAM A. ANDERS HOUSE

CARR-316 *William A. Anders House*
3451 Uniontown Road

FIELD SHEET--HISTORIC RESOURCES SURVEY

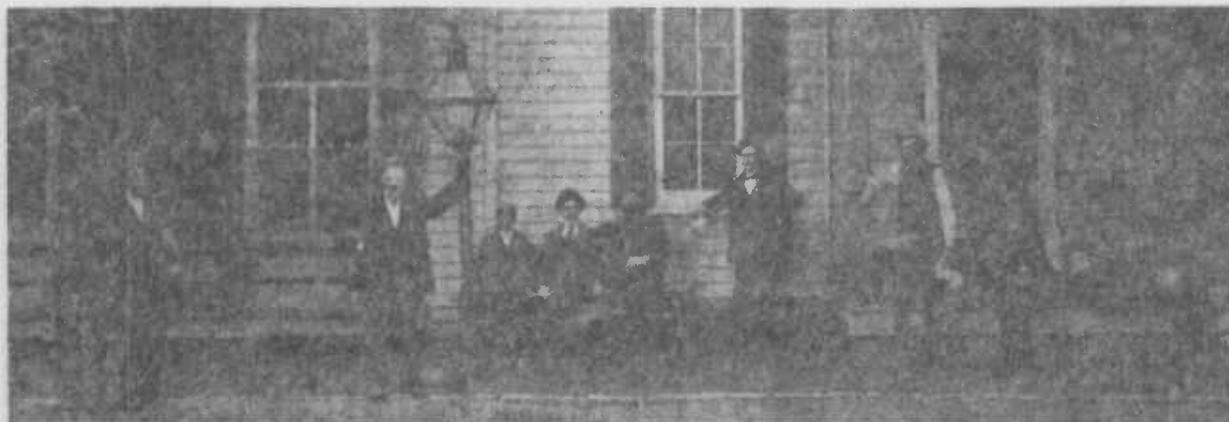
Photograph courtesy of Thomas Devilbiss

Life on Main Street—Uniontown residents posed along the street in front of 3451 Uniontown Road for this late nineteenth century photograph. This picture clearly shows the one-story, one-bay front porch with benches at each side which is a feature used on many Uniontown houses during this period. Other representative details are the window and door trim, projecting storefront bays, lamppost, and brick sidewalk.

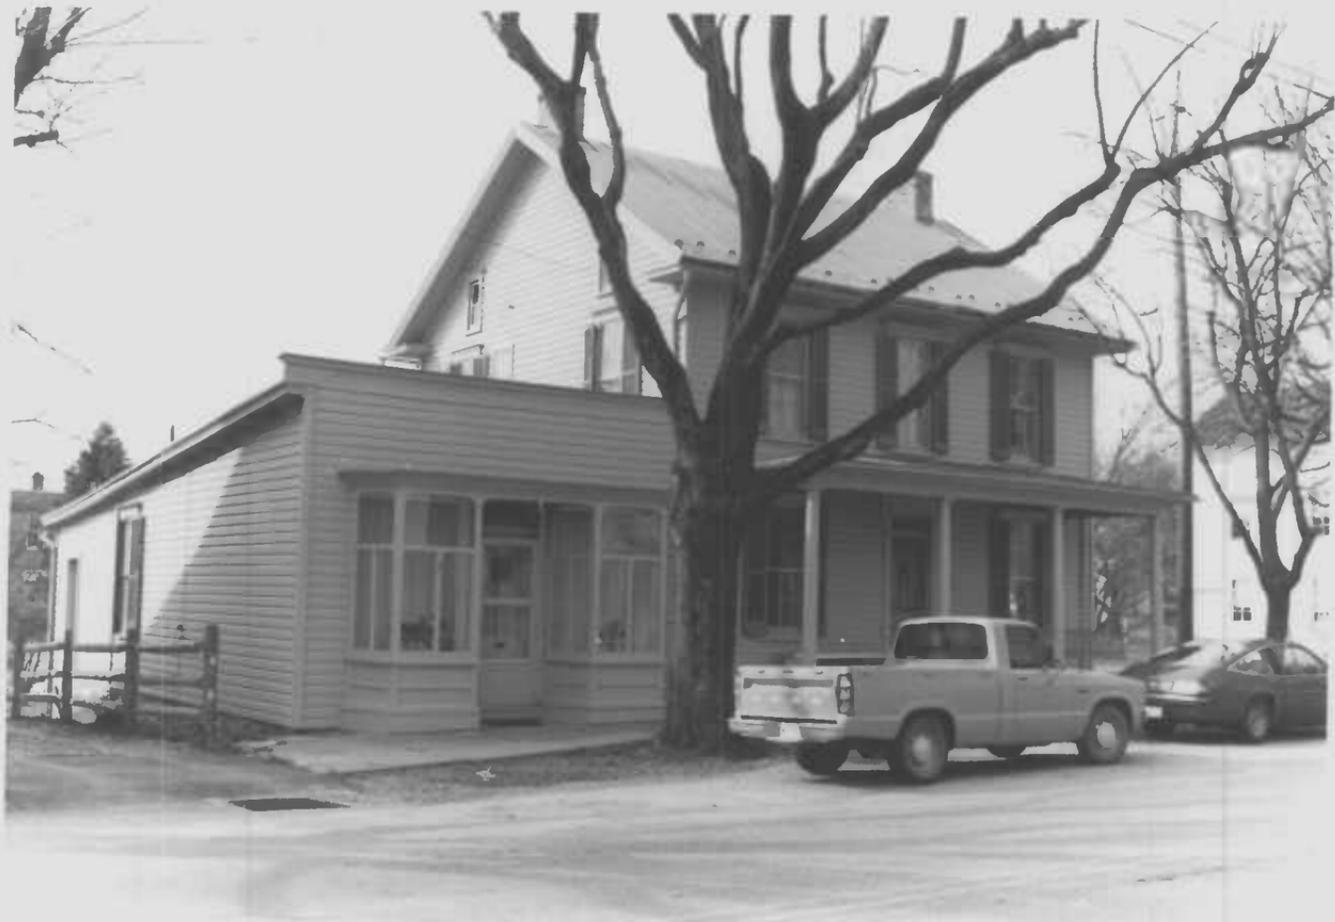
1. CARR-316 William A. Anders House
2. Carroll County, Maryland
3. Joe Getty
4. November, 1984
5. Maryland Historical Trust, Annapolis, MD
6. North & east elevation, camera facing
southwest
7. 1/1

Store addition on east side - good example of a Victorian storefront
