CARR - 715

301 CRANBERRY ROAD

FIELD SHEET--HISTORIC RESOURCES SURVEY

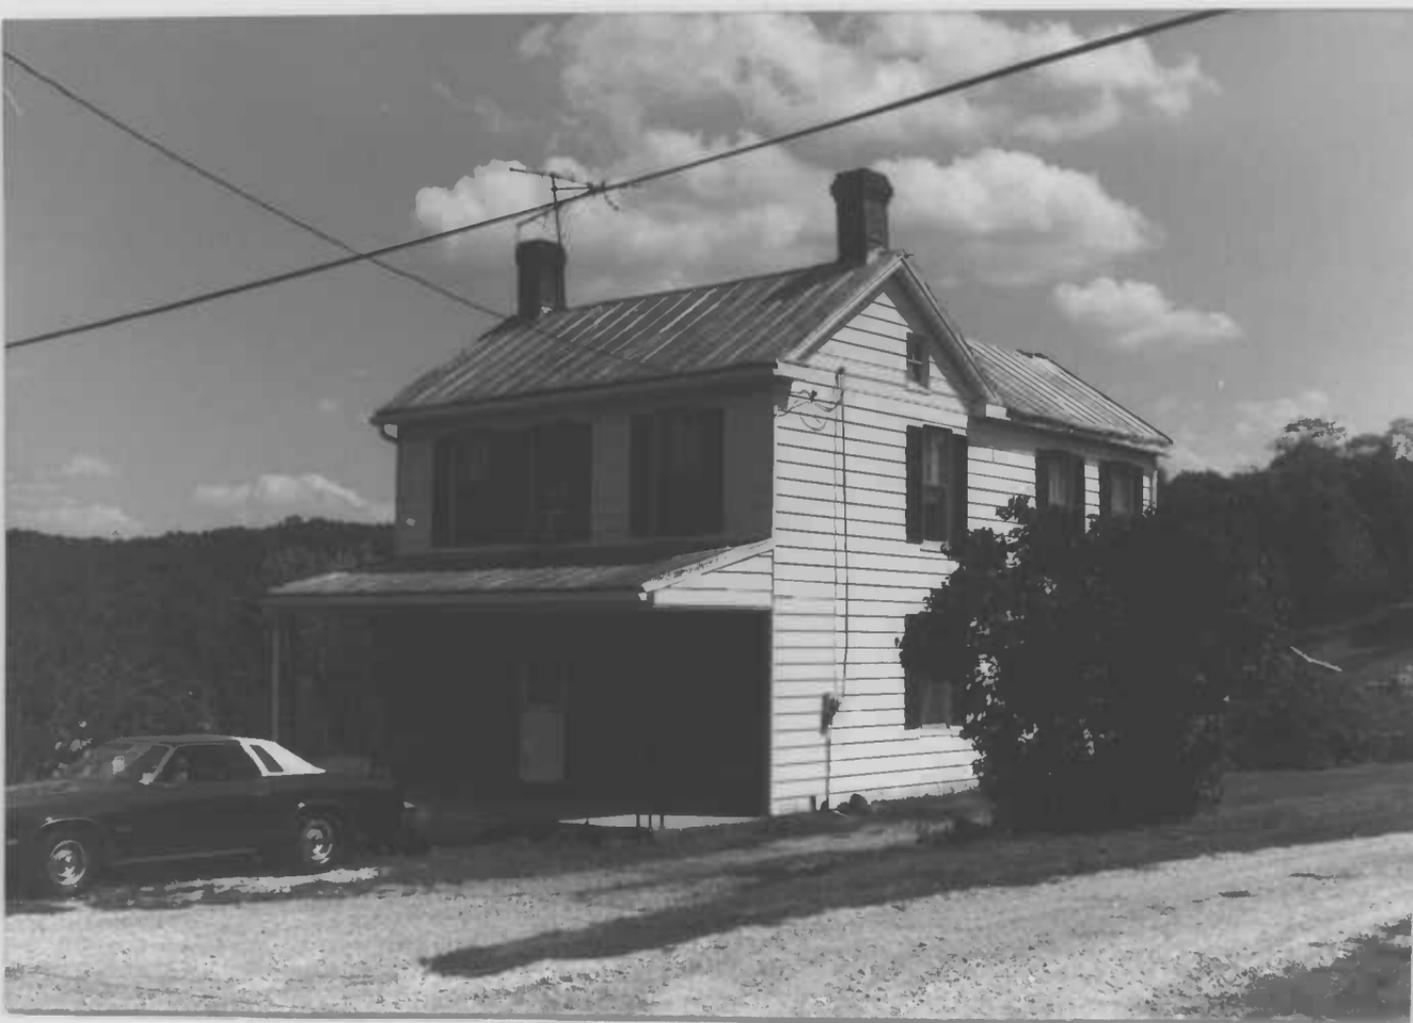
301 Cranberry Road is a late nineteenth century house of modest design. Its original features have been obscured by the aluminum siding, modern brick facade on the first story main facade, and aluminum porch posts. However, its proportions, design, two-over-two sash windows and brick chimneys give some indication of its original construction.

1. CARR-715 301 CRANBERRY ROAD
2. Carroll County, Maryland
3. Joe Getty
4. August 1983
5. Md. Historical Trust, Annapolis, Md.
6. South and west elevations
(camera facing northeast)
7. 1/1
