CARR - 747

134 SULLIVAN ROAD

Westminster vicinity

FIELD SHEET--HISTORIC RESOURCES SURVEY

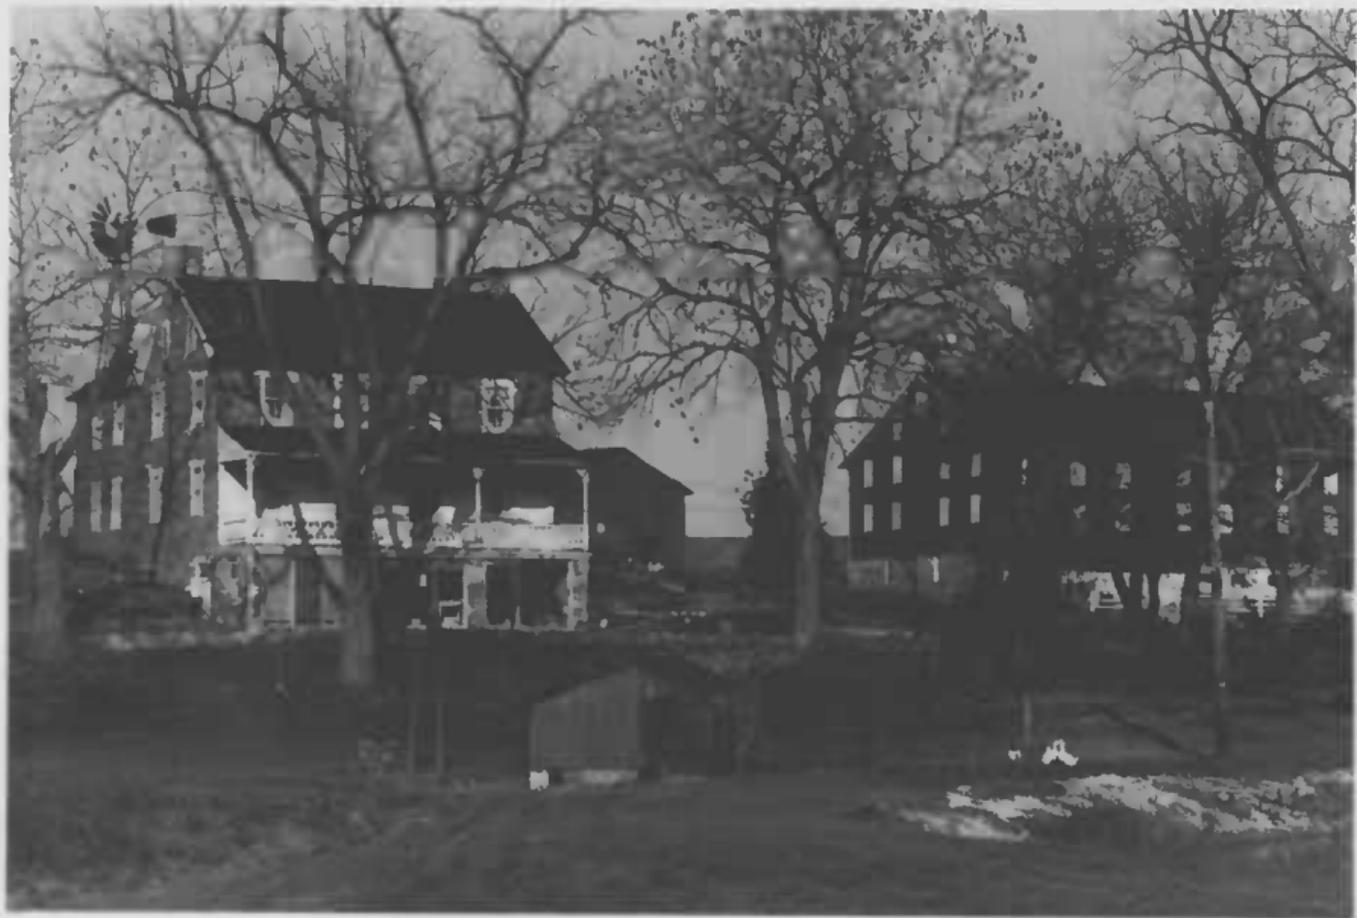
CARR-747

1. 134 Sullivan Rd.
2. Carroll Co. Md
3. J. Betty
4. 11/83
5. Md. Hist. Trust, Annapolis, Md.
6. overview from east
7. 1/2

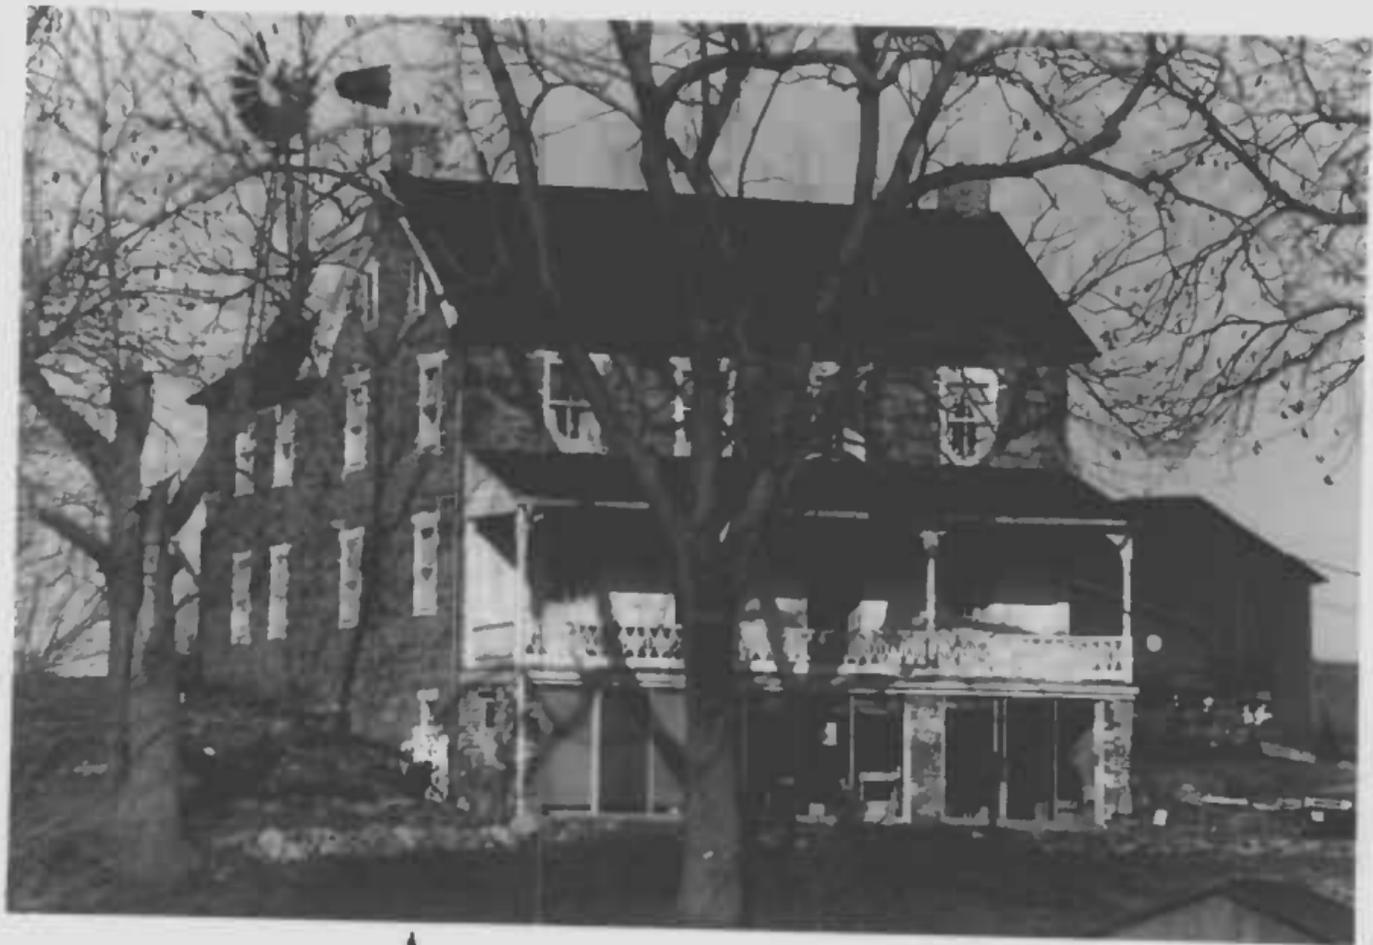
CARR-747

1. 134 Sullivan Rd.
2. Carroll Co., Md.
3. J. Getty
4. 11/83
5. Md. Hist. Trust, Annapolis Md.
6. southeast elevation
7. 2/2

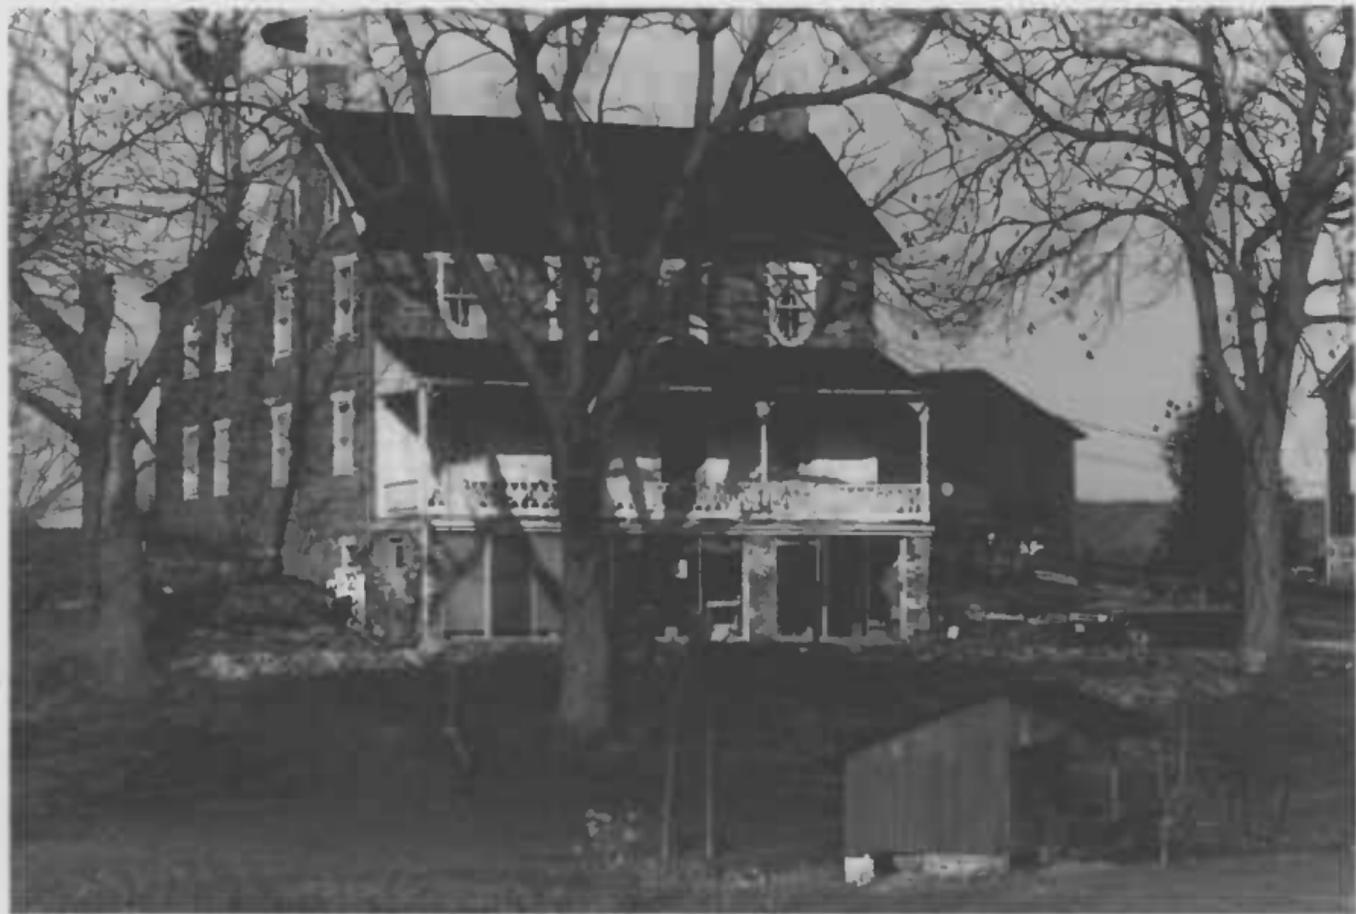
CARR-747

east facade
