**CARR-778**

**Richard Fowler House**

**December 12, 1996**

# Maryland Historical Trust State Historic Sites Inventory Form

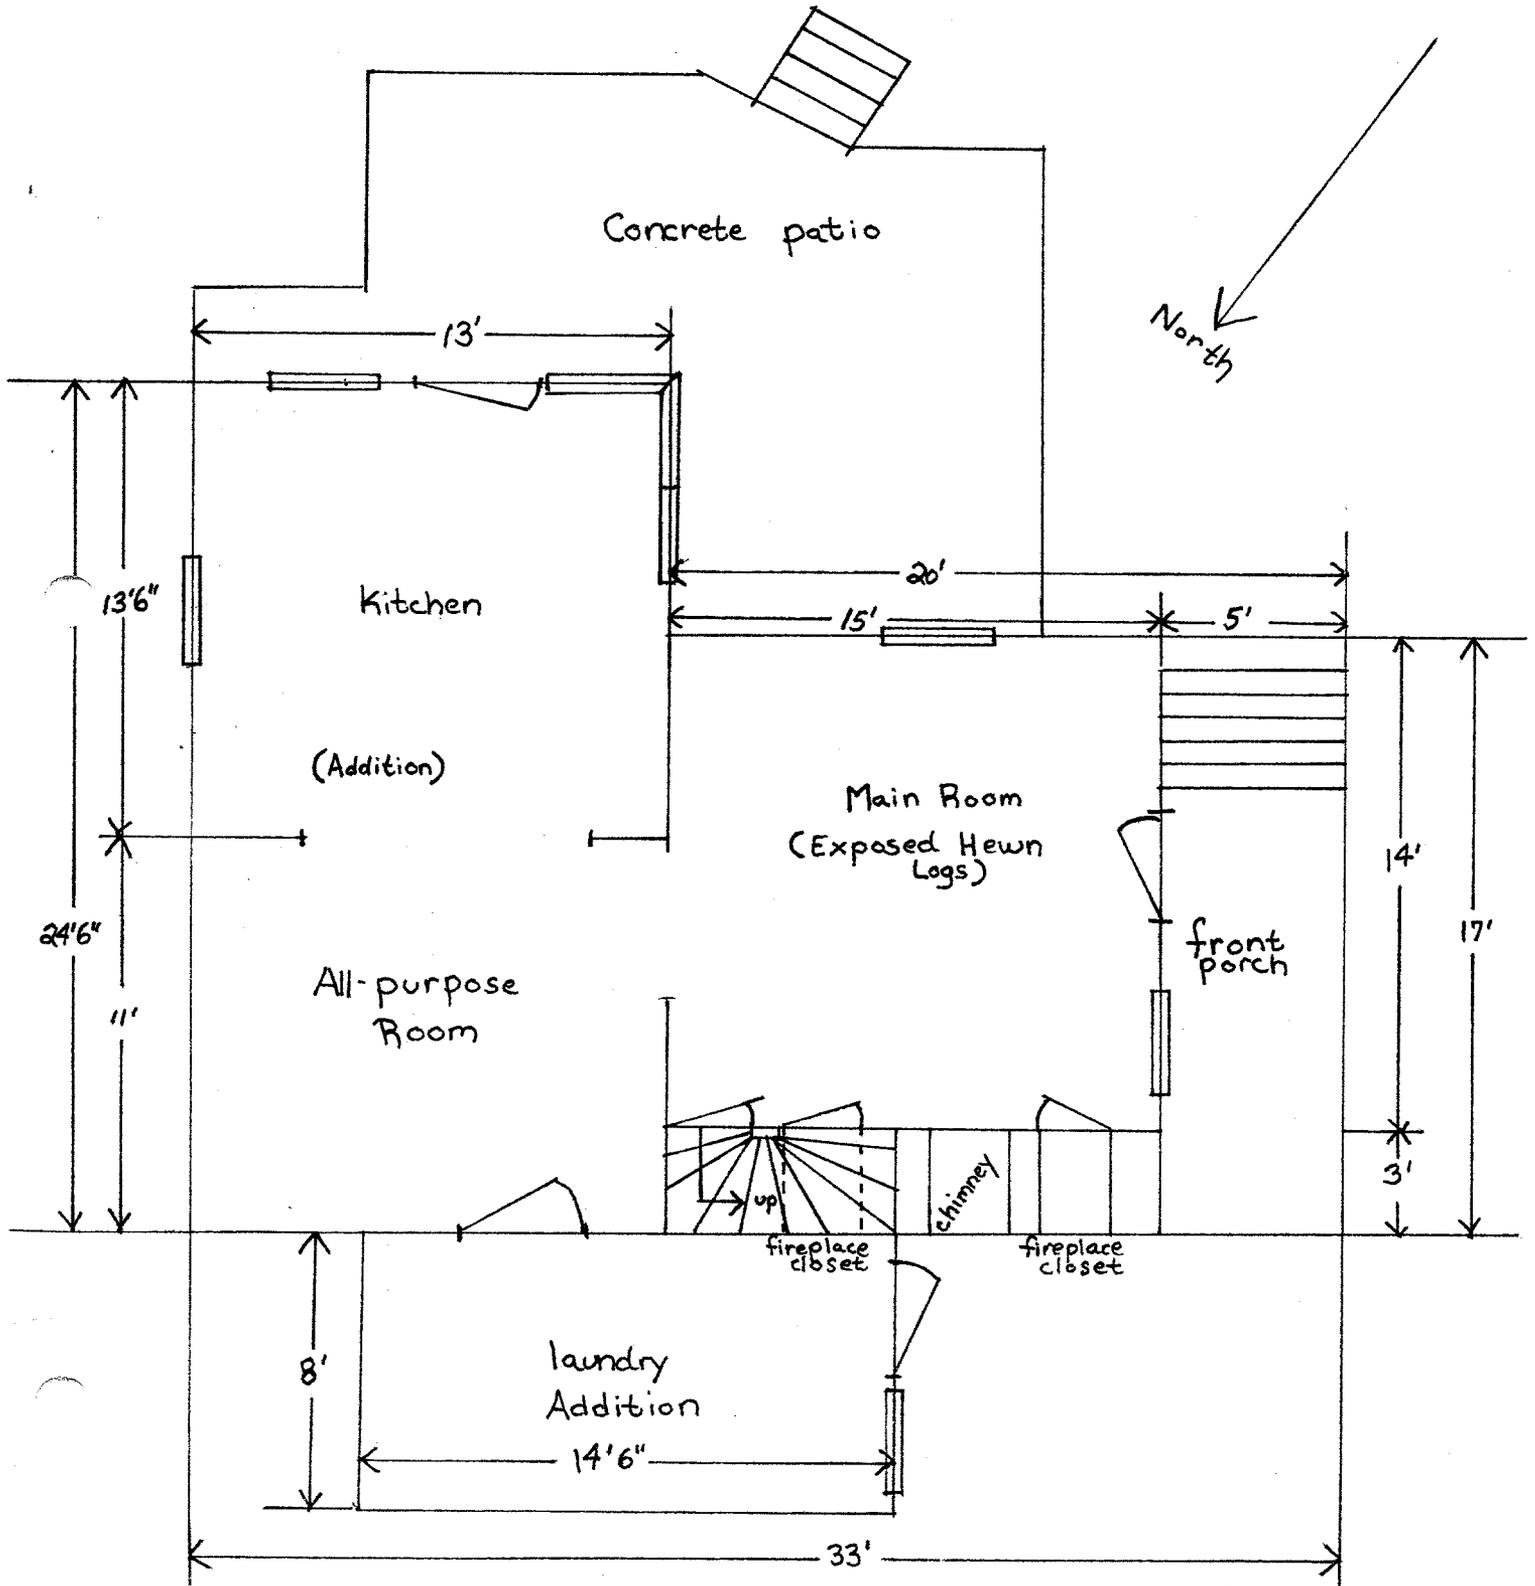
First Floor  
Not precisely to scale:  $3/16'' = 1'$

The main block of the house is a one-room plan structure. The hewn logs and chinking are exposed on the first floor. The chinking originally contained local mud and clay, but plaster has been added over the clay to create the aesthetic contrast of dark logs and white chinking. The molding throughout the main block of the house is not original, but it has been recreated in a plain, colonial style with wide surrounds. The main block of the house does not contain plumbing, but electricity has been added.

The main entrance door is located on the southwest elevation. In this one room, the logs and chinking have been exposed. On the northwest side of the room there are two fireplace closets, but where the fireplace once was is now brick and plaster. Sometime since 1950, the chimney was replaced, and at that time, the owners neglected to include a new fireplace on the first floor. Therefore, the northwest wall of this room is bare with the exception of two fireplace closets and an enclosed winder staircase in the North corner. The current flooring, on the first floor, is alternating length boards, but the original flooring remains underneath. The original tongue and groove flooring is visible inside the fireplace closets, and it runs perpendicular to the new flooring on a northwest, southeast axis.

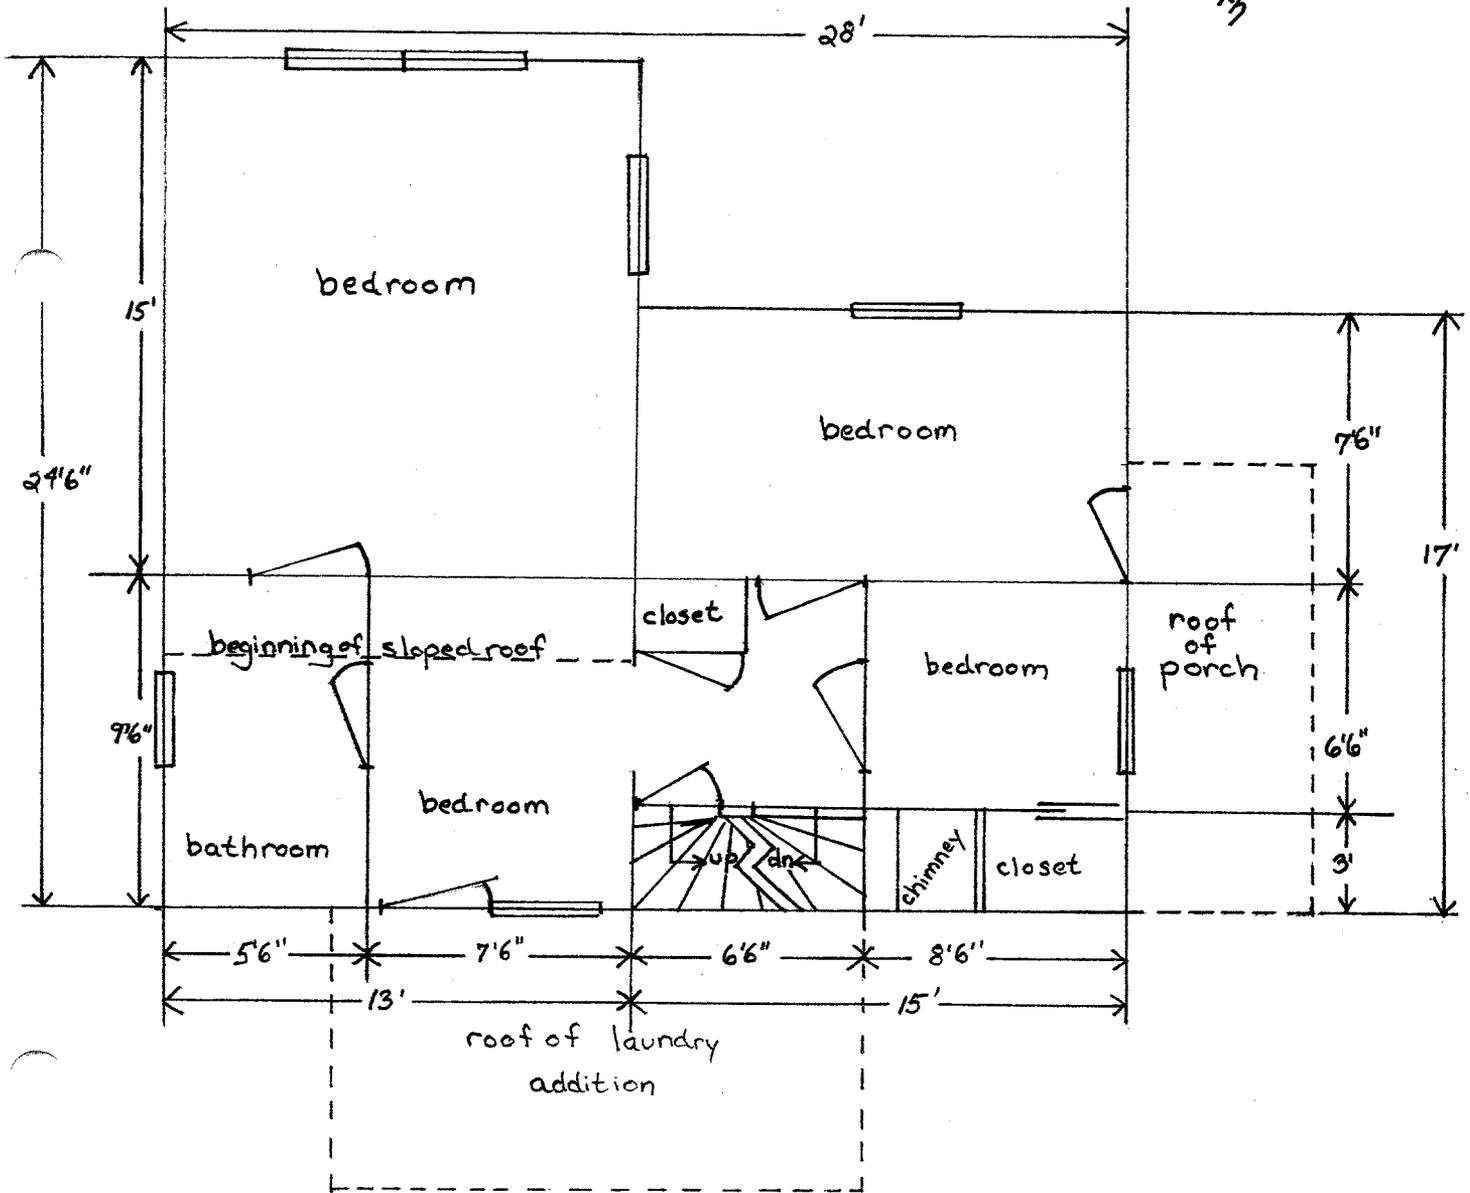
Second Floor  
Not precisely to scale:  $\frac{3}{16}'' = 1'$

At the landing on the second floor, there are three doorways and a closet. The closet was added sometime in the past fifty years to allow for more storage space. The door to the southwest enters into a small room with one central window. The door on the southeast wall on the second story landing, leads to a rectangular, one bay room. From this room, on the southwest side, is the second story door viewed from the front elevation. This door, most likely, opened onto a flat roofed porch sometime during the first half of the 20<sup>th</sup> century. From the landing on the second floor, the door on the northwest side leads to the attic stairway.

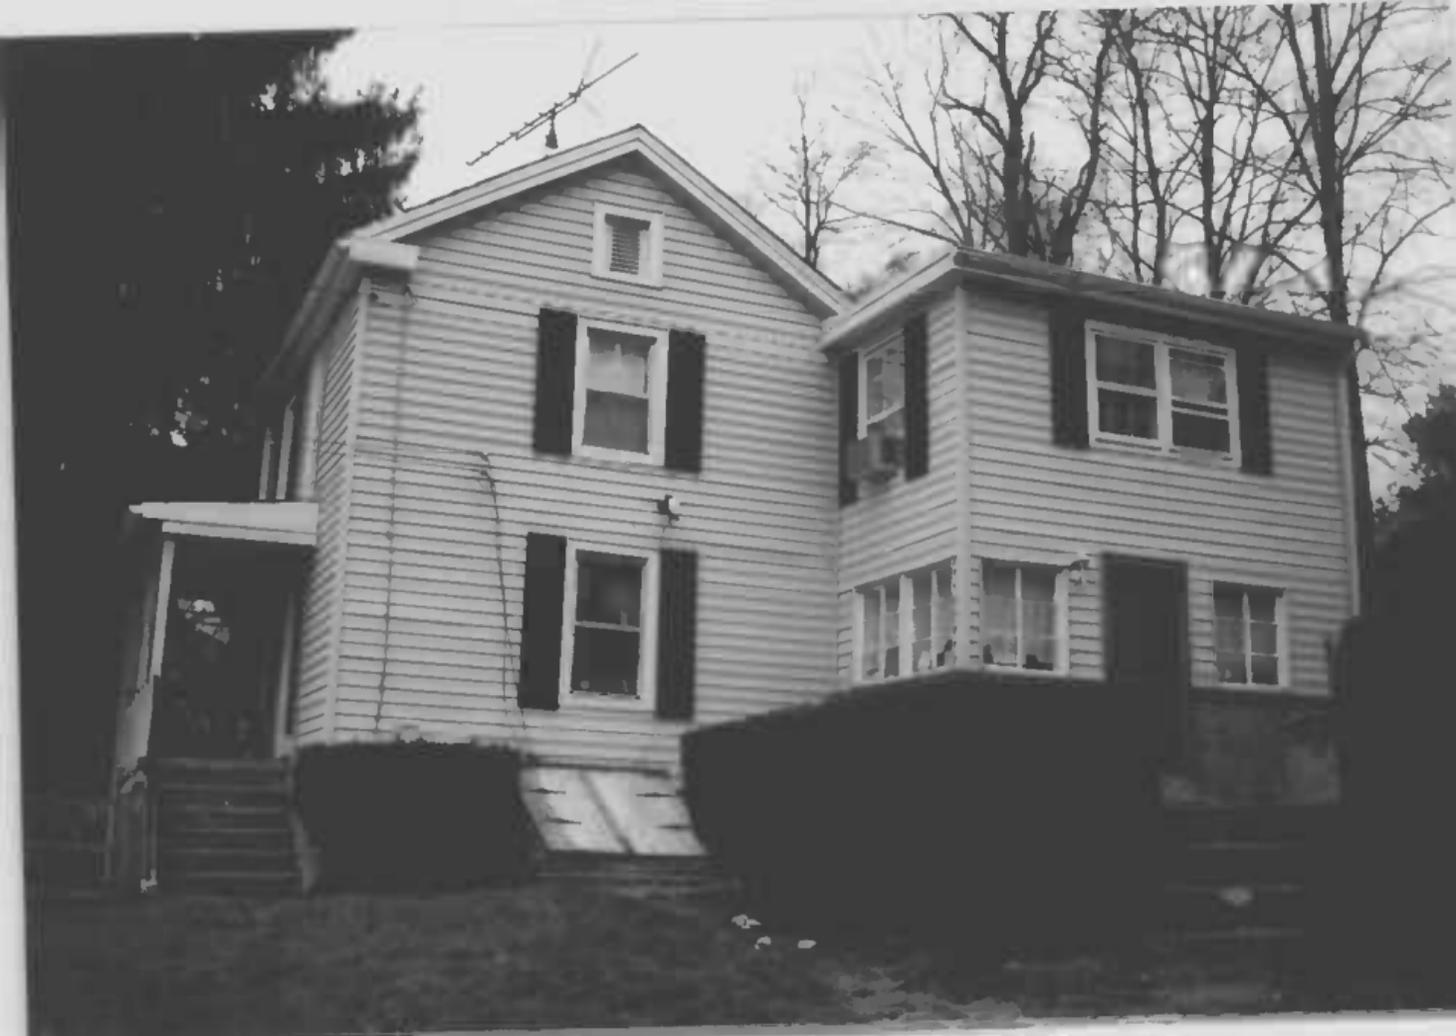
1 of 8

The southeast, gable end elevation of the main block of the home has a four over four sash window on each floor, and in the gable, a smaller four over four sash window which is aligned with the other two. There is an access door to the basement on this elevation. Modern bilco doors have been added to protect the entryway, but behind the bilco doors is a coursed rubble staircase covered with concrete that leads down to the basement door. Towards the northeast, on this elevation, is the two-story addition juts out beyond the original house. On this elevation, the addition is pierced with a four panel door and four, six paned windows on the first floor. On the second floor, the addition is pierced with three, six over six sash windows. On the southeast side of the addition, there is a large concrete patio.

Southeast Elevation of Home

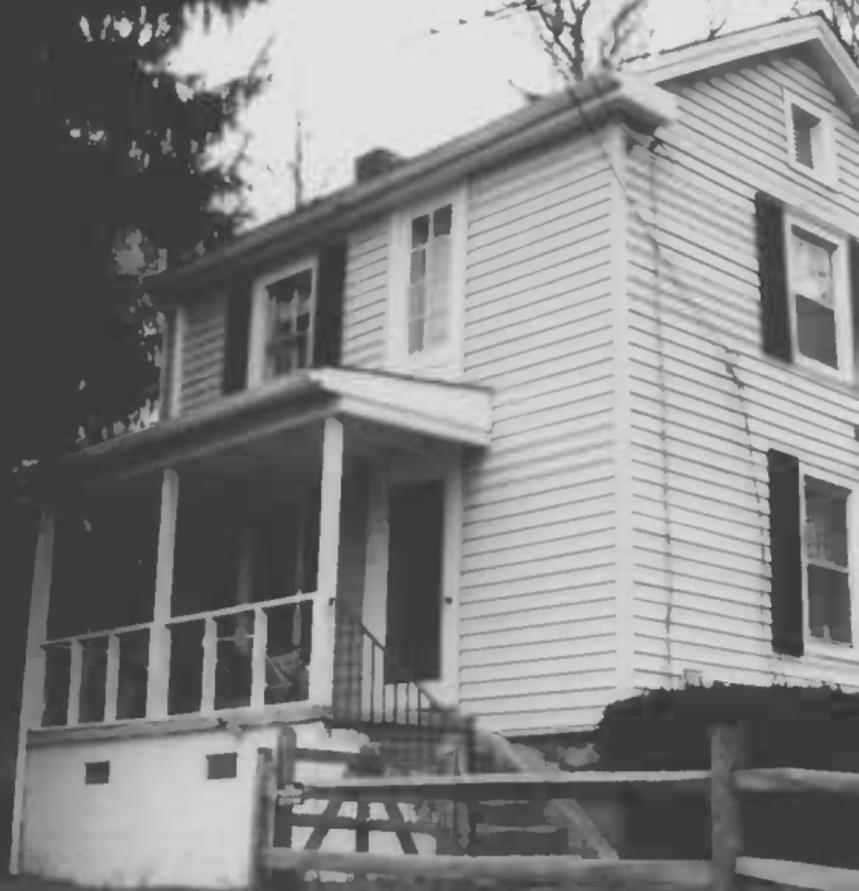
The main, southwest elevation is unornamented and asymmetrical. This elevation of the home is pierced with a door and a window on the first floor and another door and a window on the second floor. There is a full bay, contemporary, concrete, front porch on the southwest elevation that is accessible from a set of concrete stairs to the southeast. The enclosed porch on this elevation was originally two stories, which allowed for the second story door to be useable. The front door on the first floor has eight lights whereas the door on the second floor is a four paneled door.

Southwest Elevation of home  
& of 8

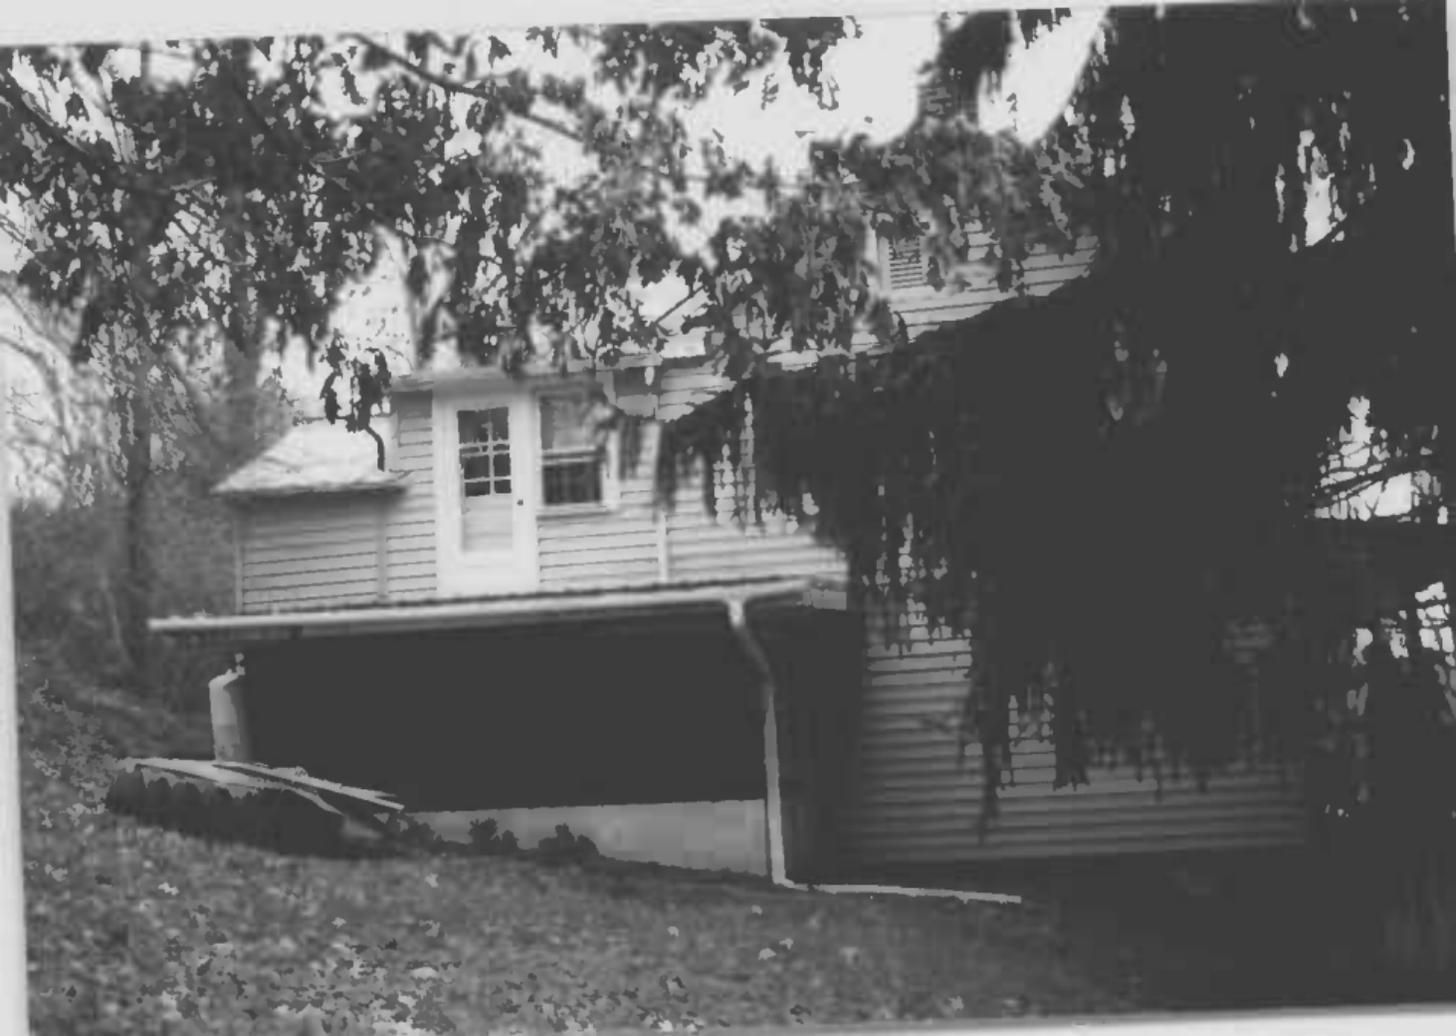
3 of 8

The northwest, gable end elevation of the main block of the house is blind with the exception of a louvered gable vent. However, on the northeast side of this elevation is a two-story addition which was added sometime since 1950. The two story addition has, one six over six sash window and a four light three panel door on the second floor. This door opens onto the slightly sloped roof of the laundry shed. The laundry shed is attached to the northwest elevation of the main block; it is one story. The laundry addition is pierced by a door and a six over six sash window on its southwest elevation. This addition, which was added in the last thirty years, is covered with cedar siding, and it has a slightly sloped metal roof.

Northwest Elevation of Home

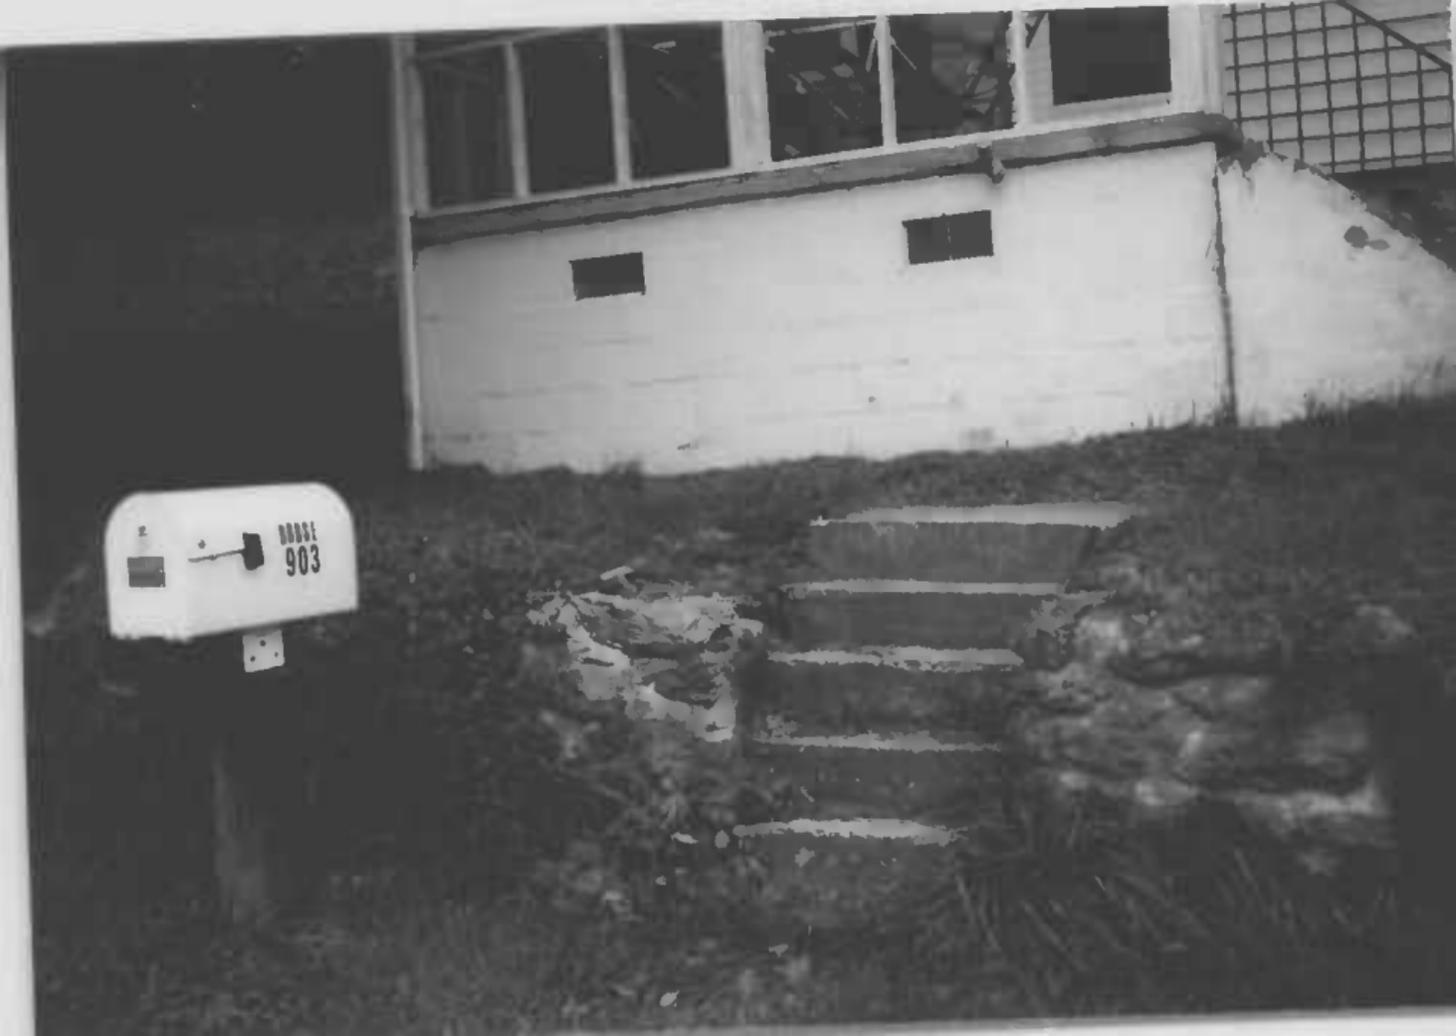
4 of 8

front retaining wall on southwest elevation

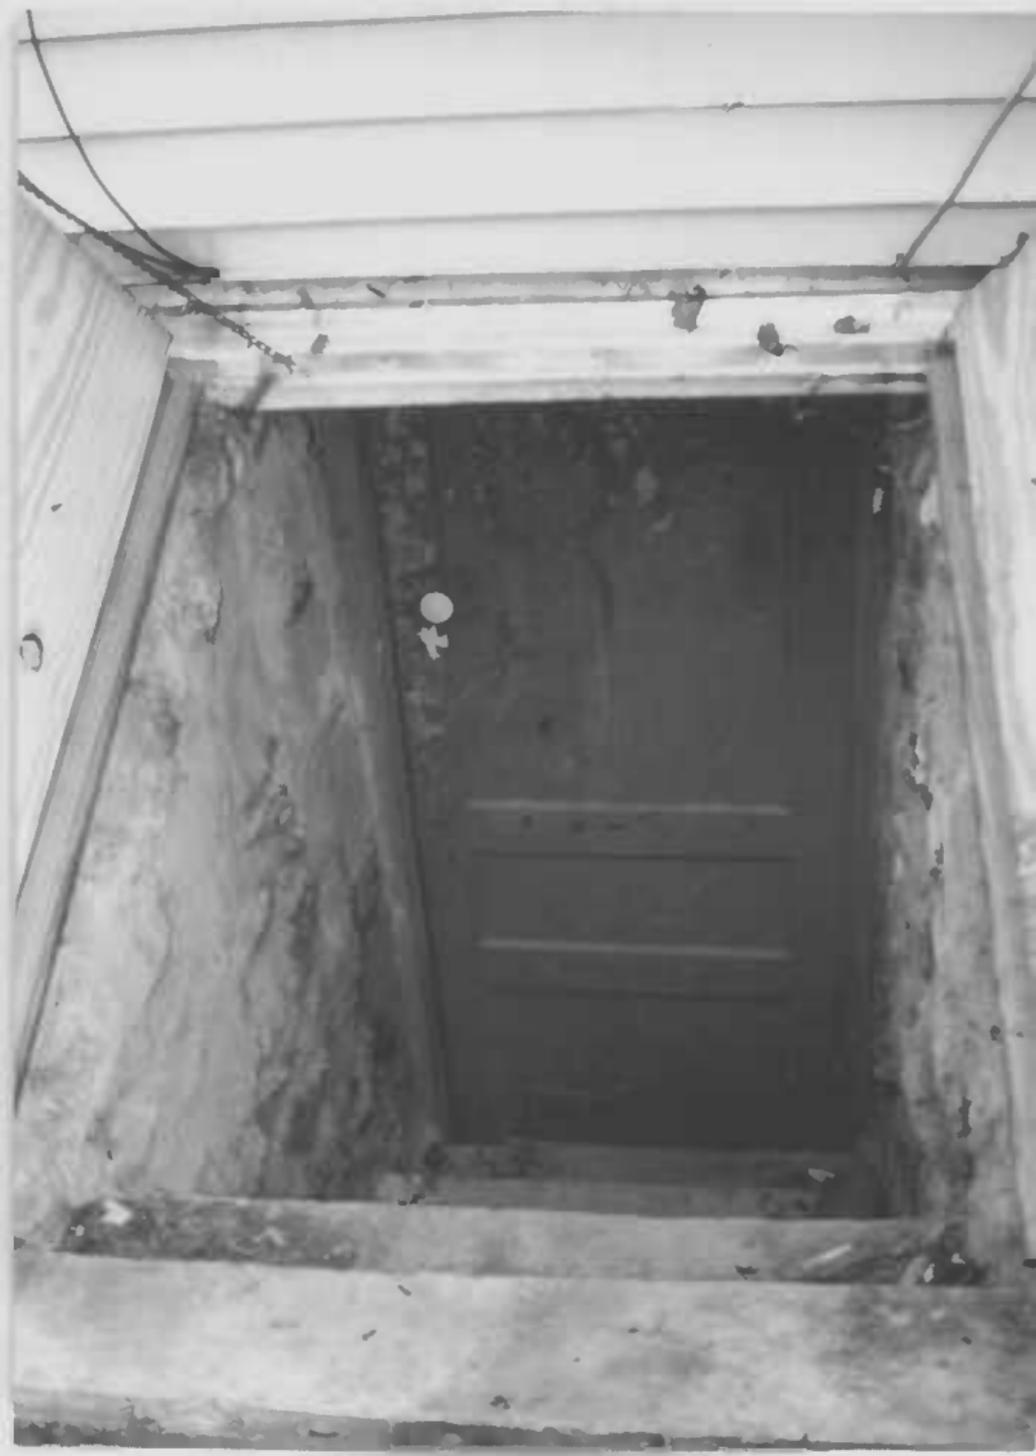
5 of 8

The basement of the home is only accessible through the bilco doors on the southeast elevation of the house. These doors lead down a short set of stairs lined with coursed rubble to the basement door. The basement itself is surrounded by the stone foundation, and it has a dirt floor. On the northwest wall is a large, stone hearth presumably used for cooking. This stone hearth is all that remains of the original chimney because sometime since 1950, it was replaced with a sold brick chimney. The basement is one bay wide and one bay deep, just like the main block of the house. From the basement view, the hand hewn floor joists and tongue and groove flooring is visible. In the floor joists, are early machine cut nails.

Basement Entrance

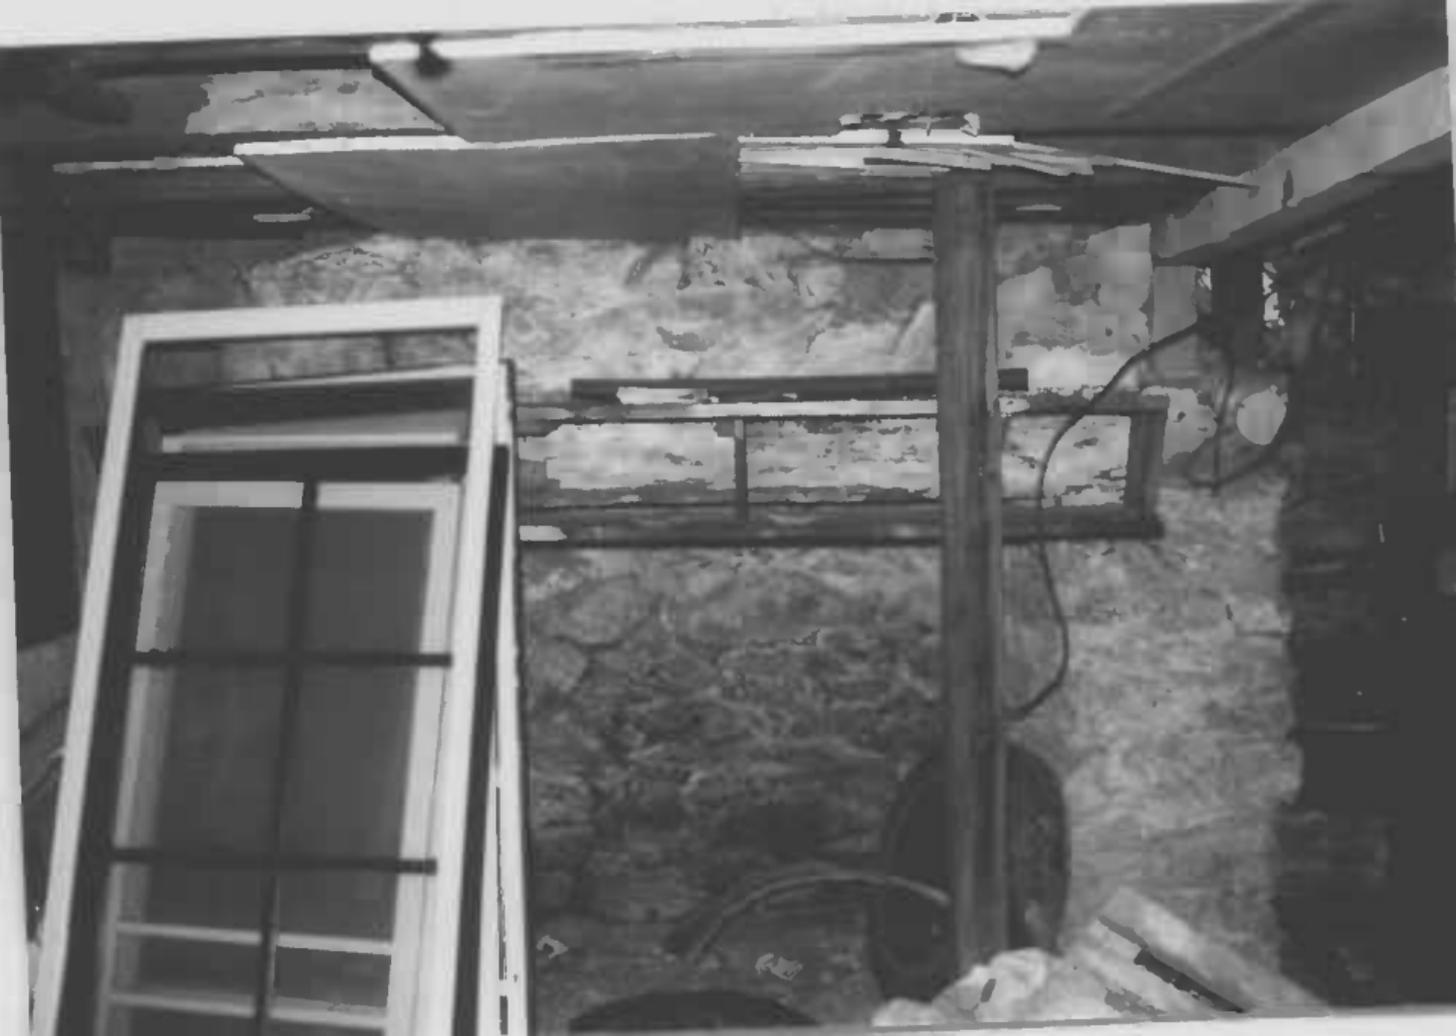
December 1, 1996  
Maryland SHPO  
Basement Hearth  
6 of 9

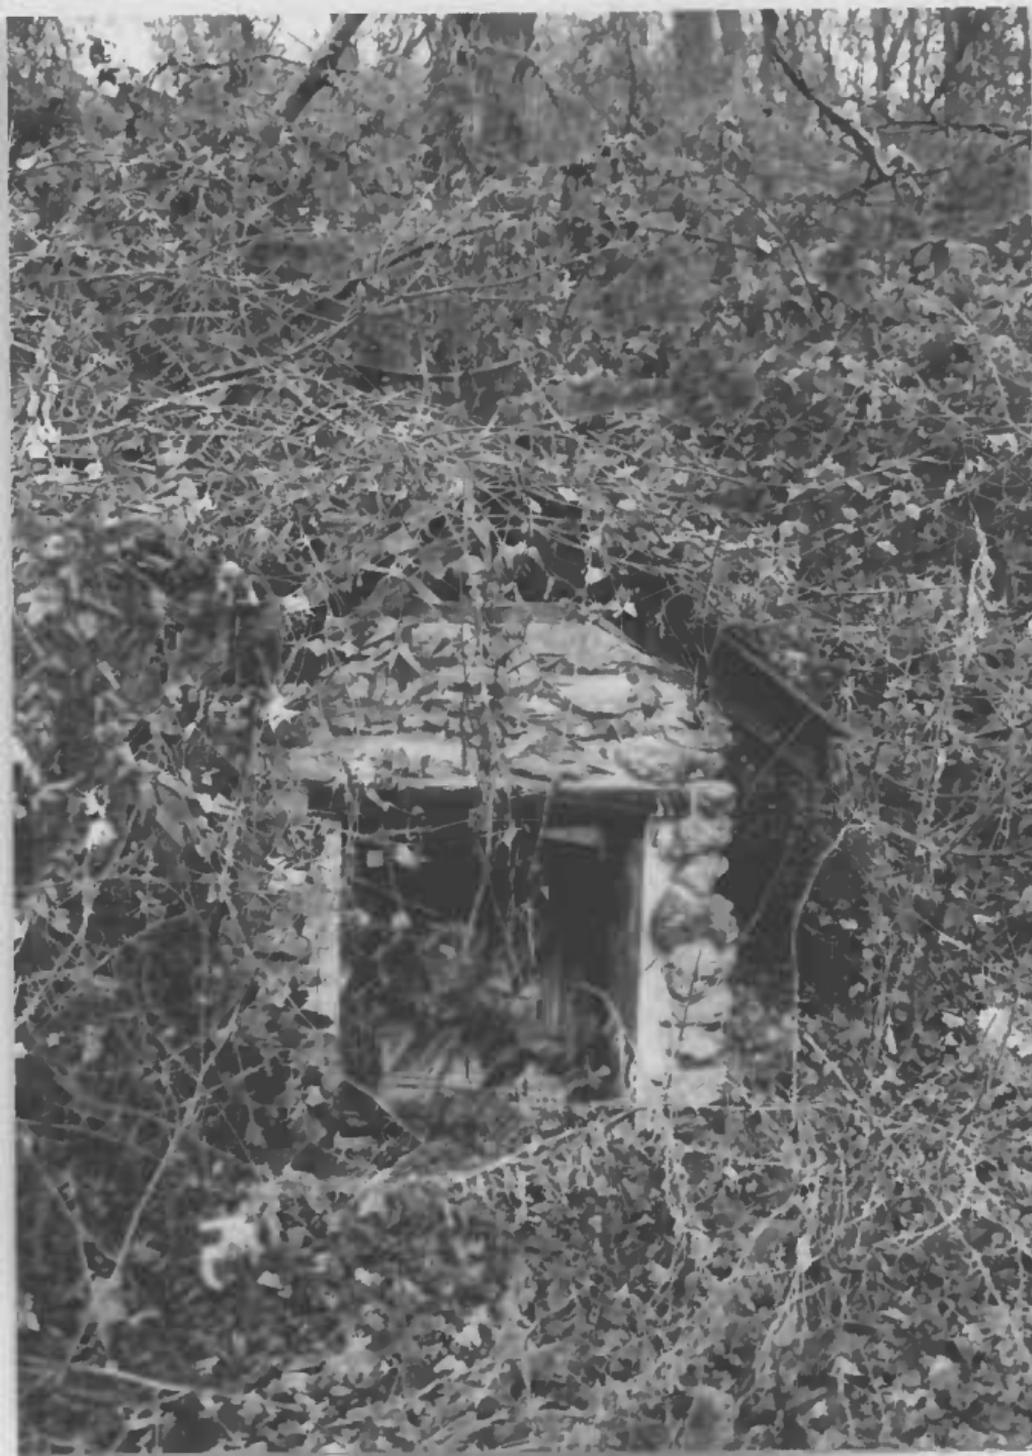
7 of 8

There is only one outbuilding on the property. The well house, though the casing is not original, has been restored to its original condition since 1950. The well house is constructed with coursed rubble, and the asphalt shingles rest on a gable roof oriented on Northeast, Southwest axis.

Well House

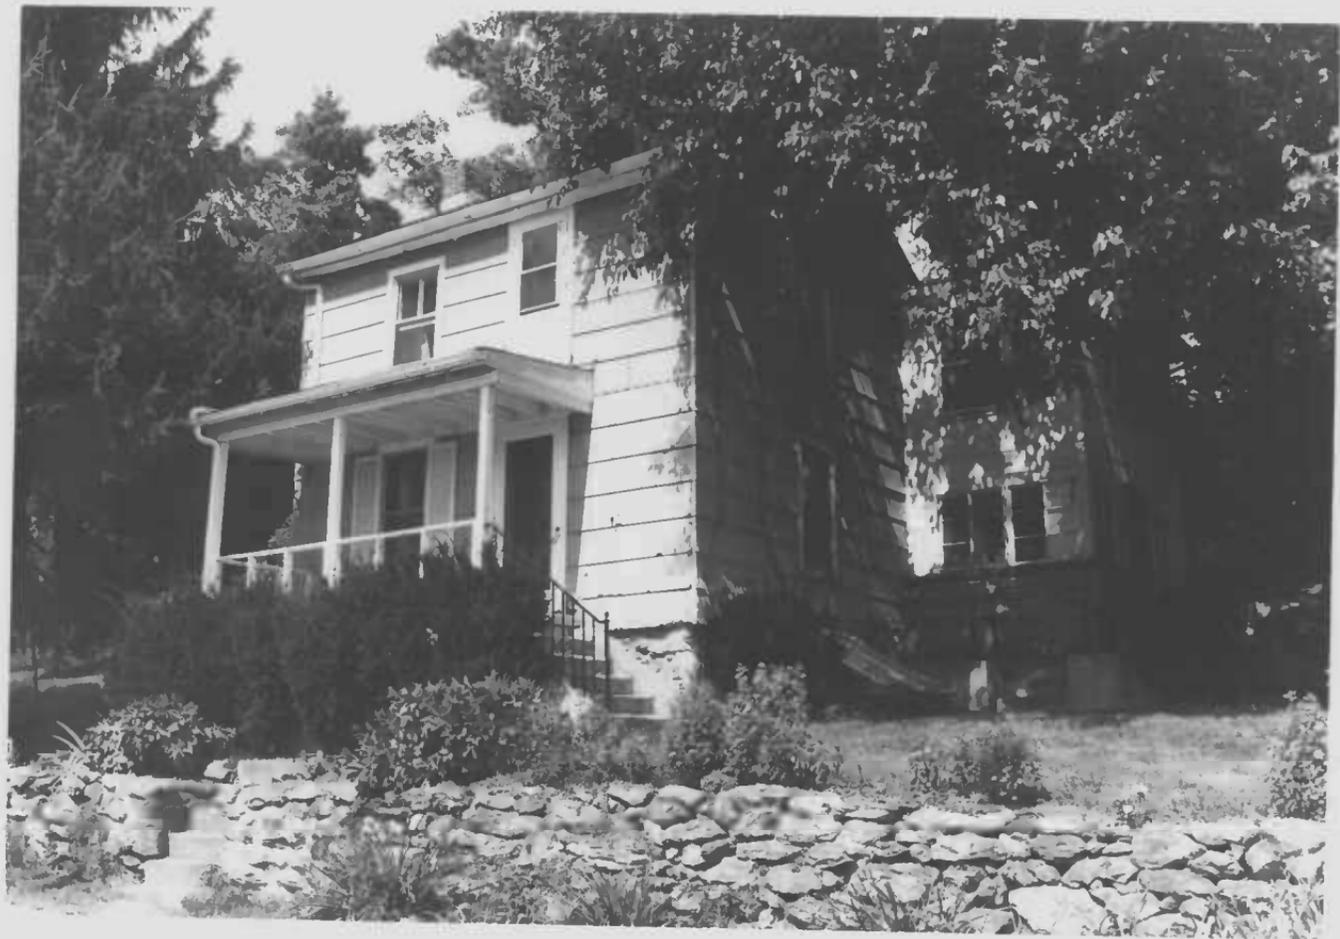
903 Poole Road illustrates mid-nineteenth century log domestic architecture in Carroll County. It is a small, two-bay by one-bay structure on a high stone foundation. It has been remodeled with a two-story addition on the rear and the exterior has been covered in abestos siding. The house is built on a sloping site and has a stone retaining wall in front of it.

1. CARR-778 903 Poole Road
2. Carroll County, Maryland
3. Joe Getty
4. August 1983
5. Md. Historical Trust, Annapolis, Md.
6. South and east elevations; camera facing northwest
7. 1/1
