National Register of Historic Places Registration Form

historic name Spye Park
other names/site number CH-304

Spye Park
Charles County, Maryland

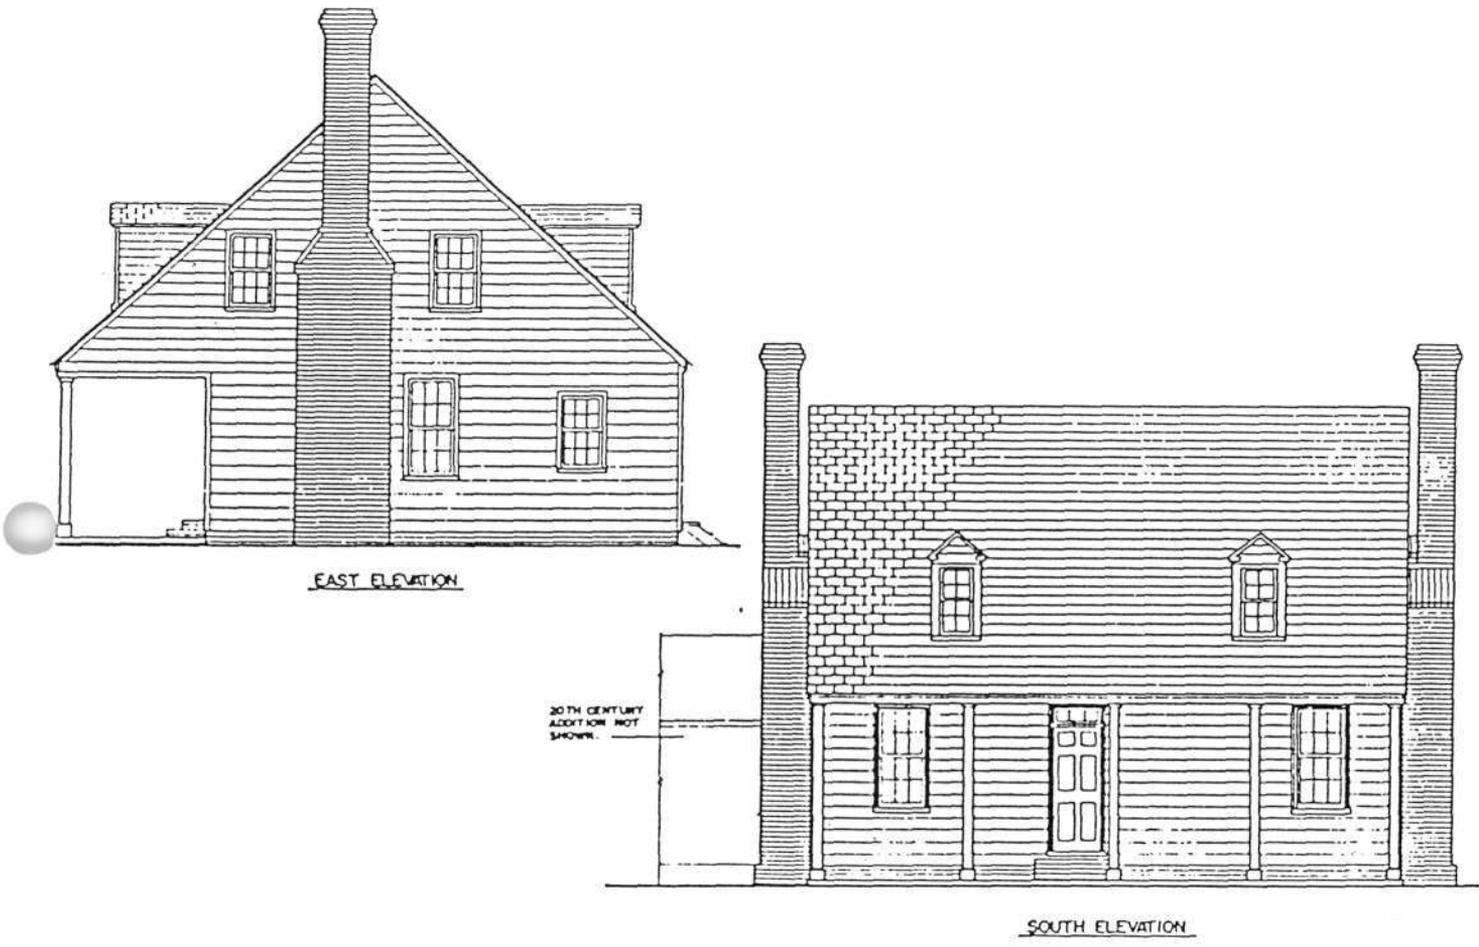
Section number 7 Page 7.5

SPYE PARK. Exterior elevations.
J. R. Rivoire

A one-story, three-bay, gable-roofed frame house built on an east-west axis, Spye Park's exterior features a full-width porch across the south front elevation, two gable-fronted dormer windows on each side of the roof, and clapboard siding. A single exterior chimney stands at each end of the house, and these are positioned forward (south) of the apex of the gables. The house has brick foundation walls and the roof is sheathed with asphalt shingles. A small, two-part, frame wing stands at the building's west end. (See Sheet 7.5 .)

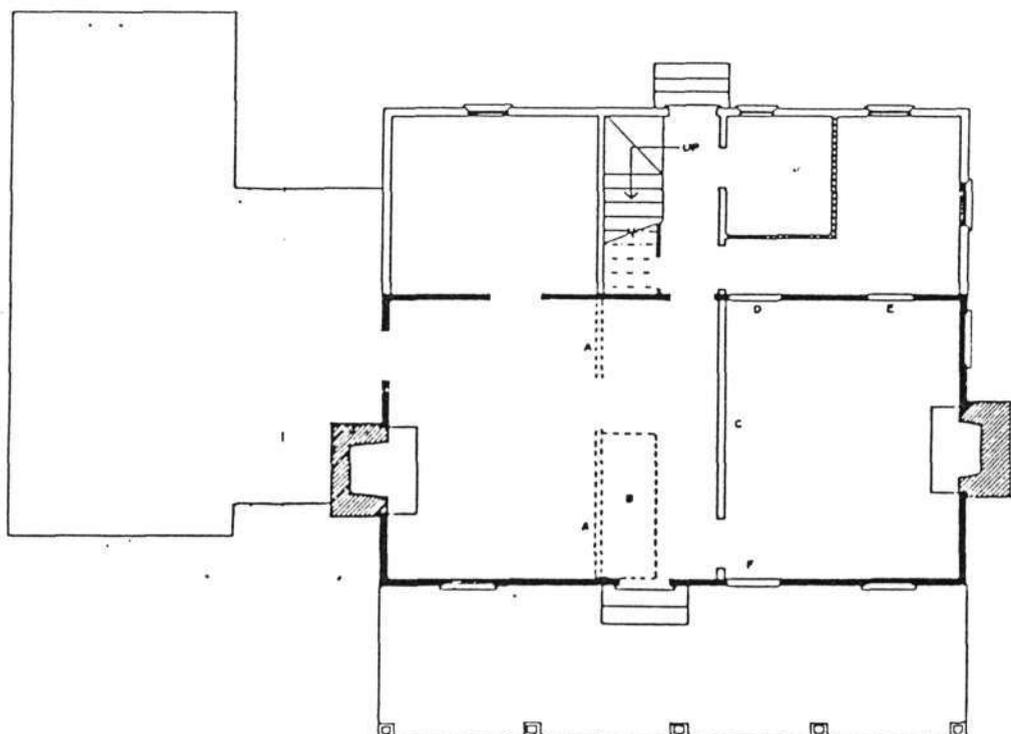
Section number 7 Page 7.6

SPYE PARK. First floor plan. (Period I section defined by bold lines.)
A. Period I partition wall location; B. Period I stair location;
C. early twentieth-century partition wall; D. Period I exterior
door location; E. possible Period I window location; F. Period
I door location. Early twentieth-century wing not detailed.

The centered door of the front elevation opens into the largest of Spye Park's two front rooms. Behind these are two smaller rooms flanking a central stair passage. Surviving early woodwork and finishes of the first floor rooms include flooring, exposed and painted brick nogging on the north wall of the southwest room and the south and east walls of the northeast room, sections of chair rails and the architraves of several doors, and partially exposed wall posts and wall plates in the southwest room. There are two chambers at the attic level separated by a closet and a small stair lobby. Both bed chambers retain their early nineteenth-century finishes except in the areas of the twentieth-century dormer windows.

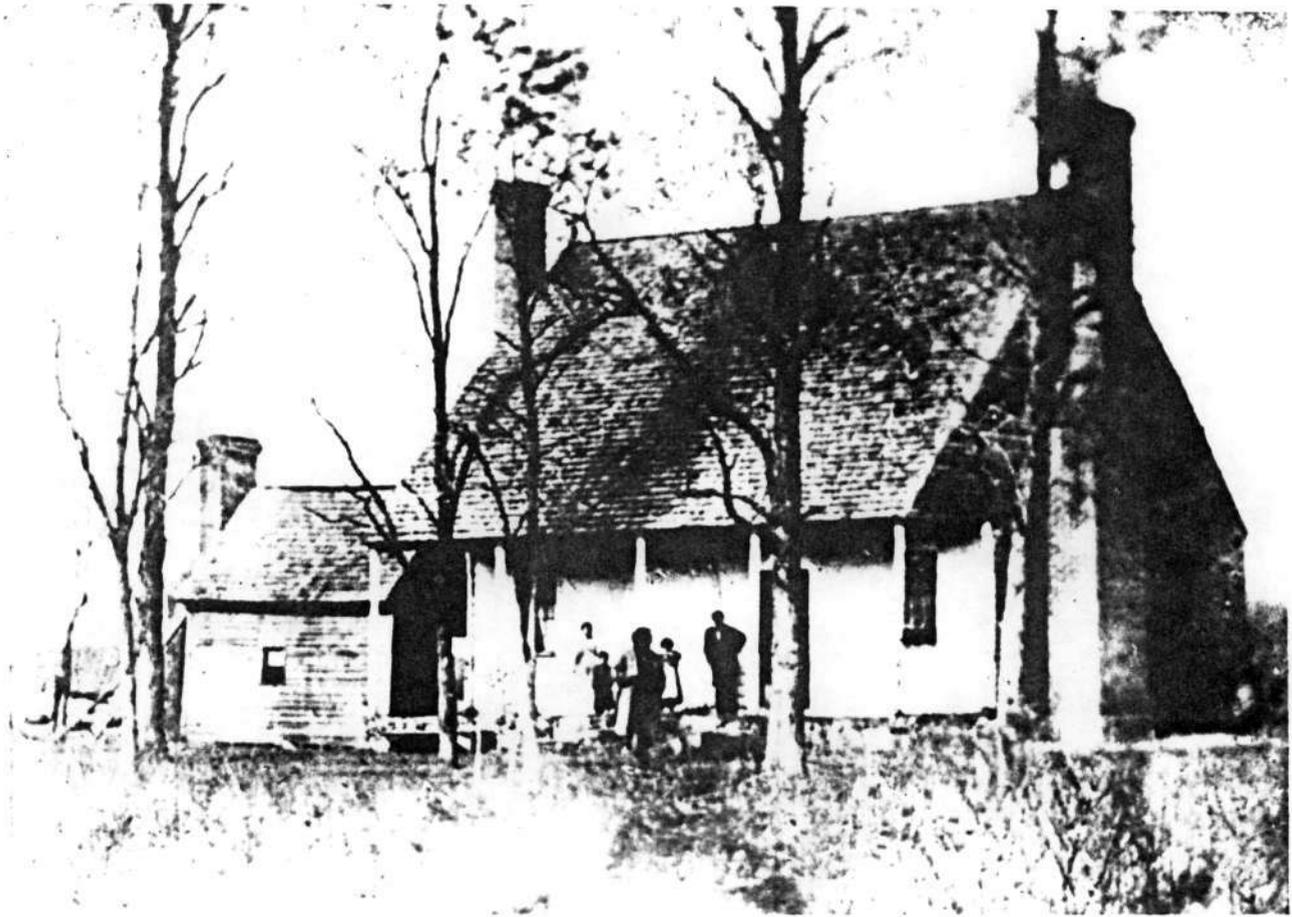
Section number 7 Page 7.7

Spye Park. Circa 1866. Owner's Collection.

Other improvements to the property thought to be contemporary with the alteration of the house included construction of a detached kitchen dependency off the west end of the dwelling, a meathouse, a dairy, and possibly the existing historic tobacco barn (#2 below) as well. All of these buildings are referenced in an 1843 estate inventory, but are not identified in any earlier documents. The detached kitchen, a frame structure with a small window in its south wall, a door in its east end, and a large exterior chimney at its west end, is depicted in a circa 1866 photograph of the house. (See 7.7 and Section 8: RESOURCE HISTORY.)

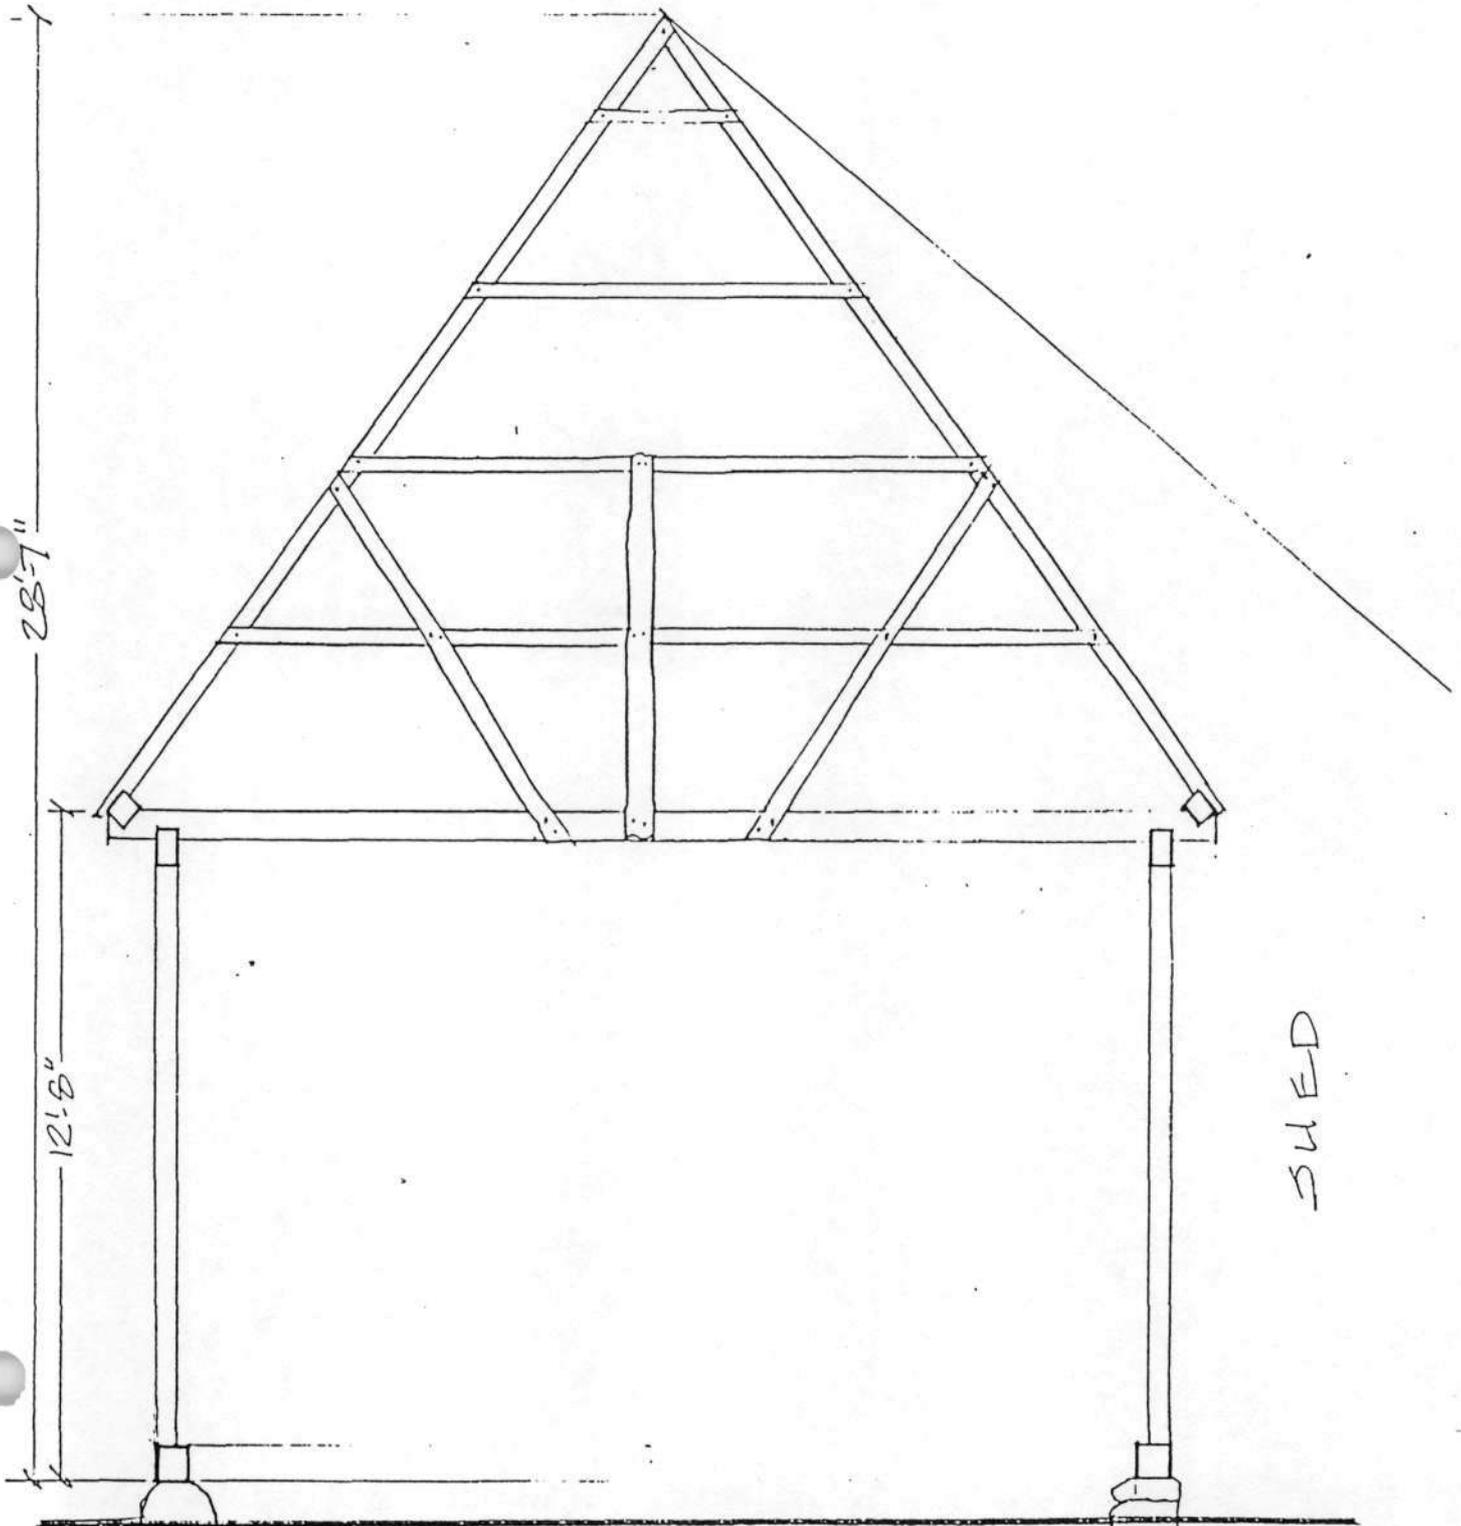
Section number 7 Page 7.8

Spye Park. Historic tobacco barn. Typical rafter truss. 1/2-in to 1-foot.

The oldest part of this barn is a heavily timbered, post and beam structure measuring 20-by-40 feet. The barn's mortise and tenon joinery and other carpentry details is consistent with building methods commonly practiced in the region from

the latter part of the seventeenth century well into the first decades of the nineteenth century. One feature possessed by the Spye Park barn that is especially characteristic of local, eighteenth-century building customs is its tilted false plates; however, as illustrated by the nineteenth-century additions to the Johnstontown Tobacco Barn (CH-332; demolished), tilted false plates continued to be used in building barns in this locality long after they ceased to be used in building houses. The Spye Park barn has evenly spaced, down-braced wall posts seated on raised, full sills. The barns most distinguished feature is its roof frame, which utilizes rafter trusses braced by diagonal timbers in a manner similar to a king post truss but with a less substantial centered vertical brace. (See 7.8.) Originally having a single, double-leafed door centered in each side elevation, the sills spanning the central bays were removed to provide for a wagon aisle. In the late nineteenth or early twentieth century the barn was extended by an addition of the same height and depth at its east end, and a full-width shed across the south elevation. Nail patterns on the surface of the original roof rafters over which the shed roof was built, indicates that the roof of the oldest part of the barn was initially sheathed with horizontally laid riven clapboards. The exterior walls were probably similarly sheathed. In its present form, the barn is clad with vertical planks and the roof with metal.

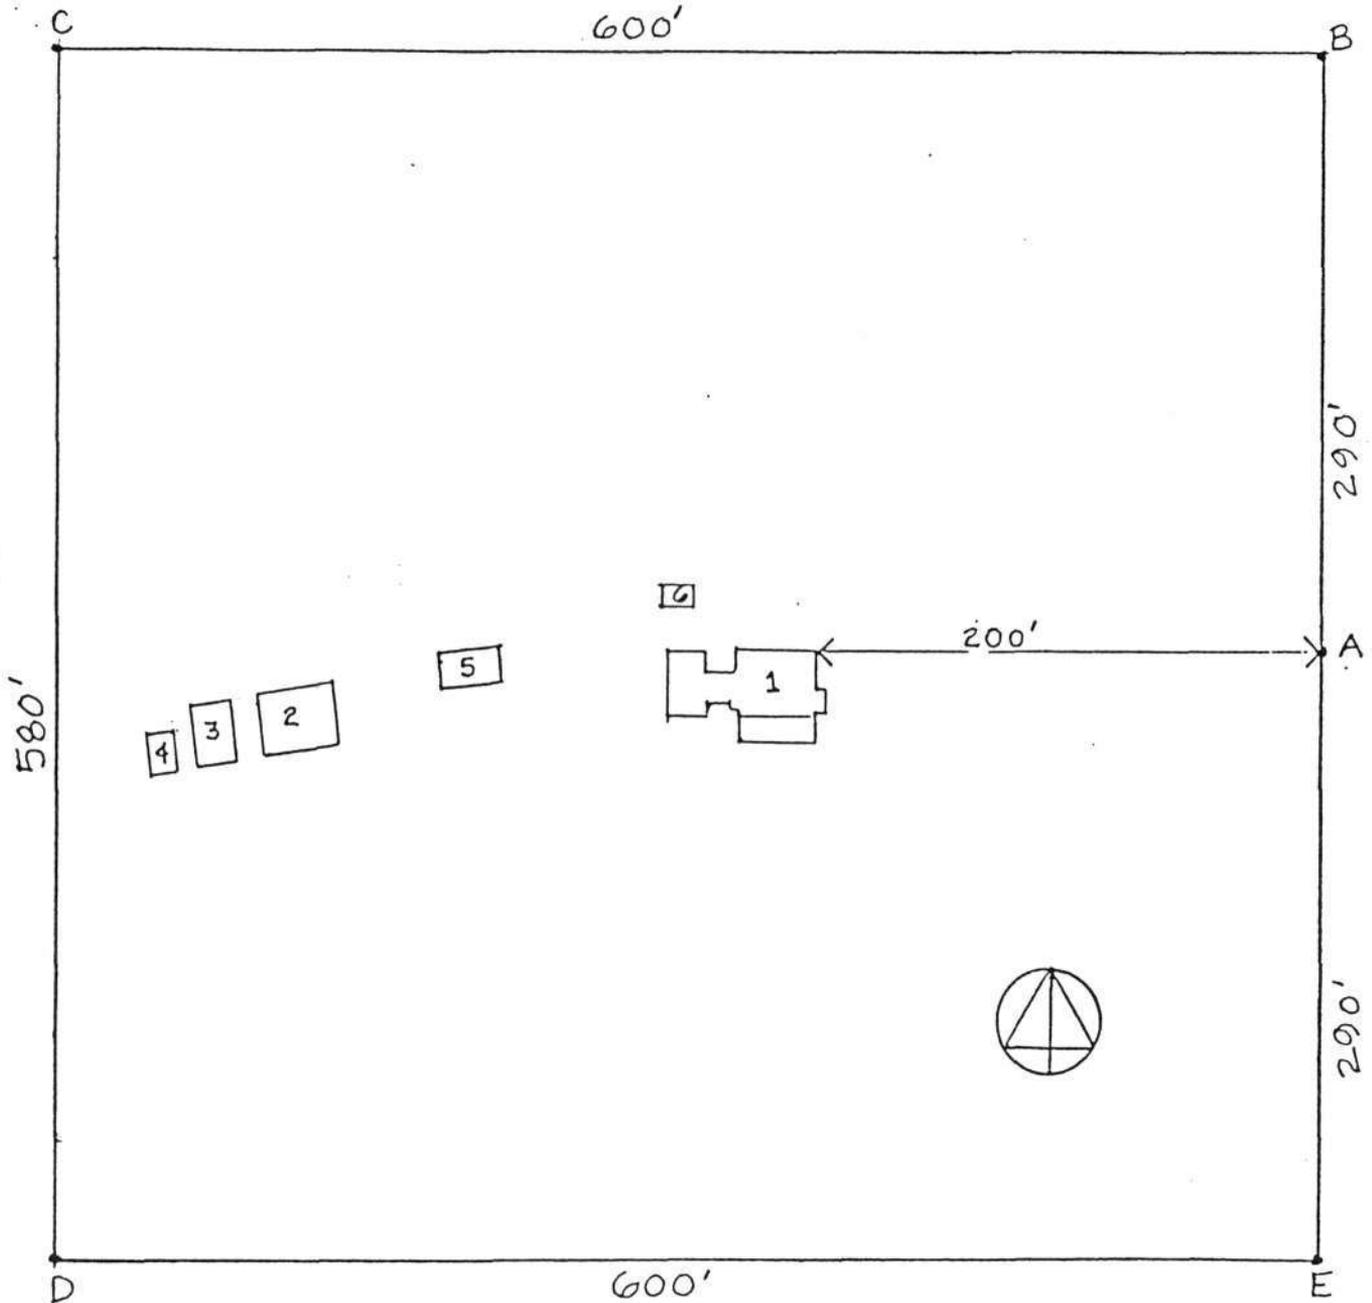
Section number 10 Page 10.1

BOUNDARIES: Begin at Northeast corner of house, 200 feet East to Point "A"; then North, 290 feet to Point "B"; then 600 feet West to Point "C"; then 580 feet South to Point "D"; then 600 feet East to Point "E"; then 290 feet North to Beginning Point "A". Containing 8 acres ±.

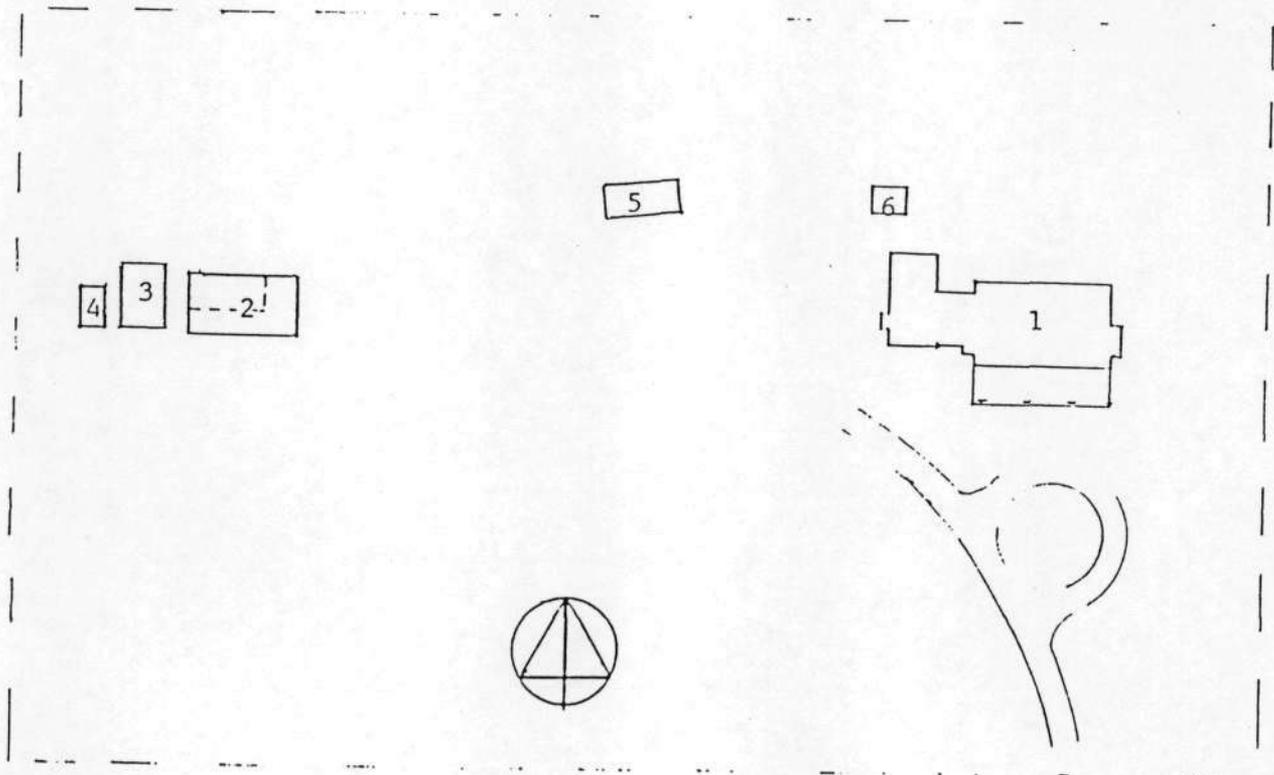
Section number 7 Page 7.4

Spye Park. General Site Plan.
Not to scale.
J. R. Rivoire

The following building descriptions are keyed to the site plan on Sheet No. 7.4:

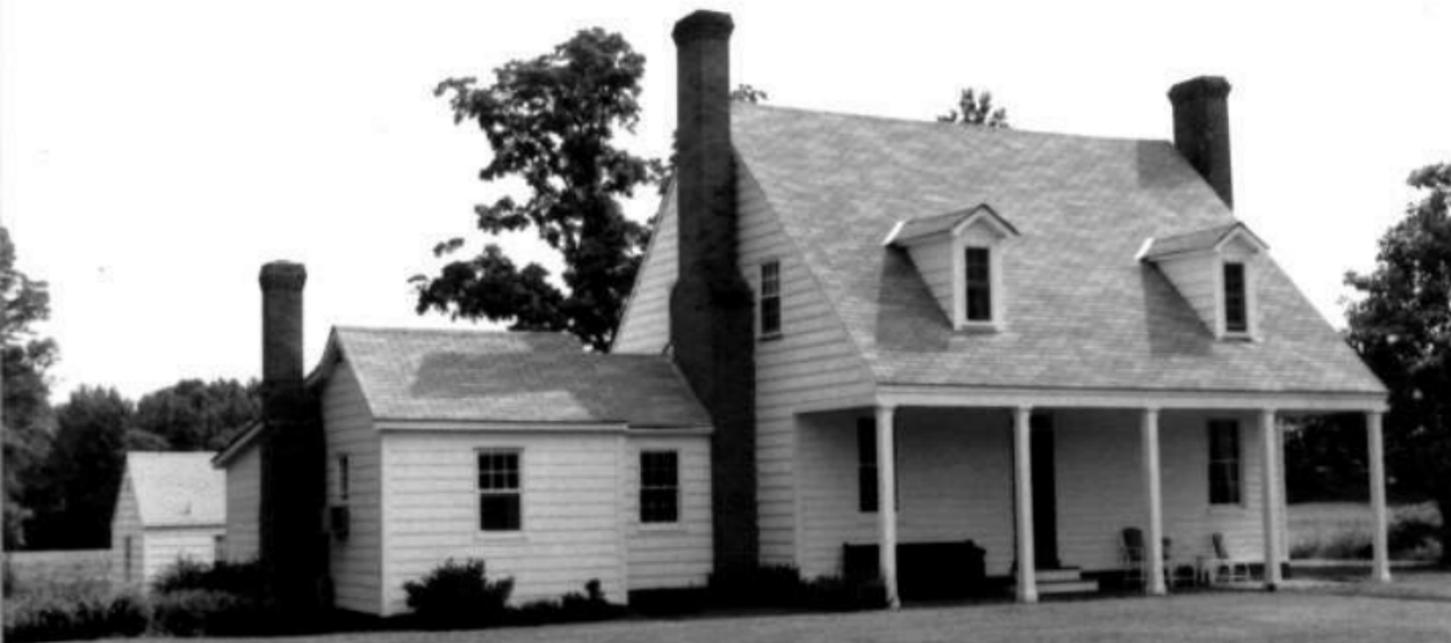
SPYE PARK

VIEW FROM SE

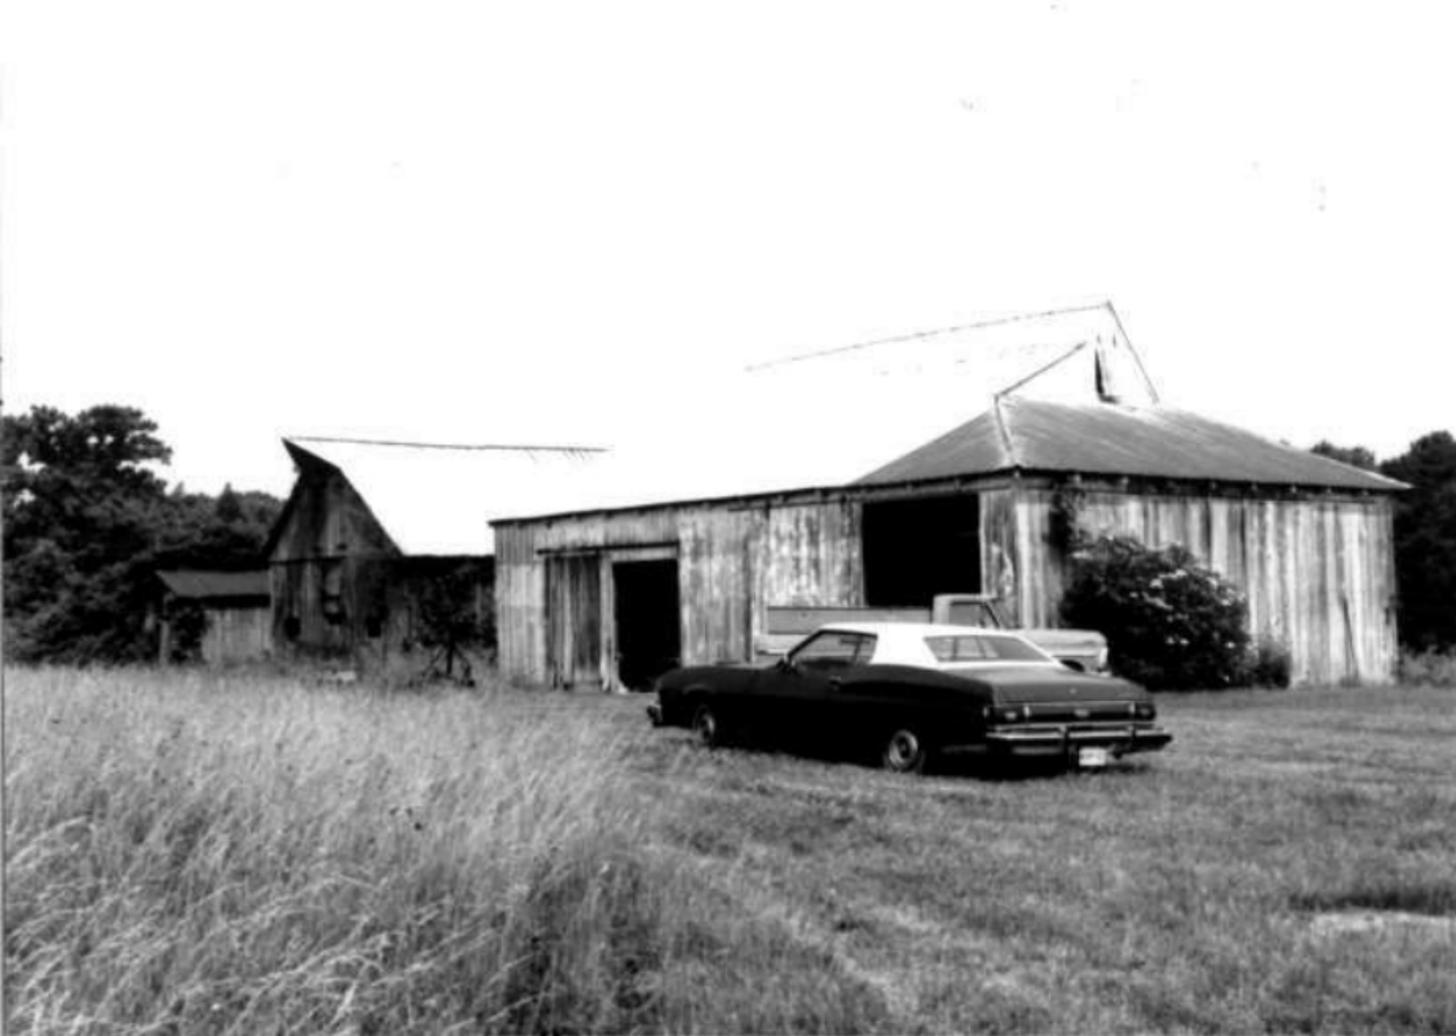
SPYE PARK CH-304

Similarly important in a local context is Spye Park's tobacco barn, the original portion of which is in unusually good condition. While heavily timbered tobacco houses with mortise and tenon joinery and tilted false plates were commonly built in this locality from the seventeenth century through the first several decades of the nineteenth century, they have suffered the same fate as the smaller dwelling houses. Today, only three tobacco houses with tilted false plates survive in a reasonably good state of repair, while only 20 years ago there were more than a dozen. Of those that exist, Spye Park's is the only one with braced roof trusses. Charles County's early agricultural buildings have been especially vulnerable to abandonment and destruction in recent years as more and more agricultural land is given over to residential, commercial and industrial development. More than two-thirds of the county's pre-Civil War agricultural buildings and domestic dependencies recorded since 1970 have disappeared or are now in complete ruins.

VIEW OF BARN FROM SE

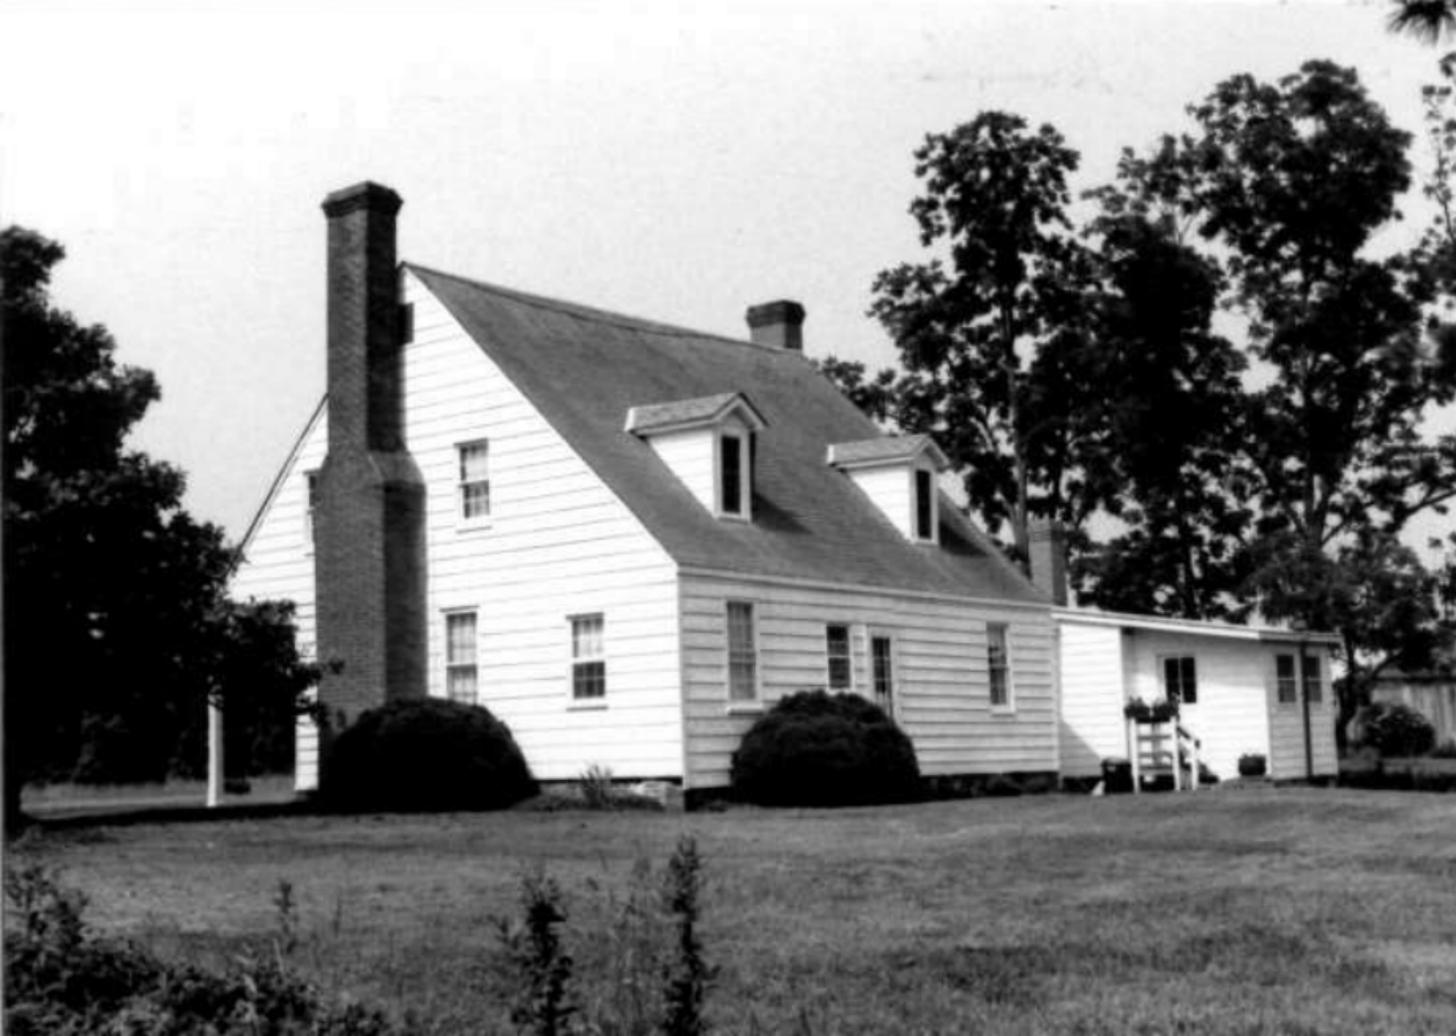
SPYE PARK

VIEW FROM NE

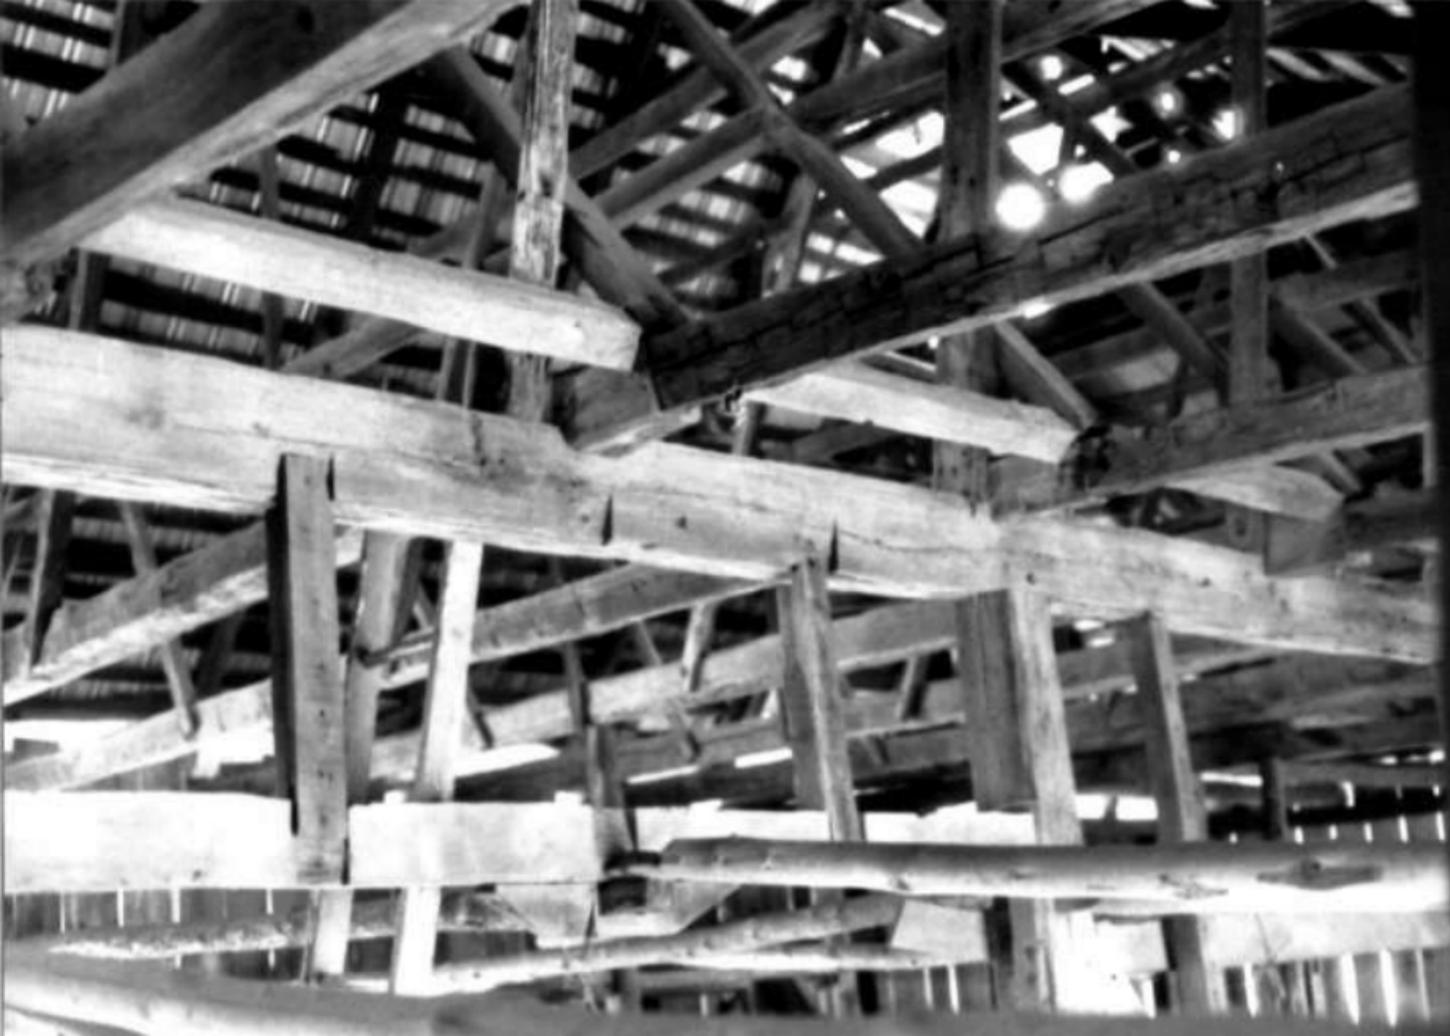
SPYE PARK (BARN)

VIEW OF EAVE FRAMING,
SOUTH SIDE.

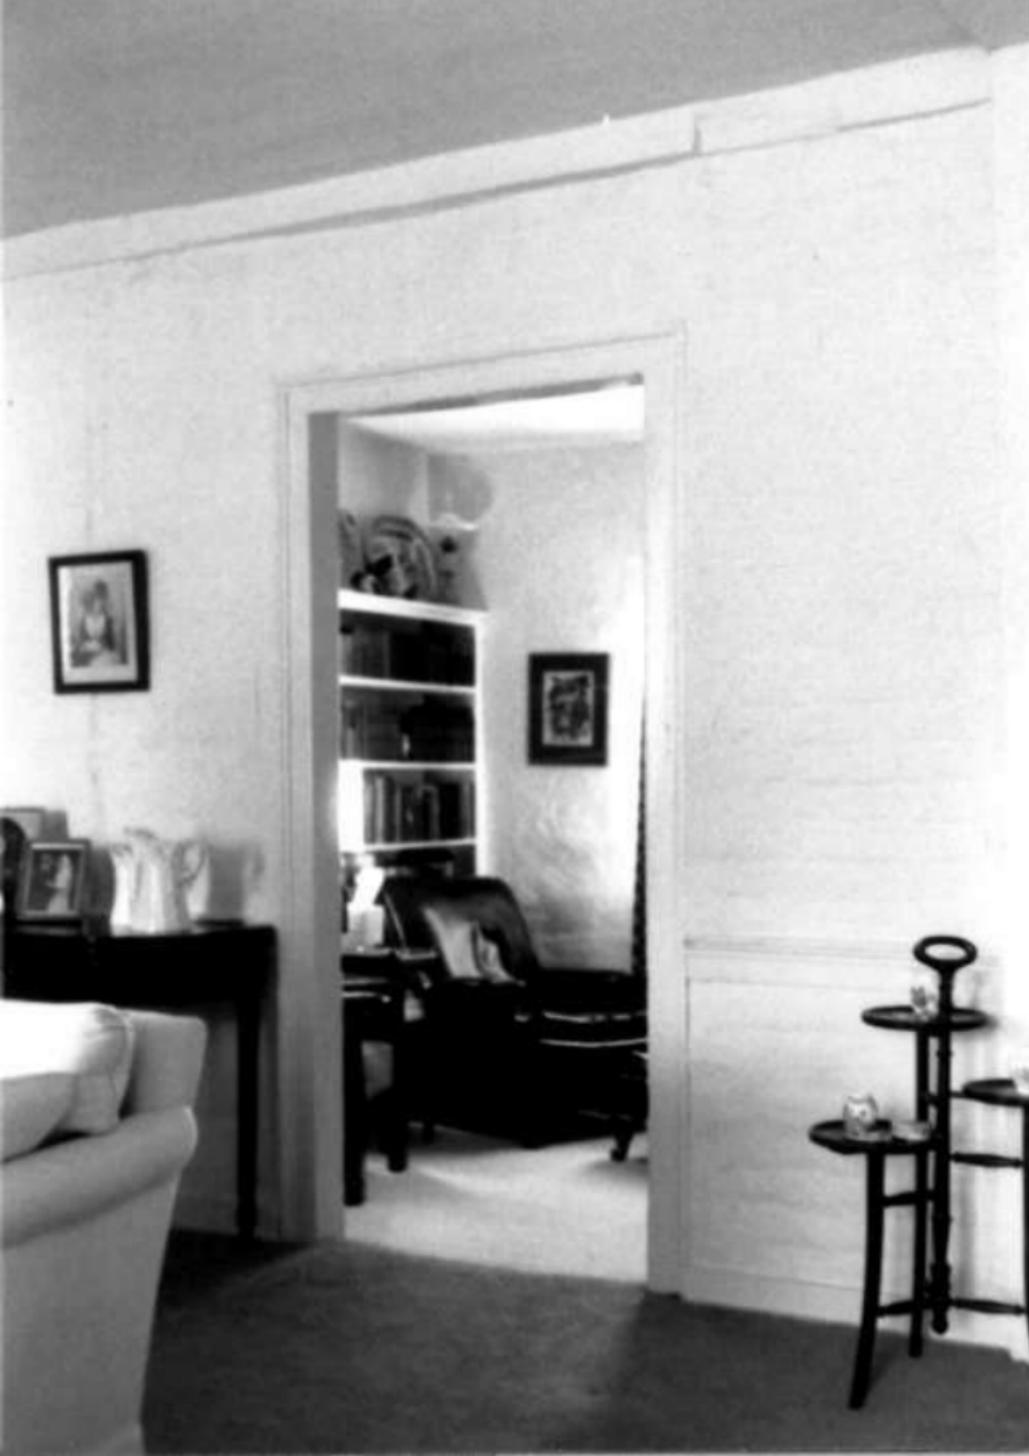
N. WALL, SW 1st FLOOR ROOM

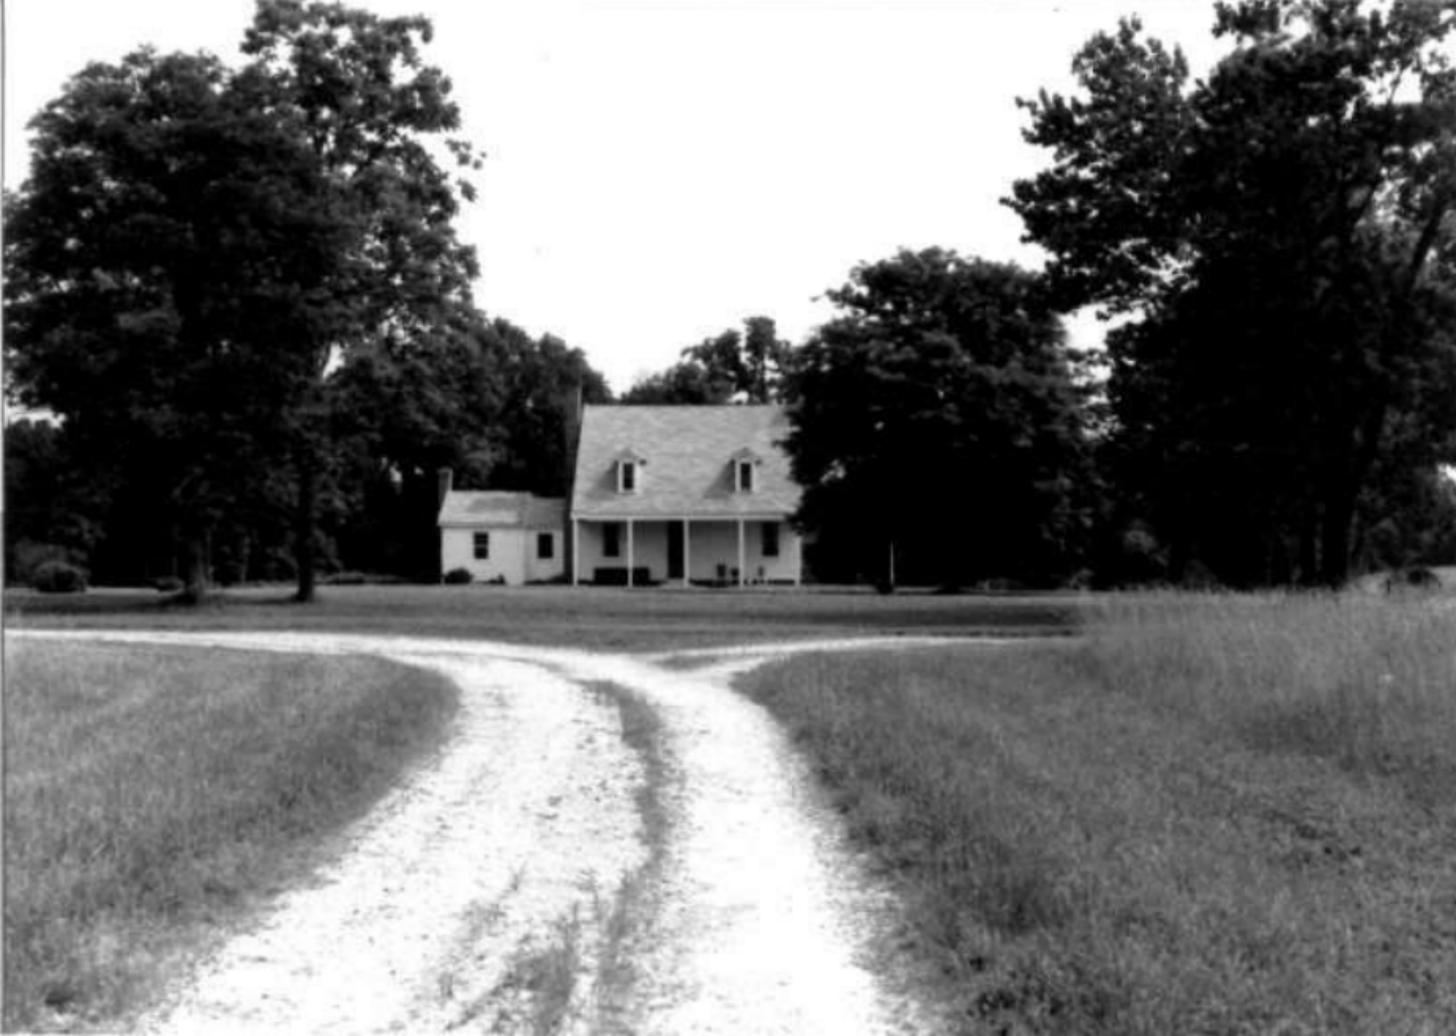
SPYE PARK

VIEW FROM SOUTH

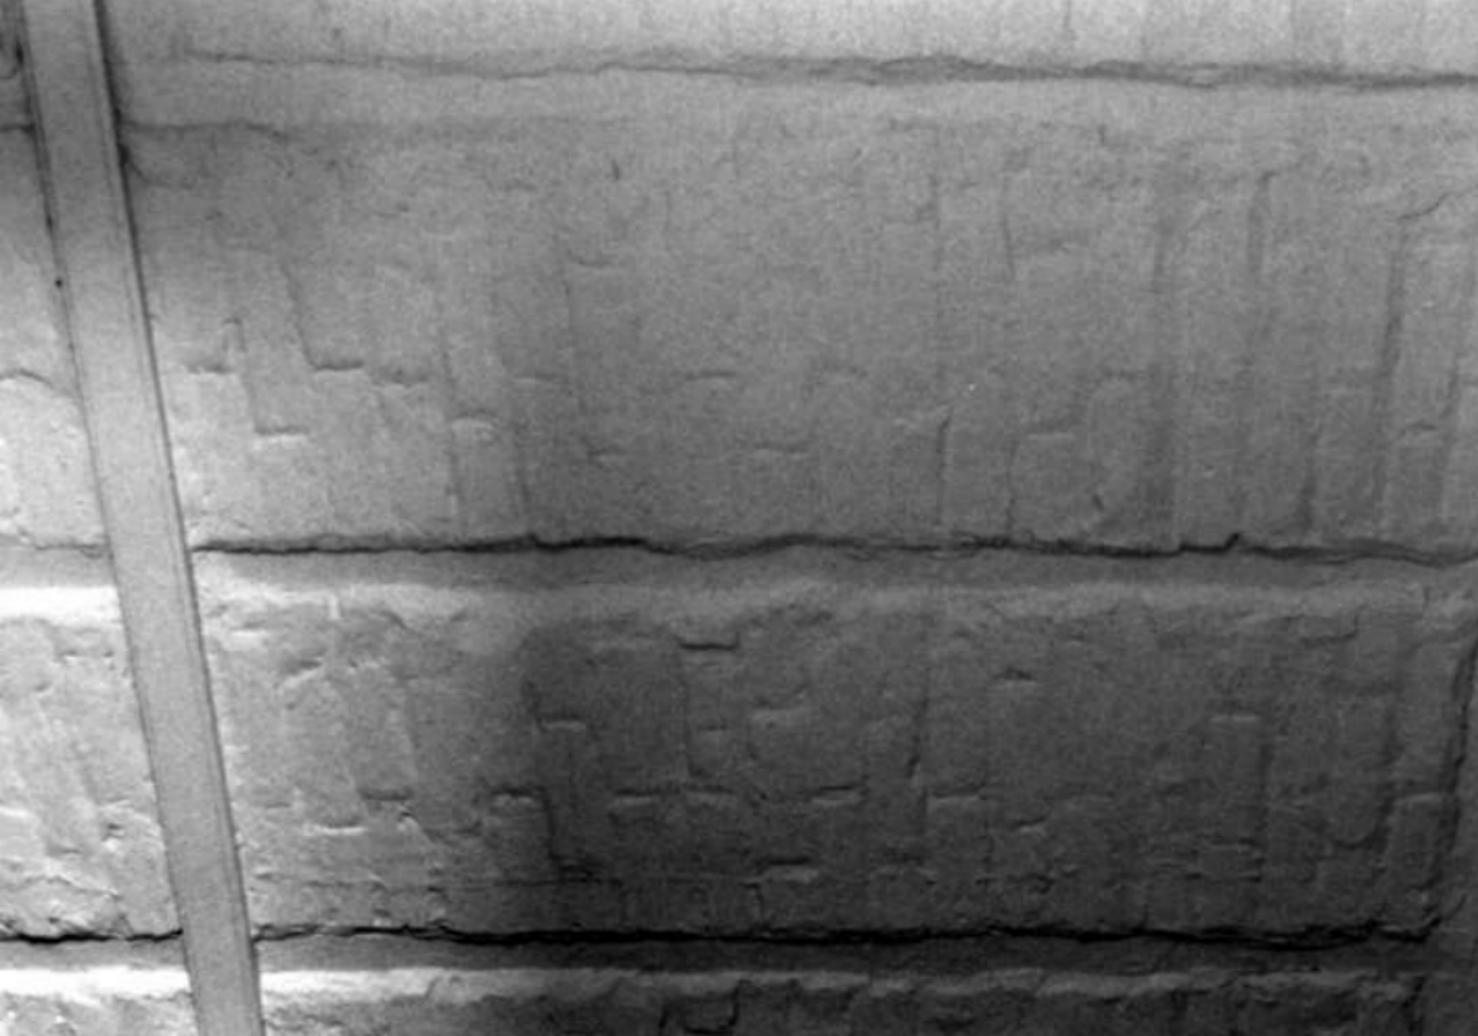
S. WALL, NE 1ST FLOOR ROOM
