Maryland Historical Trust  
State Historic Sites Inventory Form

Survey No. CARR-8098

historic Durbin Family Farm

street & number 640 Spring Mills Road  not for publication

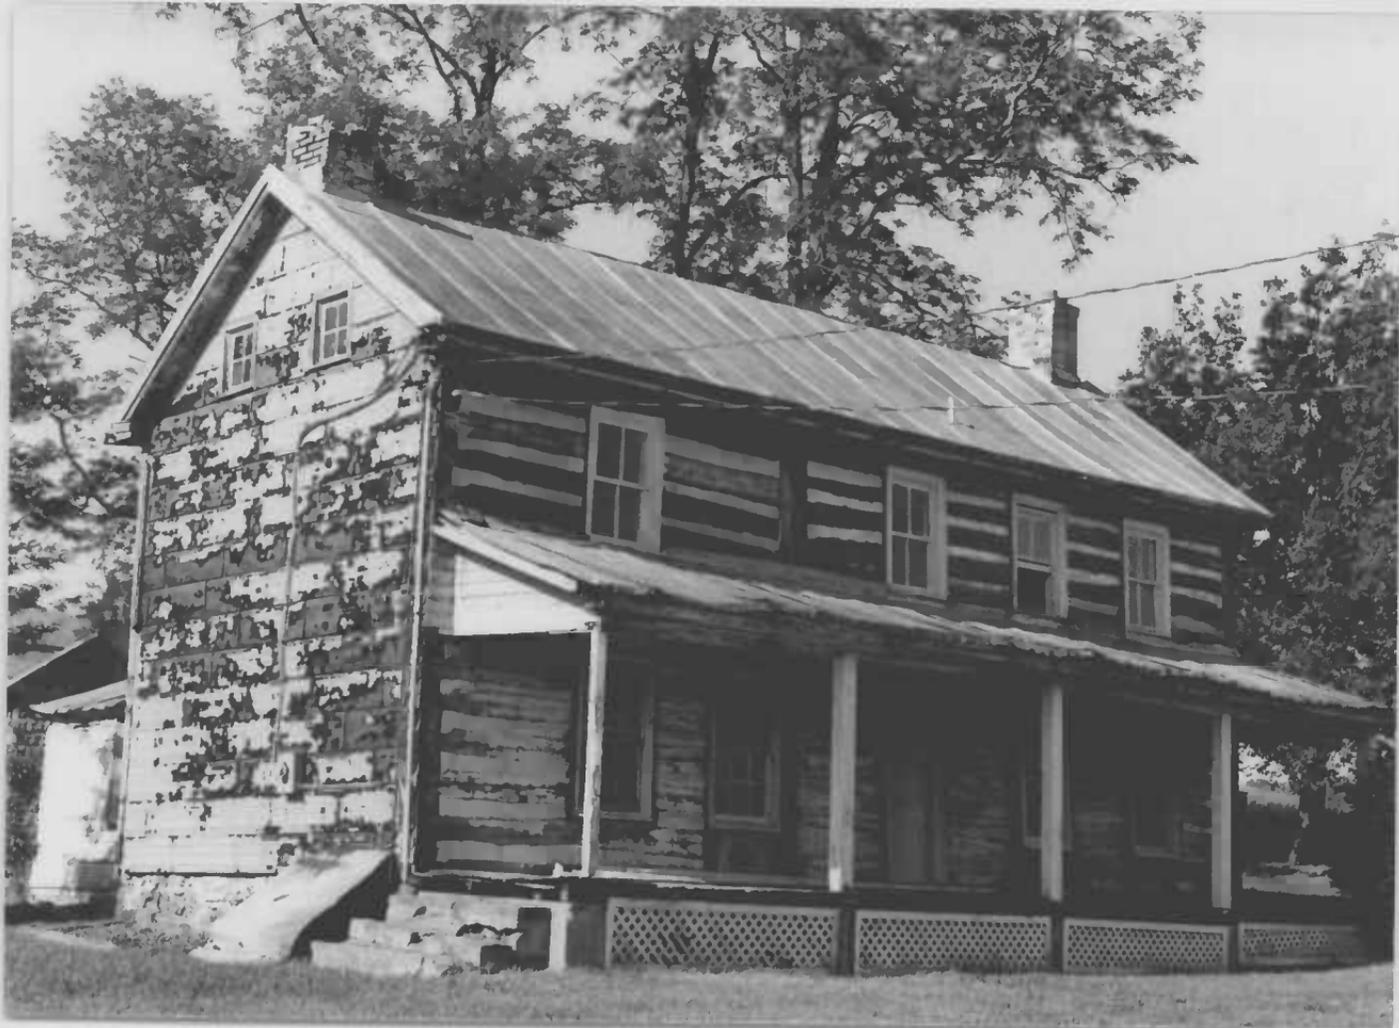
Neg. loc.: Maryland Historical Trust  
house-west & south. elevations

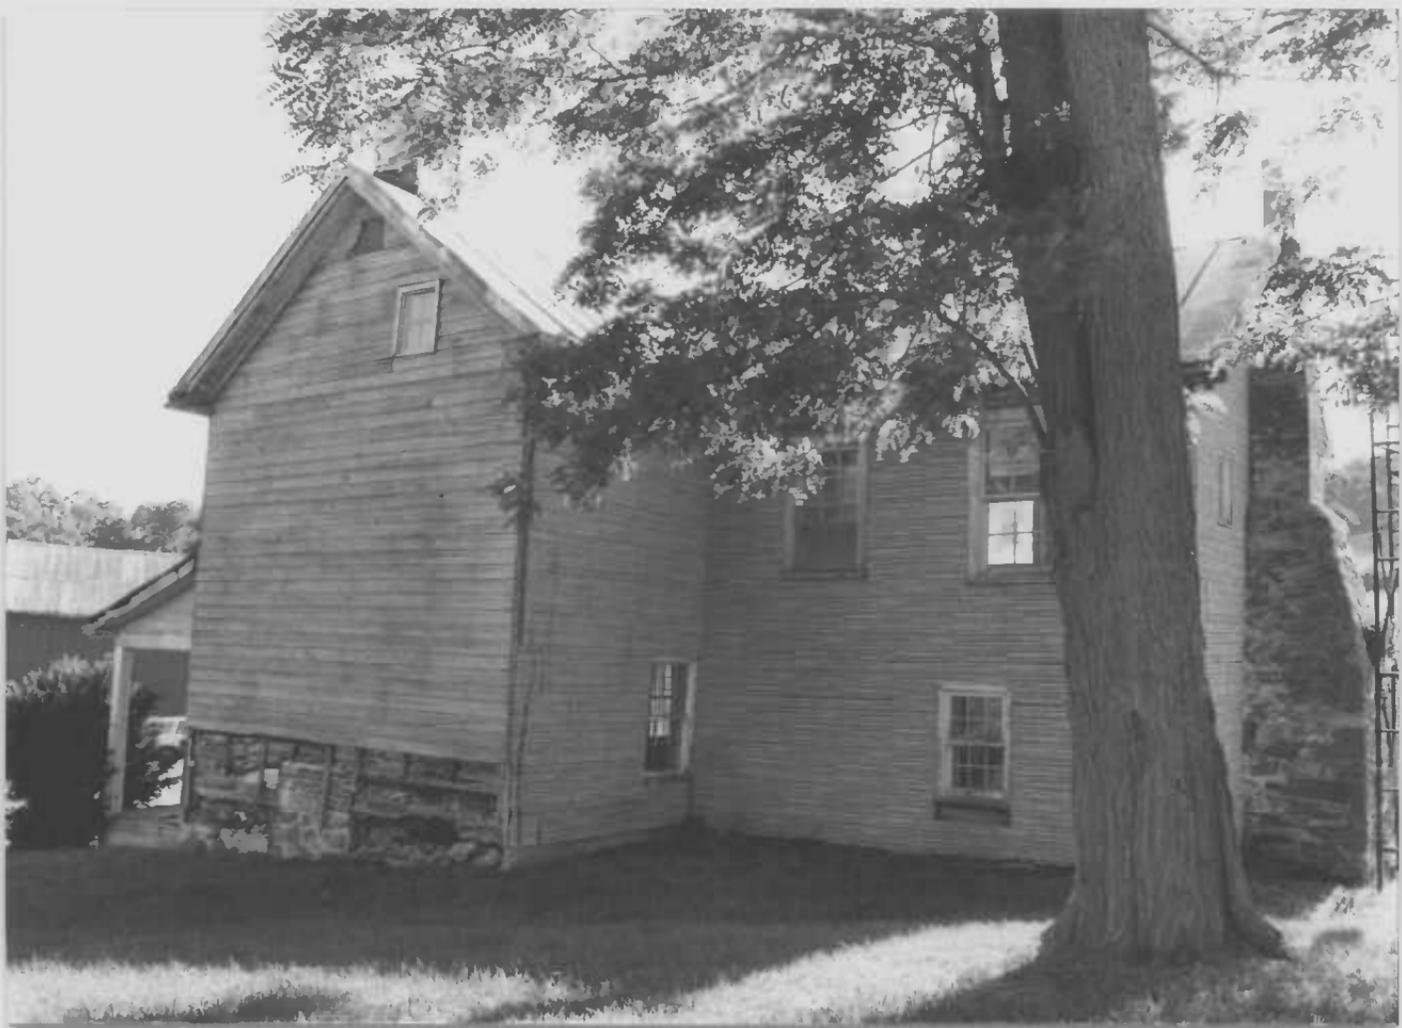
house - east - north elevations

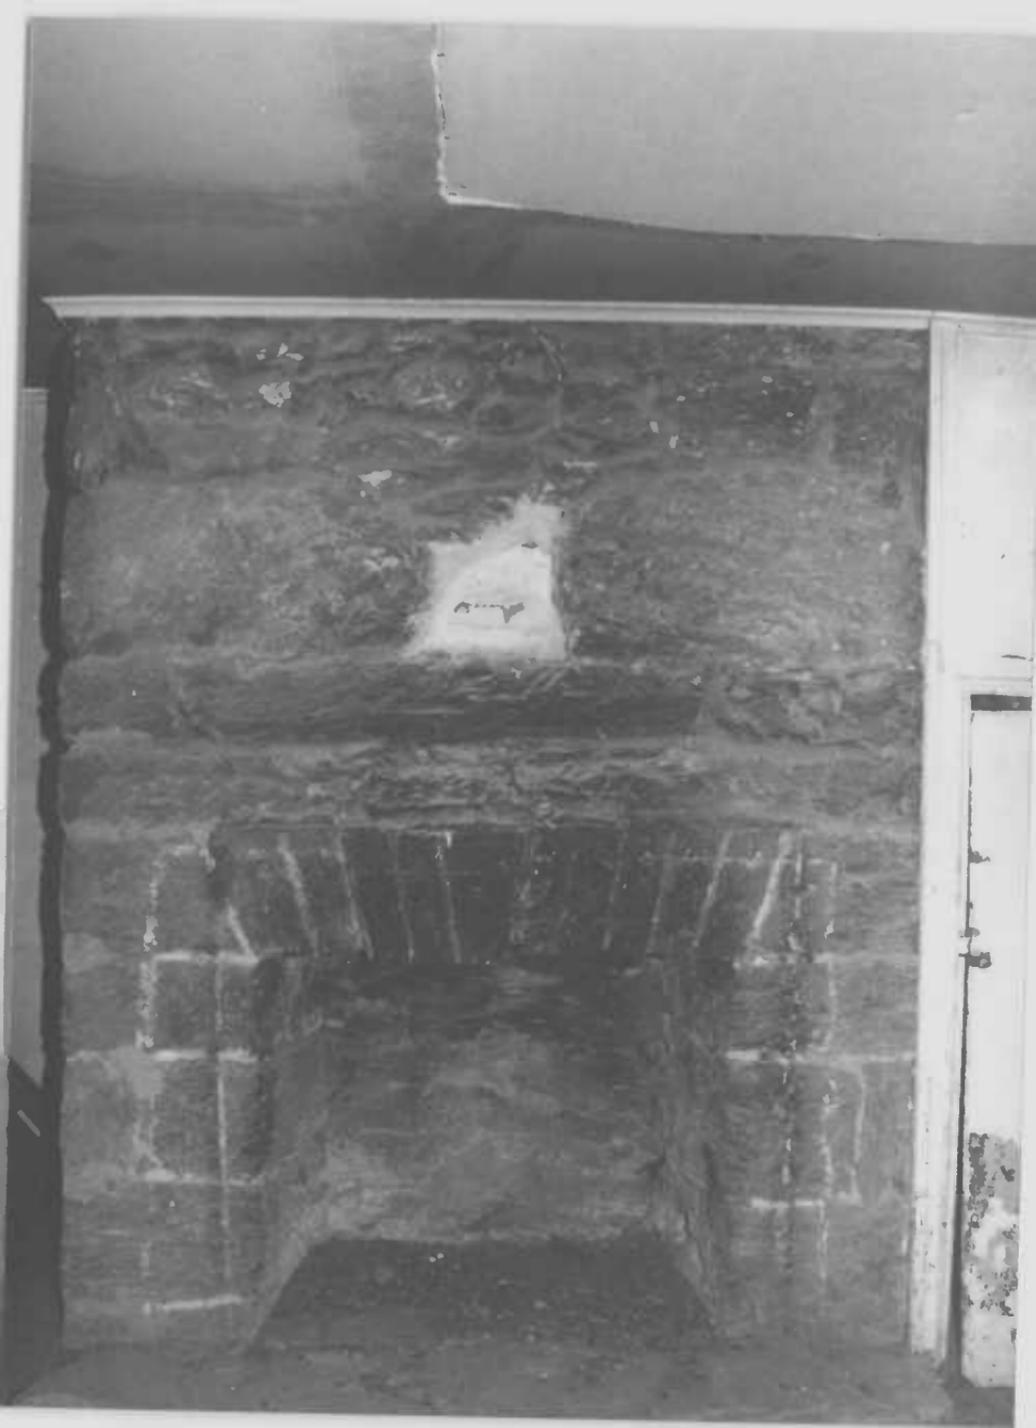
and baseboards as are found in the east room. The west addition surrounds on the first story are nailed over top of mitered architraves that have a beaded interior edge. There is an interior stone fireplace centered on the west wall. It is built of Sam's Creek metabasalt and is very finely cut ashlar. The splayed jambs are well finished and it also has well cut voussoirs and keystone. It appears that the joints were once painted white. It also appears that there was once a wide low mantle that left about 8½ inches of stone exposed on all three sides of the opening. Later, a taller, narrower mantle was installed with lead anchors sunk in the stone. The hearth is new. There is a winder stair in the northwest corner that has a new board-and-batten door that replaces an earlier one that hung on butt hinges. There is a closet door under the stairs that is made of tongue-and-groove beaded-edge vertical-board doors and has a surround with an ogee with kick. The door was hung on cast iron butt hinges. The narrow board floor goes only part way under this winder stair. In the corner of the wall is hand split vertical lath that laps over the stair treads. This suggests that the stairs must be original. The lath is nailed with cut nails. The logs underneath the lath were white washed, as is the chinking, suggesting that the logs were originally exposed before being lathed and plastered. It appears that there was a door on the north wall of this room in the west bay. The opening is now filled with shelves.

Neg. Loc.: Maryland Historical Trust  
house - west room fireplace

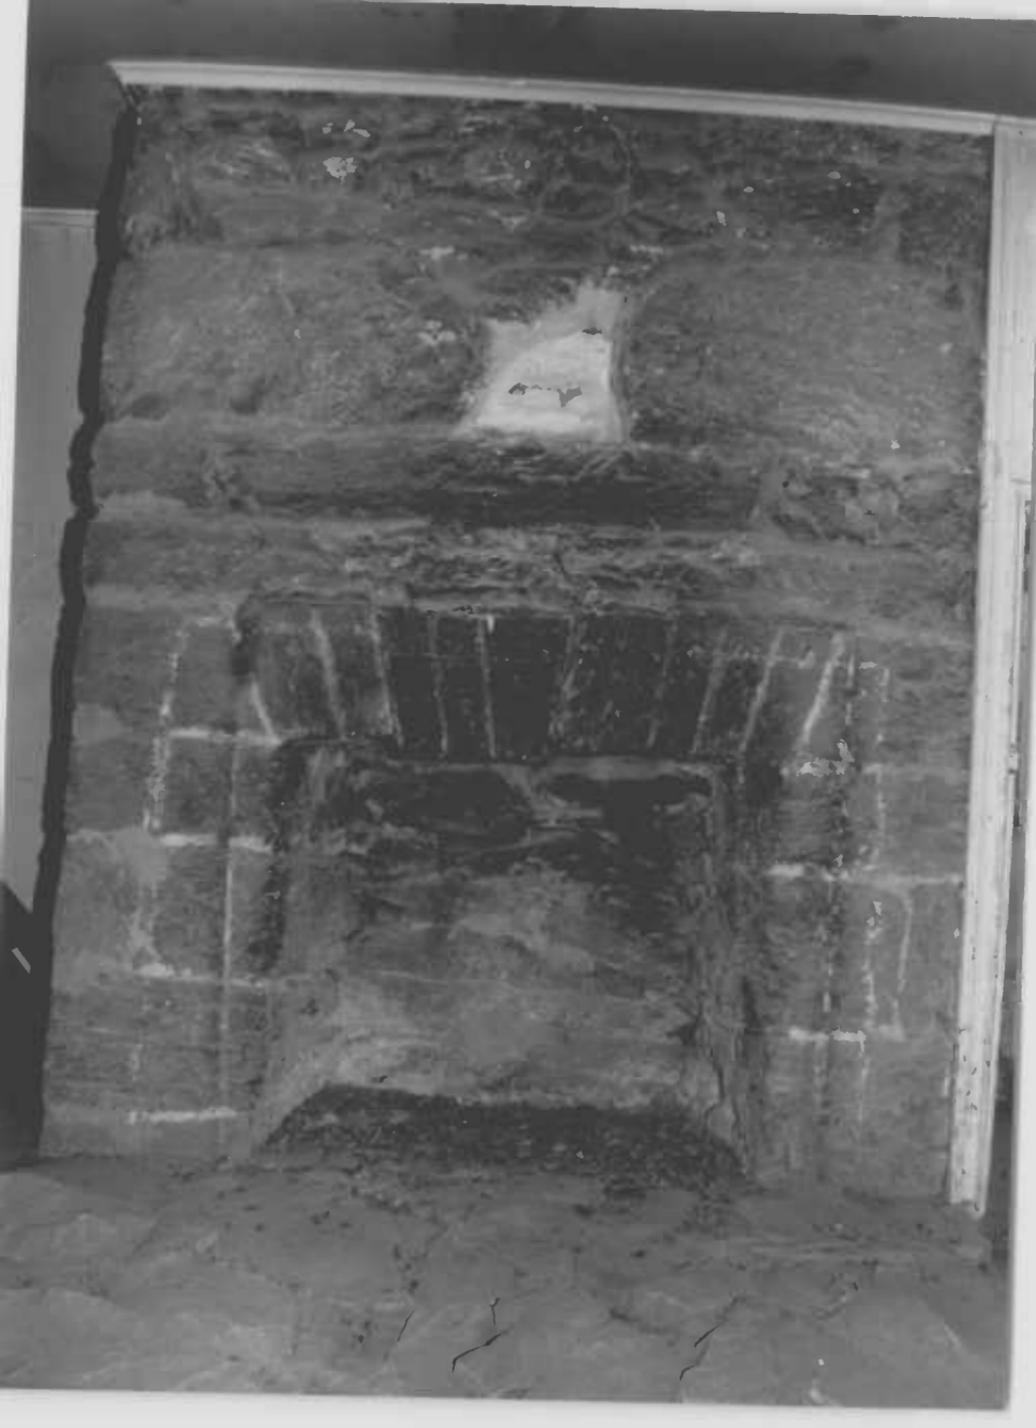
Durbin Family Farm  
640 Spring Mills Rd.  
Carroll County, Maryland  
Photo: Kenneth M. Short  
Date: May 1995  
Neg. Loc.: May 1995  
west room fireplace
