CARR-819

Willis F. Tracey Mill Farm
3969 Lineboro Road
Lineboro

c. 1905

Maryland Historical Trust State Historic Sites Inventory Form

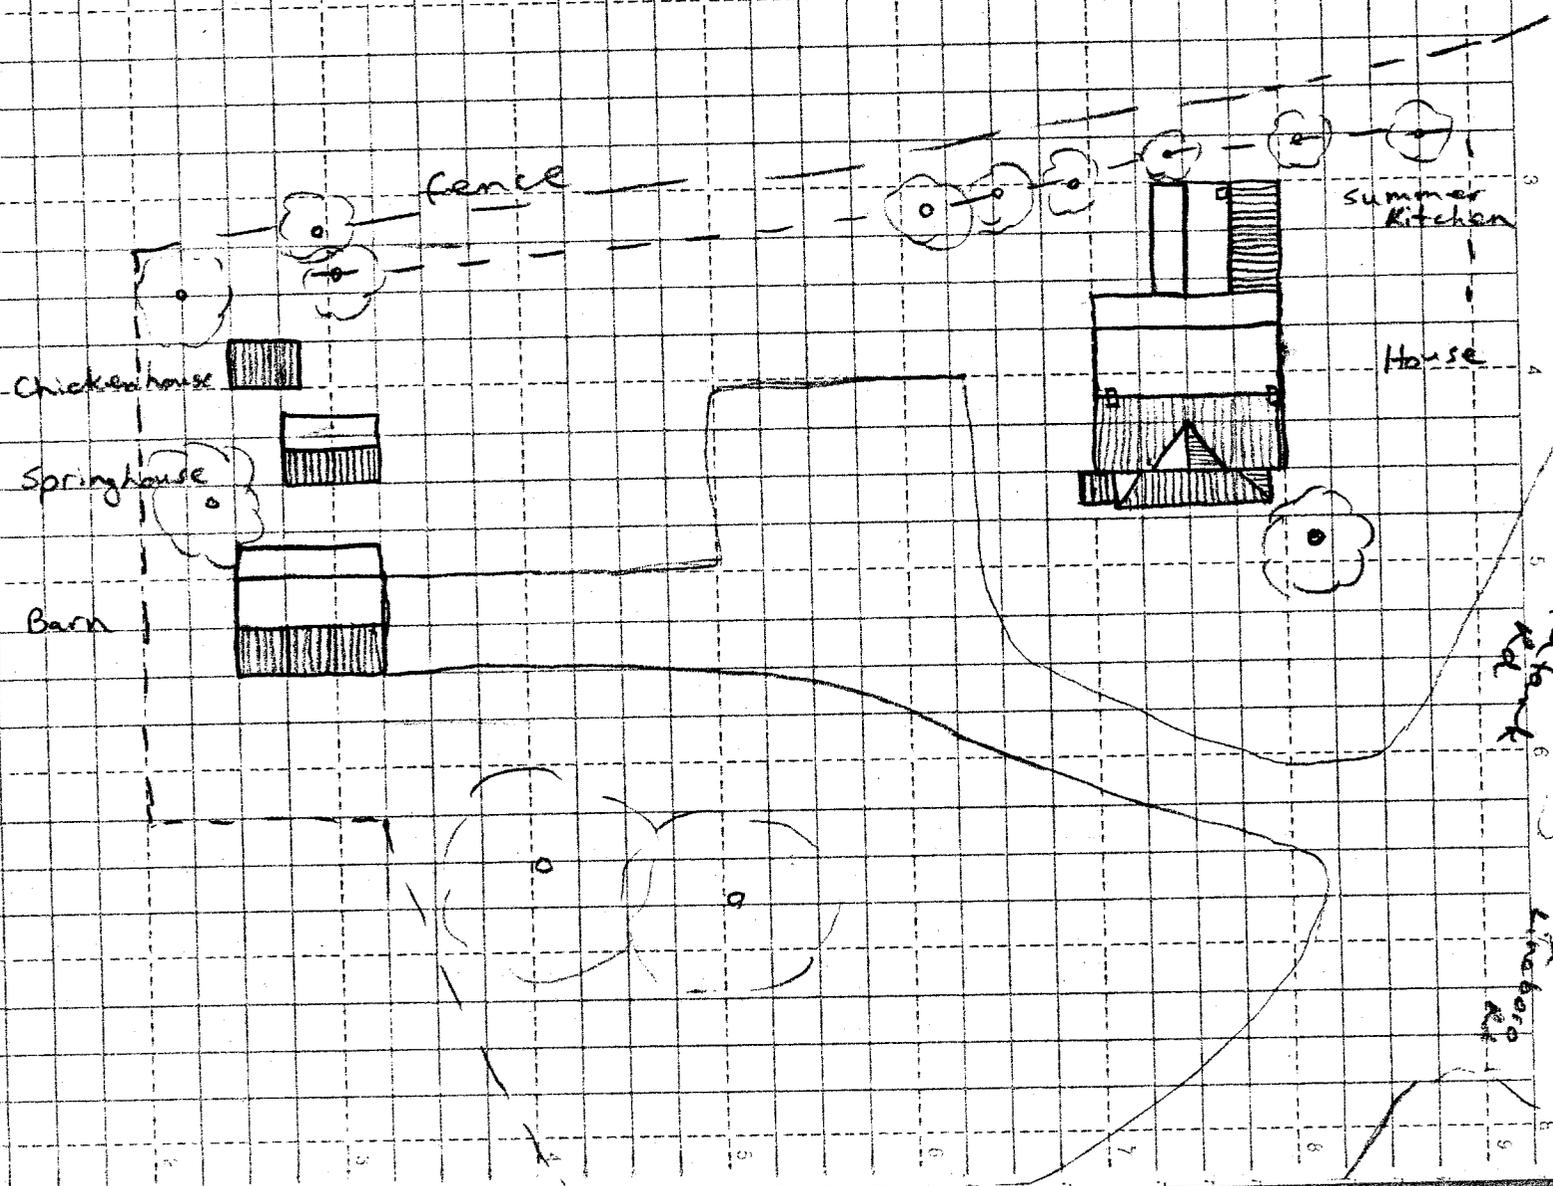
3969 Lineboro Rd. CARR-019
Site Plan

The Willis F. Tracey Mill Farm is located east of Lineboro Road, at the intersection of Watertank Road. It is situated in the flat valley of the south branch of the Gunpowder Falls, at the base of a low ridge. The brick house, built c. 1905 faces toward the new Lineboro Road and beyond toward the Conrad Kerlinger Mill, which at that later date was the Willis Tracey Mill. Lineboro Road originally snaked around to the west of the mill and did not separate the house from the mill. Also on the property are a summer kitchen, a small barn, a springhouse and a poultry house.

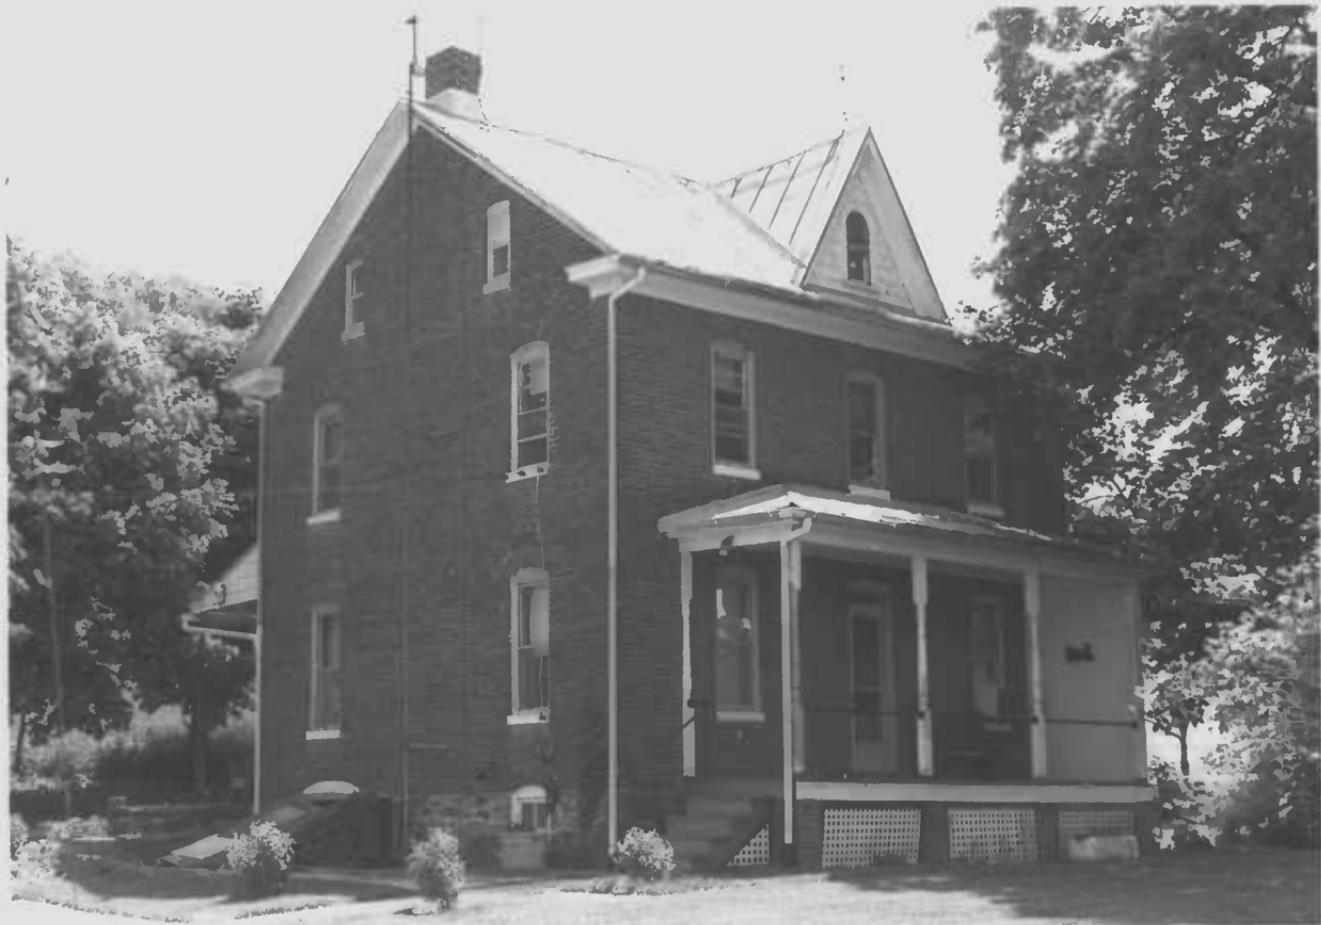
114

The house is a two-and-one-half-story, three-bay by two-bay structure of all-stretcher bond brick on all four elevations. It has a rubble stone foundation, 1/1 segmentally-arched windows, with wood sills, and a standing-seam metal gable roof. The northwest (front) facade has two segmentally-arched sash in the cellar covered by the porch. There is a central entrance with a one-light transom and a later six-panel wood door. The half-hipped-roof porch has brick piers with wood lattice infill at the cellar level and five steps on the northeast end. There are four turned posts. There is no evidence that it ever had balusters, but the porch did have brackets once. The southwest end of the porch is enclosed now with wood. There is a boxed cornice with returns. The center bay has a gabled dormer on the roof with siding of wood shingles with clipped corners. The dormer has a round-arched 9/1 sash. There is an internal brick chimney on each end. Each chimney contains a copper lightning rod with glass ball.

House - NE : NW elevs.

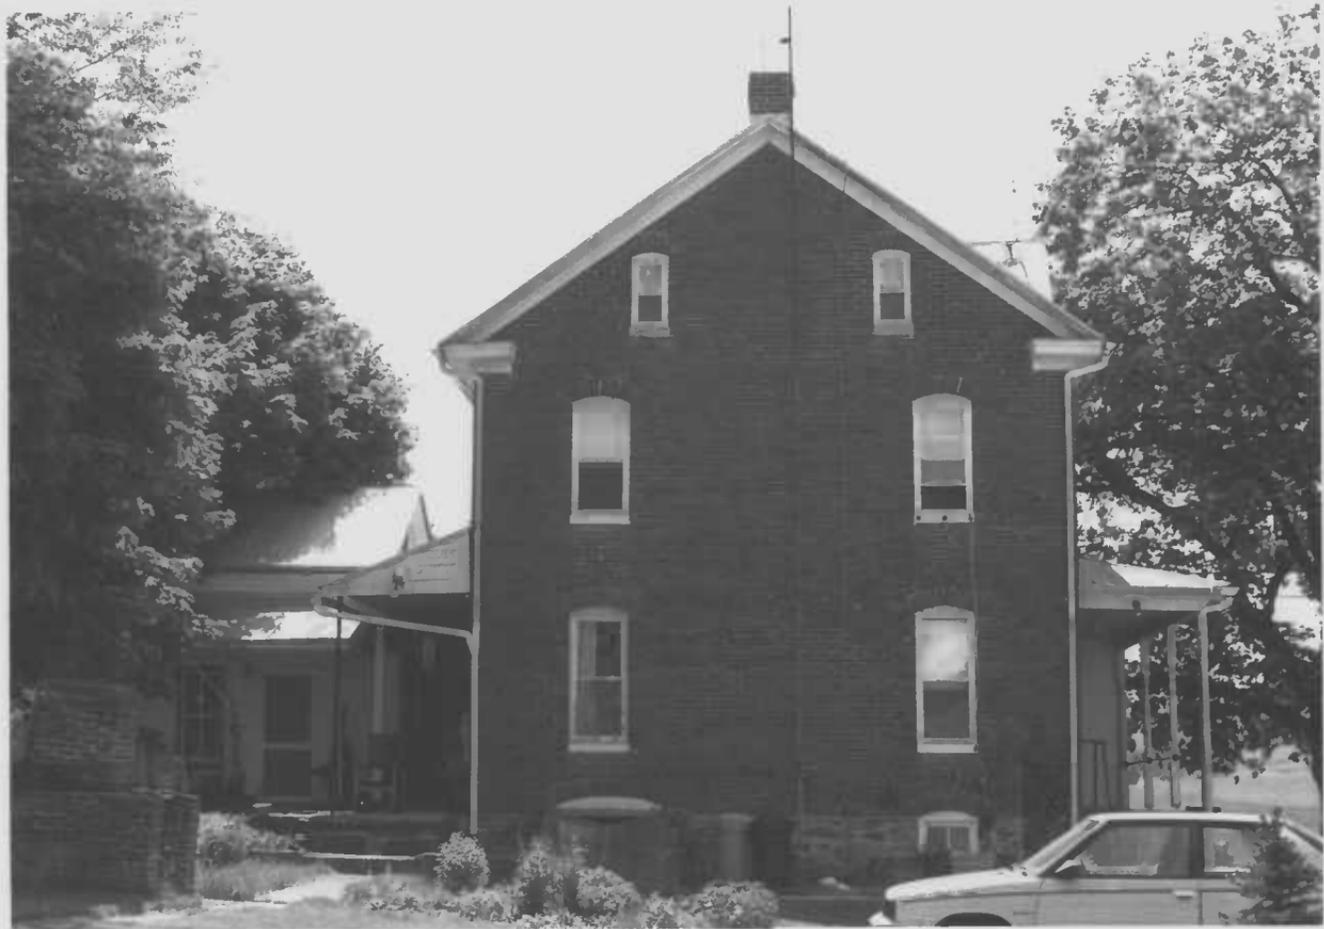
2/4

Southeast of the house is a frame summer kitchen that butts against the roof of the rear porch and is perpendicular to it. The summer kitchen is one-and-one-half stories, with a rubble stone foundation, German siding with corner boards, and a standing-seam metal gable roof. The northeast elevation has a 2/2 sash in the center and a vertical board door to the north. There is a one-story, shed-roof porch with standing-seam metal roof and new metal posts. The southeast elevation has an exposed brick fireplace flush with the siding of the wall. The internal brick chimney is just east of the gable ridge. The southwest elevation has one 2/2 sash. The siding extends northward beyond the end of the summer kitchen and butts the house at the south corner, enclosing the southwest end of the rear porch. There is a 2/2 sash set in this siding.

Summer kitchen; house - NE elev.

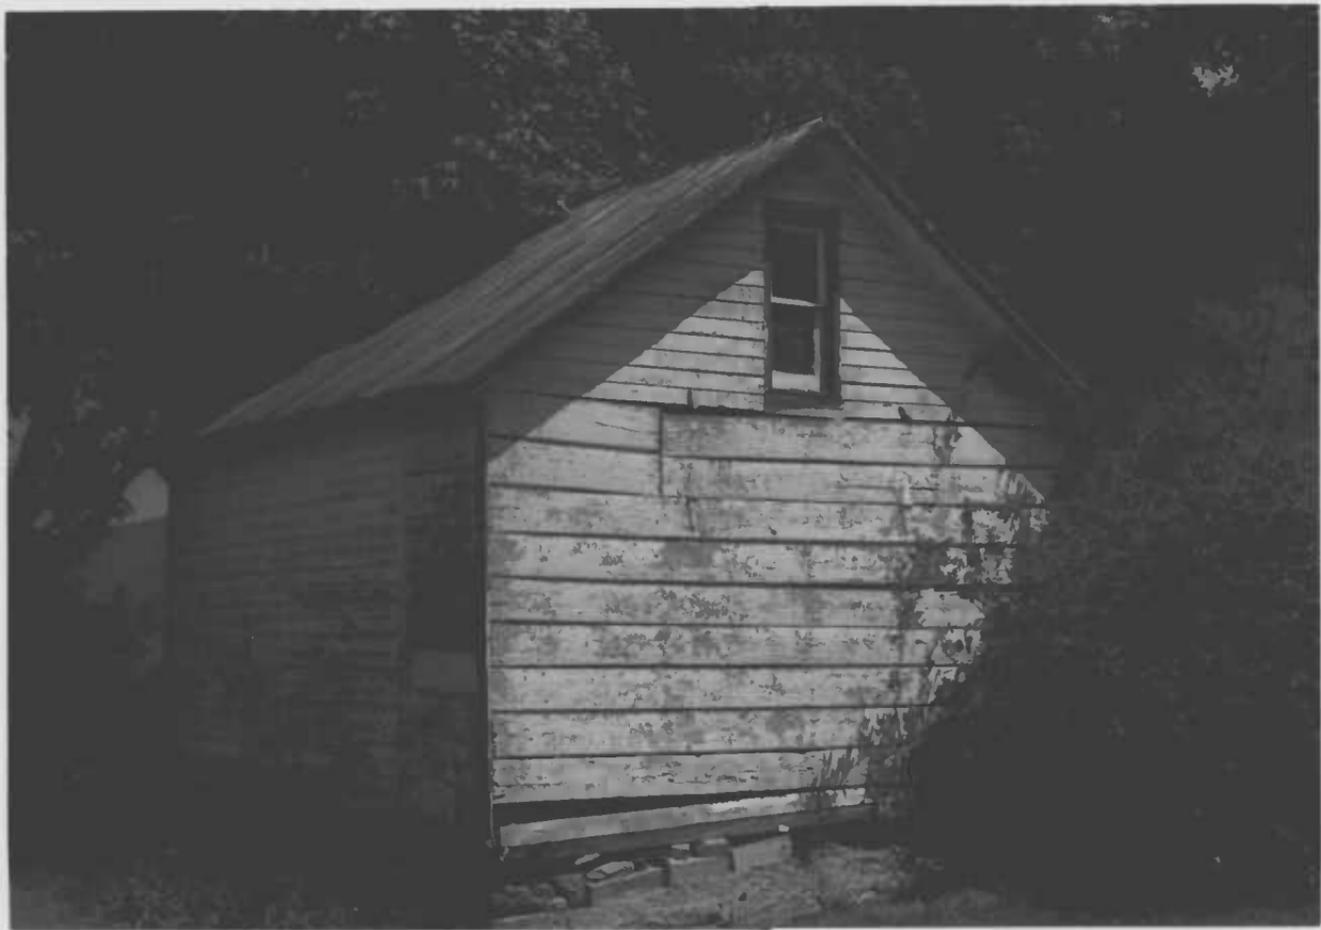
4/4

Southeast of the barn is a frame springhouse on a stone foundation, with a corrugated metal gable roof. It has German siding with corner boards. The roof is cantilevered about two feet on the southwest end, and the gable end is filled with German siding and a 1/1 sash. The space below the cantilever has been enclosed with clapboard on the southwest and northwest sides. The southeast space below the cantilever has a vertical board door and German siding. The southeast elevation of the springhouse has a vertical board door in the center.

Springhouse - NW & SW elevs.
