CARR-1238

Dairy Barn

Springfield Hospital Center

Maryland Historical Trust State Historic Sites Inventory Form

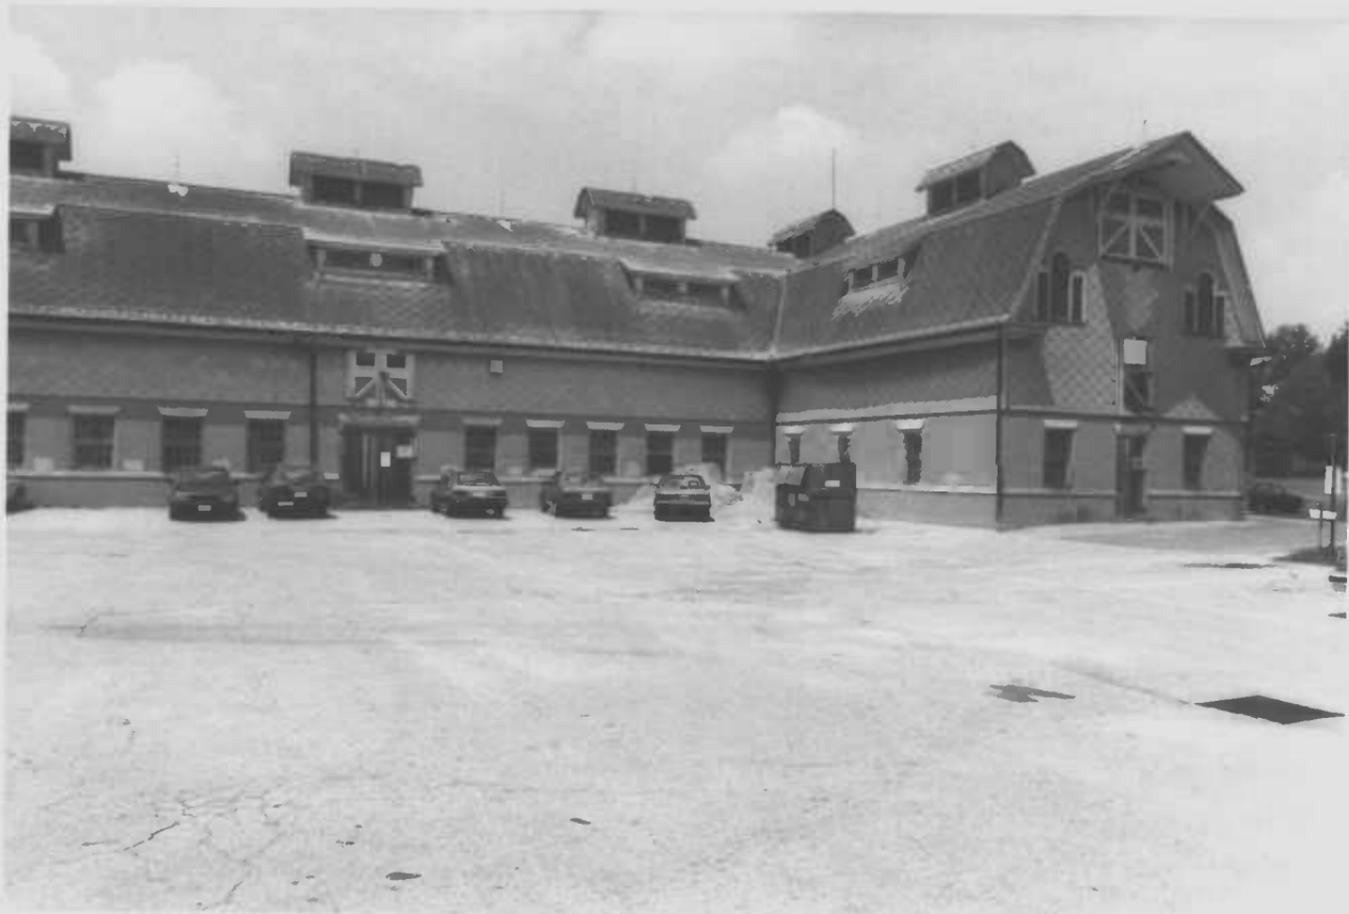
East

The east and west gambrel ends exhibit return eaves and plain projecting verges. The windows on the gambrel ends are Palladian with louvered faces. The surrounds of the windows are wooden. The gambrel ends also display a third floor, barn door. The double wooden door is located below the peak of the roof. The roof overhang shelters the door. The overhang itself is supported by brackets.

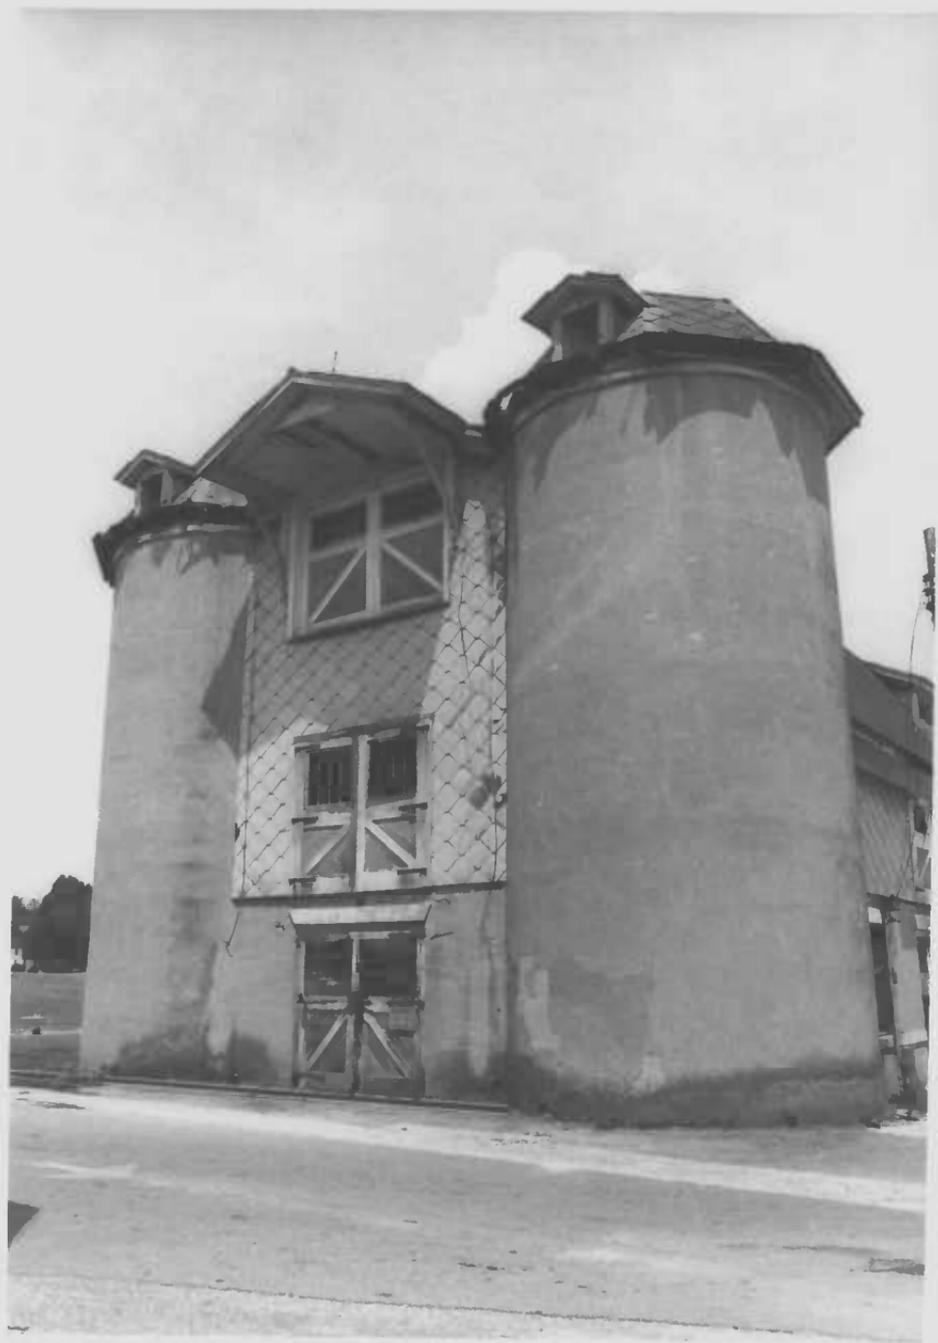
South Walls

The southern wall of the T projection does not end in a gambrel. The corners of the building are embellished by two silos constructed of stucco over cast concrete. The silos rise the three stories of the barn and are capped by a bellcast tower roof. On the southern portion of the silo roofs, there is a gabled dormer. The roof of the dormer mimics the large overhang of the other roof. This southern wall between the two silos does not reveal any Palladian windows but instead a wooden door occupies the central bay on each floor.
