Springfield Hospital Center

# Maryland Historical Trust State Historic Sites Inventory Form

Survey No. CARR-1256

historic Staffhouse #12

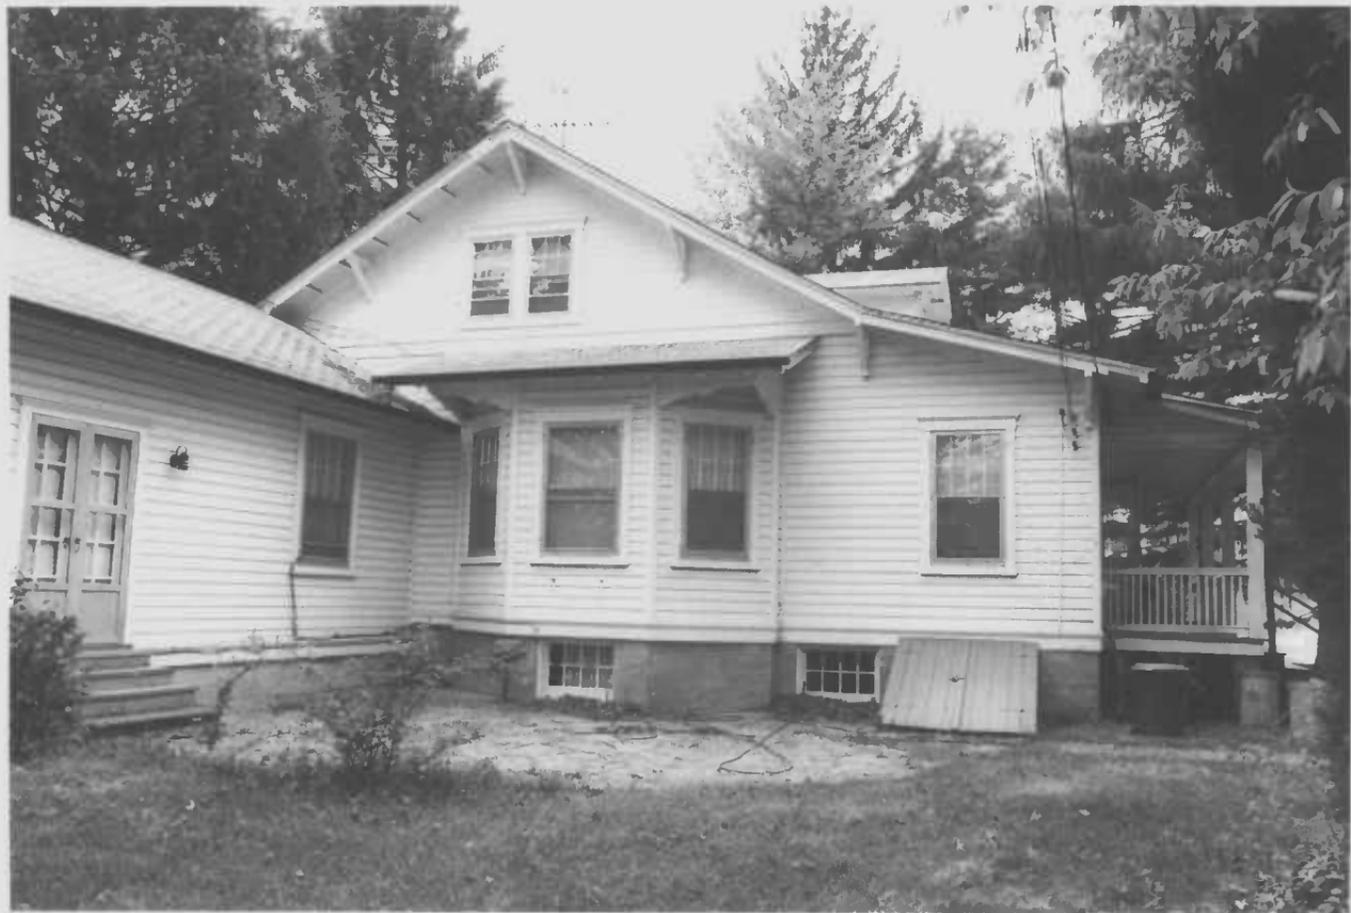
East

The attachment on the east wall is also covered by shiplap siding and a gabled roof. The attachment ends with a gable wall and an exterior brick chimney of a single flue. The fenestration repeats.
