CARR-1303

John Werner Farm
4400 Watertank Road
Manchester

c. 1850

Maryland Historical Trust State Historic Sites Inventory Form

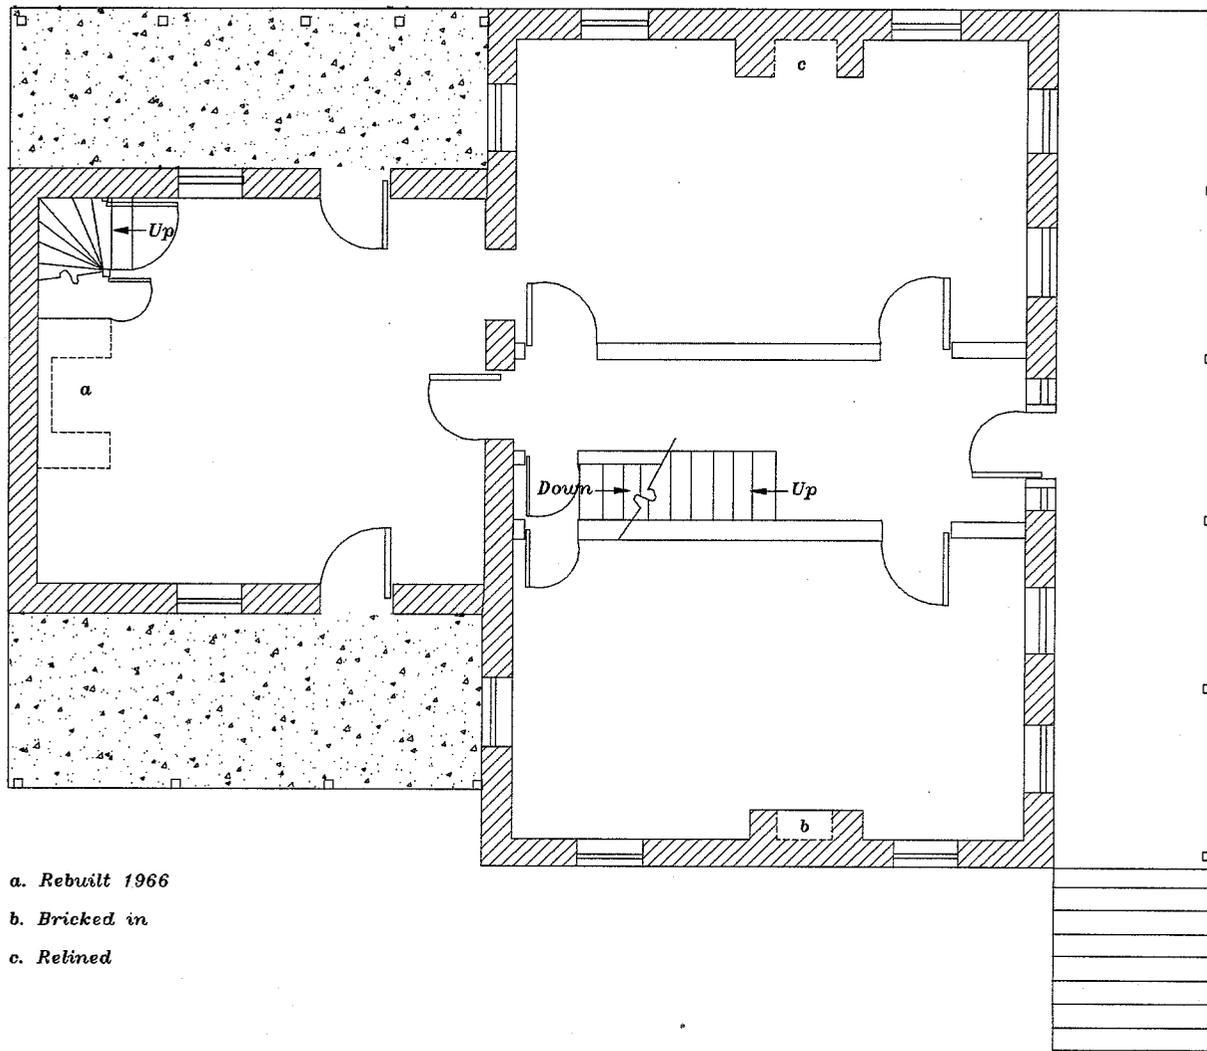
CARR 1303	John Werner Farm-House	First Floor Plan	February 1992	
	4400 Water Tank Road		Kenneth M. Short

The interior has a central passage stairhall with the stairs along the southwest wall. The passage is flanked by two rooms, each with a fireplace that is southeast (toward the front) of the center of the room. This suggests the possibility that the rooms were subdivided originally, but there is no evidence to confirm this. The windows and doors in both rooms and the hallway have elaborate panelled architrave moldings with ogee panel molds and a beaded inside edge, as well as bullseye corner blocks. The hallway also has a chairrail with ogee molding. Beneath the windows are panels with ogee panel molds and a horizontal double bead in the center. All the moldings have Greek profiles. At the end of the passage is the addition, which was probably the kitchen. It is a single open room with a large rebuilt brick fireplace on the northwest wall and original boxed winder stairs in the north corner of the room. The cellar has arched brick piers that support both chimney stacks. They are of plastered and contain wood shelves within the arches.

- a. Rebuilt 1966
- b. Bricked in
- c. Relined

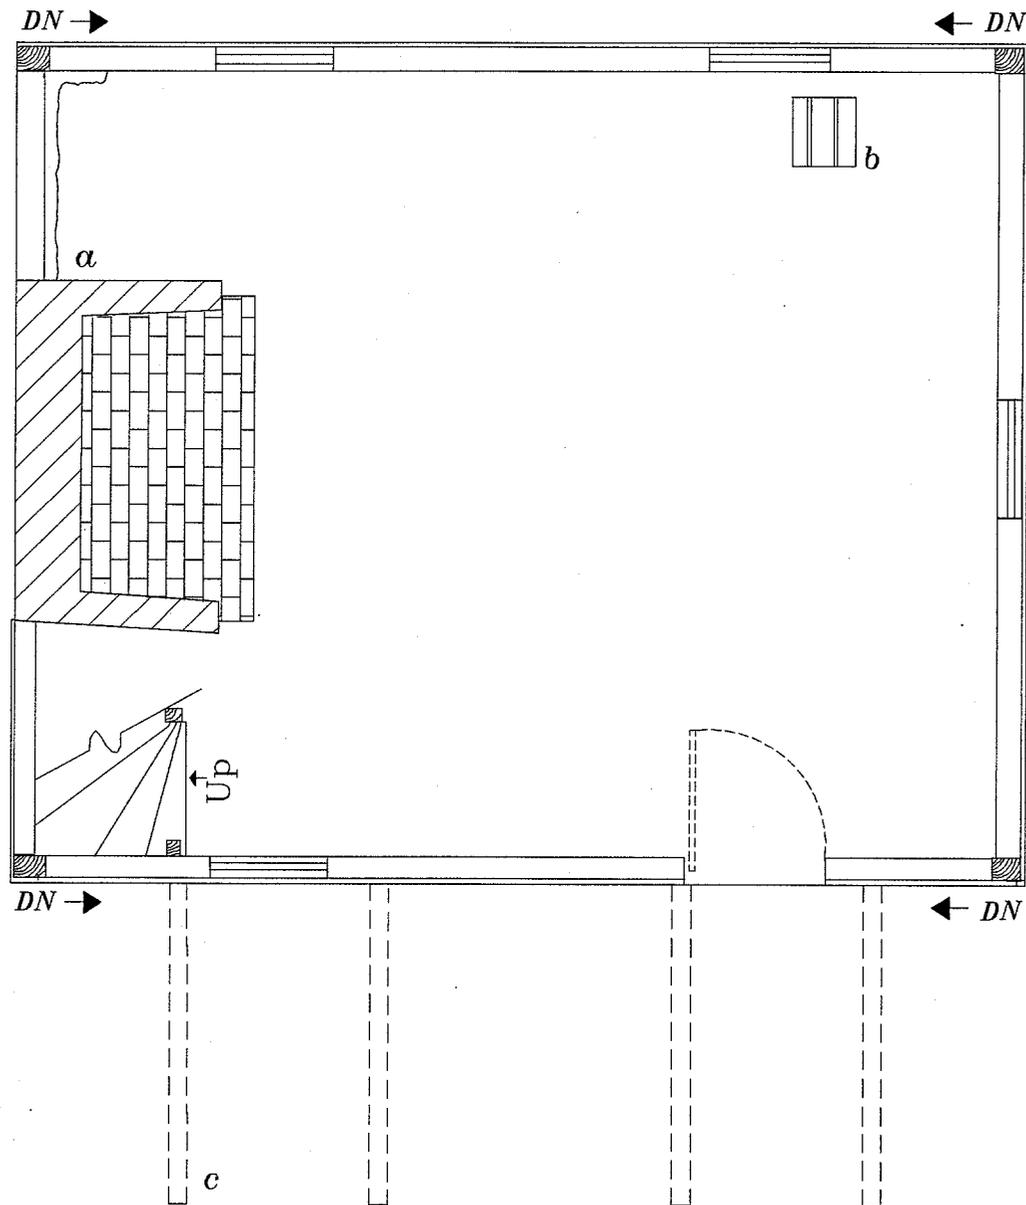
CARR 1303	John Werner Farm - Log Summer House	First Floor	February 1992		
	4400 Water Tank Road	Plan	Kenneth M. Short

The tenant house/summer kitchen is a one and one-half story hewn log structure with mortised corner posts for the tenoned and pegged log ends, and down braces on the northwest and southeast sides. The braces are approximately one and one-half inches thick and set into mortises in the logs so as to be flush with the front wall surface. The logs have stone rubble chinking laid diagonally and set in mortar. The building rests on a rubble stone foundation. The northwest elevation has a 6/3 double hung sash in the north bay, with one board shutter surviving. The west bay has a door opening. Inside the building is a tongue and grooved vertical board door that is probably what originally hung in the opening. Projecting from the wall at the attic floor level are portions of several joists that were probably part of a one-story porch .

- a. Brick Wall Rubble
- b. Wood Drain Under Removable Floor Board Trap Door
- c. Reflected Plan of Deteriorated Porch Beams
- DN → Corner Braces

fireplace flush with the outside wall, which flush brick chimney centered on the ridge of the gable roof. There is a single 3/3 sash west of the chimney in the loft that lights the winder stairway in the north corner of the single-cell-plan building. The gable roof is covered with corrugated metal on wood laths. The building is deteriorating and is now exposed to the elements, and is quickly becoming in danger of collapse.

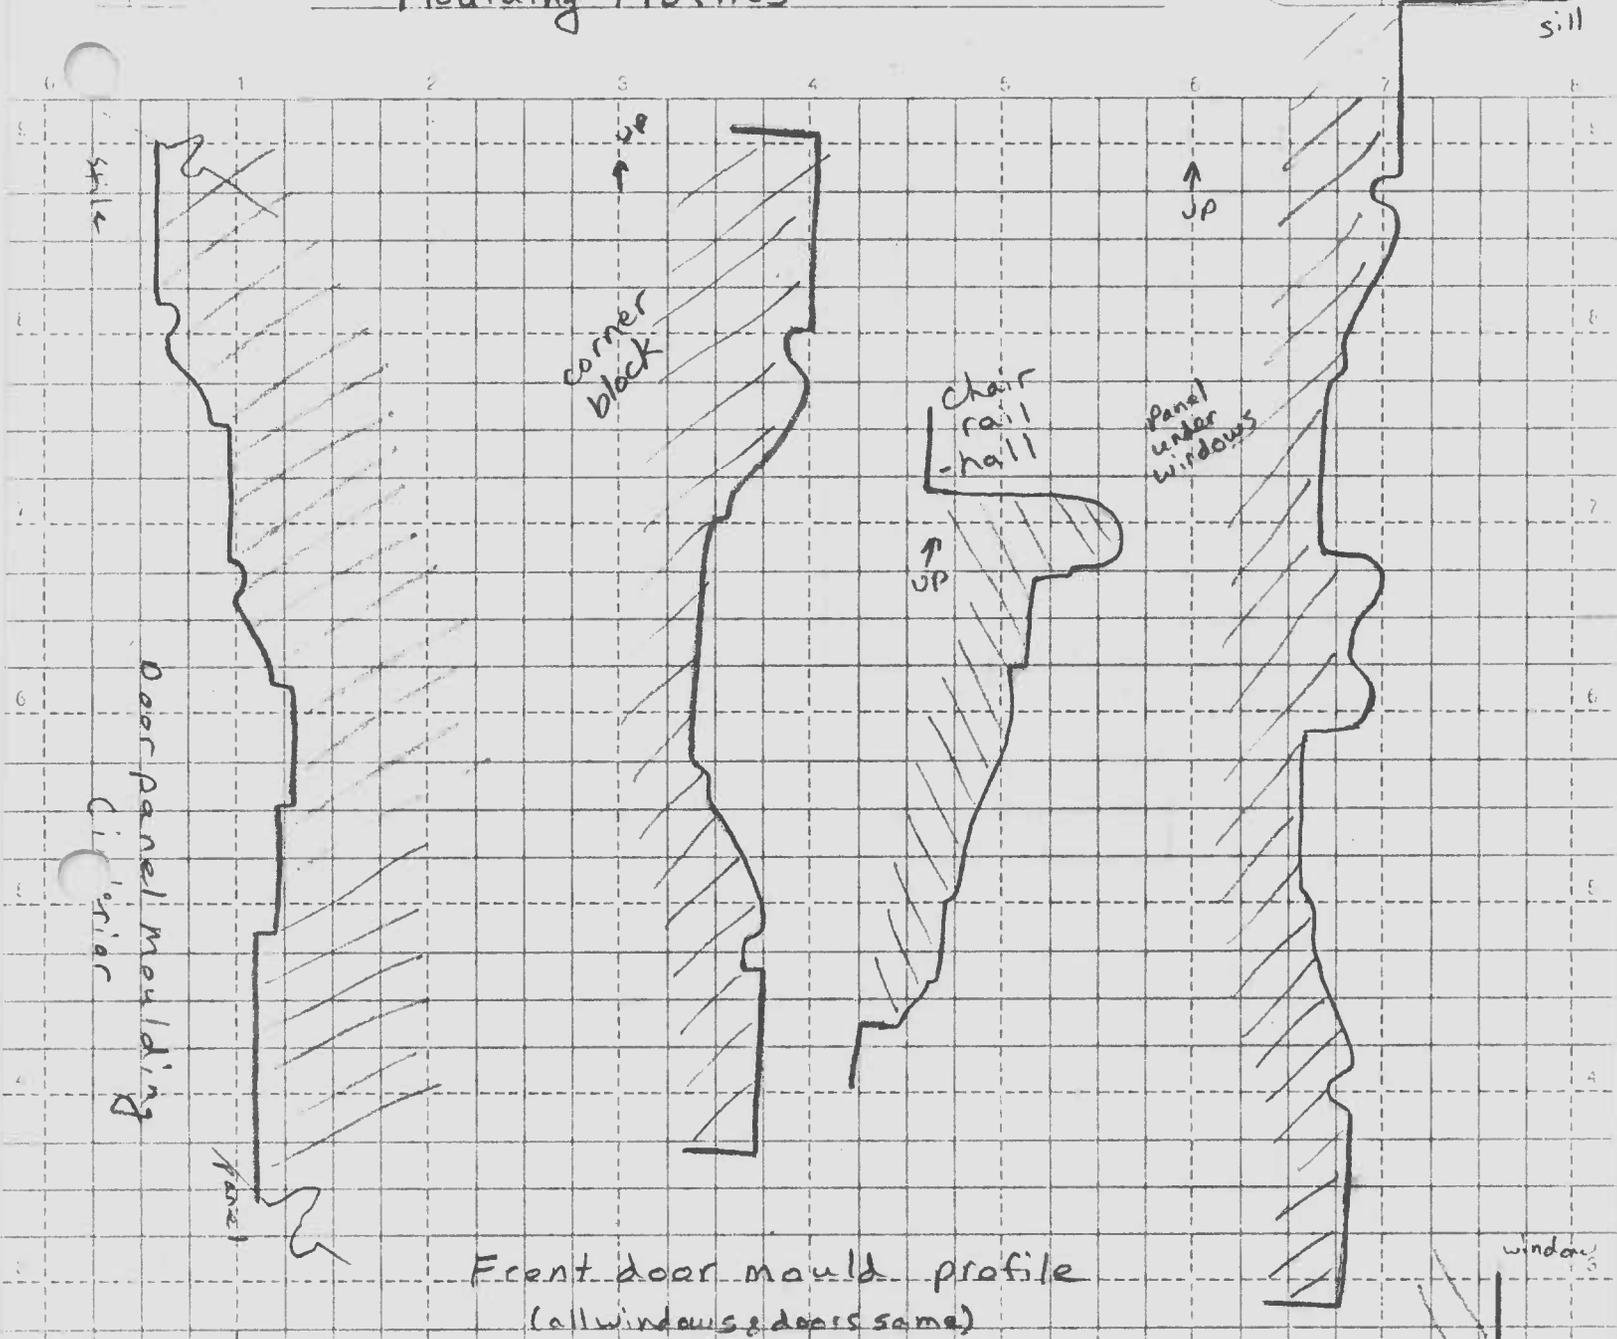
Moulding Profiles

Front door mould profile
(all windows & doors same)

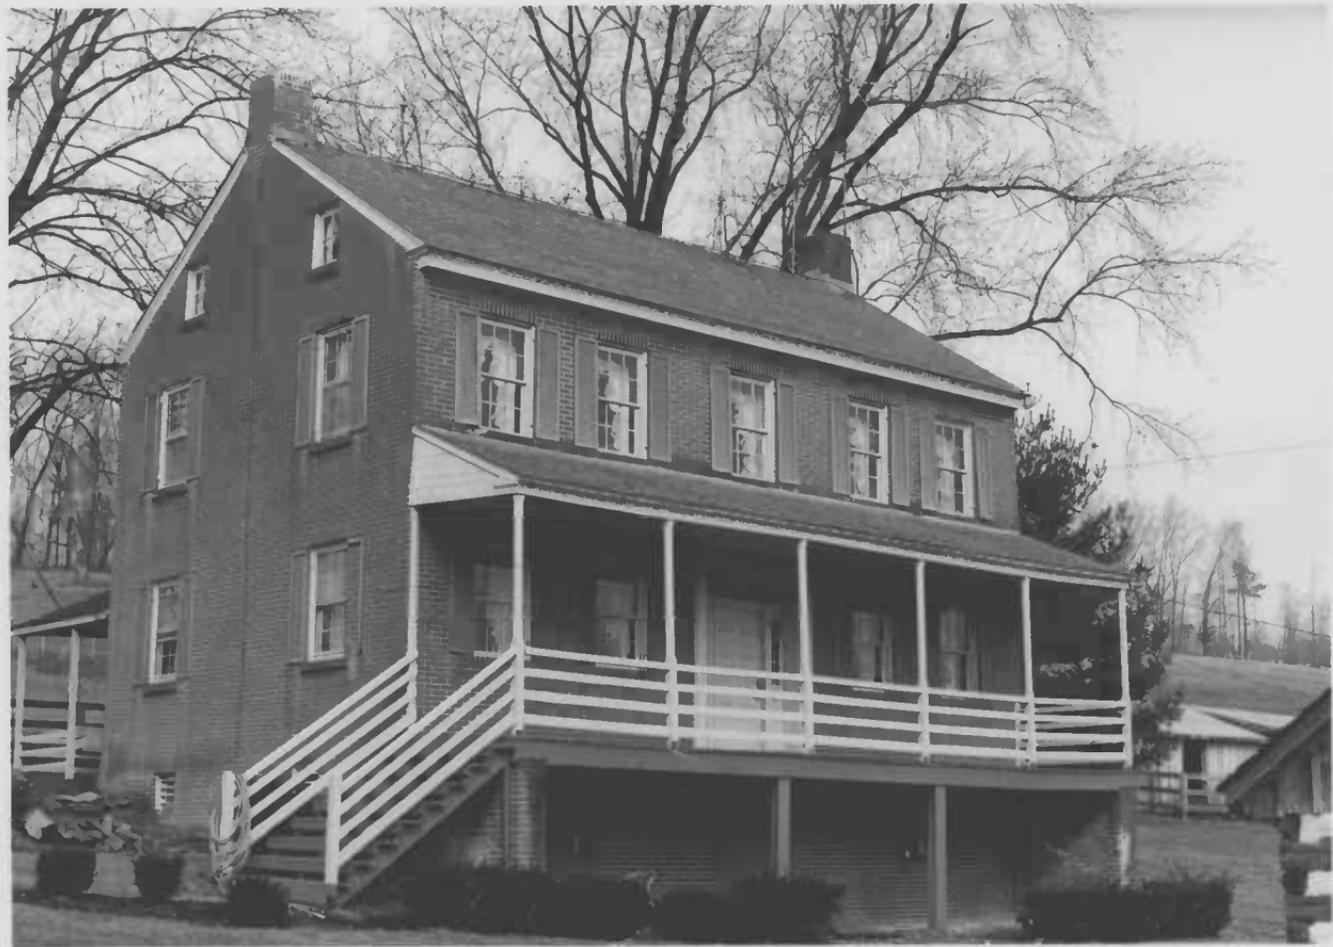
1/13

The brick house is a two-story, five bay central passage plan building, now covered in a brick-pattern stucco. It is banked into the hillside, with an exposed foundation wall on the southeast facade. This wall has a central vertical board door flanked on each side by a single 6/3 double-hung sash centered between the windows in the story above. The first and second stories have 6/6 double-hung sash with applied exterior blinds, though the hardware for earlier exterior blinds survive. The central entrance on the first story contains a transom and sidelights of multiple lights, with panels at the bottom half of the sidelights and a panelled soffit and jambs. The door has six square panels above two vertical rectangular panels. The doorway is framed with an architrave molding with corner blocks. There is a one-story porch with shed roof supported by end walls of masonry and two wood posts at foundation level, and by six chamfered posts at the first story. Currently the balustrades are four horizontal rails, which are not original, with eight wood steps on the southwest end of the porch.

SW & SE elevs.

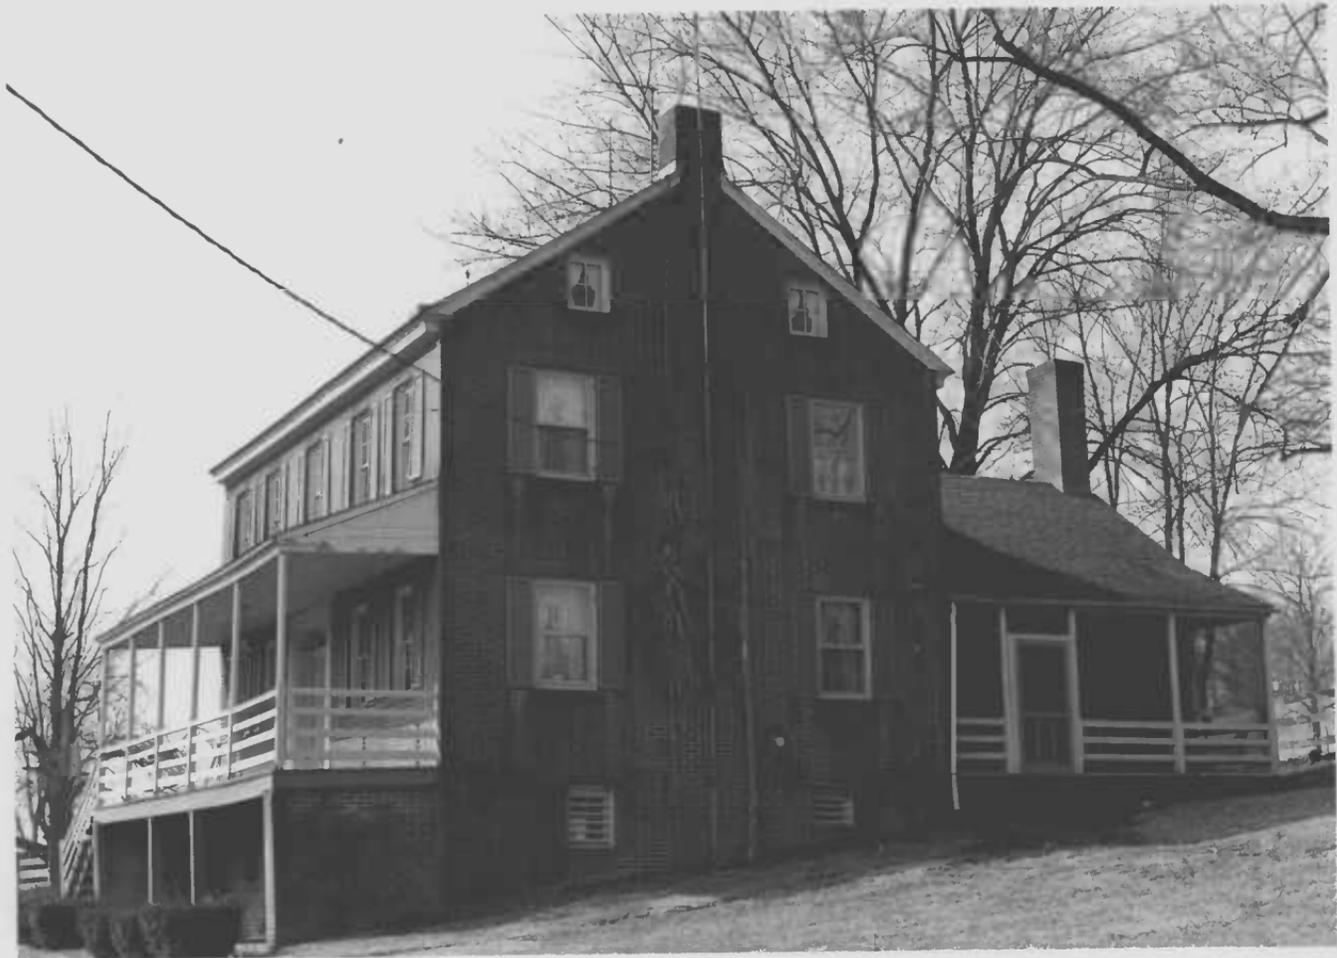
2/13

The house has a boxed cornice with crown mold on the fascia and bedmold below the soffit. There is a gable roof with asphalt shingles and a flush brick chimney centered on the ridge at either end. The southwest and northeast elevations have tapered rake boards at the eave, with two four-light sash in the gable end, two 6/6 double-hung sash

NE elev - House

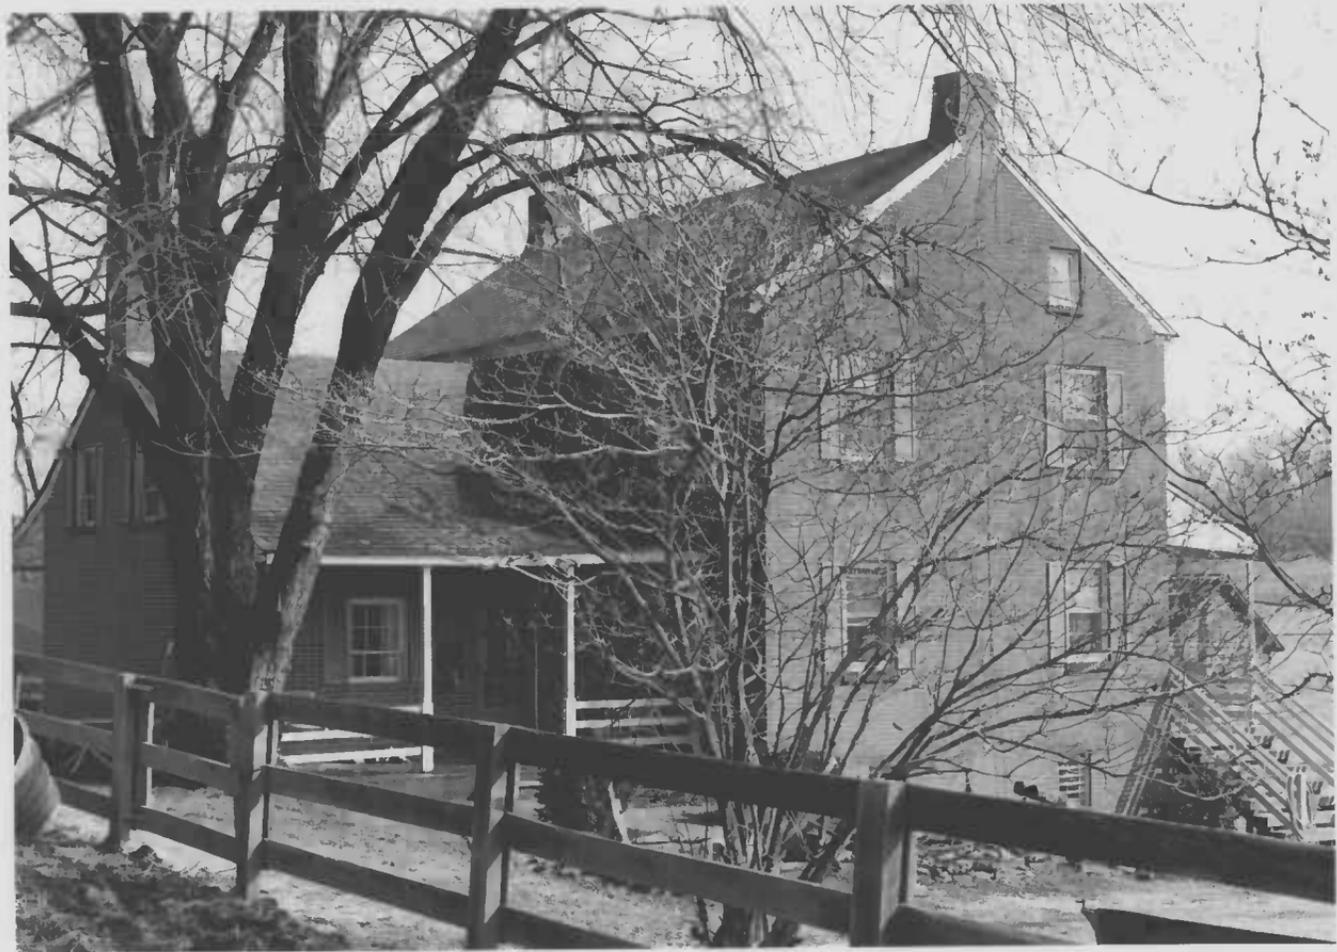
3/13

House - NE elev.

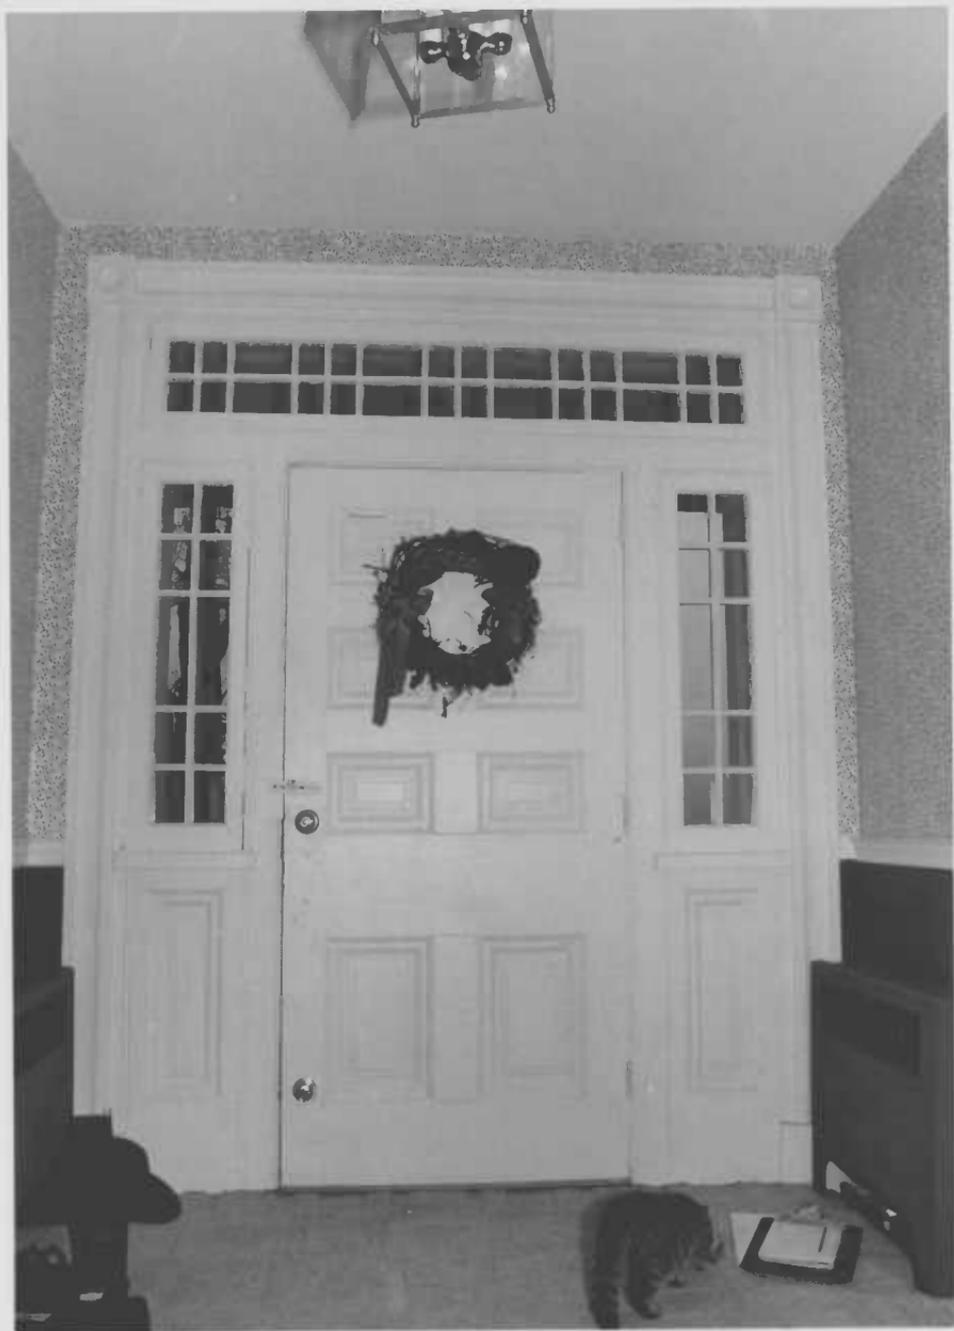
4/13

House - SE door, interior

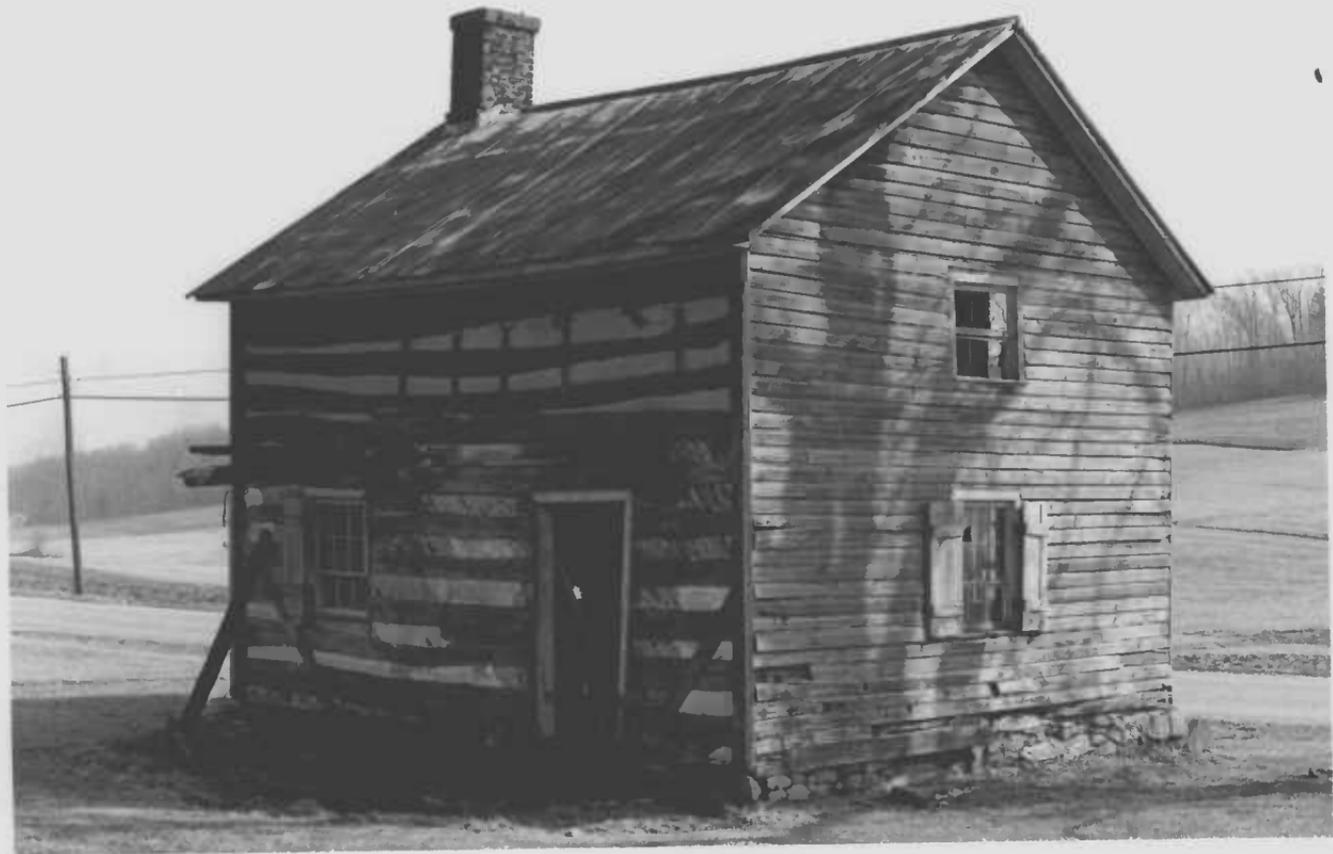
7/13

The southwest elevation is covered by German siding and has one 6/3 double hung sash with board shutters on the first story and a 3/3 sash above. The southeast elevation copies this arrangement, but is two bays. The northeast elevation has an exposed brick

Summerhouse - NW & SW elevs.

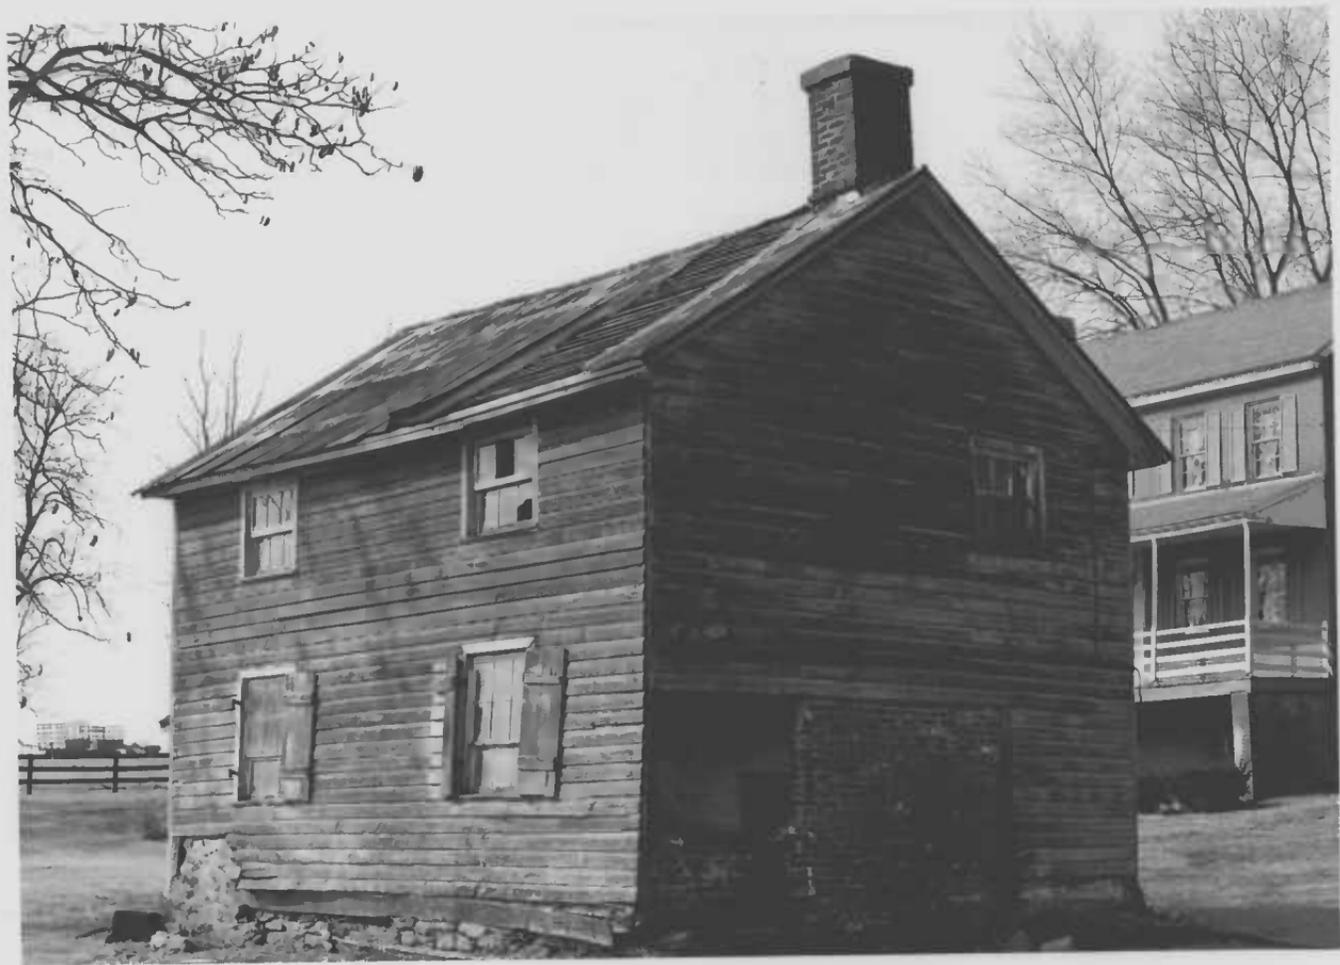
2/13

Summerhouse - SE & NE elevs.

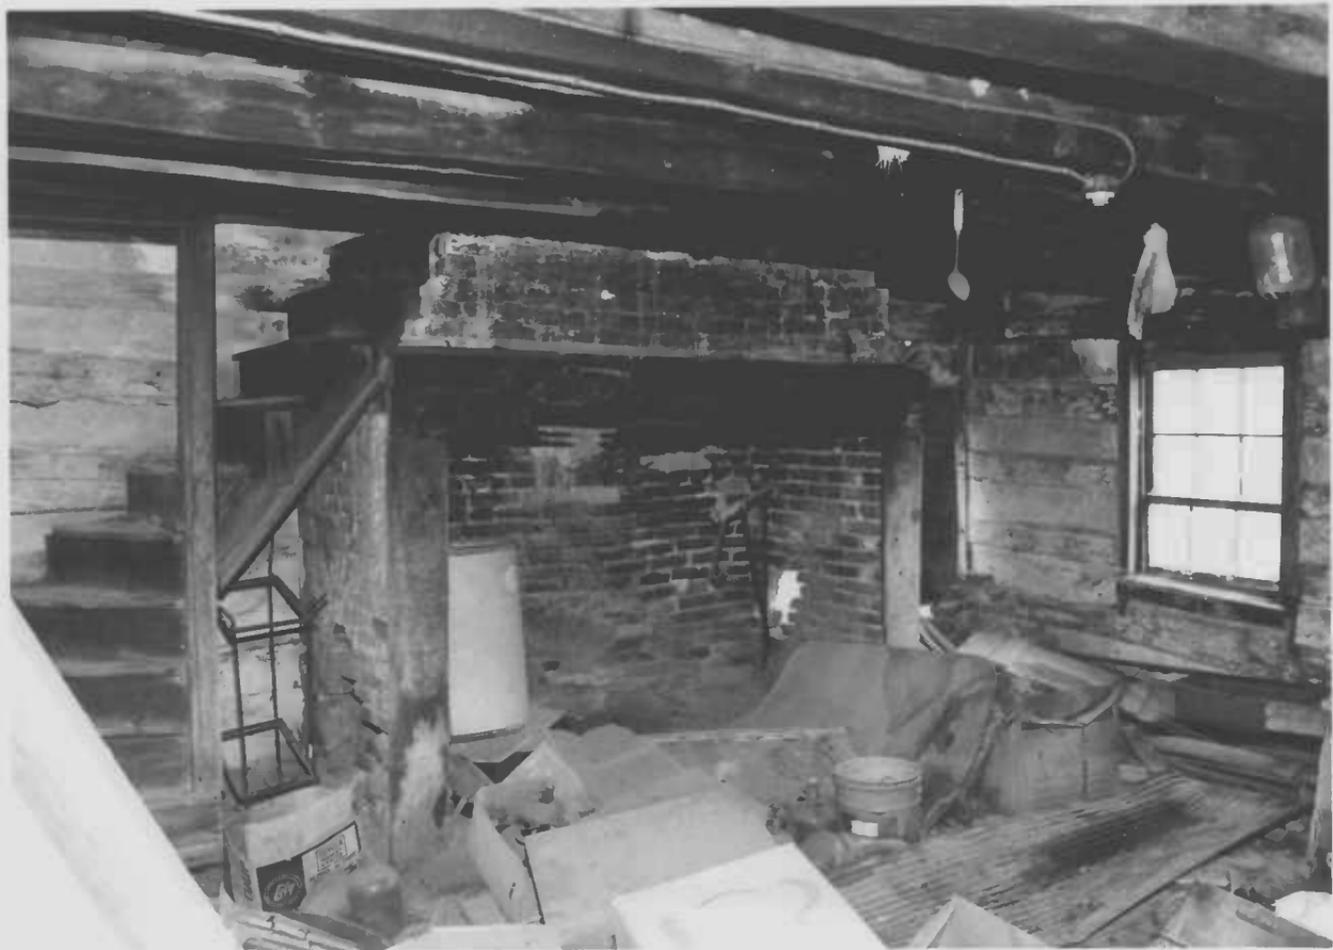
11/3

Summer kitchen, interior, view east

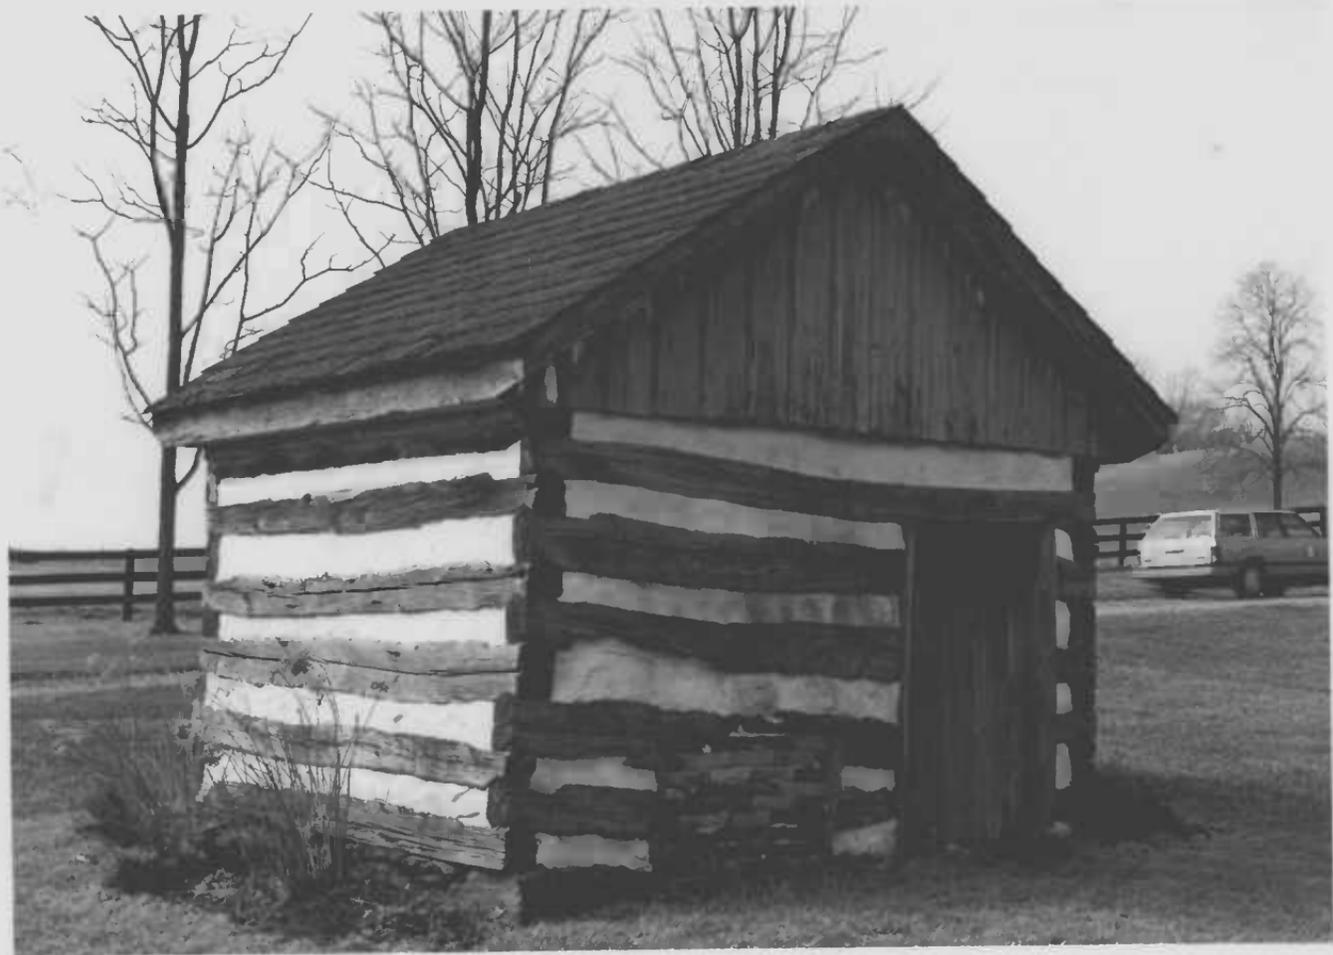
10/13

The smokehouse is a V-notched log structure on a stone foundation, with a wood-shingled gable roof and board and batten siding in the gable ends. The battens have tapered sides. The northeast elevation has a vertical board door in the west bay and the rebuilt brick remains of the firebox exposed in the bottom of the east bay.

Neg. Loc.: Maryland Historical Trust
Smokehouse - SE : NE elevs.

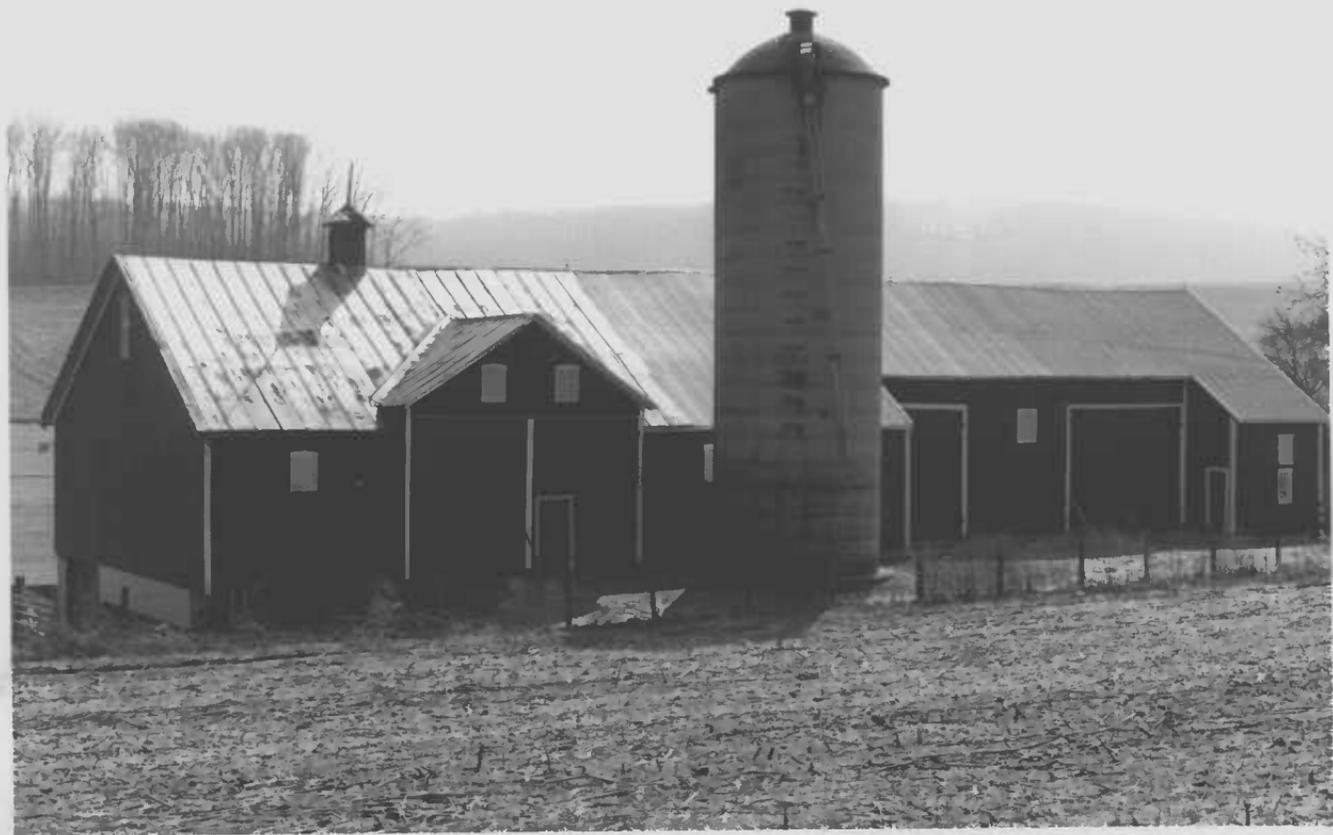
12/13

The barn is a banked structure with cantilevered forebay facing southeast. The basement wall under the forebay has been altered and has a later block wall to the north, but several bays in the middle contain their original vertical board dutch doors between horizontal board wood siding. The forebay wall has, from south to north, two wood vents with horizontal board siding, then vertical board siding with a vertical board door, three wood vents, another door, four vents, double doors, and two vents. The ends of the barn have a single vent in the gable. The northwest elevation is complicated. From south to north it contains a wood vent above a 4/2 window in what was probably a granary, then a pair of double doors on strap hinges recessed about six feet back from the wall plane, with a single wood vent between them. Then there is possibly a second granary in line with the first, then a wood vent, a pair of double doors on strap hinges that project forward about six inches, with a low cross gable roof and two wood vents in the gable end above the doors, and finally another wood vent in the northernmost double doors. There is a freestanding concrete silo with metal domical roof centered along the northwest wall of the barn.

Barn - NE c. New elevs.

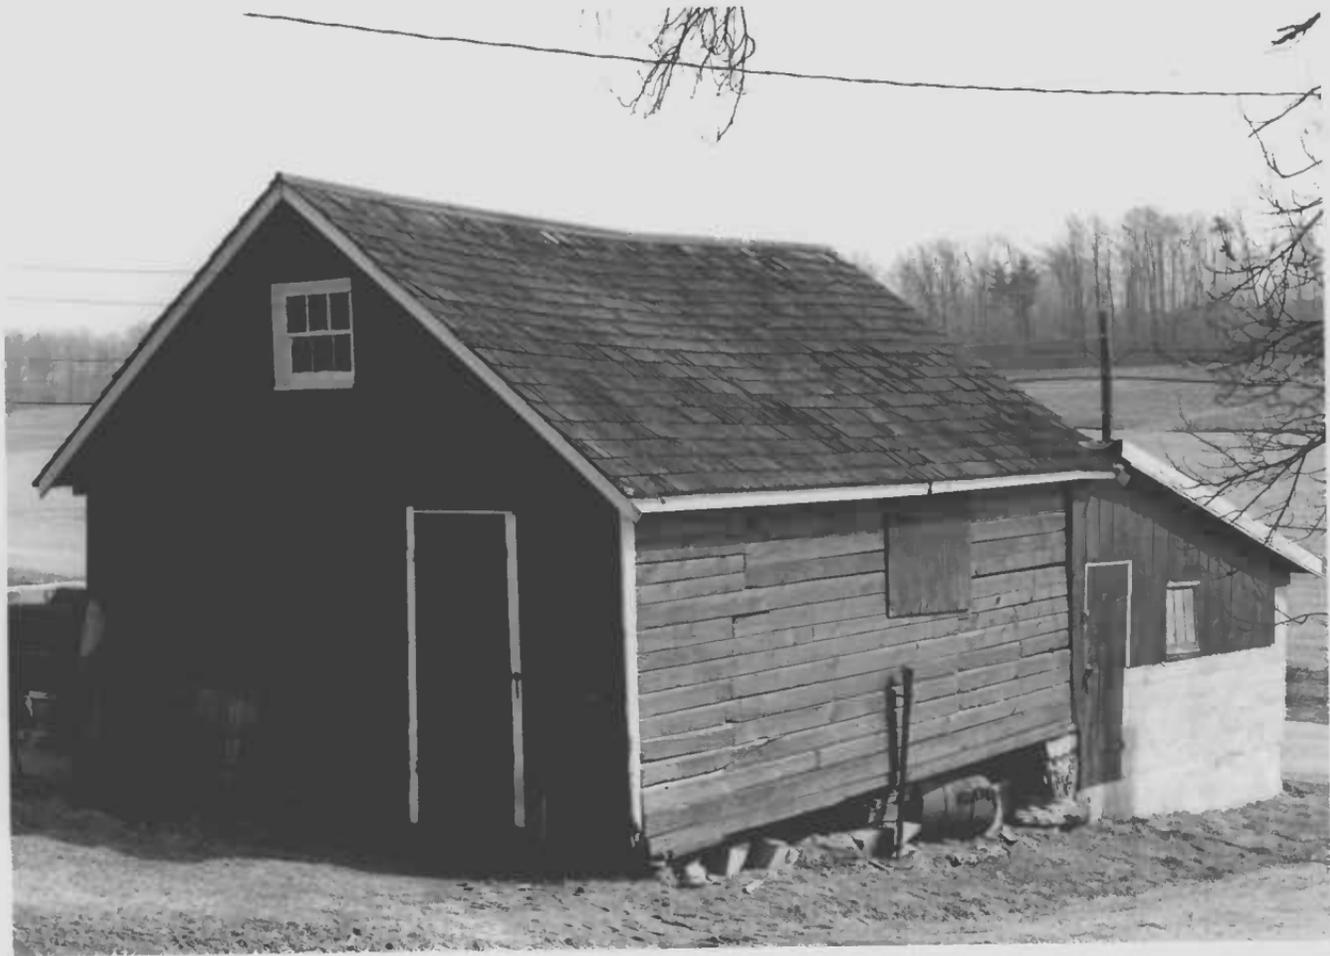
13/13

There is a corn crib just south of the barn, set on stone piers, and with a gable roof with wood shingles. The crib is positioned on the southwest side and is covered with horizontal wood slats. The remainder of the structure is covered in vertical board and batten. The northwest end has a vertical board door to the south and a 3/3 sash centered in the gable end.

Corn crib - NW of Swelevs.
