CARR-1318

Weaver-Myers Farm
3261 Bixler Church Road
Bachman's Mills

Maryland Historical Trust State Historic Sites Inventory Form

historic Weaver-Myers Farm

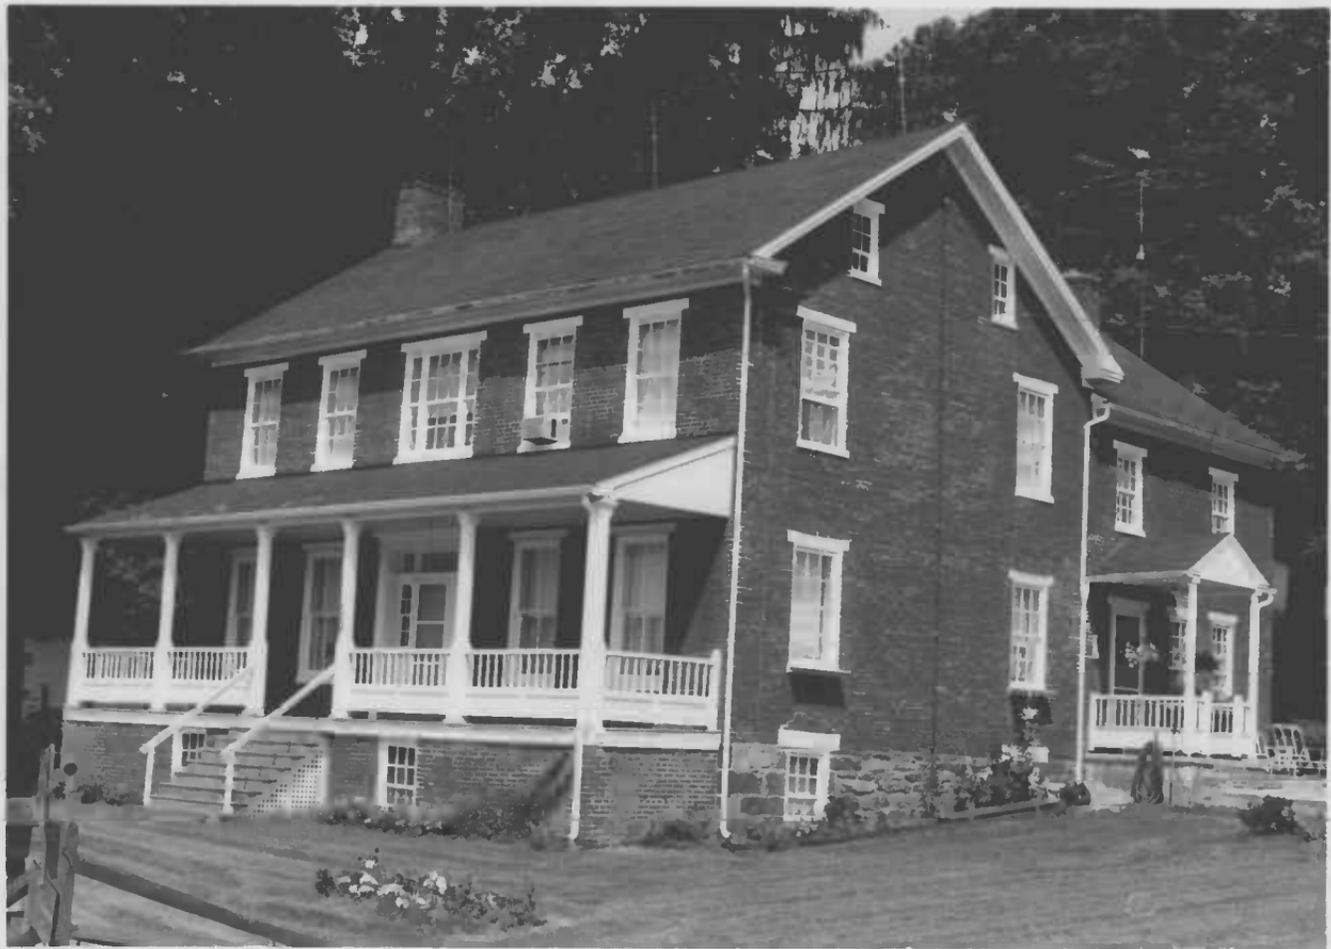
1/2

House south - east church "

The house is a two-story, five-bay by two-bay, center entrance plan brick house that faces south. The south elevation is built of Flemish Bond and the remainder of the house of 5-1 common bond brick. The foundation is of partially dressed, partially coursed fieldstone. The first story of the south elevation has 2/2 sash in bullnose frames with wood sills and lintels. The latter have an ogee moulding at the top and bottom with a large bead in the field. There are also bullseye corner blocks. The center entrance has a stone sill. The corner blocks have a Greek fret moulding. Above the surround is a cornice with an ovolo at the top, a torus with Greek profile, a scotia below it, and another torus with Greek profile. There are sidelights that have 4/4 sash above a lying panel, with a vertical panel at the bottom. The door has two lying panels at the top, then two large square panels, two square panels flanking a lying panel, another row of two square panels flanking a lying panels, and two large square panels at the bottom. Between the sidelights and door is a column that supports a cornice with a fillet at the

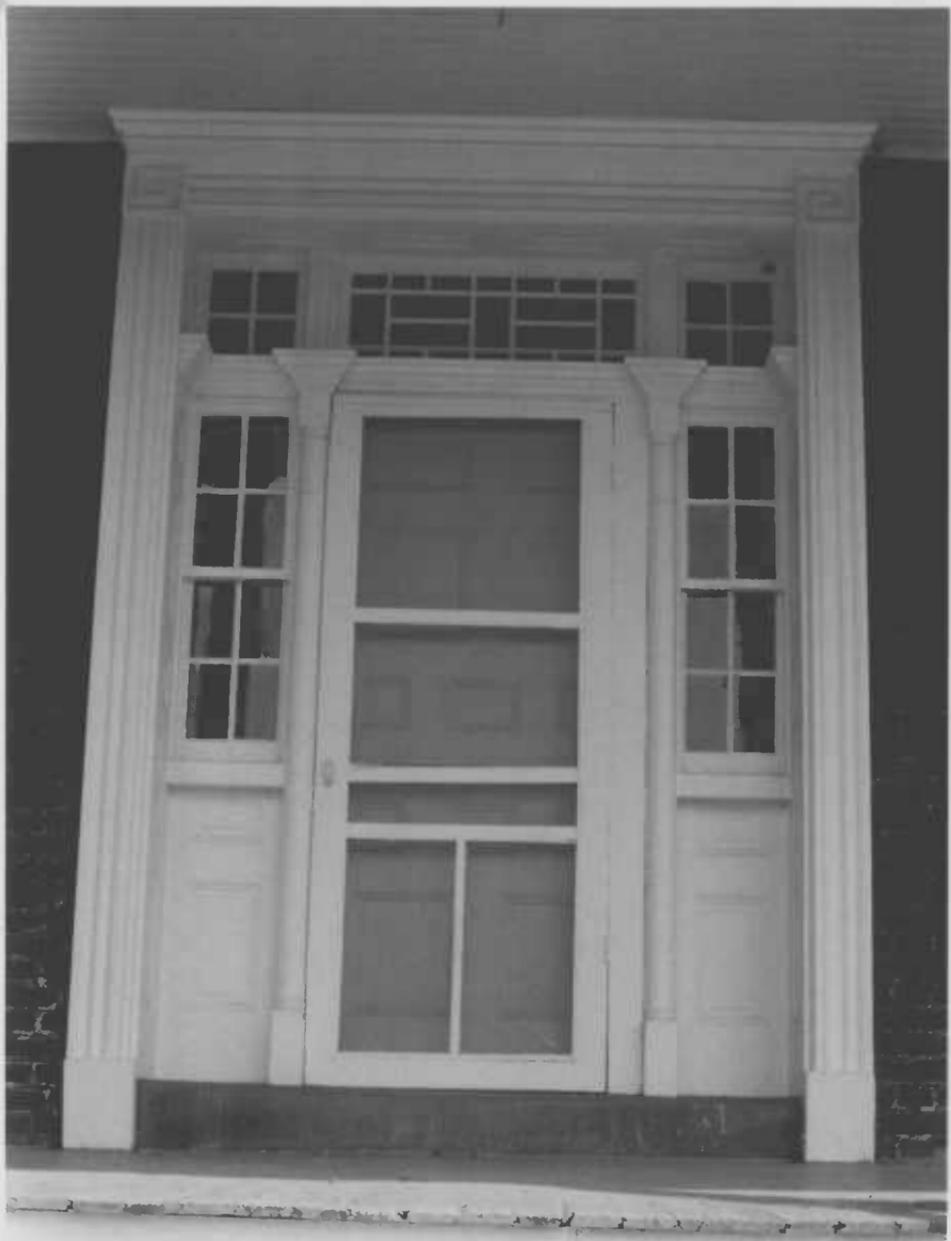
2/8

House South elevation - front
entrance

top, a Greek profile ogee, an ovolo, a conge', two fillets, and an astragal at the bottom. Above each column is a vertical wood moulding with a profile that matches the window lintels. Above the door, between these two mouldings, is a transom with 21 lights. Above each sidelight, in line with the transom, is a 4-light sash. The soffit has four panels and the jambs are panelled to align with the location of the panels on the door.

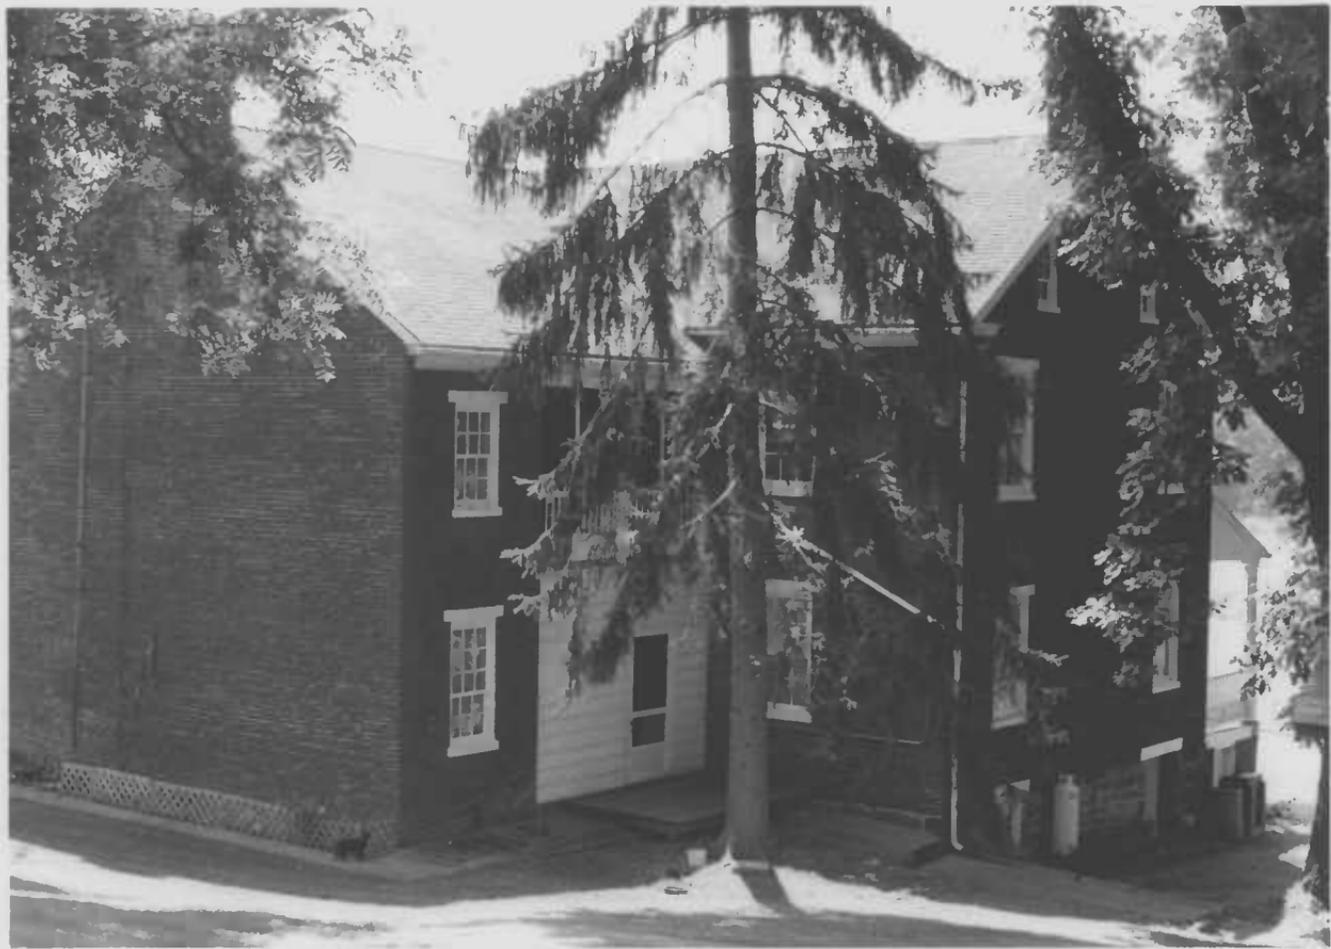
3/8

House: North + West elevations

The west elevation has a 6/3 sash with a flat wood lintel in the north bay of the cellar and, in the south bay, a door with 6 lights above three flat, flush panels. The upper stories have 6/6 sash with the same lintels and blocks as on the south, and the gable end has two 4/2 sash with matching lintels and blocks. The east elevation has two 6/3 sash with flat wood lintels in the cellar, and otherwise matches the west.

window in the center bay of the original brick wall and a door in the south on this story. This door has six panels and a 12-light transom. The cornice of the wing has a plain fascia board. Both stories of the north elevation of the main block have a 6/6 sash with matching lintels and blocks in the west bay, and a six-panel door onto the porch of the ell in the west-center bay.

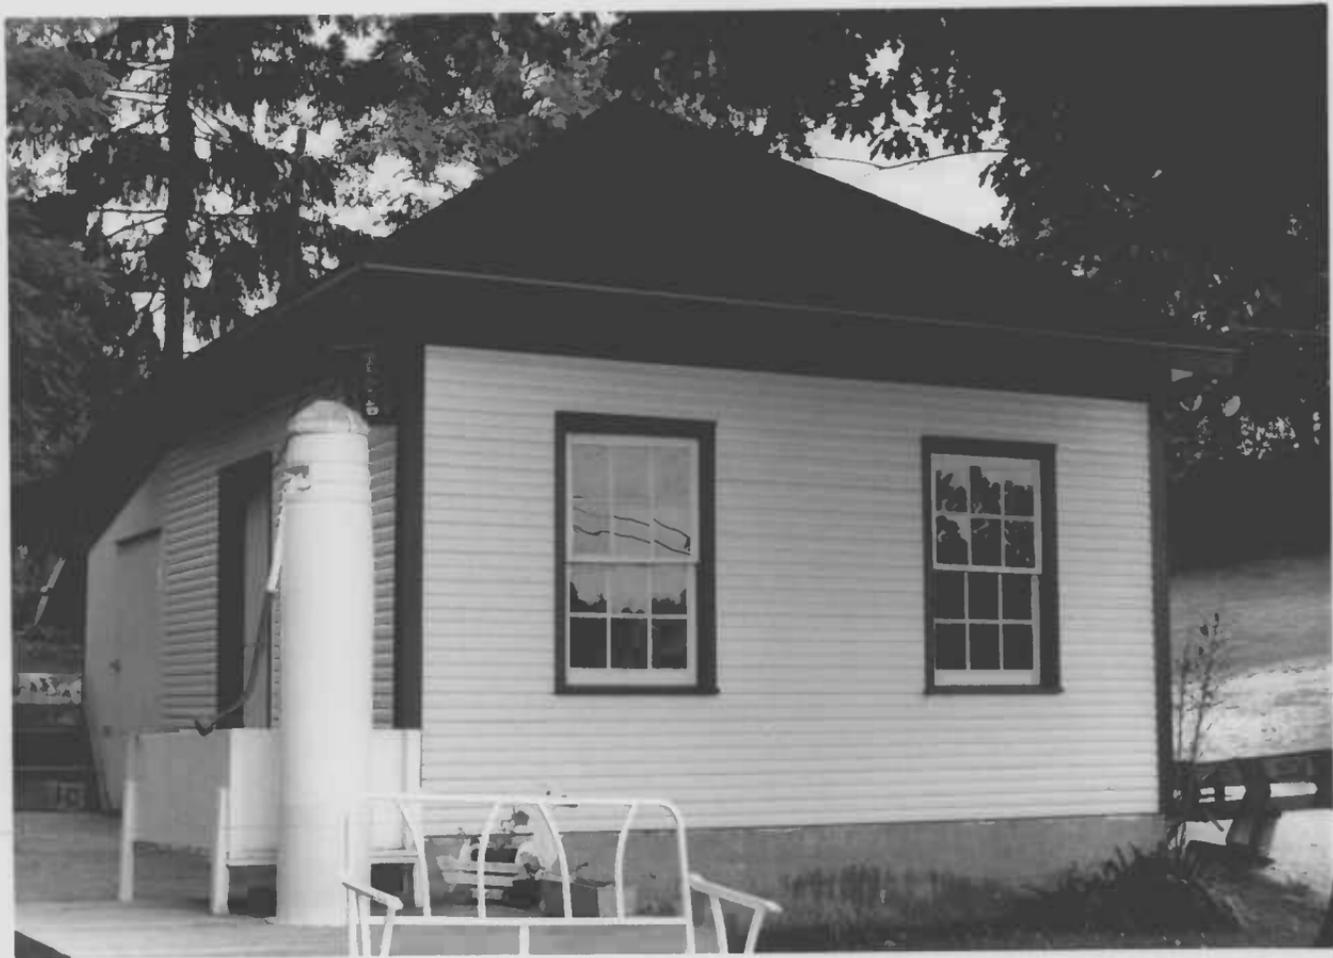
4/8

Pump - Springhouse West + South
elevation

West of the house is a shed with corrugated metal shed roof and door on the east end. North of this is a smokehouse with a door on the east, a metal door on strap hinges to the fire pit in the south elevation of the foundation, and a gable roof of asphalt shingles. On the east side of the house is a springhouse with a hip roof of asphalt shingles. It has a door on the east and west elevations, two 6/6 sash on the south, and a shed roof addition on the north that has beaded-edge-and-center vertical board siding. Southwest of the springhouse is a well with pump.

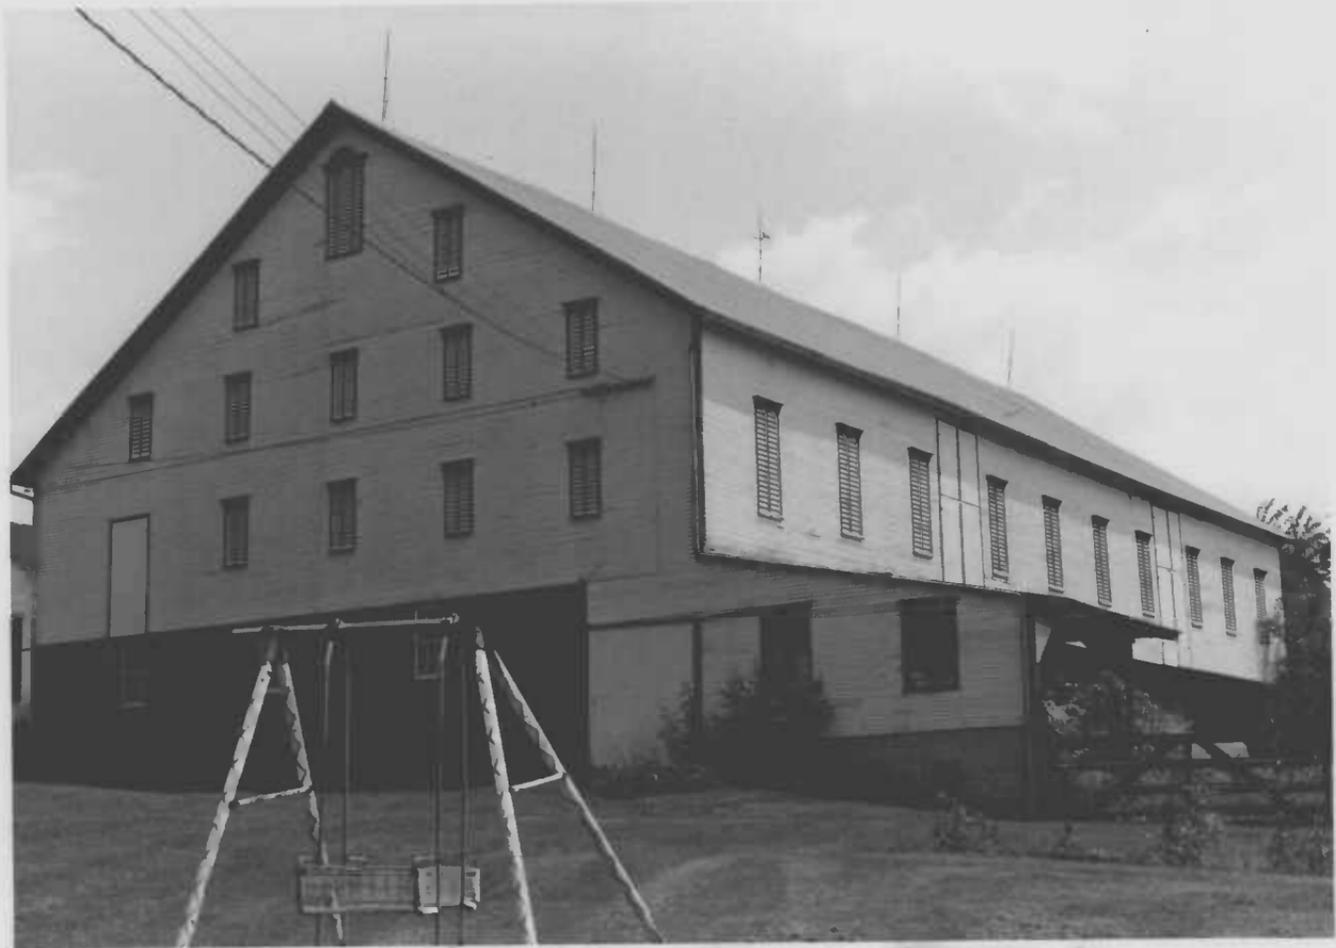
5/8

Barn - west + south elevations

East of the house and surrounding outbuildings is a bank barn with forebay facing south. It has a rubble stone lower story, with quoins, on all four elevations. The south elevation of the lower story has, from west to east, a door, window, door, window, two doors, window, door, window, door, window, door, window, and door. The doors are dutch doors on strap hinges and the windows are 4/4. The joists are hewn. The upper story has three wood louvered vents, two pair of double doors, one above the other, four vents, two more pairs of doors, and three vents to the east. All of the vents on all four elevations have a cornice with three brackets. The gable roof has inverted-V-seam metal. The west elevation has three 6/6 sash and a door on rollers under the forebay in the lower story. Above is a door on strap hinges and four vents, a row of five vents above that, then a row of two vents and one large Palladian vent in the peak. The east elevation is identical to the west. The north elevation has a projecting granary on both ends. Each granary has two openings, but only one 4/2 sash survives. In between the granaries are three pairs of double doors on rollers.

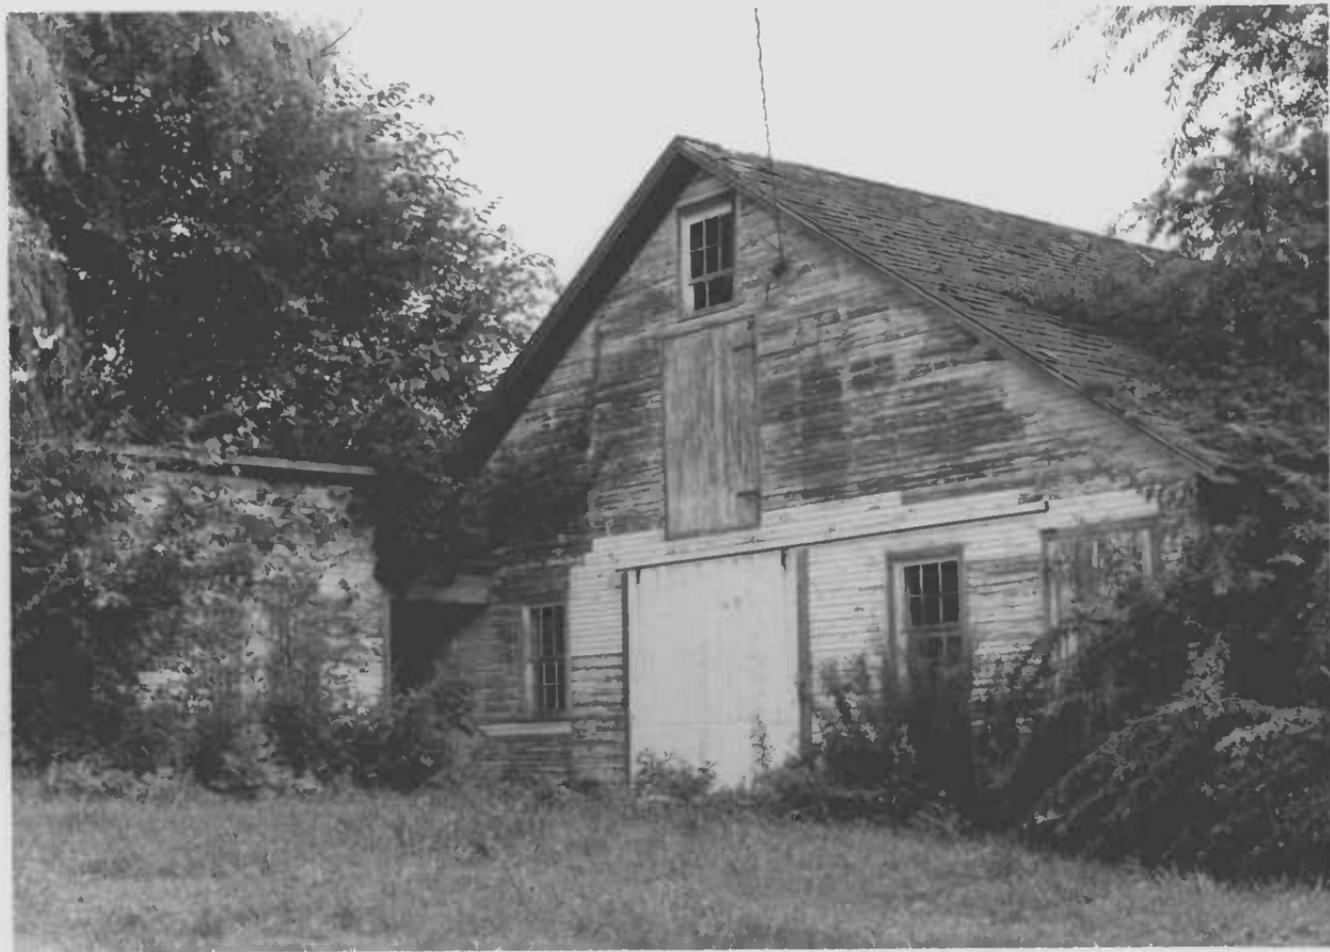
7/8

Stable - west elevation

East of the barn is a cow stable that is five bays wide on the west gable end. It has a large roller door in the center and a smaller door on strap hinges on either end, with a 6/6 sash between the center and end doors. Above the center door is a large door on strap hinges, with a 6/3 sash above it. The gable roof has wood shingles. The other three elevations were overgrown and not visible.

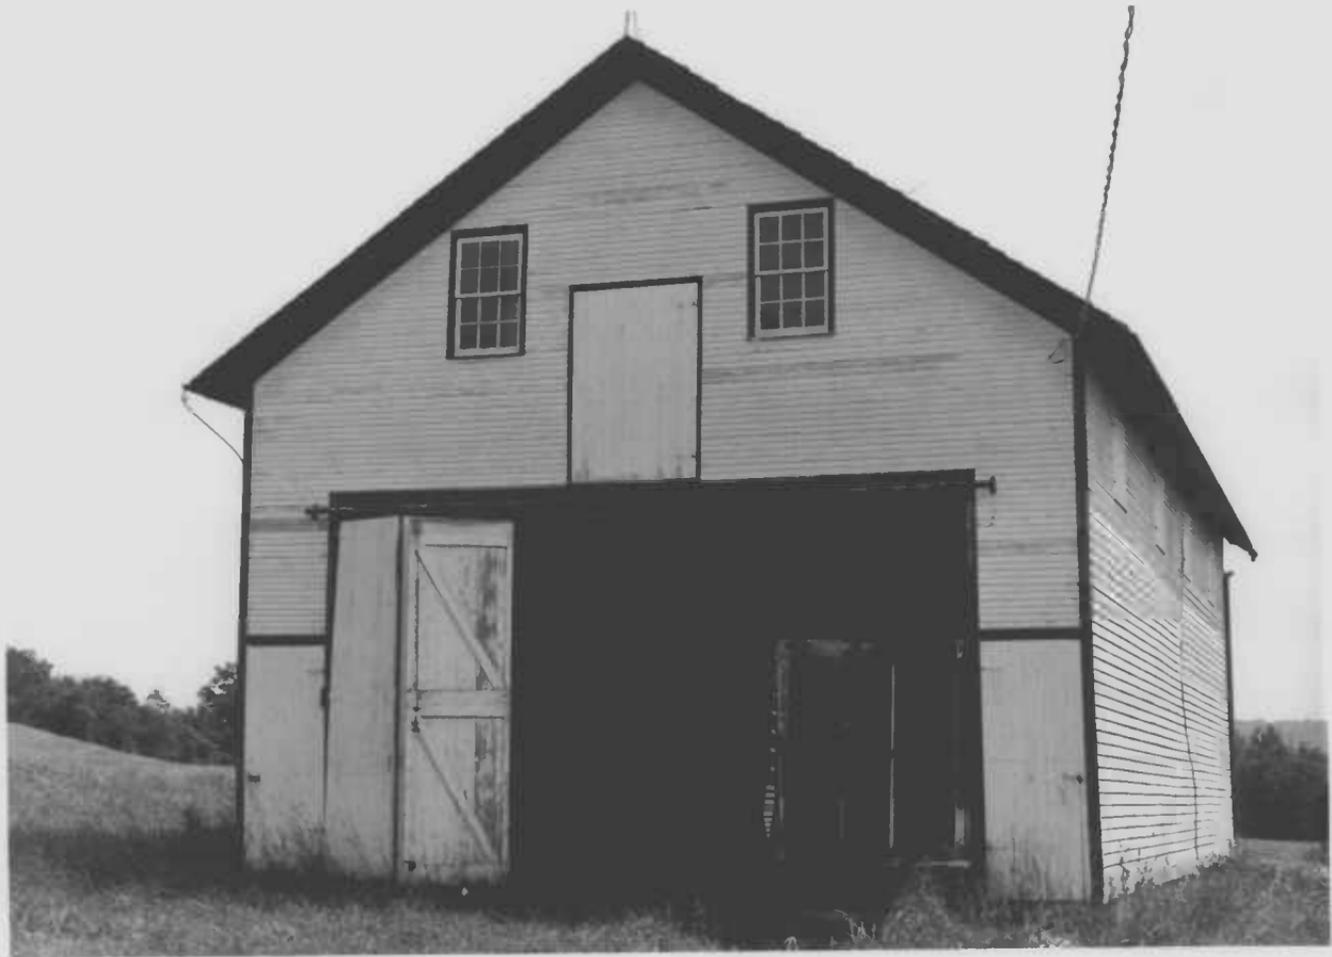
E/E

Corn Crib - West + South elevations

North of the barn are two wagon sheds with corn cribs. The east wagon shed has cribs on the north and south, with horizontal boards on the north and south sides and four shuttered openings high on the wall. The east and west ends have doors to the cribs on strap hinges and a center pair of trifold doors. Above the latter is a large door on strap hinges, flanked by two higher 6/6 sash. The doors and shutters are all beaded-edge-and-center vertical boards. The gable ends have the narrow German siding and the gable roof has wood shingles. The frame is 2 x 6 circular-sawn. There are stairs in the northwest corner up to the upper floor.

West of this is another, very similar wagon shed with a corn crib on the south only. It has the same roof, siding, and doors, but only has the German siding in the gable ends.
