CARR-1400

3280 Sam's Creek Road
New Windsor (vicinity)

MARYLAND HISTORICAL TRUST
STATE HISTORIC SITES INVENTORY FORM

CARR-1400
Stem-Nusbaum House
3280 Sam's Creek Road

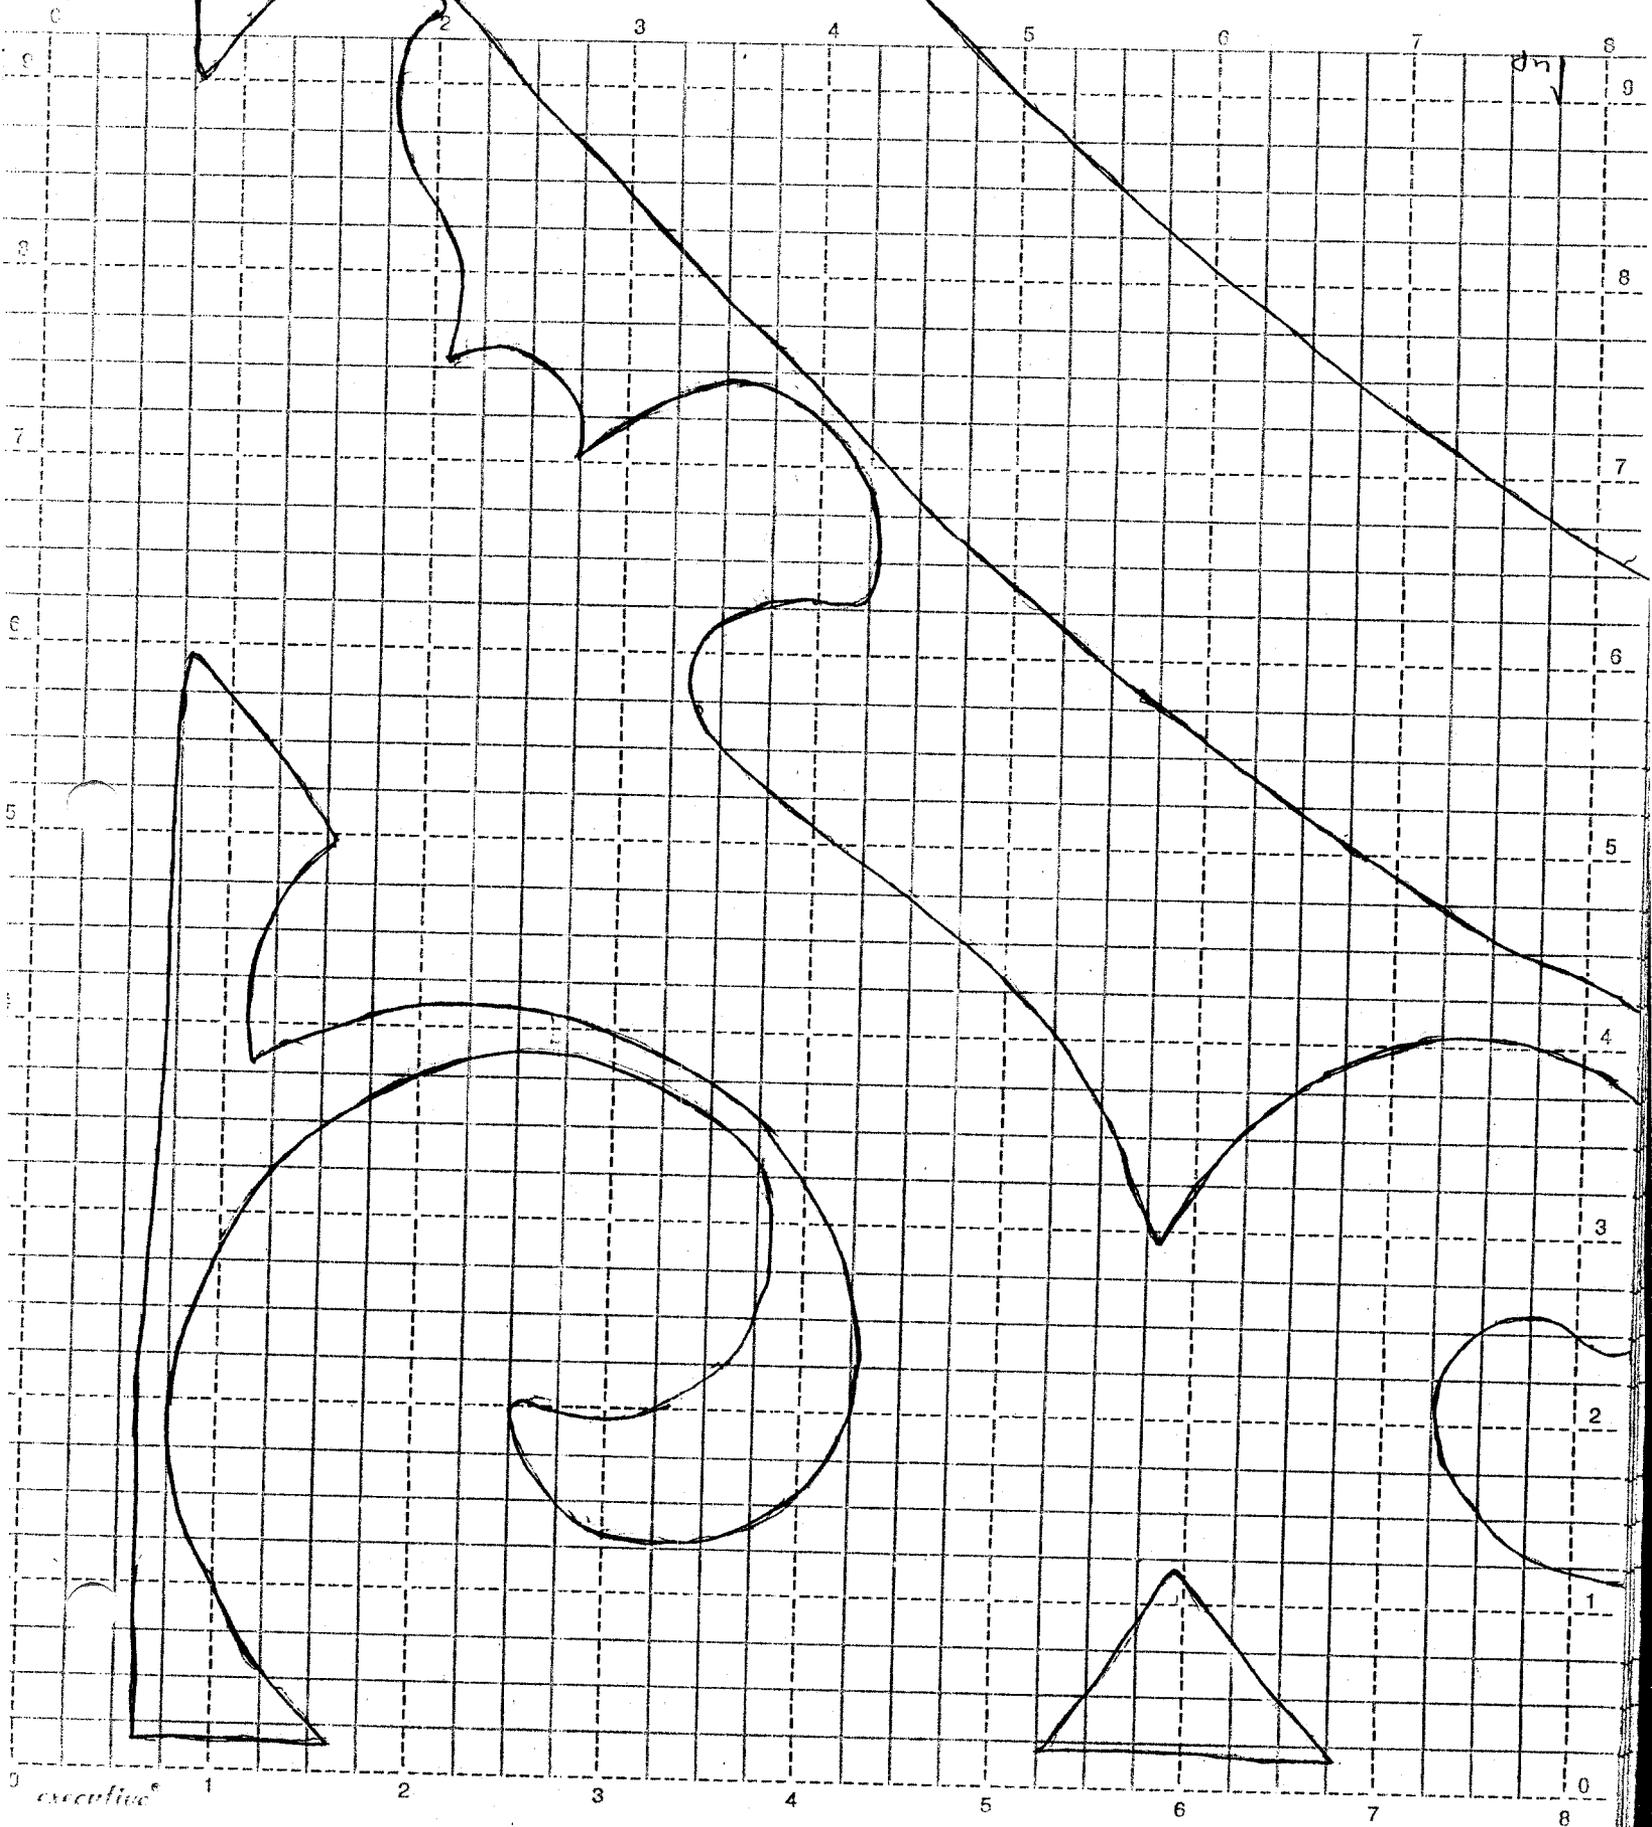
3280 Sam's Creek Rd.
Porch Bracket

one-story, three-bay shed roof porch with a corrugated metal roof on the first story. It is set on brick piers that are painted red and striped. Much of this finish survives. There are brick end walls on either end of the porch. The porch has four square posts set on piers. The posts are chamfered, with an applied ogee moulding near the top, and have jigsawn brackets set above this ogee. In the middle of each pair of posts is a pendant drop. There are no railings, nor any evidence that there ever were railings on the porch. The second story has three 1/1 sash identical to the first story. There is a dentil cornice. The dentils are unusually long. There is a central gabled wall dormer with an oculus and a dentil raking cornice. On each gable end, centered on the ridge, is an interior brick chimney, and there are lightning rods along the ridge.

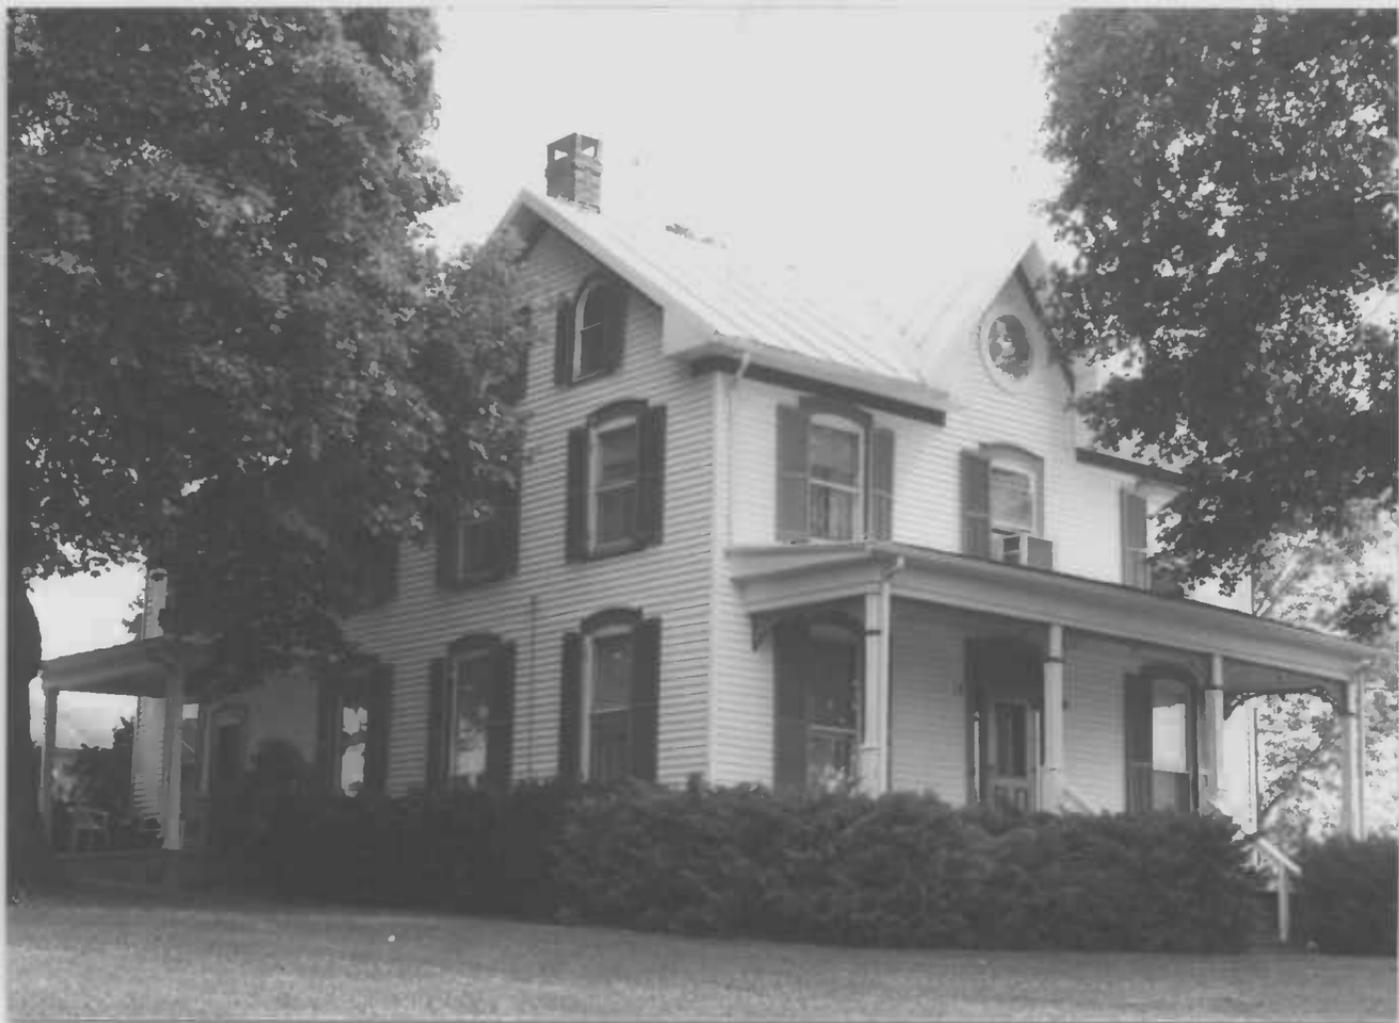
CARR - 1400

The west elevation of the ell on the first story has a typical 2/2 sash in the north bay, then a segmentally-arched, four-panel door with sunk double fields and ogee panel moulds. The trim around this door is typical. The south-center bay has no openings and the south bay has a typical 2/2 sash. The second story has a typical 2/2 sash in the north and south bays and no openings in the two center bays. There is a dentil cornice. There is also a one-story, three-bay, hip-roof porch with standing-seam metal, a CMU foundation, and square posts on the north three bays of the first story.

The west elevation of the main block has two two-light sash with beaded interior edge frames and brick jack arches in the foundation. The first story has two typical 1/1 sash as does the second story. The gable end matches that on the east.

west & south elevations

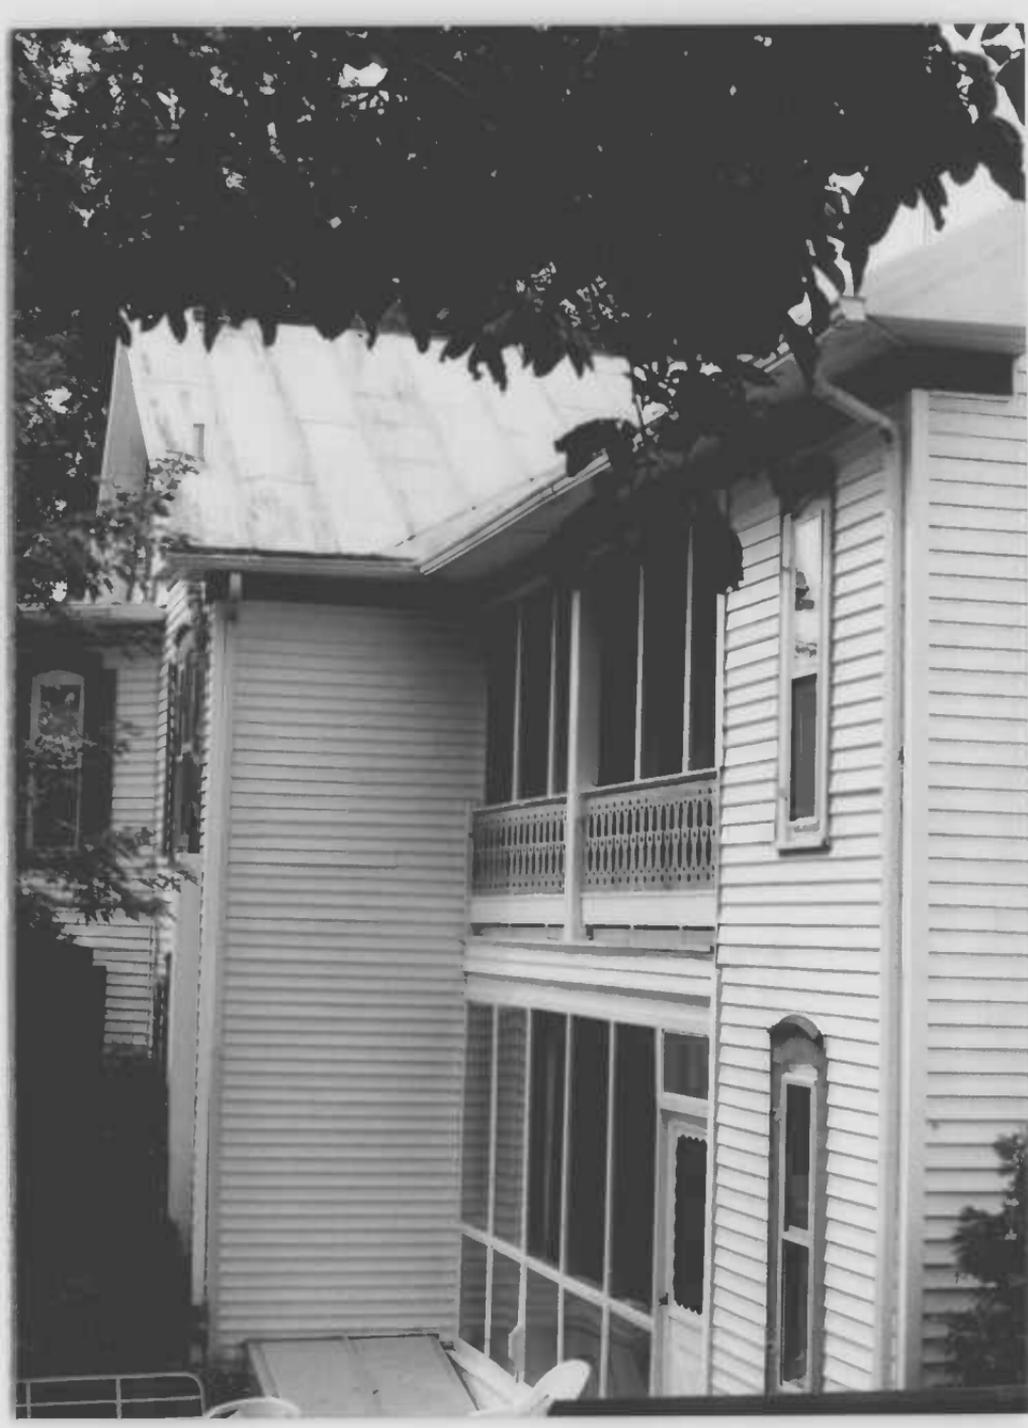
Stem-Nutbark House
3280 Sam's Creek Road
Carroll County, Maryland

The east elevation has a projecting three-sided bay in the south bay. This has a brick foundation that is painted and striped. Each of the three sides of the bay has a typical 1/1 sash with blinds on both the first and second stories. The bay has a dentil cornice. The roof is not visible. The north bay on both the first and second stories has one typical 1/1 sash. The gable end on the east elevation has two semi-circular 1/1 sash with blinds, the bottom half of which are adjustable. They also have a wood sill and a plain architrave. There is a dentil cornice in the raking eave. The north elevation of the main block has no openings. It, too, has a dentil cornice.

The east elevation of the ell is recessed from the plane of the east elevation of the main block. The southern three bays of the ell are recessed even further to create a two-story porch set under the gable roof of the ell. On the first story, from south to north, is a boarded-up door in a flat opening with a cornice that has an ogee and kick. Then is a 2/2 sash with the same details found on the south elevation windows, and a four-light over two-panel door in a flat opening with a typical ogee cornice. The north bay has a typical but narrow 1/1 sash that originally had one blind. The second story has no opening in the south bay. The south-center bay has a 2/2 sash like that found on the first story. Just south of the north-center bay is a flat-arched door with typical ogee trim. The north bay has a 1/1 sash like that found on the first story in this bay. There are no original details surviving on the first story of the porch. The second story has one center post that is square, and has jigsawn balusters.

Neg. Loc.: Maryland Historical Trust
east elevation - fr. north

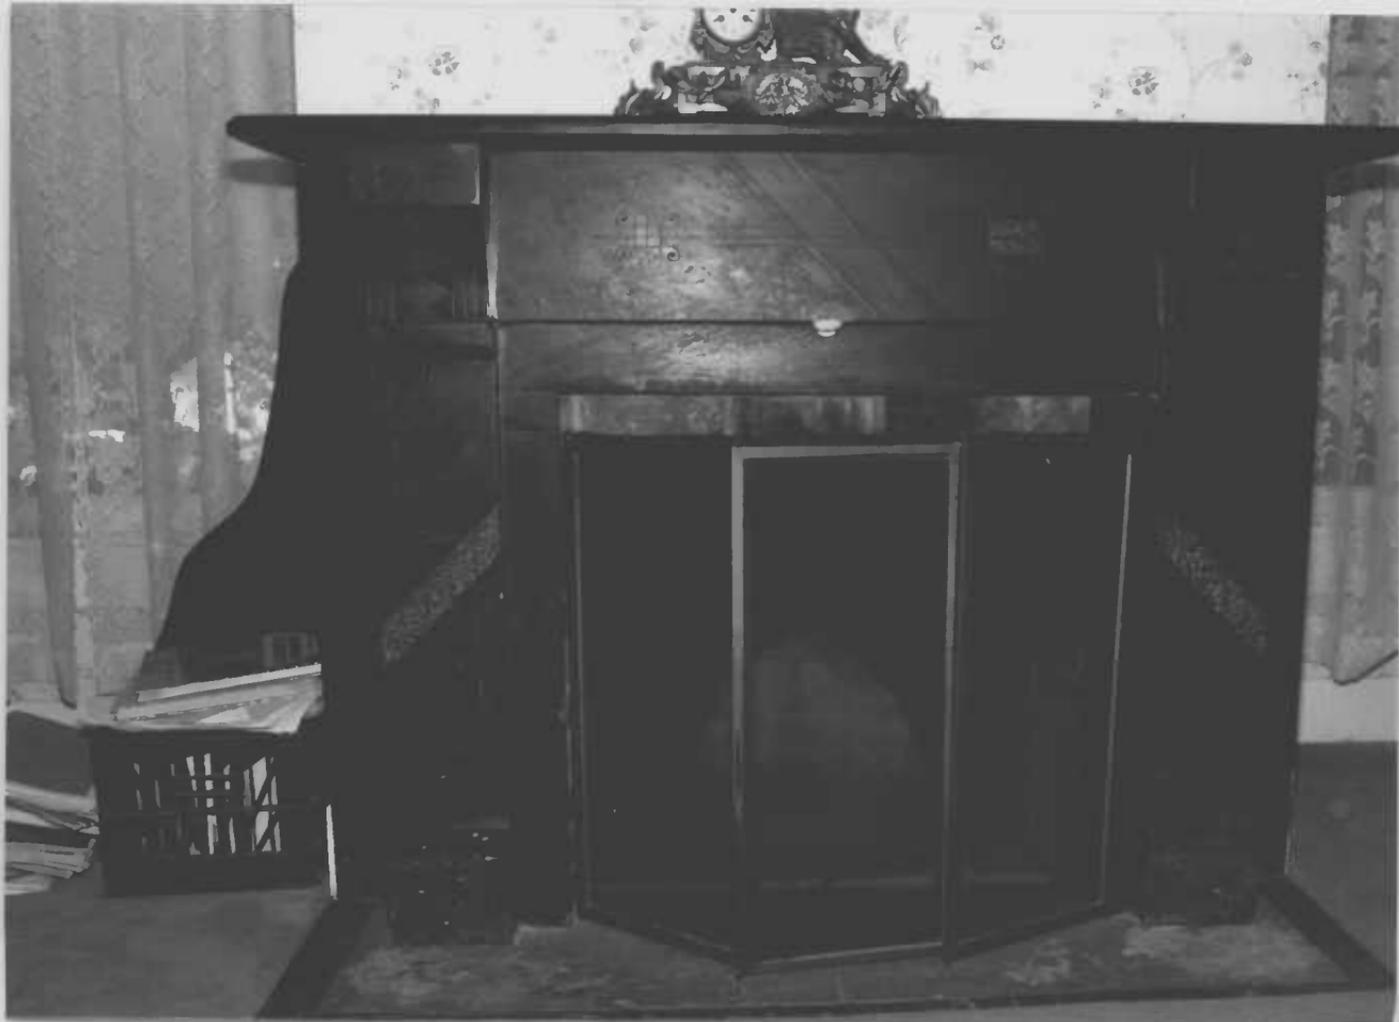
Stem-Nusbaum House

The southwest room has, centered on the west wall, a fireplace with a rebuilt brick fire box. There is a marbleized slate mantel that has pilaster strips with incised lines for decoration. The strips are painted to imitate red marble with a diagonal stripe across the center that has black bands on each outer edge and a speckled black and white center band. The brackets above the pilasters are also red, with incised diamonds that are speckled black and white and are flanked by black triangles. The frieze is also red and has a center stripe

like the pilasters. To each side of this stripe are incised squares with the speckled pattern within them. The hearth is also slate. The baseboards are plain and the door and window architraves match the passage and not the wide opening to the center room. The latter must, therefore, be a later alteration.

SW room mantle
