CARR-1454

Peter Ritz Farm
Mexico (vicinity)

Maryland Historical Trust State Historic Sites Inventory Form

MARYLAND INVENTORY OF
HISTORIC PROPERTIES

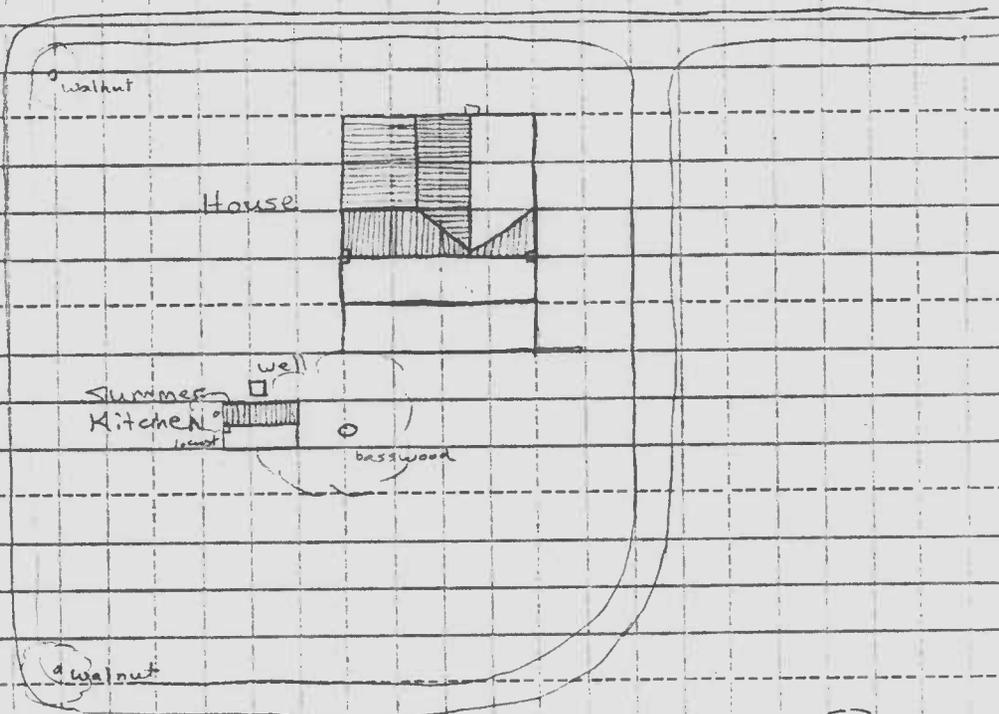
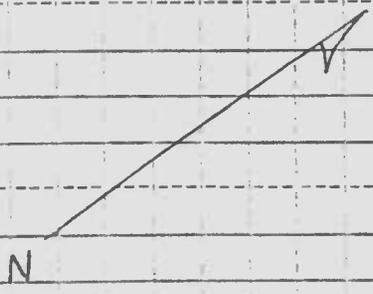
Site Plan

The Peter Ritz Farm is located at 624 Leister's Church Road, about 3 1/4 miles northeast of Westminster and 1 mile southeast of Mexico Road, in central Carroll County, Maryland. The farm is located on the southwest side of Leister's Church Road, on a long drive set well back from the road. The site has a gradual slope down to the southeast. The complex consists of a frame house, a summer kitchen, a frame bank barn, a binder shed, and a wood shed.

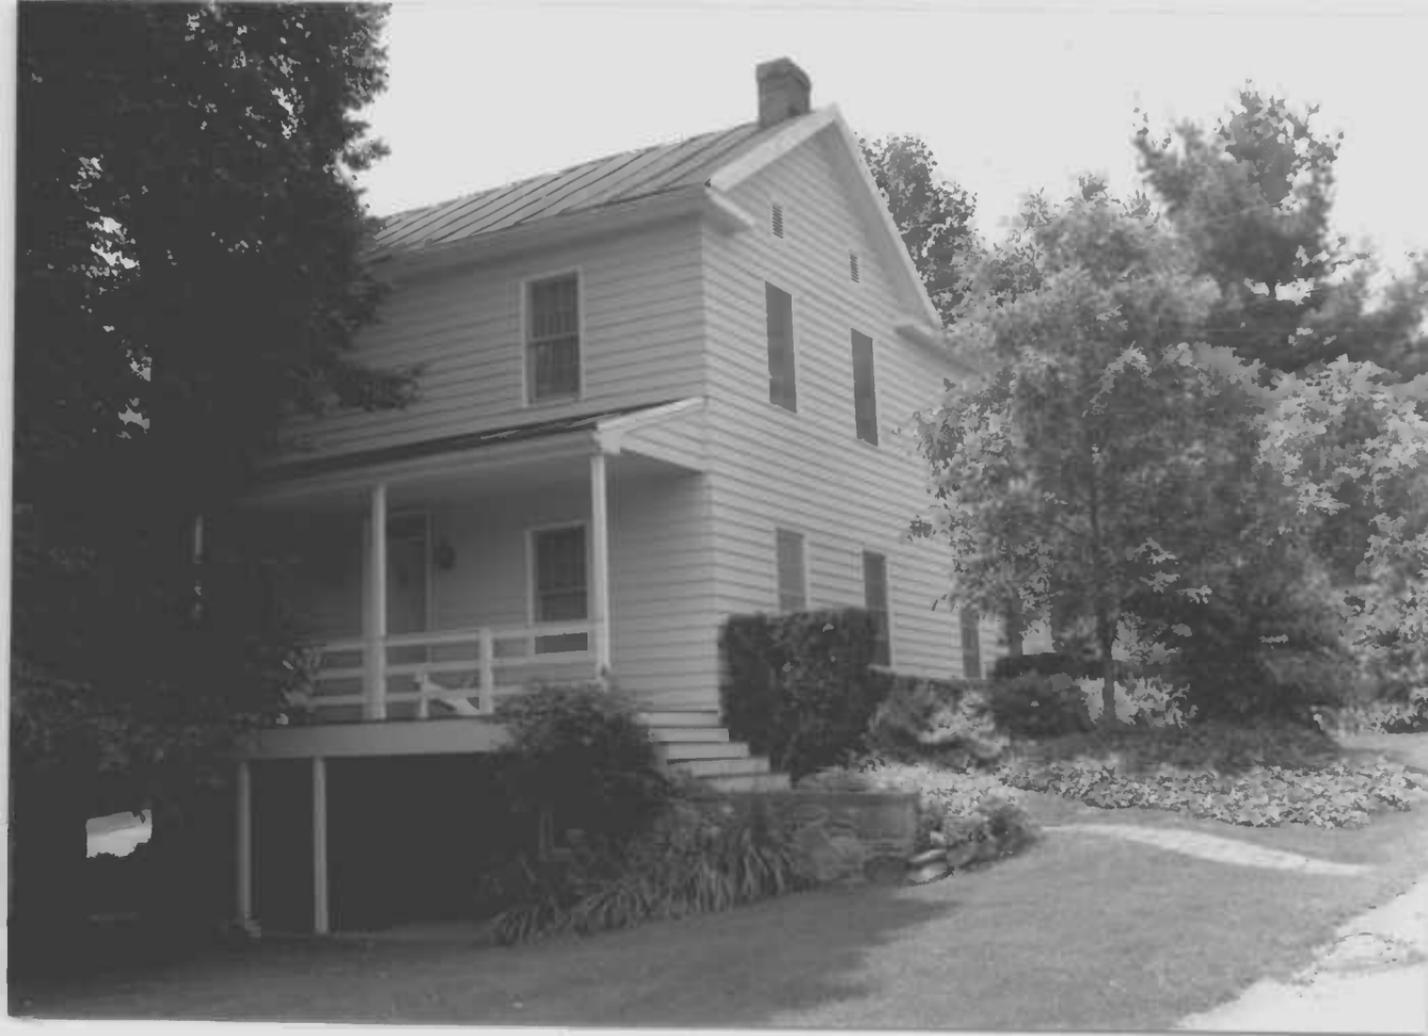
1/3

Neg. loc.: Maryland Historical Trust
house - SE elev.

The house is a three-bay by two-bay, two-story structure that is banked on the northwest and has a two-bay ell on the northwest elevation. The southeast elevation foundation is thus exposed. The foundation is rubble stone. There is new weatherboard, and the gable roof has standing-seam metal and a northeast-to-southwest ridge. There is an interior brick chimney on each end with new brick. The southeast elevation foundation has a new door in an original opening in the south bay and two new 6/6 sash. The first story has a center entrance with a new door and a one-light transom and two new 6/6 sash. There is a one-story raised porch with a shed roof of standing-seam metal. The porch has a new railing and four new posts. The second story has new 6/6 sash in the end bays with no opening in

the center bay. There is a wood box cornice with returns. The southwest elevation foundation has a new 6/6 sash in the south bay. The first and second stories have two new 6/6 sash, and there are two louver vents in the gable end. The southwest elevation of the ell has a one-story porch with a shed roof of standing-seam metal. The south half of the porch is enclosed. The second story has two new 6/6 sash. The gable roof of the ell has standing-seam metal and a southeast-to-northwest ridge. The northwest elevation of the ell has a new exterior brick chimney. The northeast elevation of the main block has two new 6/6 sash on the first and second stories, and two louvered vents on the gable end. The ell has two new 6/6 sash on both the first and second stories.

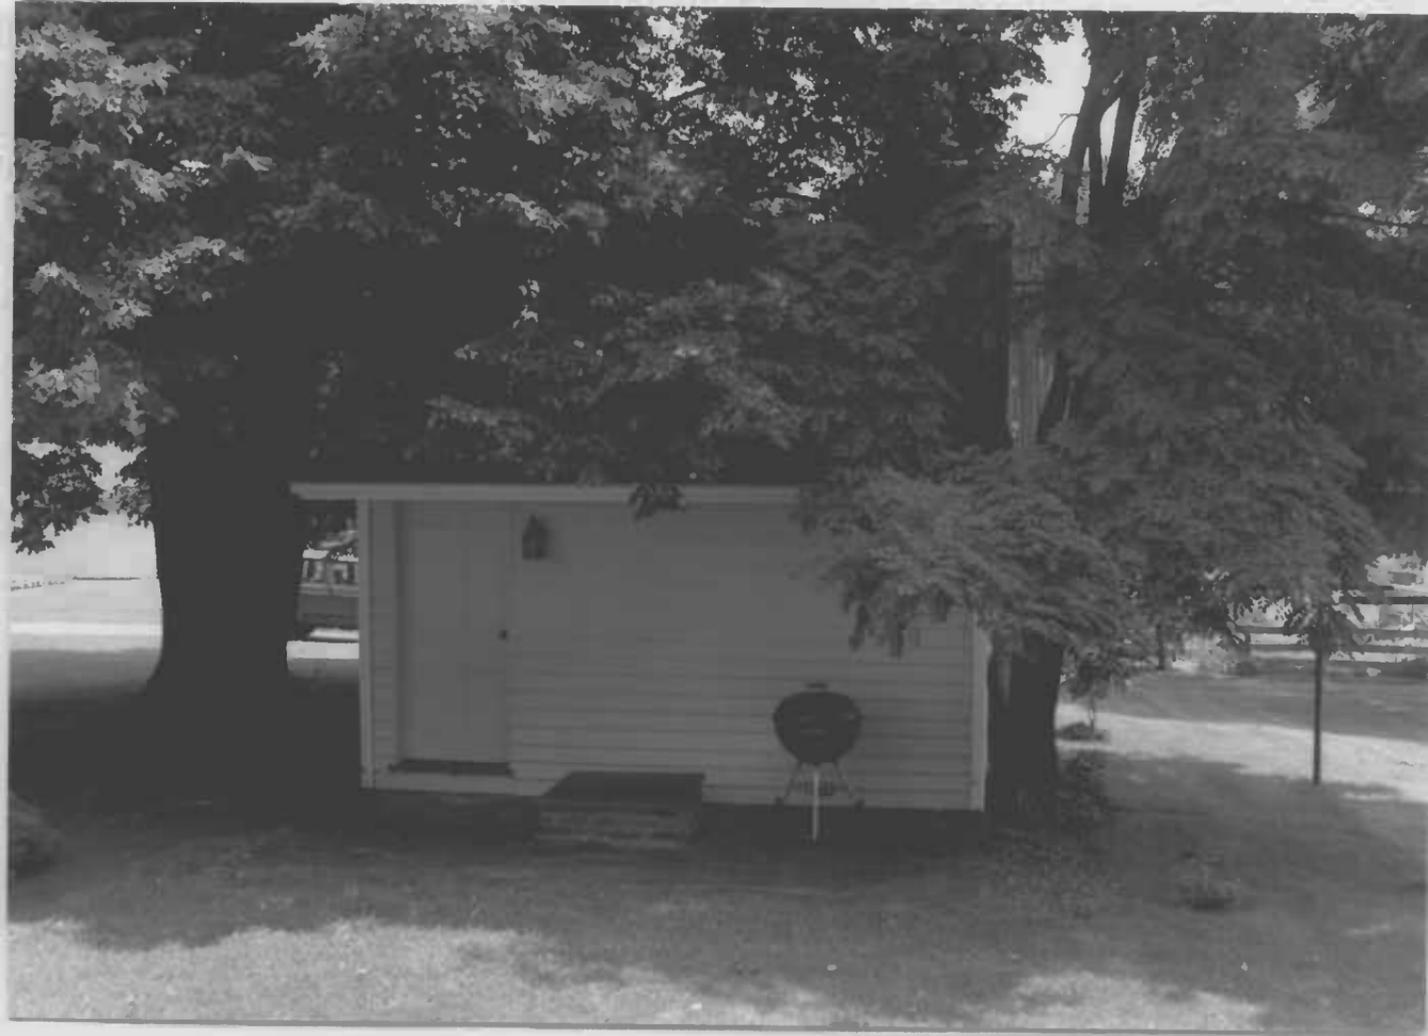
2/3

Summer Kitchen - NW elev.

There is a summer kitchen about 10 feet south of the house. It is a one-story, one-bay square building, with a rubble stone foundation, weatherboards with corner boards, and a gable roof of standing-seam metal over wood shingles with a northeast-to-southwest ridge. There is an interior brick chimney on the southwest end and a new pent roof added the northwest. The northwest elevation has a new six-panel door set to the north. The northeast and southeast elevations have a 1/1 sash. The building is of 2 x 4 construction. The southwest wall has a brick fireplace with straight jambs and a trammel crane. The wood mantel tree is circular sawn. The building has a floored attic with a ladder nailed to the studs in the south corner.

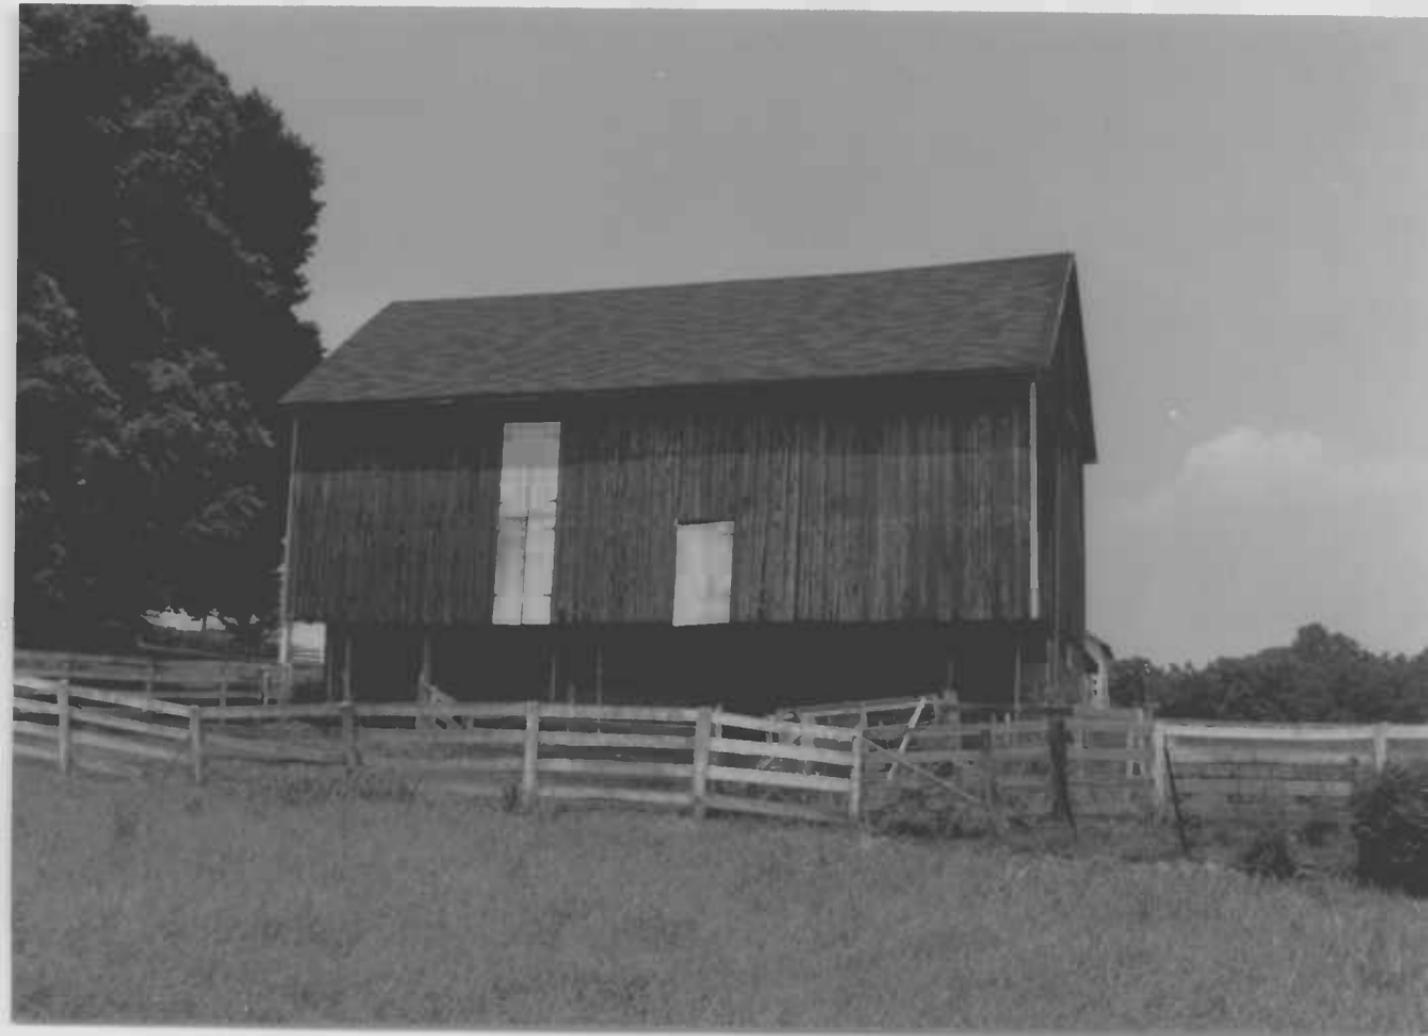
3/3

Neg. Loc.: Maryland Historical Trust
barn - SW elev.

There is a bank barn about 50 feet southeast of the summer kitchen. It has a rubble stone lower story with horizontal boards under the forebay, and a vertical-board upper story. The forebay faces southwest. The gable roof has asphalt shingles and a southeast to northwest ridge. The northeast elevation upper story has two pair of wagon doors on rollers in the center. The northwest elevation has a six-light sash on the lower story and no

openings on the upper story. The southwest elevation lower story has two vertical-board dutch doors on strap hinges, a wide opening south of this, and another dutch door in the south bay. The upper story has vertical-board double doors on strap hinges over identical doors with a similar door to the south of them. The southeast elevation is identical to the northwest elevation. The lower story has a summer beam that is circular sawn on all four sides and joists that are circular sawn on top and bottom. The forebay wall is of heavy-timber frame. The upper story has two center wagon floors with a hay mow on each end and a granary in the north corner. It has a circular-sawn, heavy-timber, mortised-and-tenoned-and-pegged frame. Each bent has four posts, and there is a Queen post truss supporting the roof. The roof has 2 x 4 rafters that are mitered at the ridge, and there is a hay track. The southeast bay of the barn was added later. On the interior upper story door is painted "H. M. 1916."
