Beta Shoe Store
14 North Washington Street
Easton, Maryland 21601

T-37
Nineteenth Century,
First Quarter

INVENTORY FORM FOR STATE HISTORIC SITES SURVEY

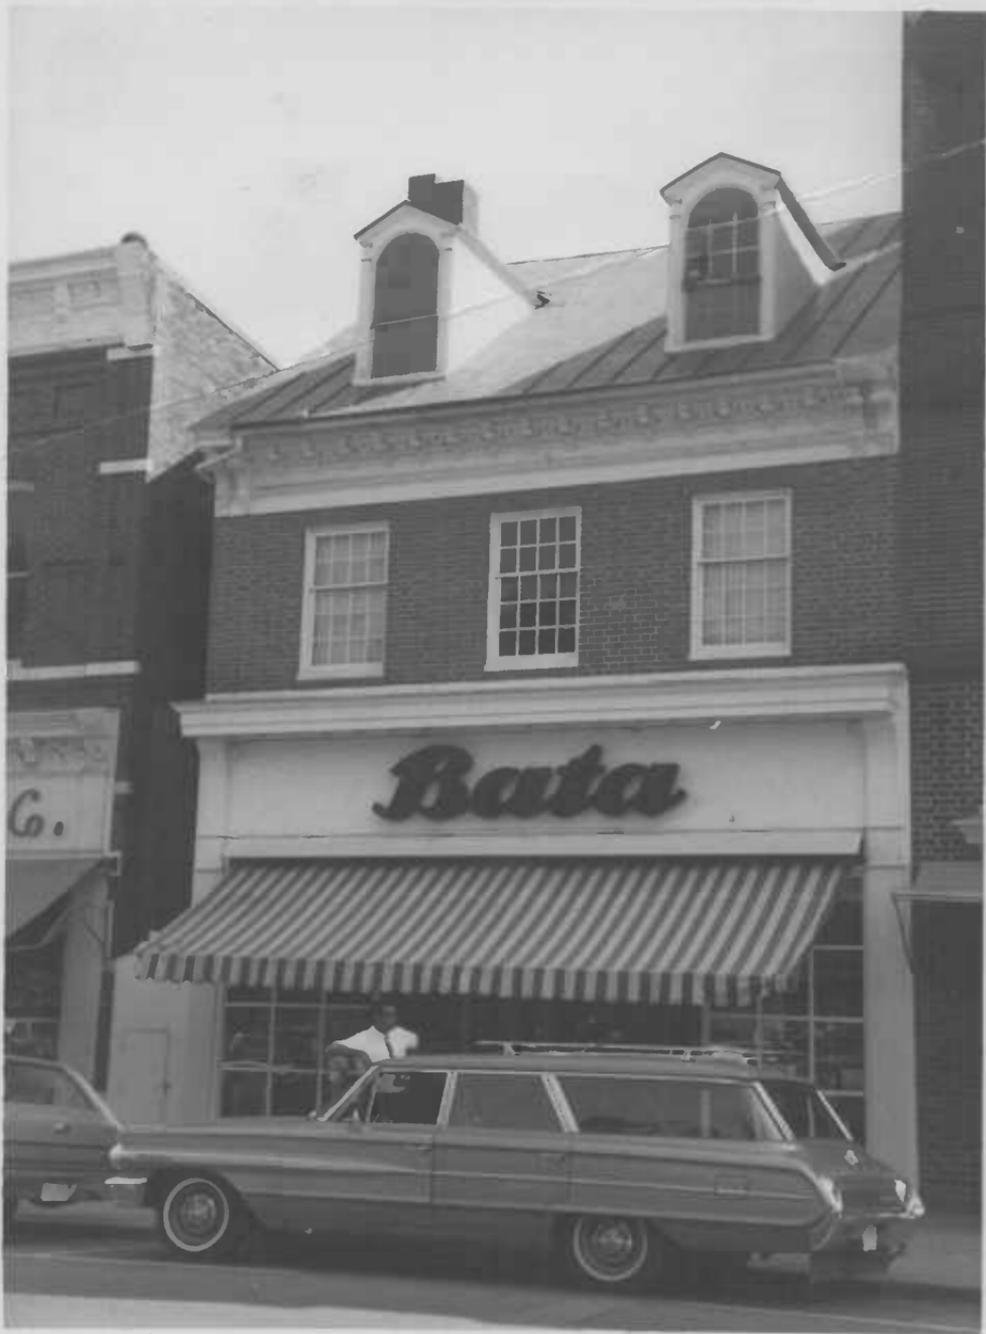
Bata Shoe Store
14 North Washington Street,
Easton
West Facade

Although greatly altered and currently in only fair condition, 14 North Washington Street exemplifies a late Federal row building, taller and bolder than similiar structures built earlier. Its Flemish bond facade is complimented by a delicate pierced-work wooden cornice probably added about the middle of the nineteenth century.

The building is brick, three bays wide and two-and-a-half stories in height. Its gable roof is taller and somewhat more steeply pitched than the other Federal period buildings on Washington Street. There are two gable dormers on the western slope of the roof; those at the rear of the building have been removed. Three additions form an ell to the rear. They have no distinguishing architectural features and appear to date from the mid-nineteenth century and twentieth century. There are two chimneys at the ridge of the roof. The one at the south wall, a double chimney with a corbelled cap, appears to be original; that at the north wall is modern.

The building has suffered substantial alterations; a large-scale store front has replaced its entire first floor. A portion of the Flemish bond brick facade remains, however, as do the windows with flat arches and eight over twelve sashes. The trim is a single one inch half round molding. The tall gable dormers have gently pitched roofs and round-headed windows with nine over six sashes. The window opening is flanked by fluted pilasters; there is a cornice and return. Despite needed repairs these features retain their original appearance. The roof is covered with raised seam metal painted green.

Probably added in a mid-nineteenth century renovation, the cornice is the building's most notable feature. The small console-type brackets alternate with stylized pierced-work festoons at the corona. Larger double console brackets with leaf-like feet are found at the corners of the building. A line of tiny half-globes and moldings decorates the frieze. Although added later, the cornice is well-scaled to the building and represents an interesting combination of periods of building. The original cornice remains on the rear facade; it is boxy and plain with original crown and bed moldings.
