T-775
Clyde Milbourn House
Bellevue
Private

Maryland Historical Trust State Historic Sites Inventory Form

and/or common CLYDE MILBOURN HOUSE

Survey No. T-775

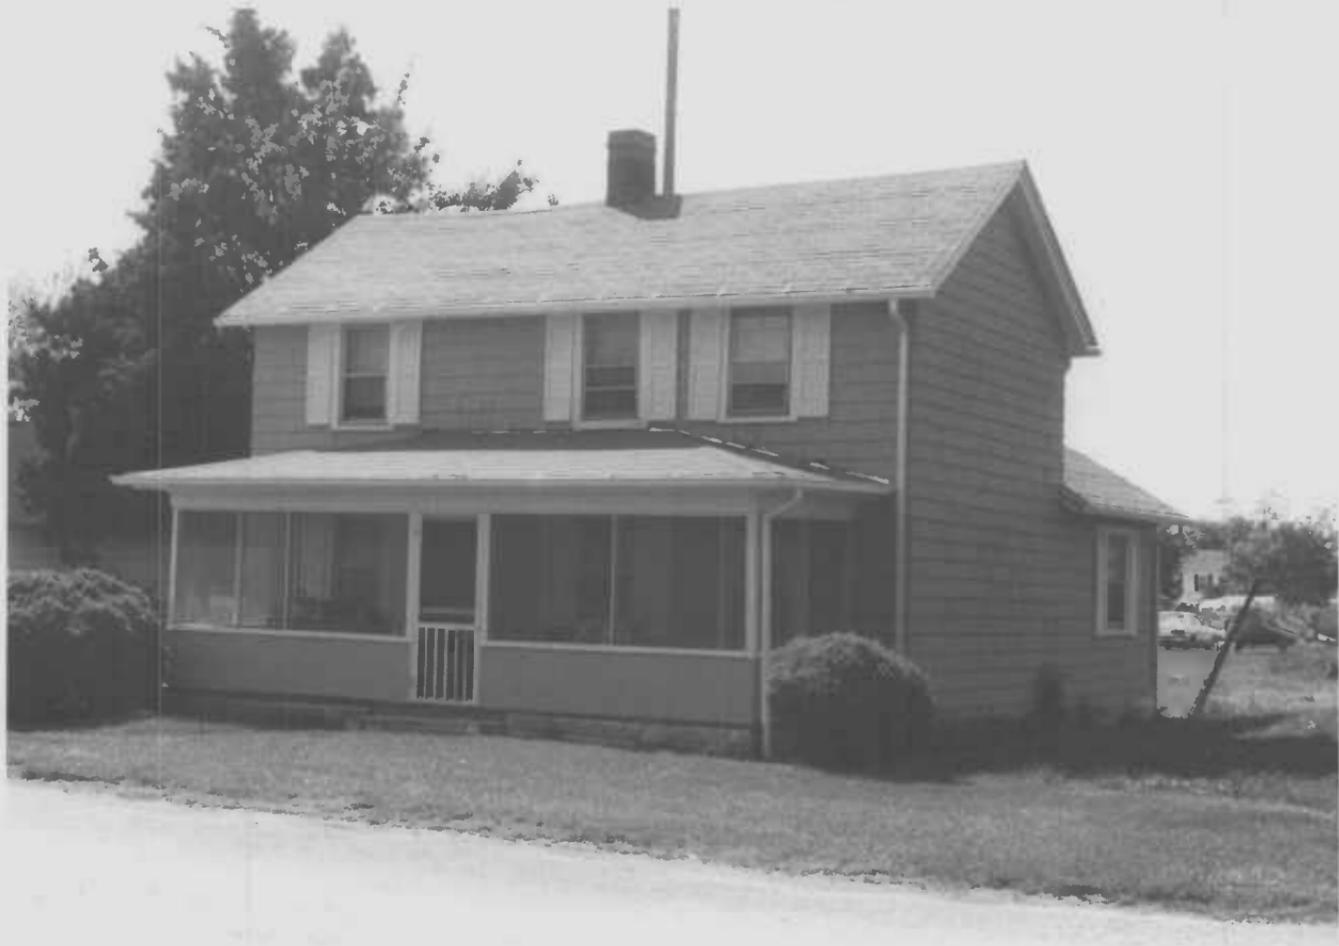
Southeast elevation

The southeast side is an asymmetrical three-bay facade with a side entrance and two-over-two sash windows filling the adjacent bays. The first floor is fully covered by a hip roof screened in porch. Lighting the second floor are three unevenly spaced two-over-two sash windows framed by aluminum shutters. Rising through the center of the house is a brick chimney.
