T-778  
Cora Brice House  
Bellevue  
Private

# Maryland Historical Trust State Historic Sites Inventory Form

and/or common CORA BRICE HOUSE

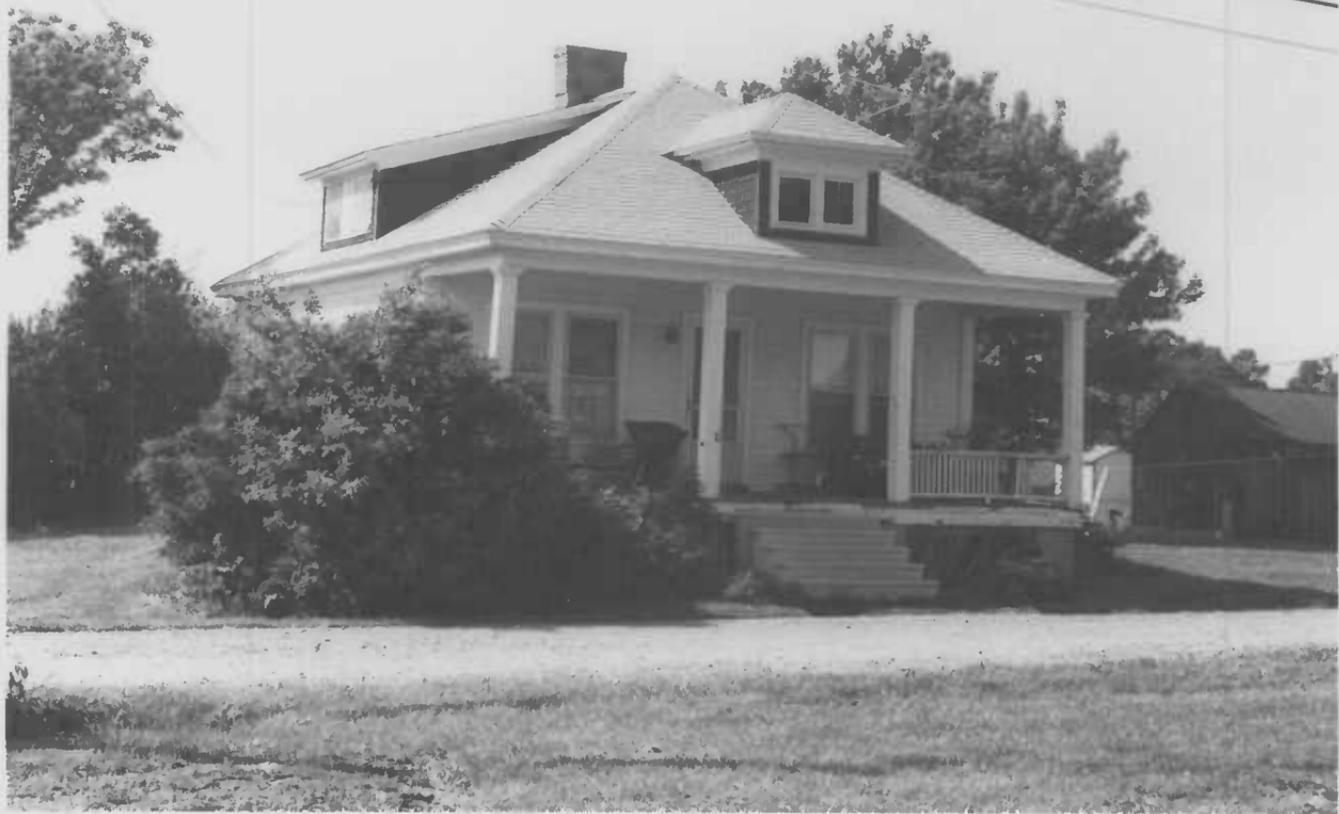
Southwest elevation

The southwest side elevation is marked by two-over-two sash windows. A long shed roofed dormer with wood shingled sides and small four-pane windows lights the upper floor.
