T-807  
Laura Miller House  
Copperville  
Private

Resource Name: LAURA MILLER HOUSE

MHT Inventory Number: T-807

# Maryland Historical Trust State Historic Sites Inventory Form

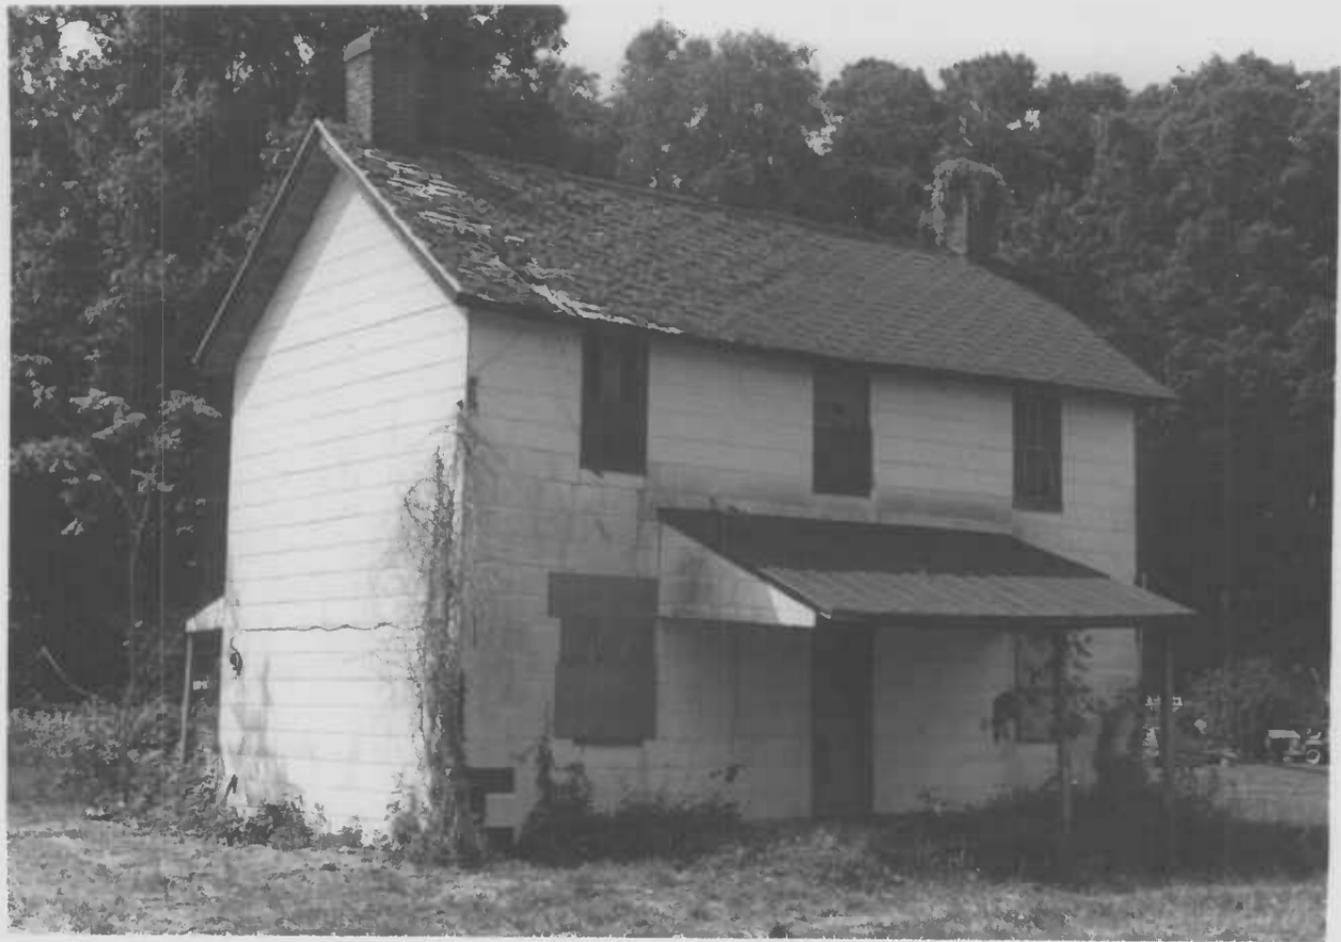
Southeast elevation

The southeast (main) facade is a three-bay elevation with a center four-panel door and flanking boarded over windows. The front door is sheltered by a single-bay porch supported on square posts. Lighting the second floor are three six-over-six sash windows.
