T-811

Harry Goldsborough House  
Copperville  
Private

# Maryland Historical Trust State Historic Sites Inventory Form

and/or common HARRY GOLDSBOROUGH HOUSE

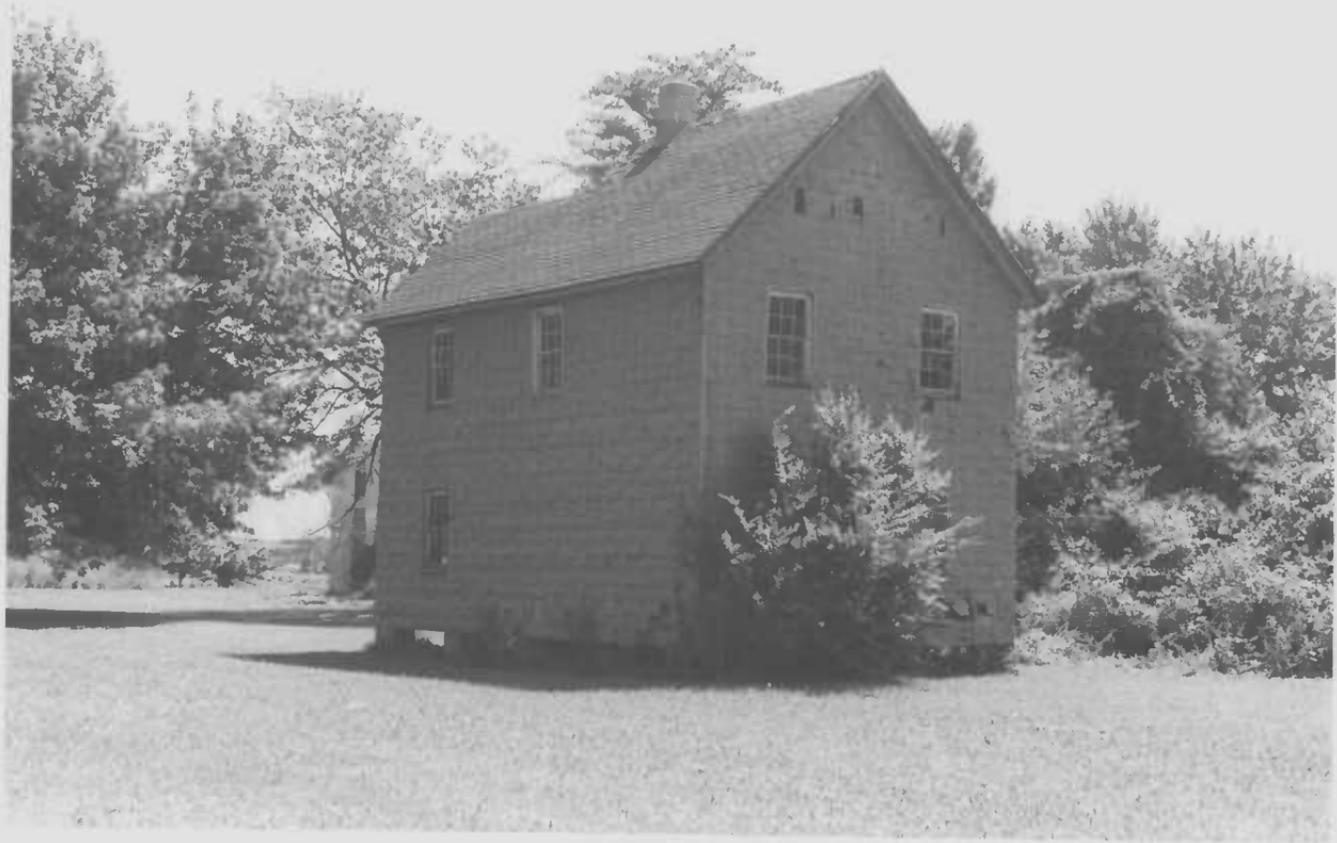
Southwest elevation

The southwest (main) elevation is a gable front facade with a side entrance and flanking six-over-six sash window. The second floor is lighted by two evenly spaced six-over-six sash windows, and the eave is slightly extended beyond the wall surface.
