Maryland Historical Trust State Historic Sites Inventory Form

Survey No. T-899

and/or common E. Russell Casson house

street & number Talbot Street not for publication

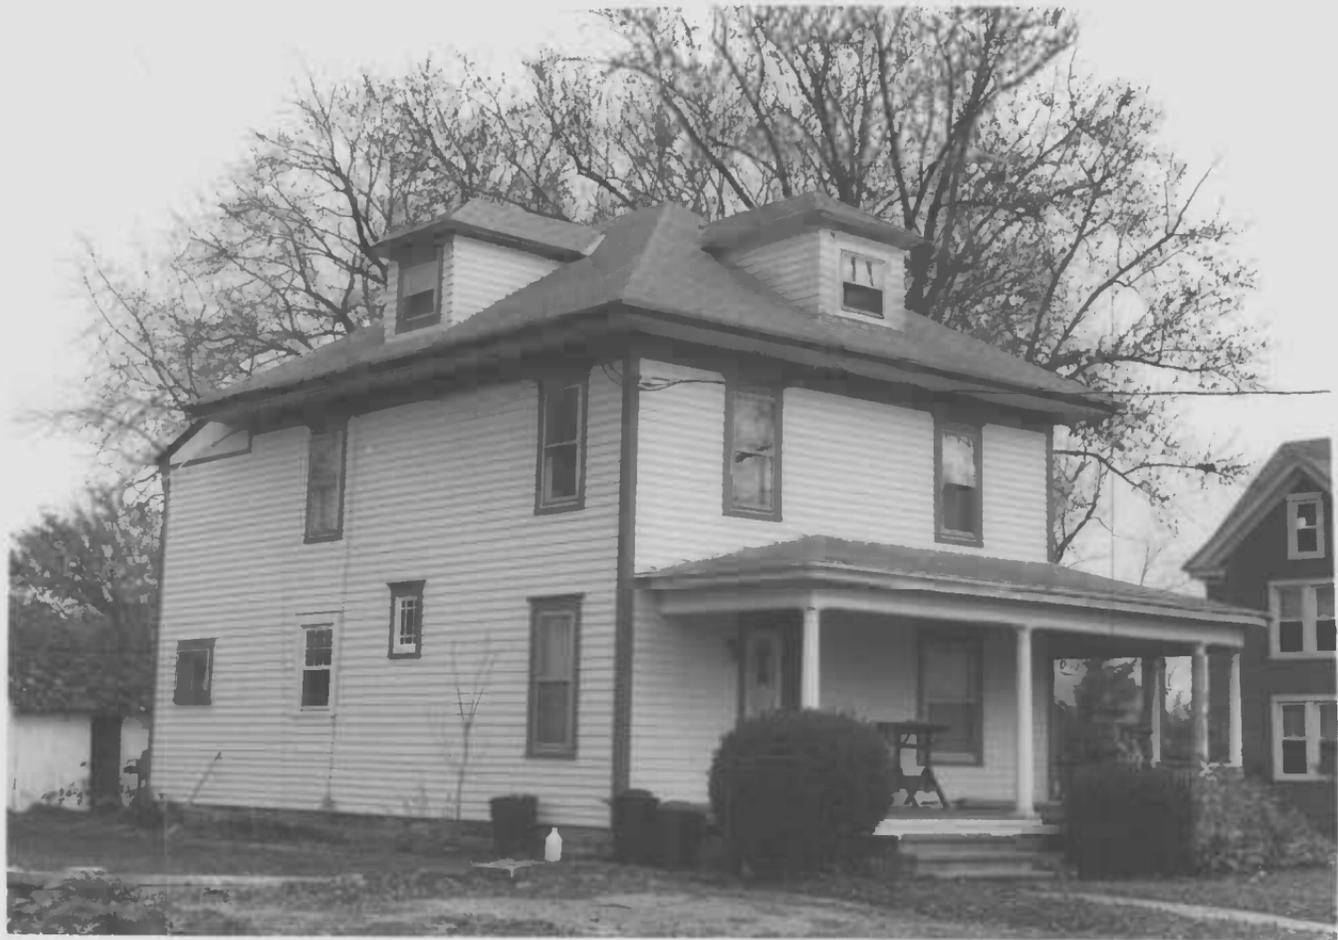
SW ELEVATION

This south (main) elevation has an open porch decorated with heavy dentil molding and supported by doric columns which stretches across this elevation and curves around to the east side of the house. The first story is lit by one one-over-one sash window with blue trim and decorative crown molding. The entrance door is a single, large, oval light over a single panel with blue trim, and decorative crown molding. The second floor is lit by two one-over-one sash windows with blue trim, and decorative crown molding. One shed roof dormer window sits in the center of the roof and is lit by one small one-over-one sash window.

The west elevation is lit on the first floor by four windows. The two original window frames of this side are one one-over-one sash window with blue trim and decorative crown molding, and one small single pane window with the same trim. One six-over-one sash window with wide surrounds, clearly replacing the original window in this site, and one two-light window with blue surrounds also light this floor of the house. The second floor is lit by two one-over-one sash windows with wide, blue surrounds and decorative crown molding. A shed roof dormer with one one-over-one sash window is placed in the center of the roof. A two-story, shed roof addition extends to the north of the house.
