Linden Grove
Frederick
Private

National Register of Historic Places
Inventory—Nomination Form

historic Rocky Creek;
Linden Grove (preferred); Howard, Edward, Farm; Beall, William M., Farm;
and or common Linden Grove

Section number 7 Page 1 Linden Grove
Frederick County, Maryland

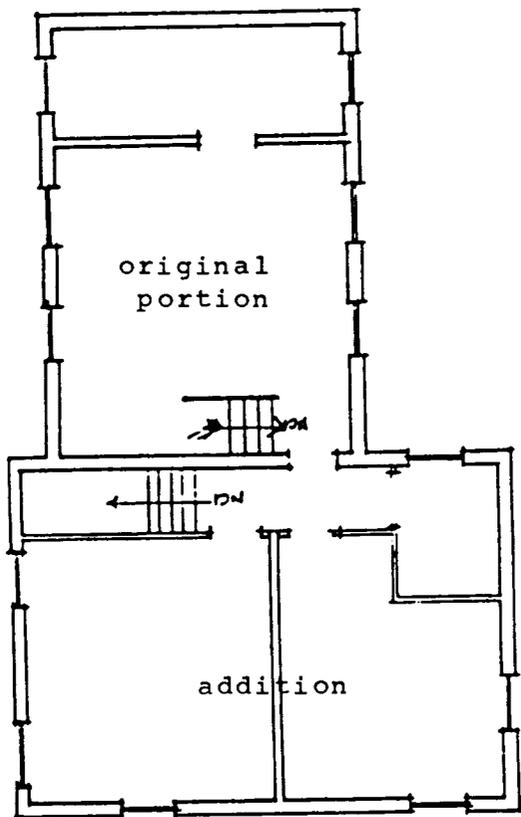
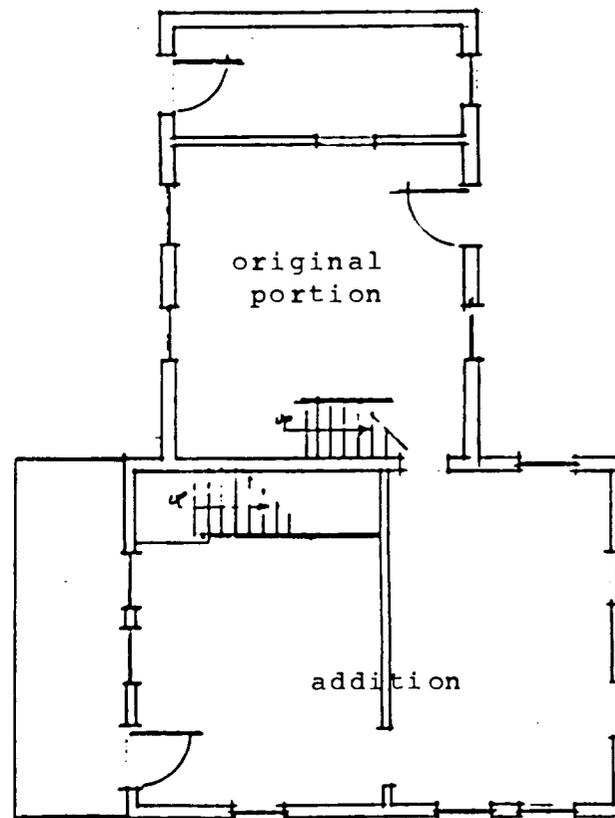
LINDEN GROVE, tenant house
Frederick County, Maryland

floor plans 1987

The secondary dwelling is a one-and-one-half story, three bay brick structure which is contemporary with or slightly later than the main house. To its west end has been attached a 1930s two story brick addition. The original portion of this structure has two rooms at each story, with an enclosed corner stair giving access to the upper level. The two story addition has four rooms and interior woodwork with dark varnish in a 1930s interpretation of Georgian design.

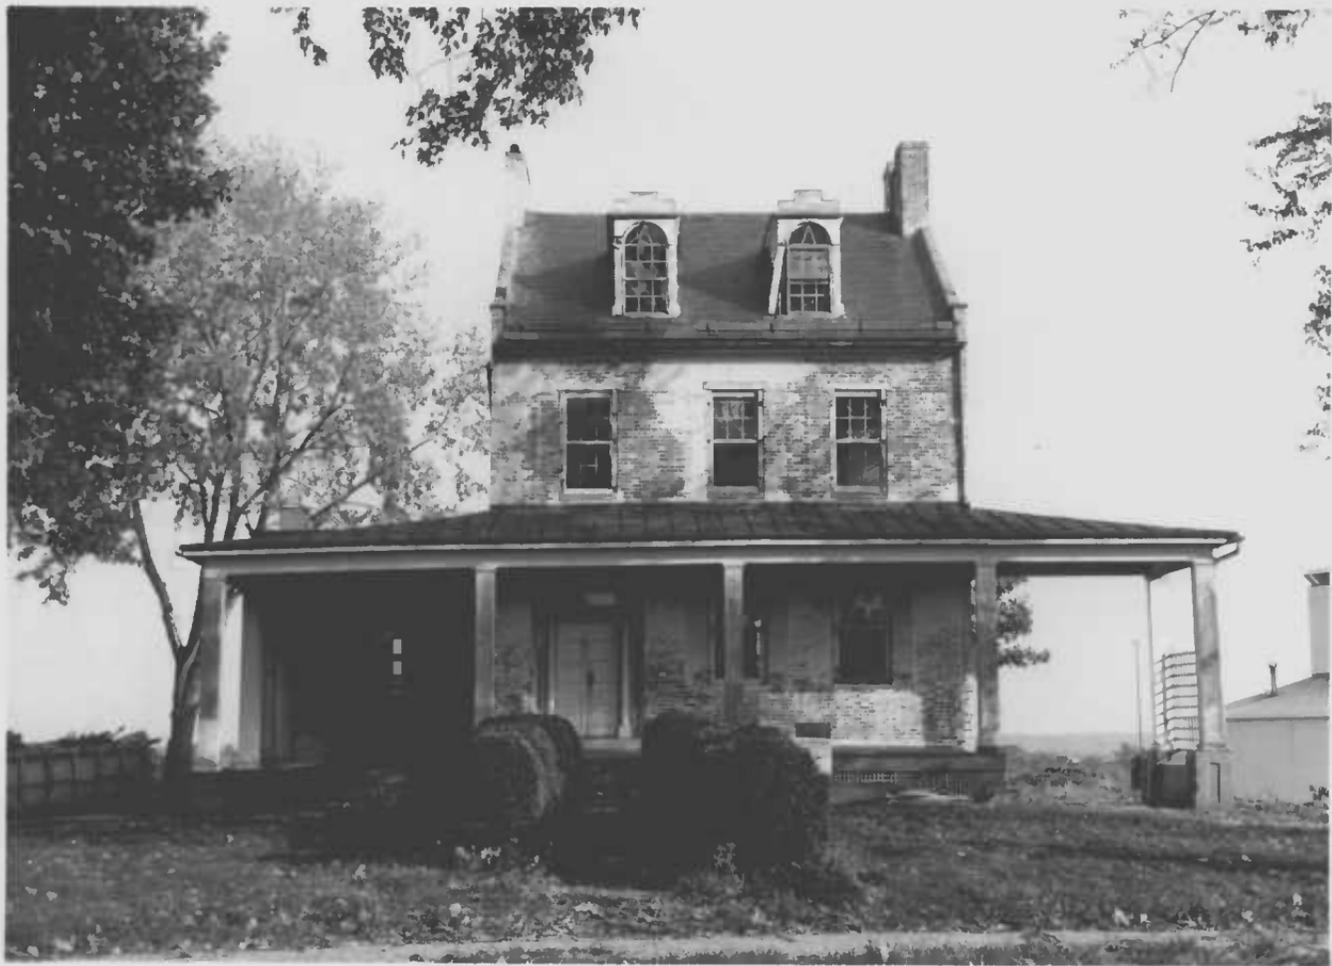
1. LINDEN GROVE
2. Frederick, Frederick Co., MD
3. Photo Date: October 1986
4. Photo by Ronald Peck
5. Neg. Location: Hagerstown, MD
Preservation Associates, Inc.
6. View: E. view, W. elevation
7. Photo #3

The front elevation of Linen Grove is very formal with a vertical orientation giving the house a tall, narrow appearance. Prominent features of the facade include Flemish bond brickwork once covered with yellowish buff paint, perhaps an original finish, beneath the present coat of white paint. Another significant feature is the entrance consisting of a two-leafed door surround by a transom and sidelights. An integral part of the entrance treatment are Doric colonettes on either side of the door. A third significant facade feature is the pair of dormers projecting from the west slope of the roof. They are gable roofed structures finished with parapets and have nine over six light arched-topped sashes. On either side of the sash are simple pilasters. Although not unique, dormers are certainly not typical in Frederick County farmhouses.

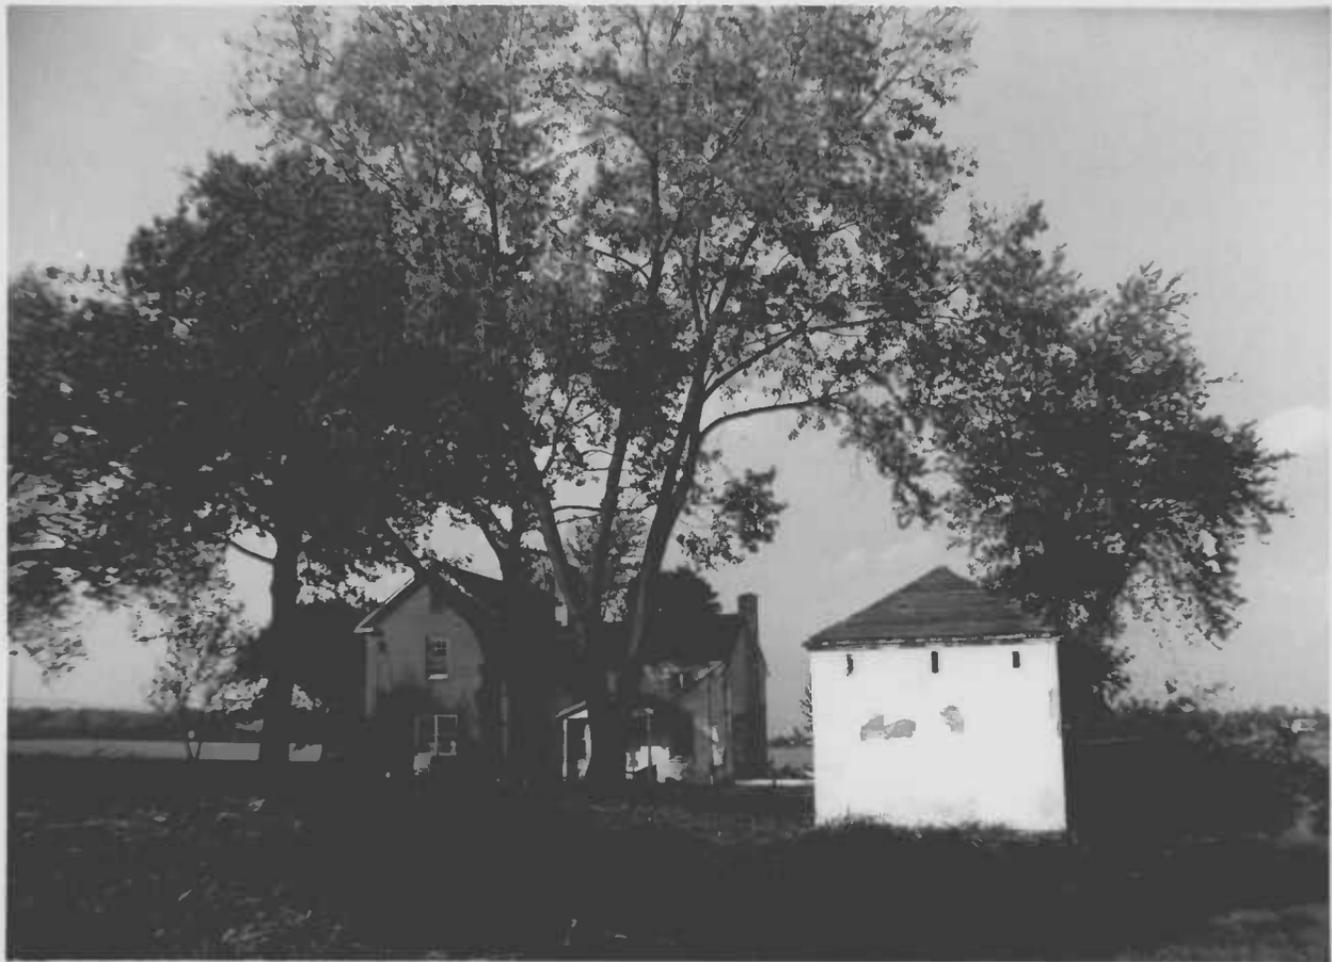
#6
Smoke House - S

1. LINDEN GROVE
2. Frederick, Frederick Co., MD
3. Photo Date: October 1986
4. Photo by Ronald Peck
5. Neg. Location: Hagerstown, MD
Preservation Associates, Inc.
6. View: Smoke House, Secondary dwelling
N. view
7. Photo # 6

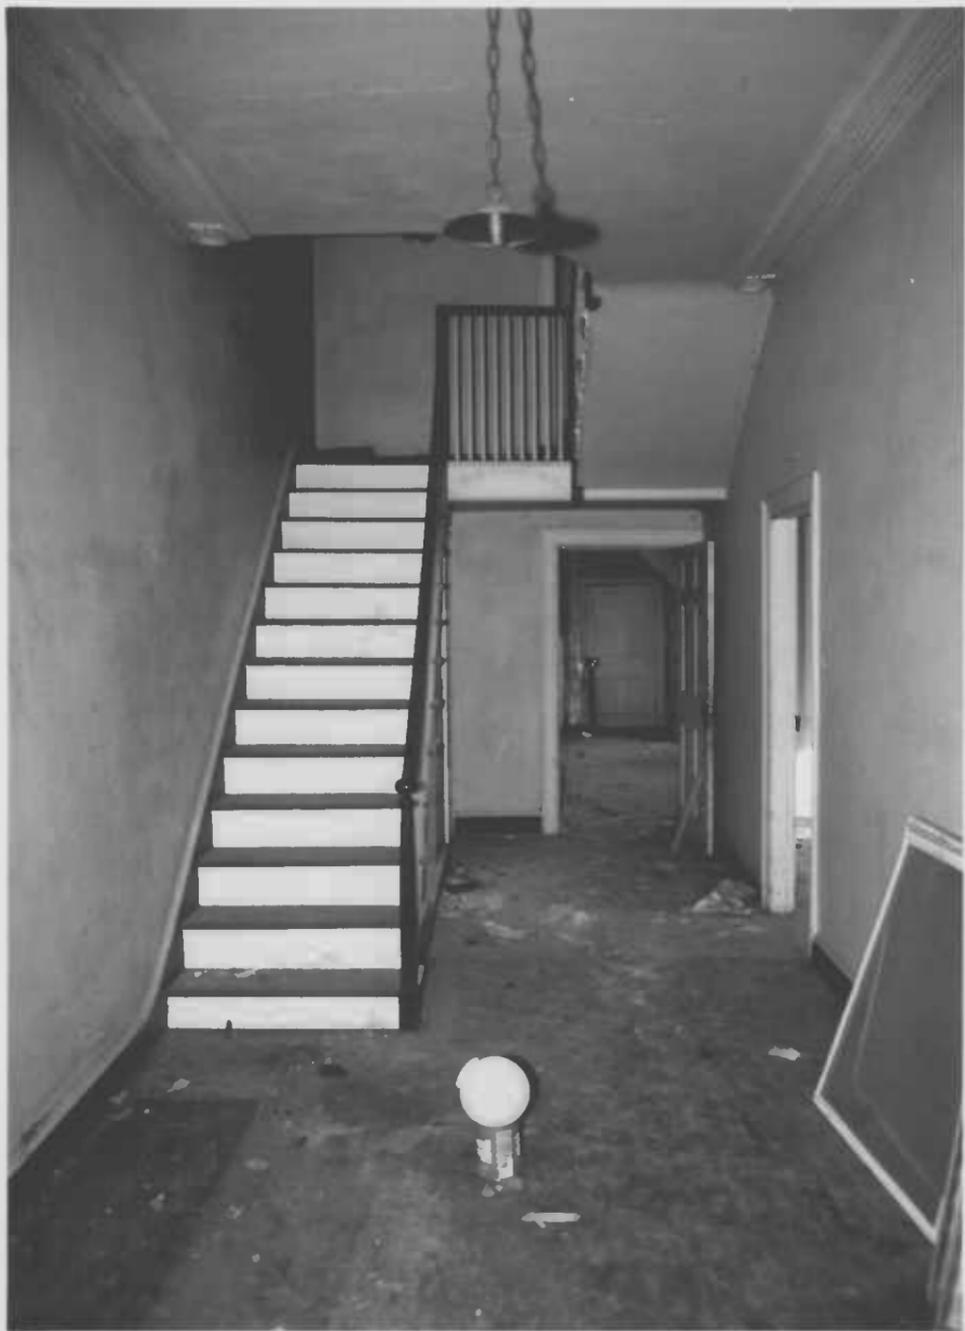
1. LINDEN GROVE
 2. Frederick, Frederick Co., MD
 3. Photo Date: October 1986
 4. Photo by Ronald Peck
 5. Neg. Location: Hagerstown, MD
Preservation Associates, Inc.
 6. View: *Main House Entrance Hall*
 7. Photo # *16*
-

The main entrance opens into a formal stair hall which retains most of its original features, including the paint on the baseboard. Perhaps the most significant feature of the entrance hall is the molded plaster ceiling trim including rosettes and a round medallion surrounding a ceiling fixture. The staircase is Federal in appearance with an attenuated newel and balusters and delicate carving on the ends of the risers and on the spandrels.

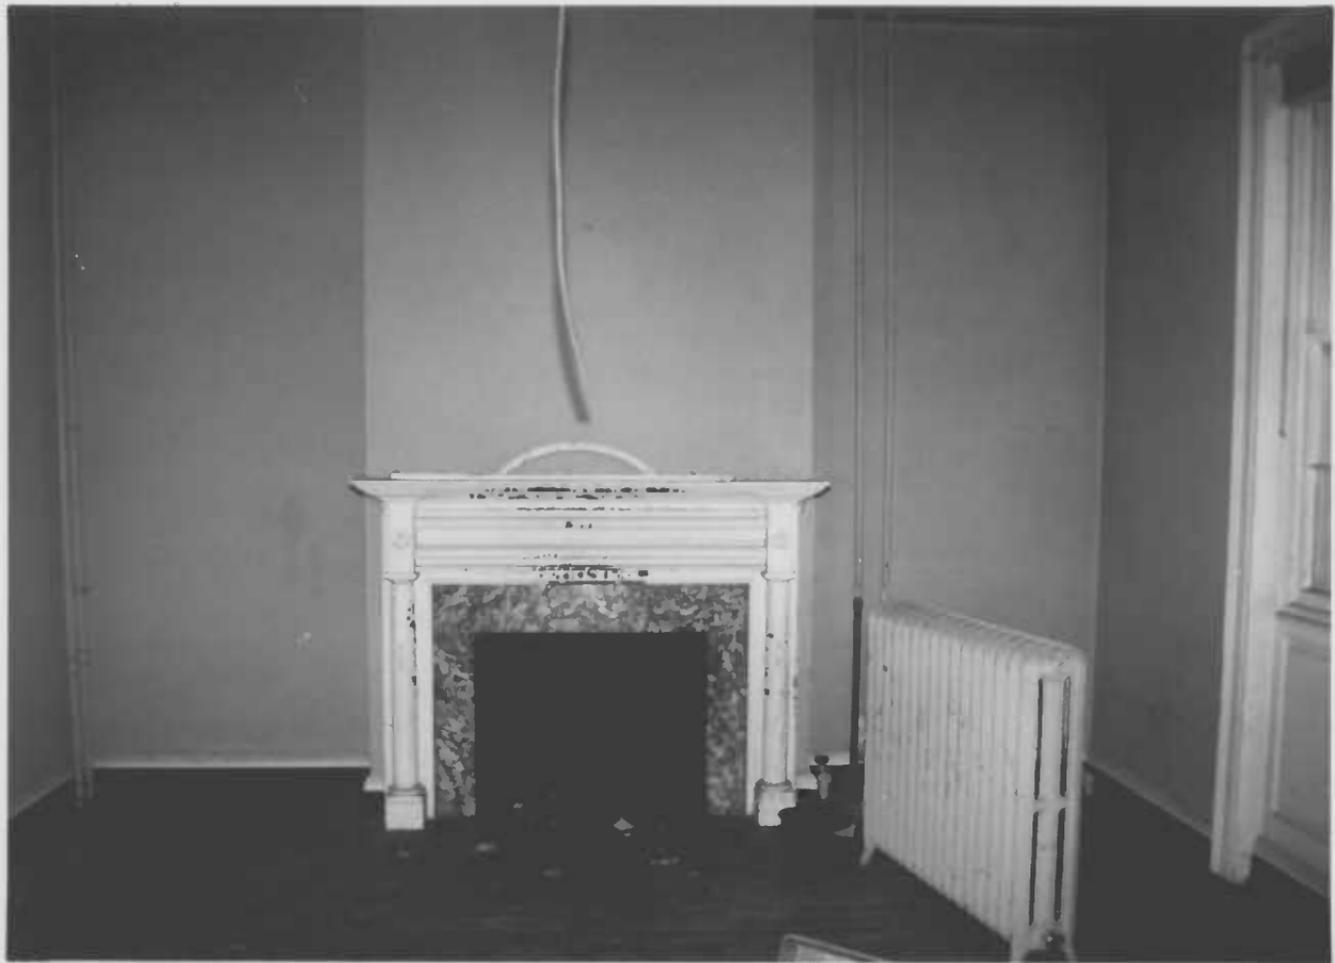
1. LINDEN GROVE
2. Frederick, Frederick Co., MD
3. Photo Date: October 1986
4. Photo by Ronald Peck
5. Neg. Location: Hagerstown, MD
Preservation Associates, Inc.
6. View: SW Parlor, Main House
7. Photo #17

Doors from the hallway open into two formal parlors, both of which retain their original trim. Prominent features of the two parlors are matching fireplaces with marble surrounds and late Federal style (with some Greek Revival style feeling) mantelpieces with Doric colonettes and bolection moldings. Windows are finished with paneled jambs and dados. The two rooms of the first story kitchen wing are much more simply appointed. The kitchen has an enclosed corner stair winding to the second floor.

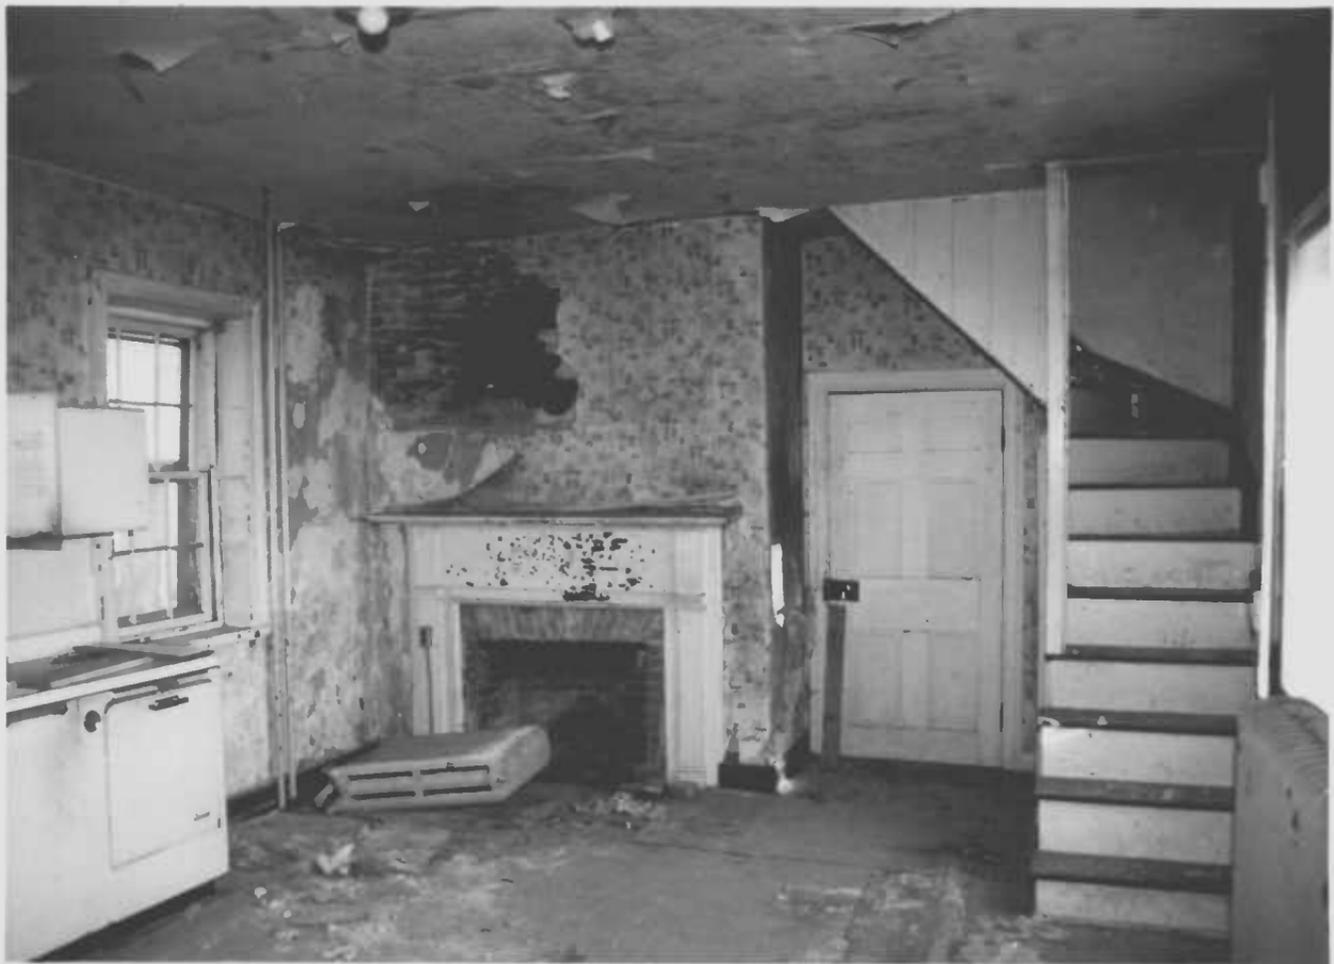
1. LINDEN GROVE
2. Frederick, Frederick Co., MD
3. Photo Date: October 1986
4. Photo by Ronald Peck
5. Neg. Location: Hagerstown, MD
Preservation Associates, Inc.
6. View: Mam House Kitchen
7. Photo #19

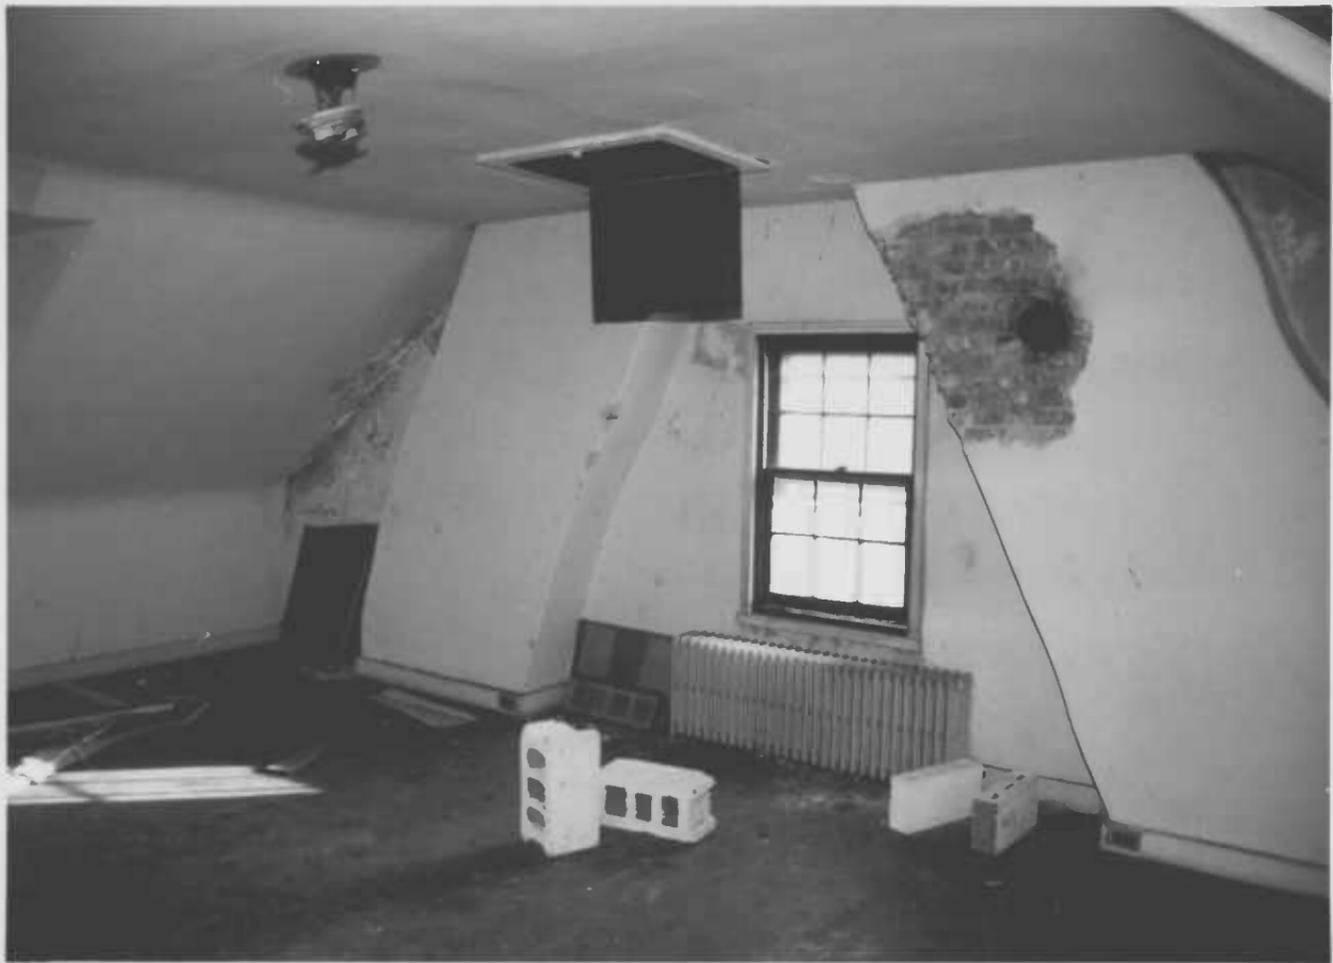
#26
Mm
Rm 301

1. LINDEN GROVE
 2. Frederick, Frederick Co., MD
 3. Photo Date: October 1986
 4. Photo by Ronald Peck
 5. Neg. Location: Hagerstown, MD
Preservation Associates, Inc.
 6. View: Main House 3rd Floor
 7. Photo #28
-

The third floor contains storage areas and has plastered whitewashed walls and the original wide floor boards. An access door in the ceiling leads to the attic, but this area was not observed.

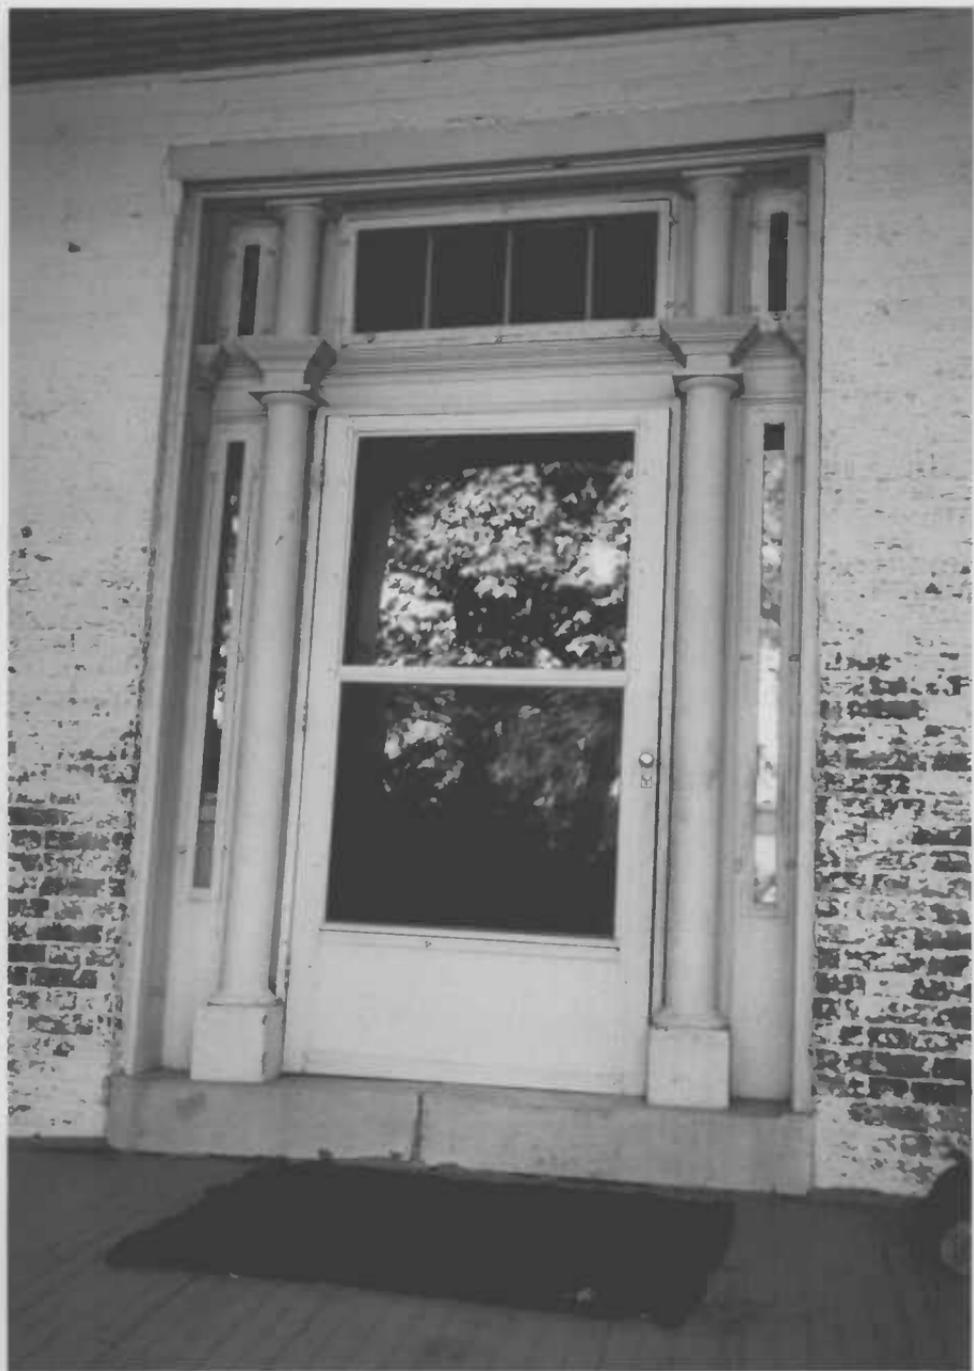
detail, main entrance

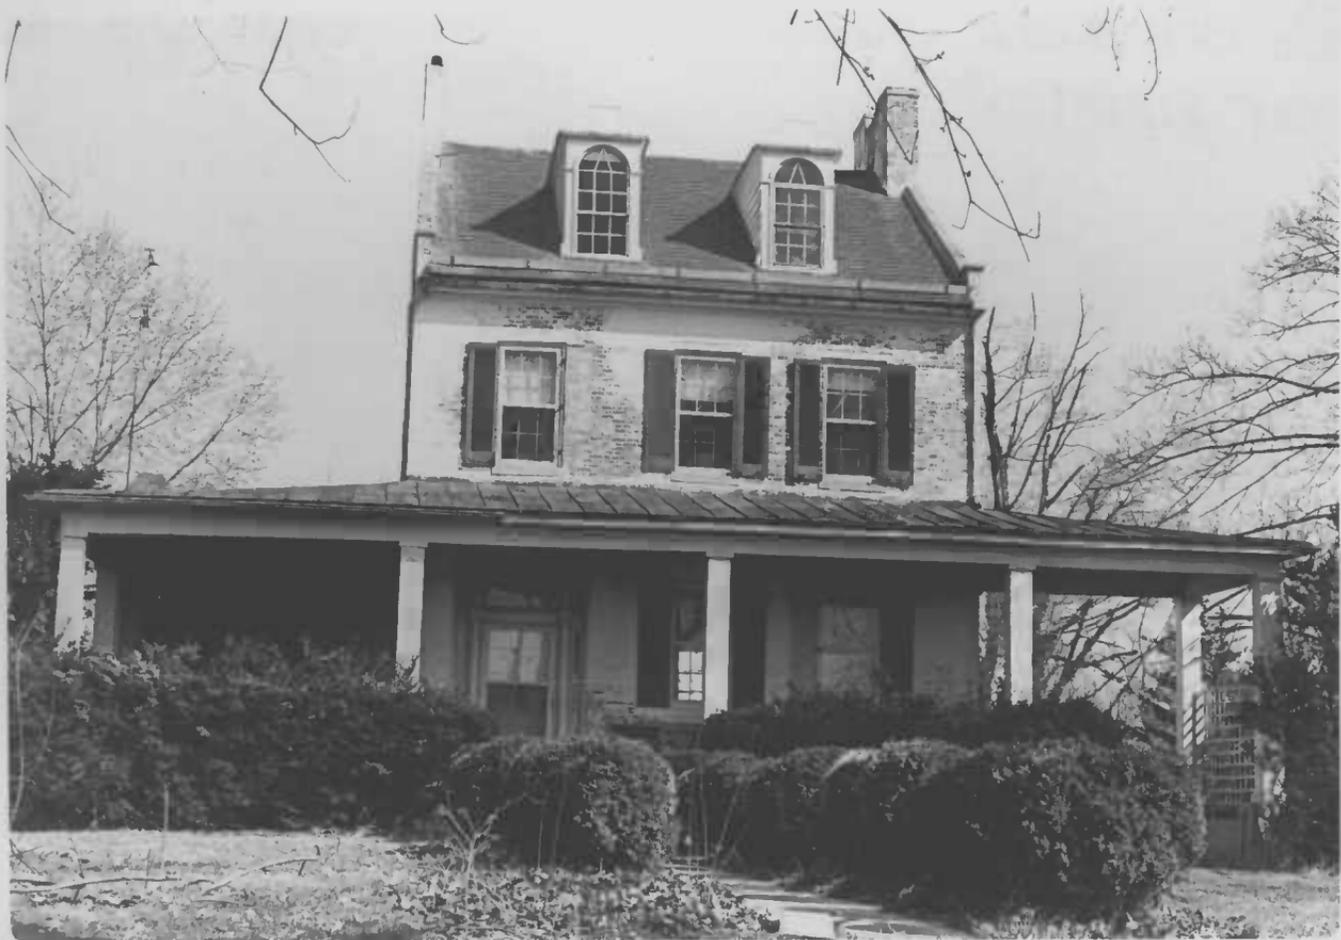
~~F-80~~ EDWARD HOWARD FARM
E/S BALLENGER CREEK PIKE
WEST ELEVATION
