F-4-51
Church Hill Survey District
Myersville
Frederick County

Maryland Historical Trust State Historic Sites Inventory Form

historic Church Hill Survey District

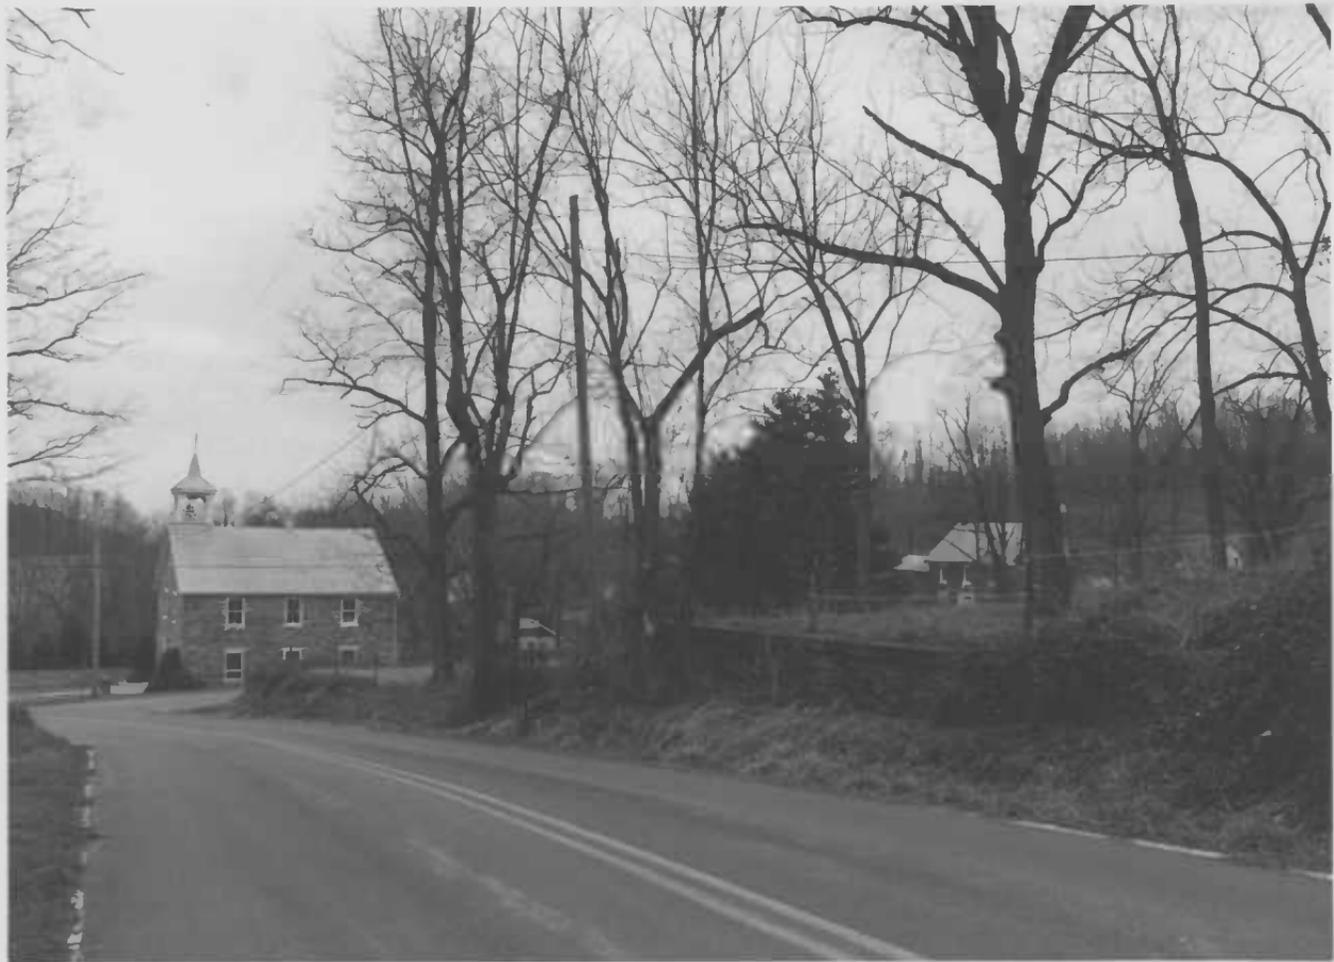
7/6

View south on Church Hill Road

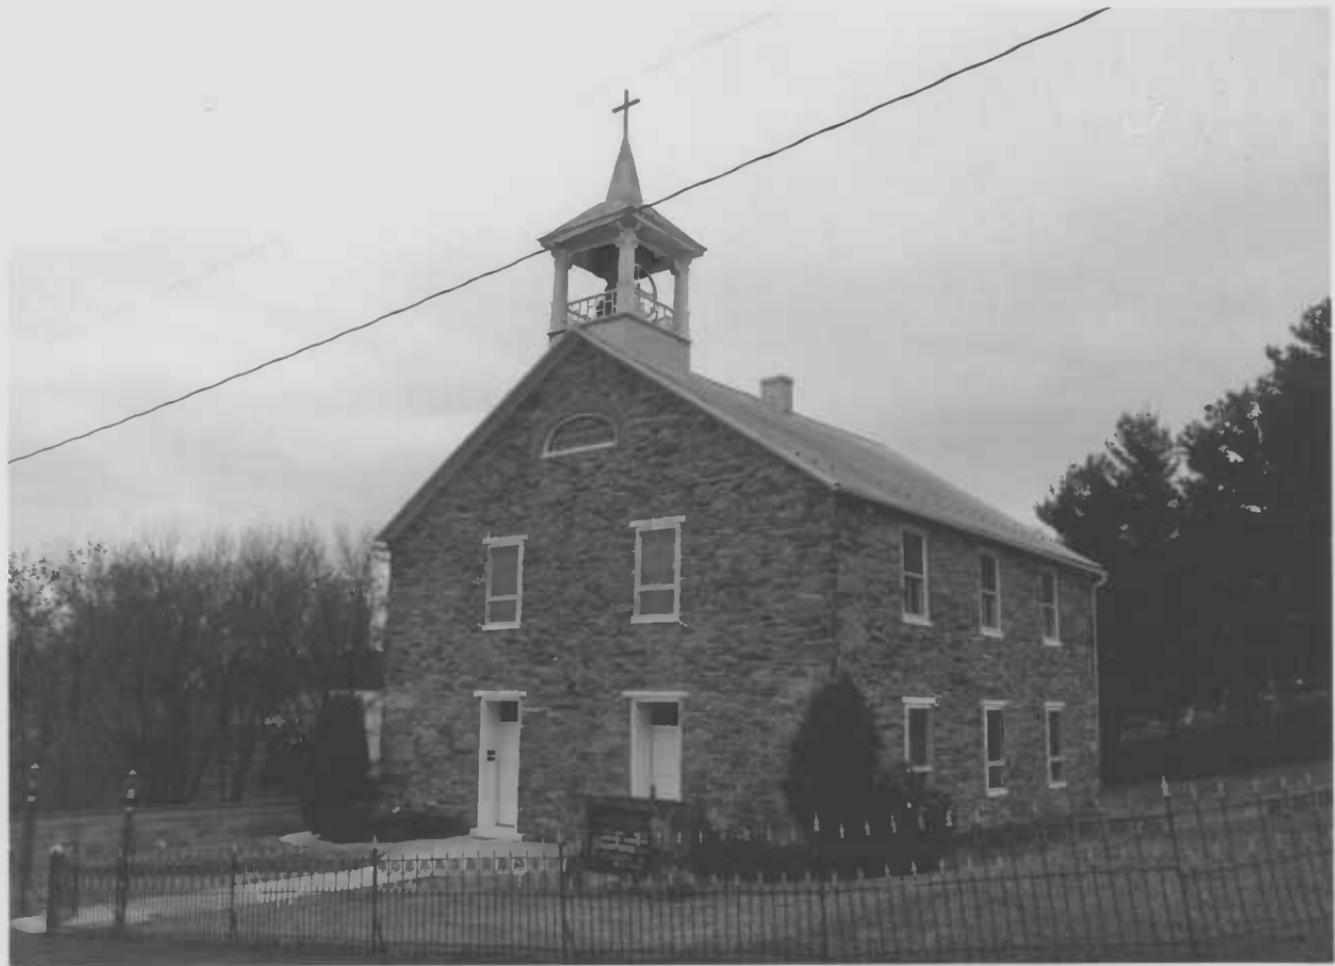
2/3

St. John's Lutheran Church, east elevation

St. John's Evangelical Lutheran Church: The 1830 church is a one-story fieldstone structure with a hall plan and a gable roof currently covered with pressed metal. The east elevation has two bays with recessed entrances in each bay. The soffits around the doorways are paneled and the doors have 5 horizontal panels. The rectangular transoms are stained glass of the early 20th century period. Two stained glass windows are located in each bay which light the gallery level of the interior. Centered in the gable is a brick-arched, semi-circular window with a leaded glass panel reading "St. John's Lutheran Church by the Sunday School". At the southeast corner of the building is a stone dated 1830. Above the east elevation is an open frame belfry added in 1895. The north and south elevations have three bays each. The south elevation has early 20th century stained glass rectangular windows. The north elevation windows are textured 2/2 sash. The west elevation has three bays of stained glass rectangular windows. An exterior brick chimney is located on the south elevation. A central brick chimney rises from the roof ridge, but may not be in current use. Located near the southwest corner of the building is a concrete block privy, one of the non-contributing buildings in the district. The church has an 1898 decorative cast iron fence on the east and north sides of the lot. The gate identifies the manufacturer as Ward Fence Co., Portland, Indiana. A concrete block fence is located along the south side of the church lot. The interior of the church was not accessible for survey, but local histories state that it had a three-sided gallery when built, an unusual feature for a small rural church of the period. The gallery may have been altered to provide space for a Sunday School and other alterations have also taken place.
