INDIVIDUAL PROPERTY/DISTRICT
MARYLAND HISTORICAL TRUST
INTERNAL NR-ELIGIBILITY REVIEW FORM

Property/District Name: Myersville Survey District _____ Survey Number: F-4-53

Project: Water appropriation permit for 3 Developments Agency: DNR/WRA

historic Myersville Survey District

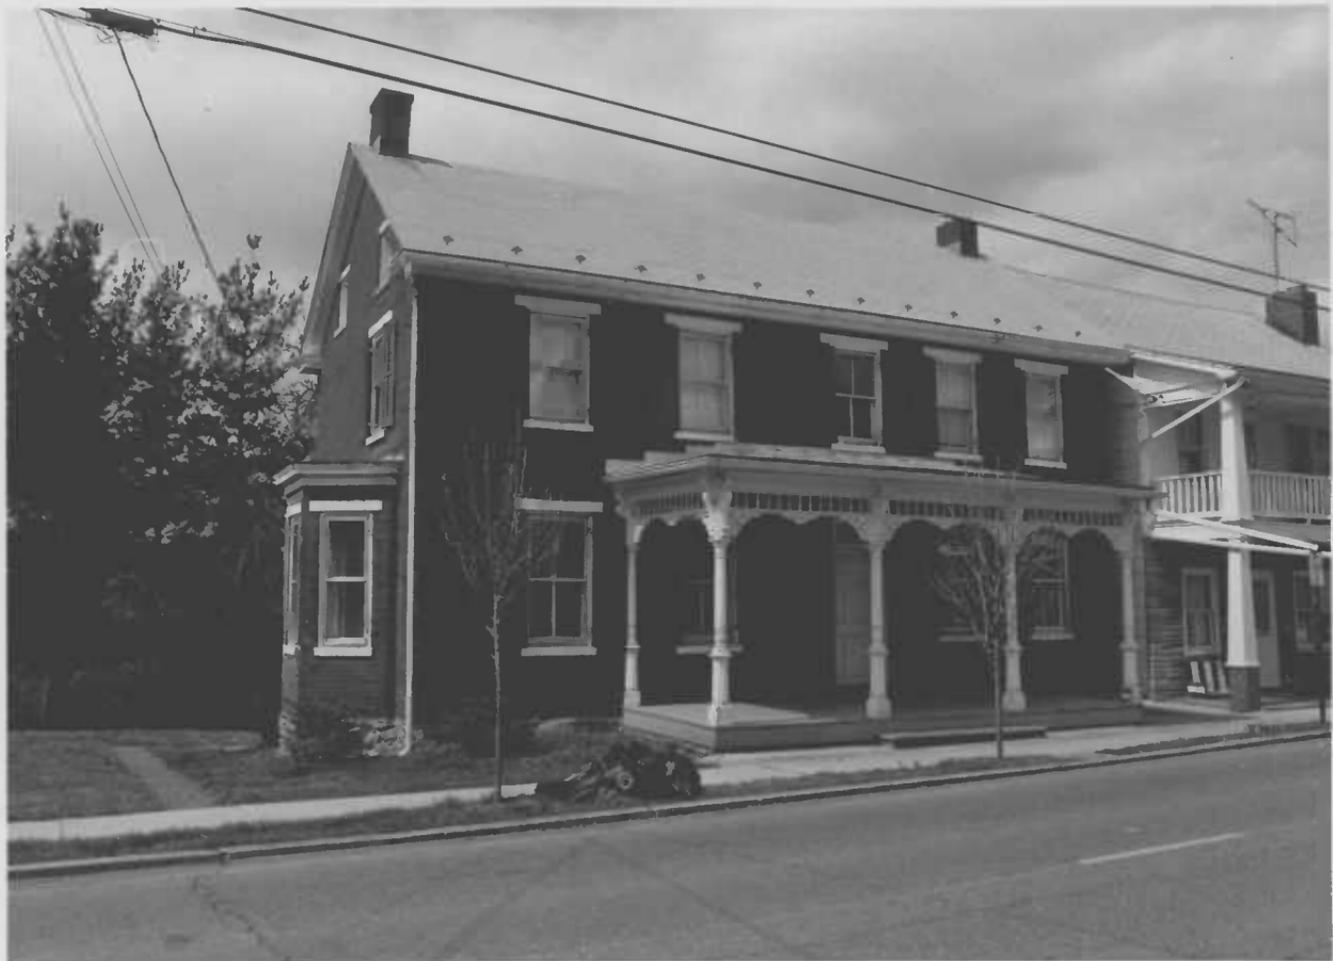
15/23

406 Main St. east elevation

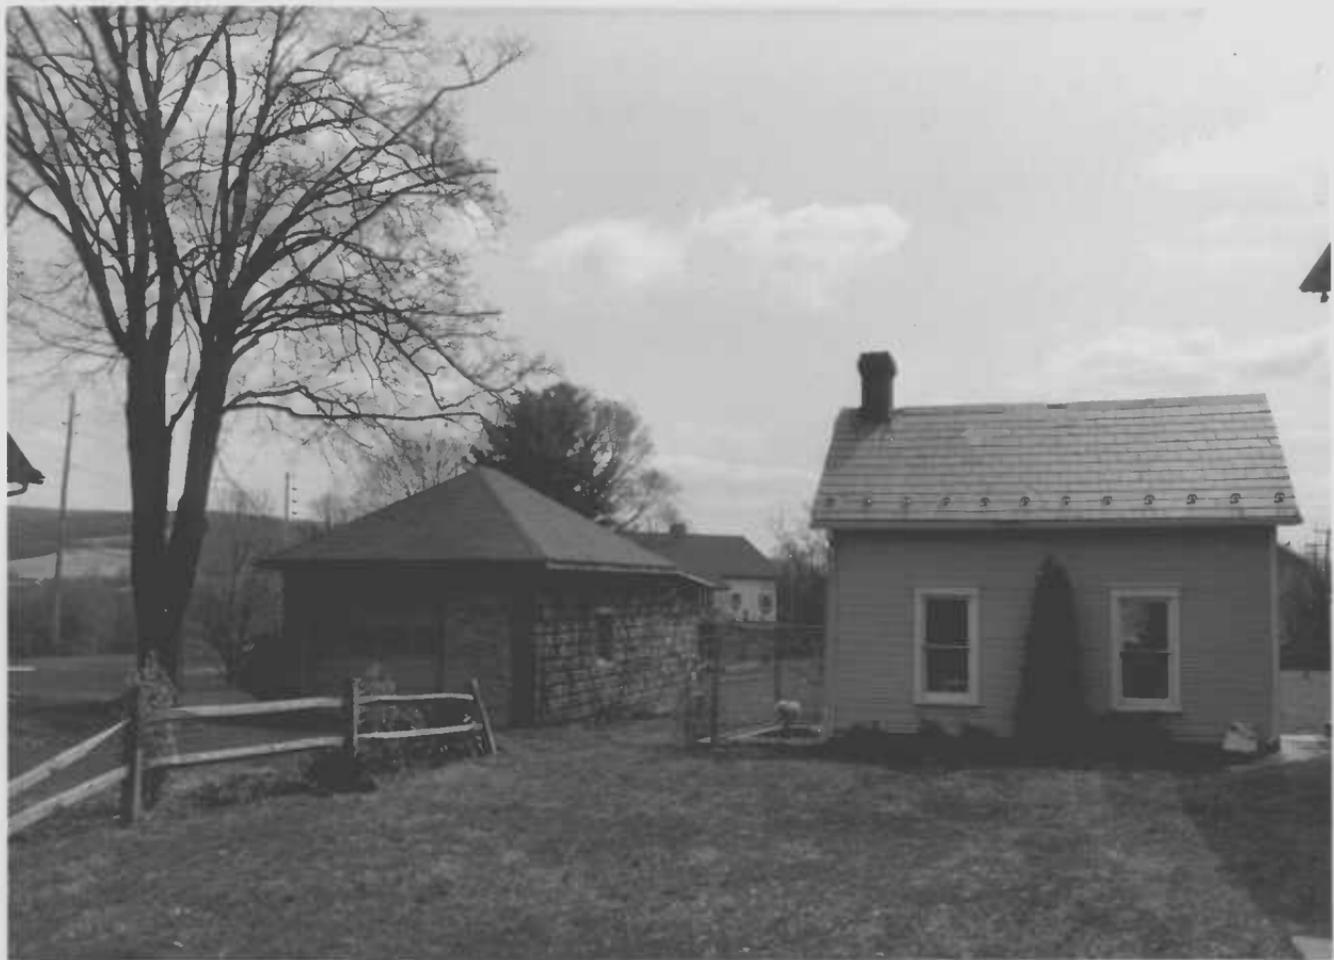
20/22

Footings: House, wash house, & barn,
view from west

Routzahn-Horine Farm, 513 Main St.: The dwelling house is a two-story brick house with a west elevation with four bays on the first story and three on the second story. Double entrances are located under a one-story porch with paired square piers and a dentil cornice. The windows are 6/6 with louvred shutters and gauged arches. The roof is pressed metal and the chimneys are located at the north and south gable ends. A two-story rear wing has a two-story porch on the south. The major outbuildings are a two-story brick wash house with a standing seam gable roof and 6/6 windows on each level. The west elevation has an extended gable over a modern exterior stair to the second story entrance. An exterior stone and brick chimney is located on the east gable end. A large frame bank barn has been much altered for use as a craft shop. It has windows placed in the vertical siding with shutters, an extension of the replacement roof over the entrance over the ramp, and a central chimney. The house was probably built about 1840-50. The wash house was used as a cabinet shop by Cyrus Routzahn in the late 19th century; he also made coffins here and served as an undertaker.
