INVENTORY FORM FOR STATE HISTORIC SITES SURVEY

HISTORIC **Brandenburg Store and House**
 AND/OR COMMON

STREET & NUMBER **12529 Fingerboard Road (MD 80)**
South Side of Route 80 **6th E D 9**
 CITY, TOWN _____ CONGRESSIONAL DISTRICT
 _____ VICINITY OF **Kemptown** **Frederick**
 STATE _____ COUNTY
 _____ **M 98 P102**

Survey No. F-7-41

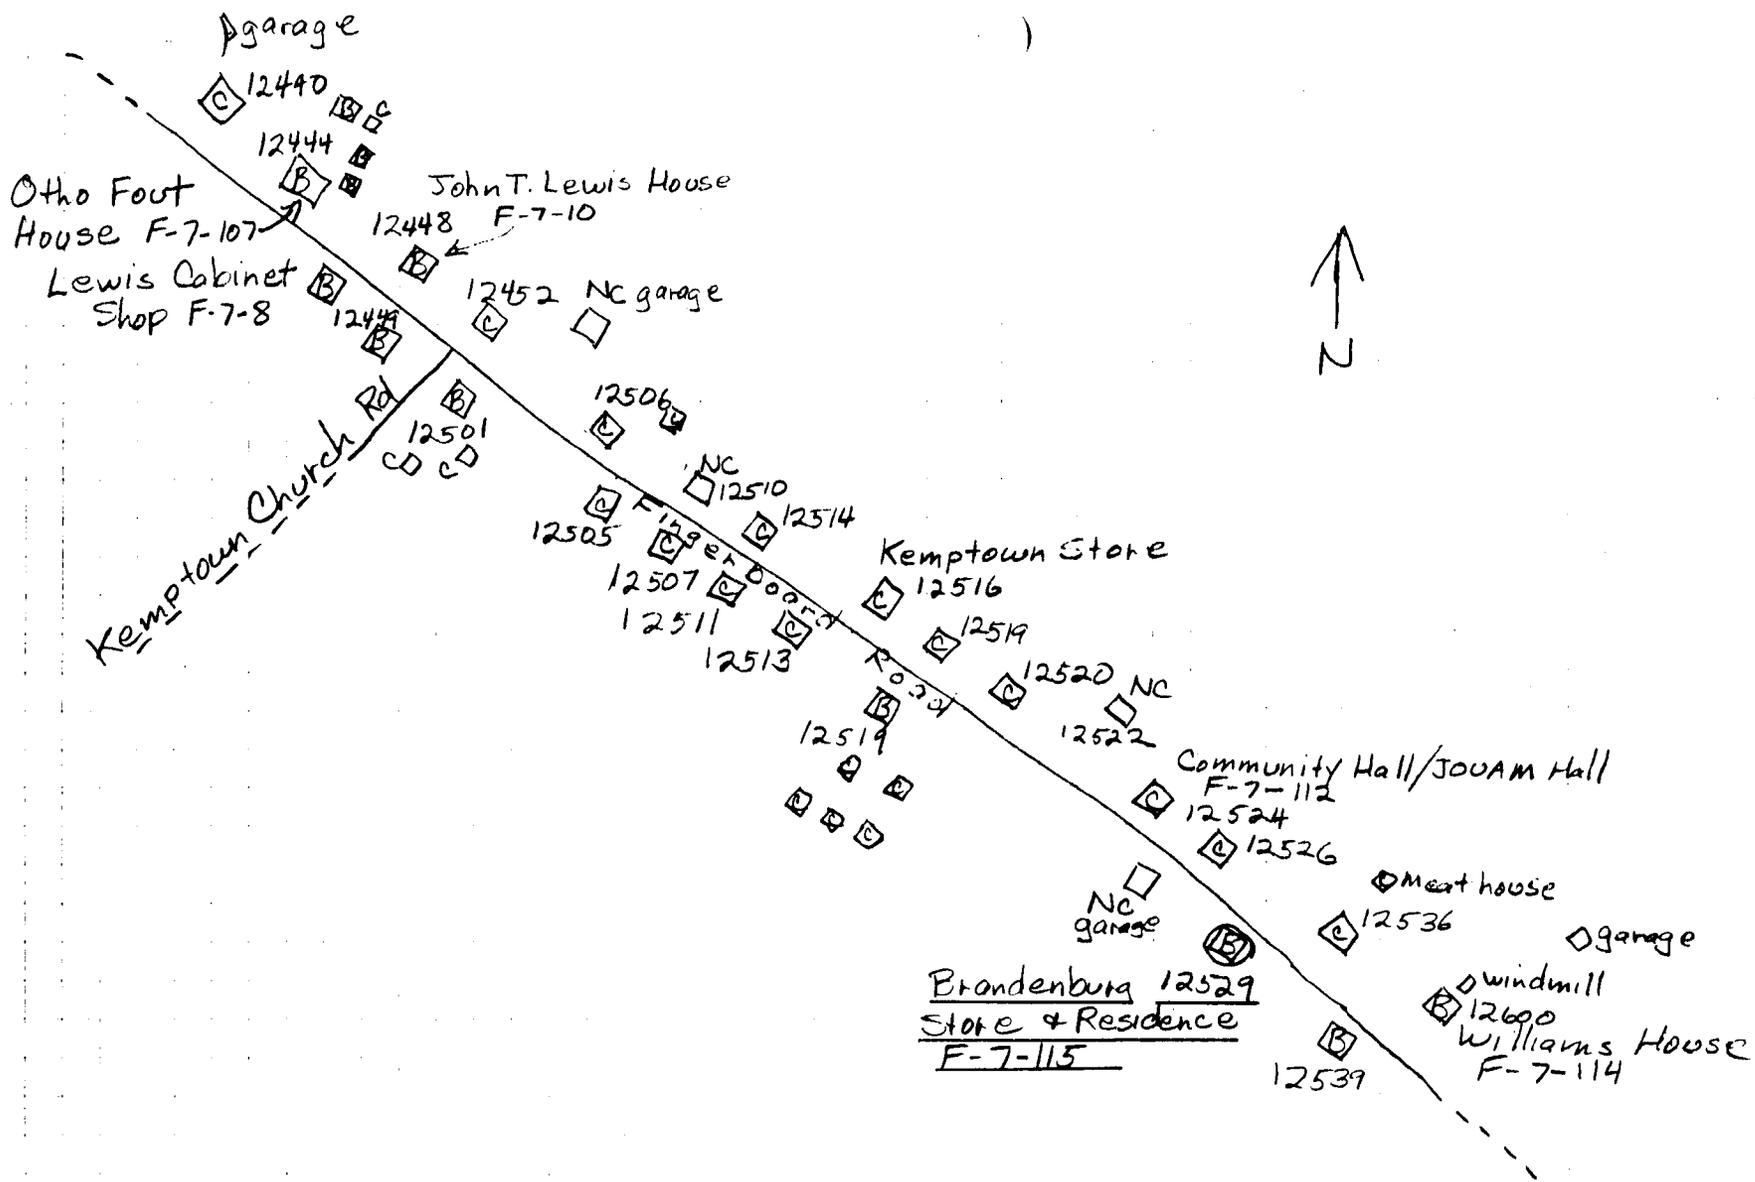
Brandenburg Store and Residence F-7-115

Brandenburg Store and Residence (F-7-115), 12529 Fingerboard: The two-story frame house with three bays and a cross gable has an adjoining flat-roofed two-story frame store building. Both sections have german siding and entry porches over the center entrance to each section. The windows are 2/2 and the gable of the house has a shingled face and dentil cornice with a central pointed arch window. The roof of the house is composition, with an off-center chimney. The doorway has a transom and sidelights and a four-panel door. The store section has three bays on the first story and two on the second. The door is a modern replacement, with a plain transom above. The dentil cornice of the house is repeated on the cornice of the store. The two parts were built about 1900, possibly by Oscar and Mary (Mollie) Brandenburg who operated the store until about the late 1930's.

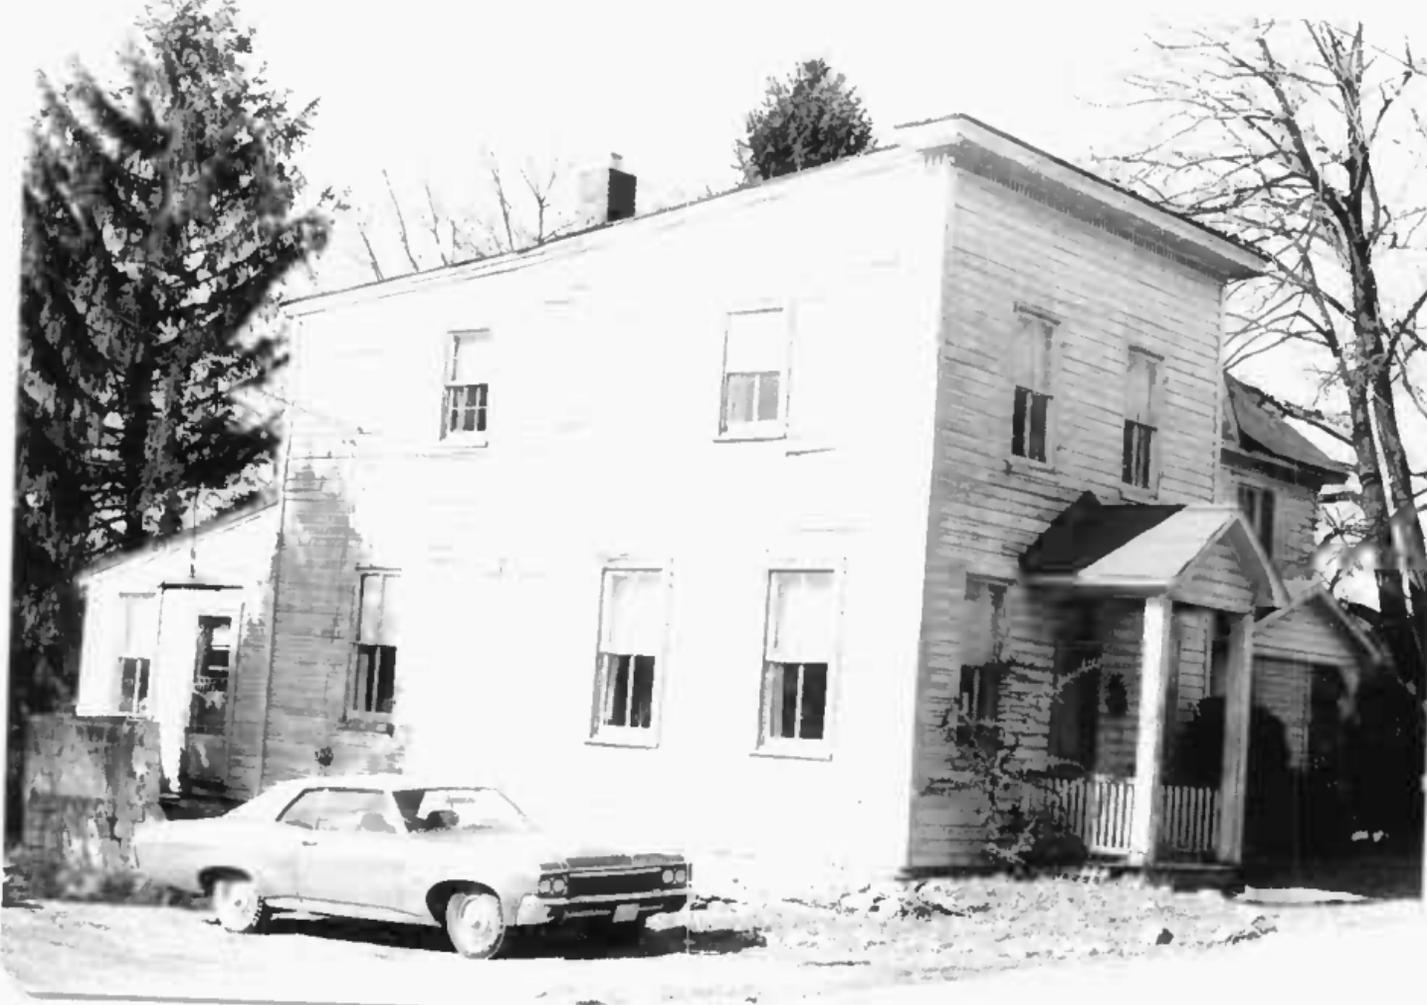
NE VIEW

The store, located to the northeast side of the house, is a two story shed roofed frame building, which is related to the Brandenburg House. The building is three bays wide, a modern door with entrance porch and railing is located in the second bay. Double hung 2/2 windows with plain trim occupy the first and third bays on the first level and both bays on the second level. The tin roof is completed with a plain cornice except on the north side of the building where the cornice is boxed with a decorate frieze. Three 2/2 windows with plain trim occupy the first level on the east side, two identical windows are located on the second level. A frame shed addition two bays wide and deep is located to the rear of the store on the south side. One 2/2 window with plain trim is located on the first and second level on the west side of the store. The building is constructed on a low random stone foundation. One replaced brick chimney is located to the center rear of the store.

The principle facade is three bays wide. The main entrance, a four panel door with screen door is located in the second bay. A wide pedimented entrance porch situated between the first and third bays extends from the front of the building. Two 2/2 windows with plain trim are located in the first and third bays. Shutters, probably louvered and similar to the one remaining example on the second level were once attached to the windows but are now missing. Three 2/2 windows occupy the second level; one louvered shutter remains on the window in the third bay.

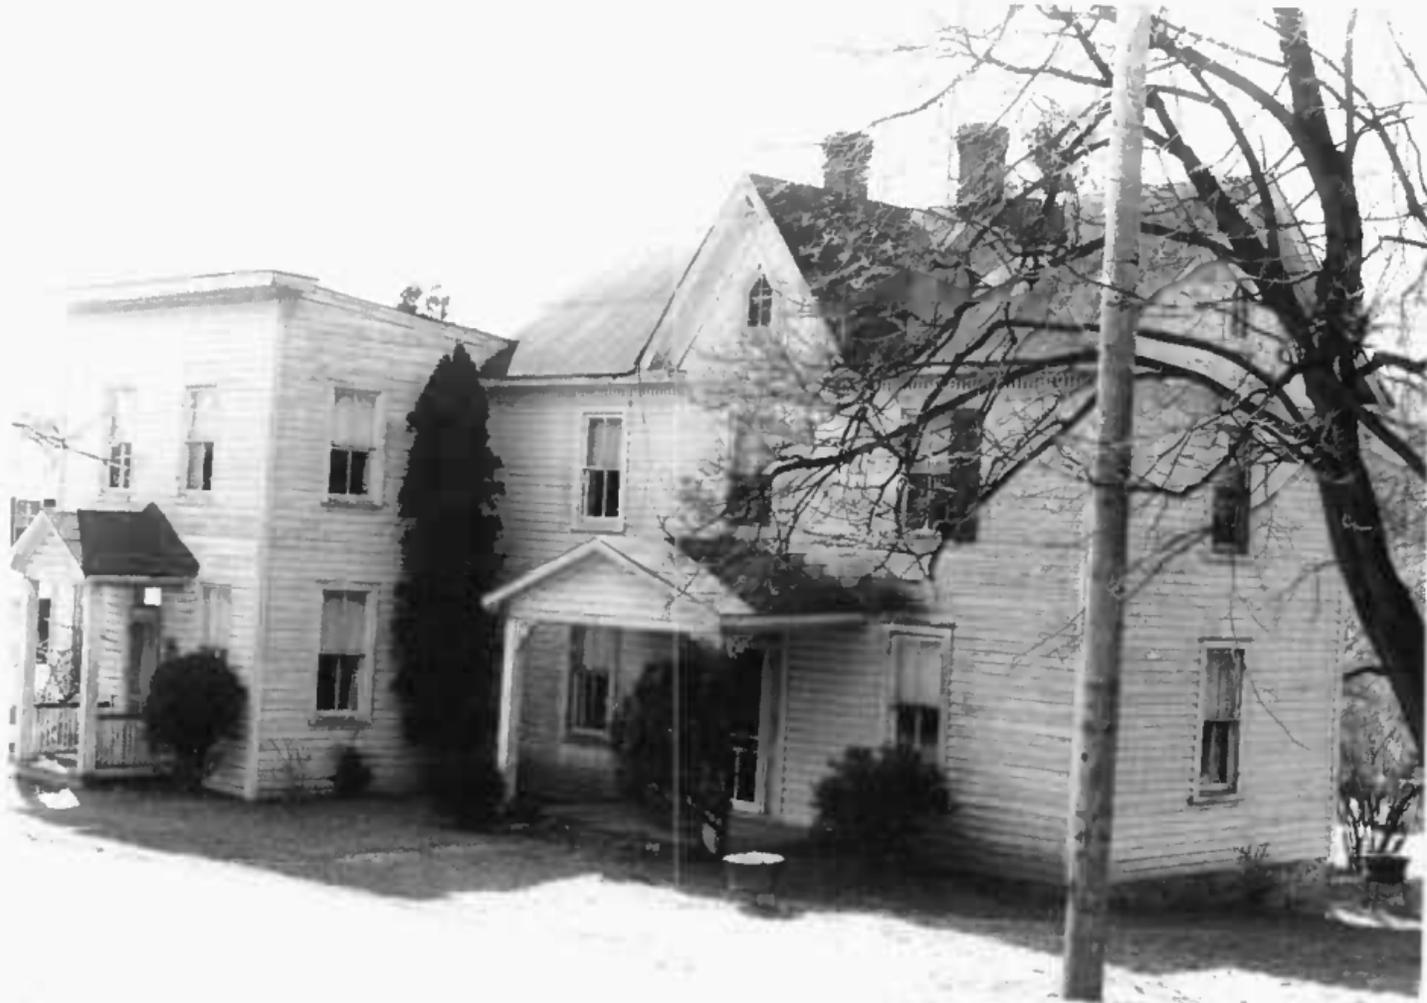
NW VIEW

The Brandenburg House is a rectangular 2½ story frame center gabled single ownership residence which is related spatially to other residences on the street and faces north from the south side of Route 80.

A small triangular window is located in the center gable. The replaced tin roof is finished with a boxed cornice with return and denticulated frieze. Two corbeled brick chimneys are located on either side of the center gable. A 2/2 window is located on each level of the west side. A small triangular window is located in the center of the side gable. Alternate rows of shingle siding with staggered butts are located in the top of each gable on the house. The southside of the building is three bays wide; two 2/2 windows with plain trim occupy the first and second bays from the southwest corner and an original frame shed addition extends from the rear. A 2/2 window is located on the south side of this addition and a modern cinder block porch juts out from the west side. A six foot brick chimney rises from the southeast corner. The house is built on a low random stone foundation and is in a fair state of repair. A large open yard lies to the south side of the building.
