Maryland Historical Trust State Historic Sites Inventory Form

historic McMurry House

Survey No. F 8-31

The following is a description of the nine buildings included in the McMurry Farmstead. These descriptions are keyed to the accompanying site plan.

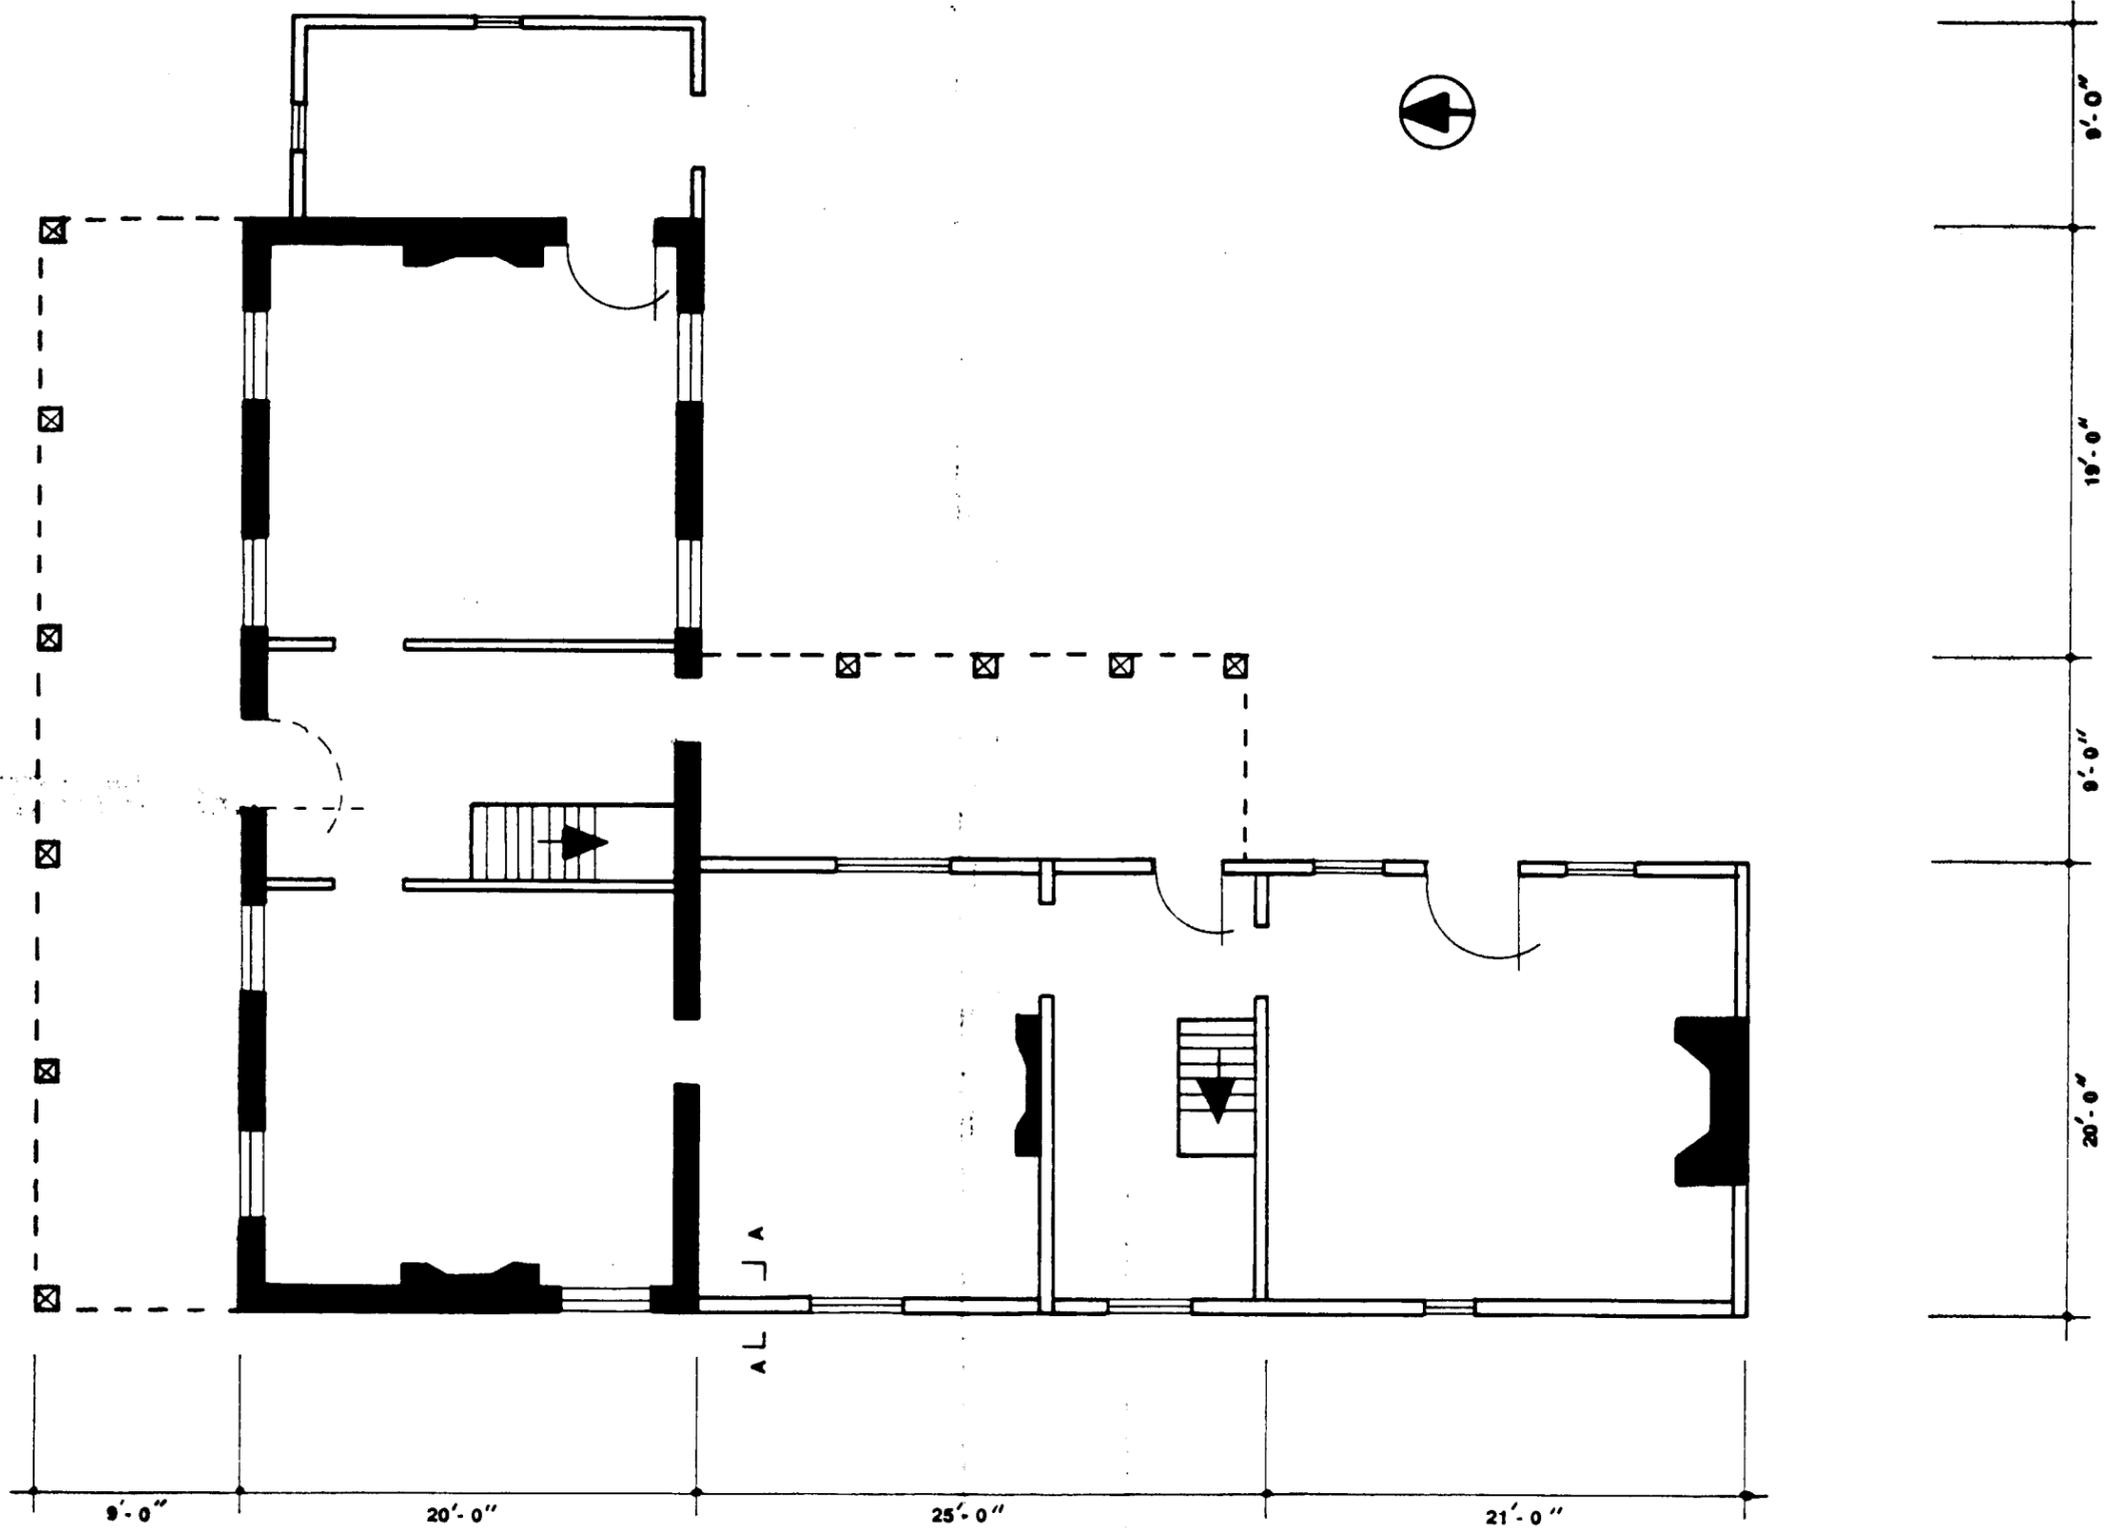
A two-and-one-half story log hyphen (ca. 1870) connected the original log dwelling with the brick house. This two-bay hyphen employed a log and post structural system in which squared wall logs were keyed to corner posts through a mortise and tenon system. These mortise and tenon joints were secured

by massive iron spikes. A drawing detail of this construction is included with this documentation. The corner posts of the east and west walls abutted both the brick house and the original log dwelling. As a consequence, no north and south walls were constructed as part of the hyphen. As in the case of the original log dwelling, the exterior wall planes of the hyphen were faced in siding. An interior brick chimney with a straight stack divided the two-room plan. The interior finishes of the building were simple plaster applied to vertical lath. Wall planes were accented by simple moldings. An open two-story gallery spanned the east elevation of the hyphen. The interior wall planes of this porch were plastered.

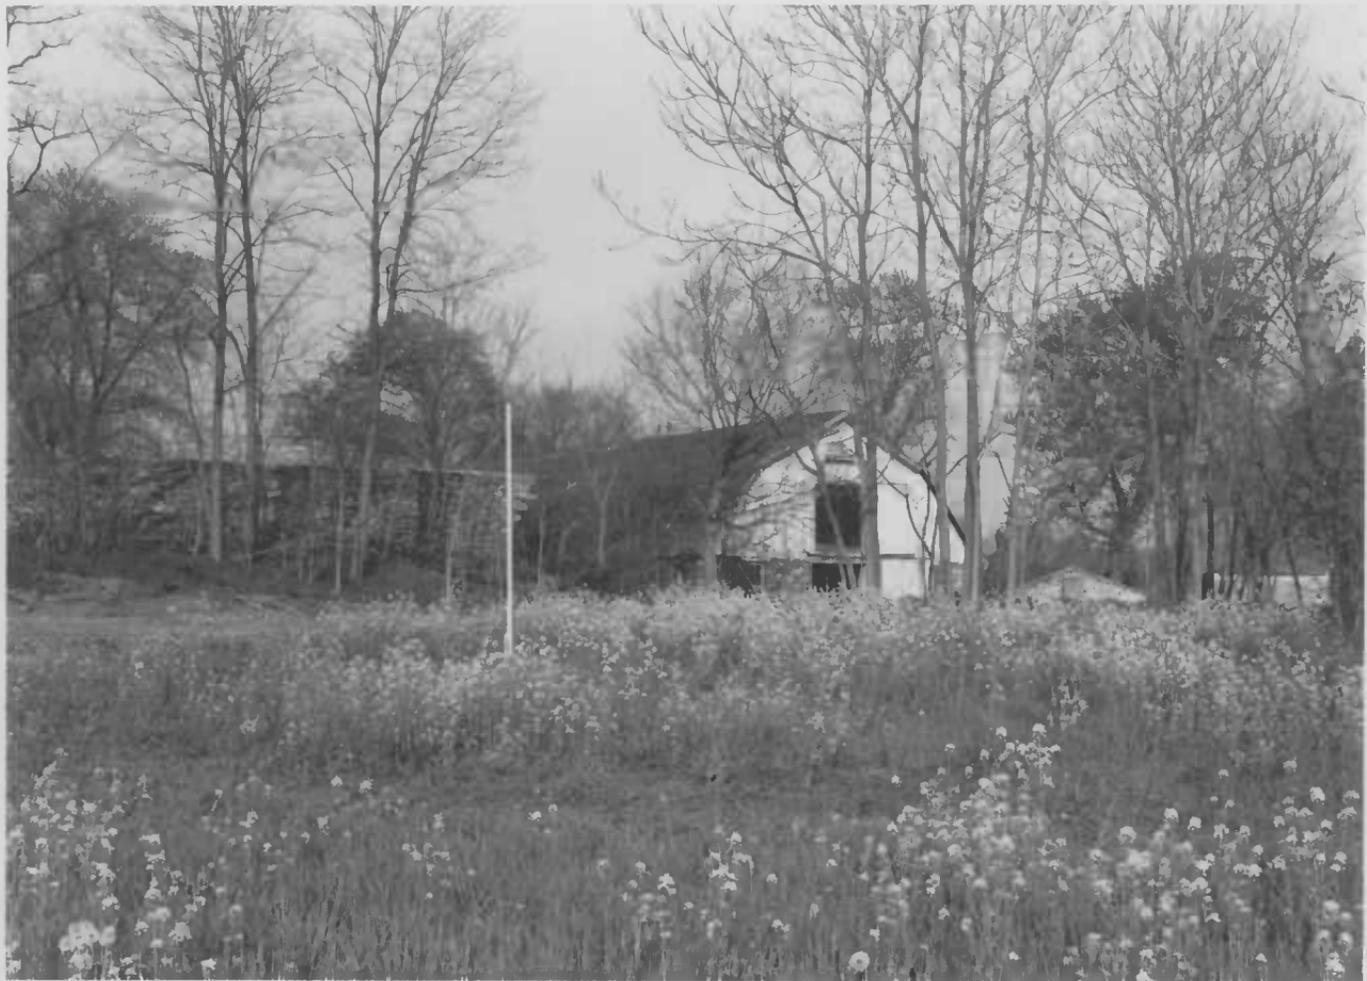
16 of 24

- 16 OF 24 VIEW SOUTHEAST LOOKING AT NORTHWEST AND SOUTHWEST ELEVATIONS,
DAIRY BARN
- 17 OF 24 VIEW SOUTHEAST LOOKING AT NORTHWEST ELEVATION, DAIRY BARN
- 18 OF 24 VIEW NORTHWEST LOOKING AT SOUTHEAST ELEVATION, DAIRY BARN
- 19 OF 24 DETAIL, INTERIOR MAIN FLOOR DAIRY BARN LOOKING SOUTHWEST
- 20 OF 24 DETAIL, INTERIOR DAIRY BARN LOFT LOOKING SOUTHWEST
- 21 OF 24 VIEW WEST LOOKING AT EAST ELEVATIONS, ICE HOUSE & DAIRY
- 22 OF 24 VIEW EAST LOOKING AT WEST ELEVATIONS, DAIRY & ICE HOUSE
- 23 OF 24 VIEW SOUTH LOOKING AT NORTH ELEVATION, DAIRY
- 24 OF 24 VIEW NORTH LOOKING AT SOUTH ELEVATION, ICE HOUSE
