G-II-B-080
Dillon Farm
Cove
Private

INVENTORY FORM FOR STATE HISTORIC SITES SURVEY

Dillon Farm

G-II-B-080
 SITE PLAN - NOT TO SCALE
 (DOTTED LINES SHOW SITES OF
 FORMER STRUCTURES)

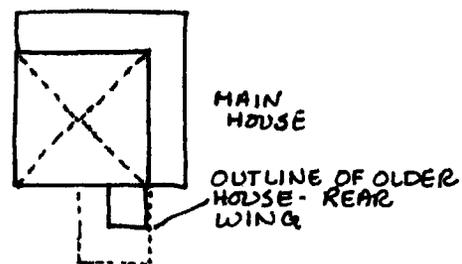
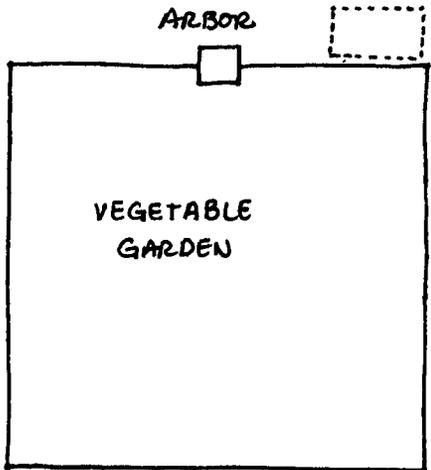
The site also contains a gable-roofed frame bank barn, built 1918 and used as a garage, a frame smoke house later used as a chicken house and now used for storage, a frame pigpen also now used for storage, a kennel, a modern greenhouse, and a frame storage building. The property also contains a large vegetable garden and many flower beds.

According to the owners, at one time the site included, in addition to the extant farm buildings, a coal house, corncrib, and a grist mill, all of which have been demolished.

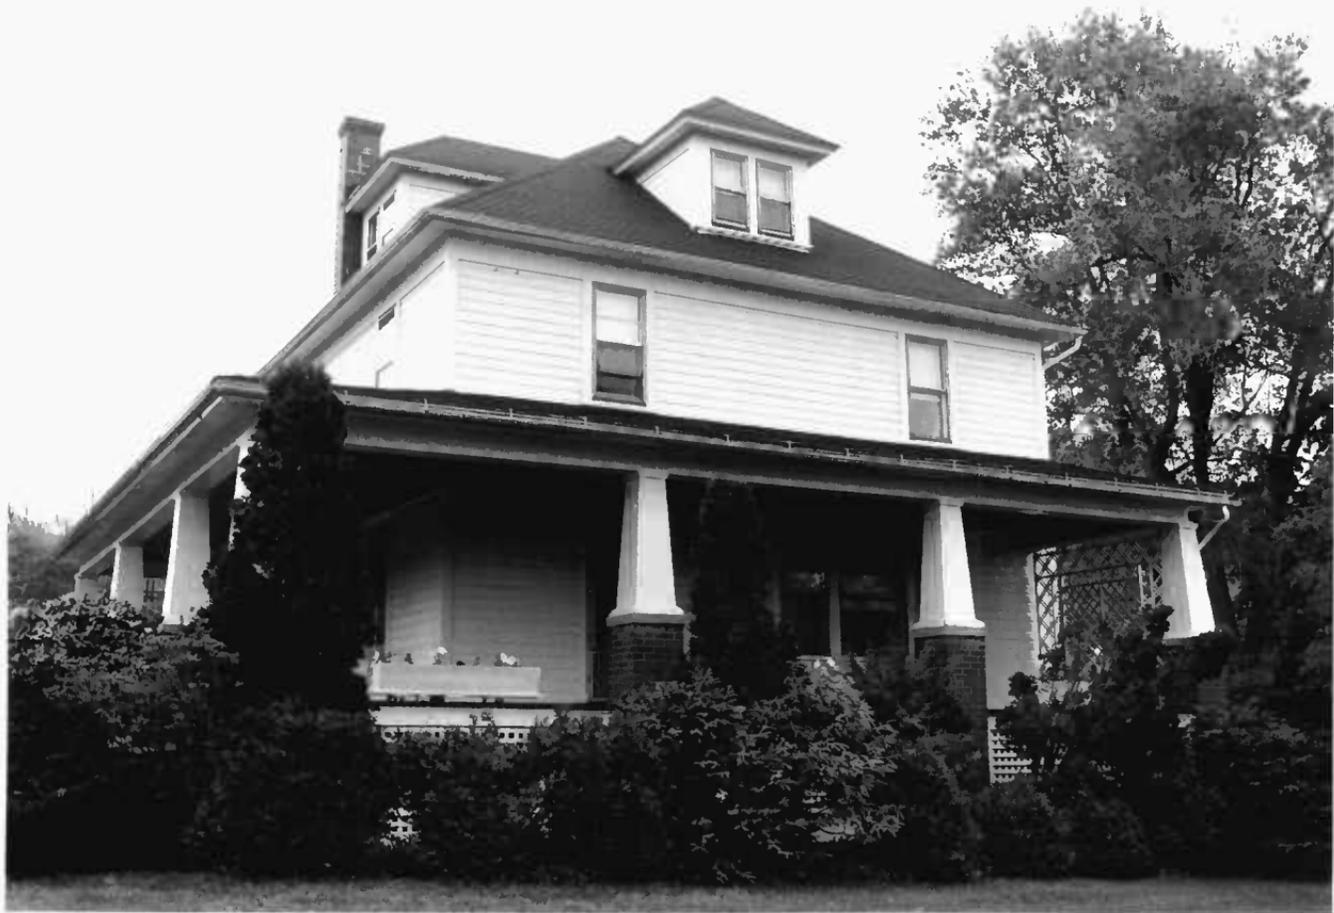
N elev.; Facade-W elev.

The house is a square-plan, two-story, two-bay by two-bay dwelling with an asymmetrical facade. The facade points west. A one-story, hipped-roofed porch covers the north and west elevations and a one-story storm-porch shelters a door on the north end of the elevation. A one-story, three-sided, hipped-roofed bay projects from the east end of the south elevation on the first floor.

The house rests on a poured concrete foundation which is laid on the coursed stone foundation of a previous dwelling. The walls are covered with white German siding. The windows are one over one sash and have plain board surrounds. The first floor facade, south of center, is a triple window. North of center is the facade door, which has a rectangular transom. The pyramid roof has two-windowed, hipped-roofed dormers on its N, W, & S faces. All roof surfaces are covered with asphalt shingles.

The house has one brick stove chimney on the north face of the roof. The porch roof is supported by square, tapering pillars set on brick pedestals. The interior of the house is unknown.

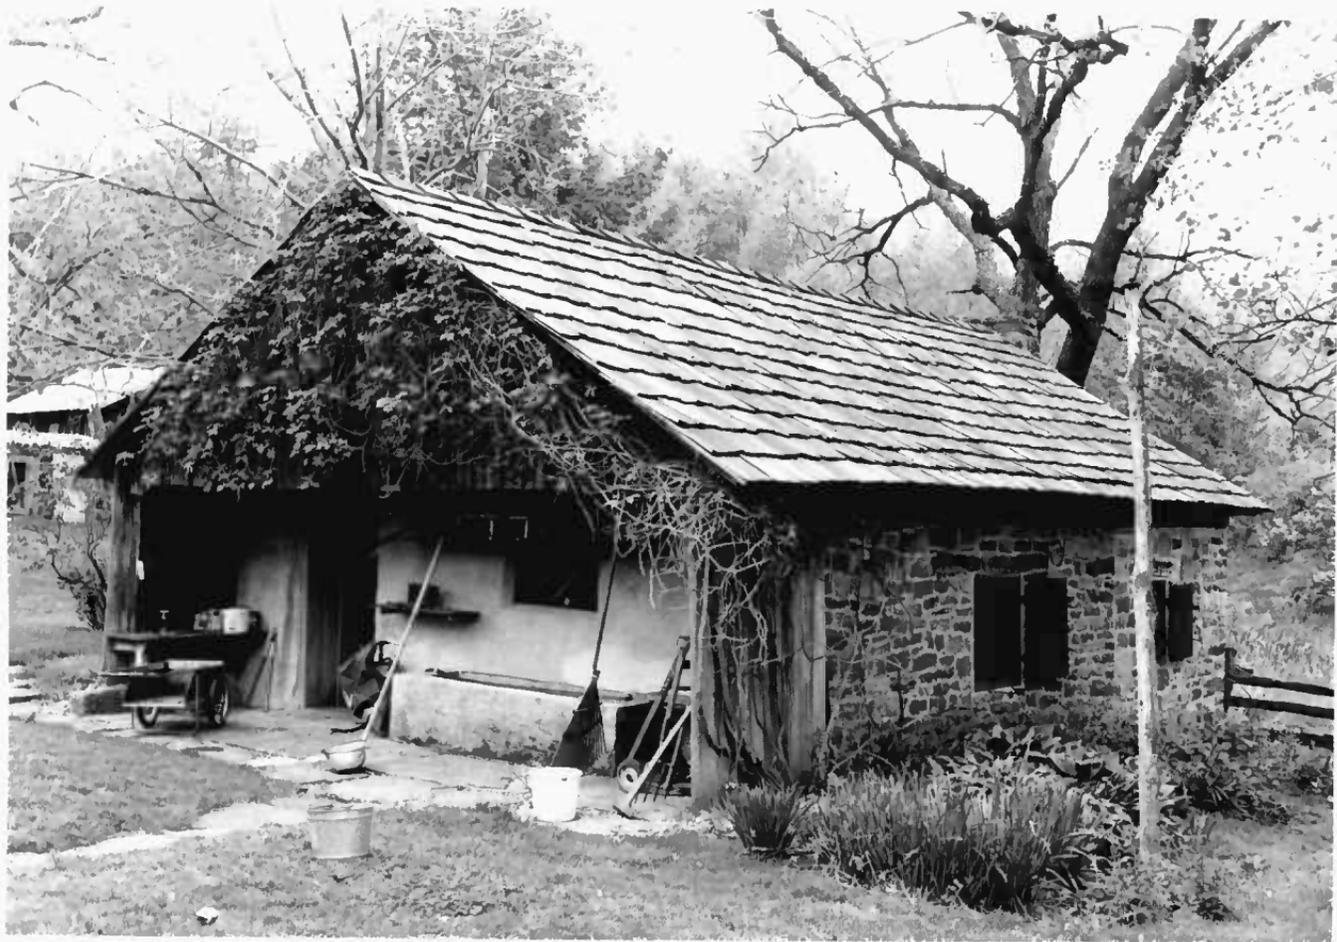
Springhouse/Washhs. N&W elevs.

Southeast of the house is a one-story combination springhouse/washhouse. The N, E, & S walls are constructed of roughly squared and coursed stone, while the west wall or facade is faced in new cement. The gable roof is covered with wood shingles, and the gables are vertical boards. Windows are square nine-light casements covered on the exterior with wooden diagonal lattices and wooden board casement shutters. The entrance, to the south of center on the west elevation, has a board door. North of center on the west elevation is a rebuilt trough which contains the spring water and feeds it to a rebuilt L-shaped trough on the W & N walls of the cooling room. On the E wall of the springhouse is a large exterior fieldstone chimney which serves the washhouse fireplace.

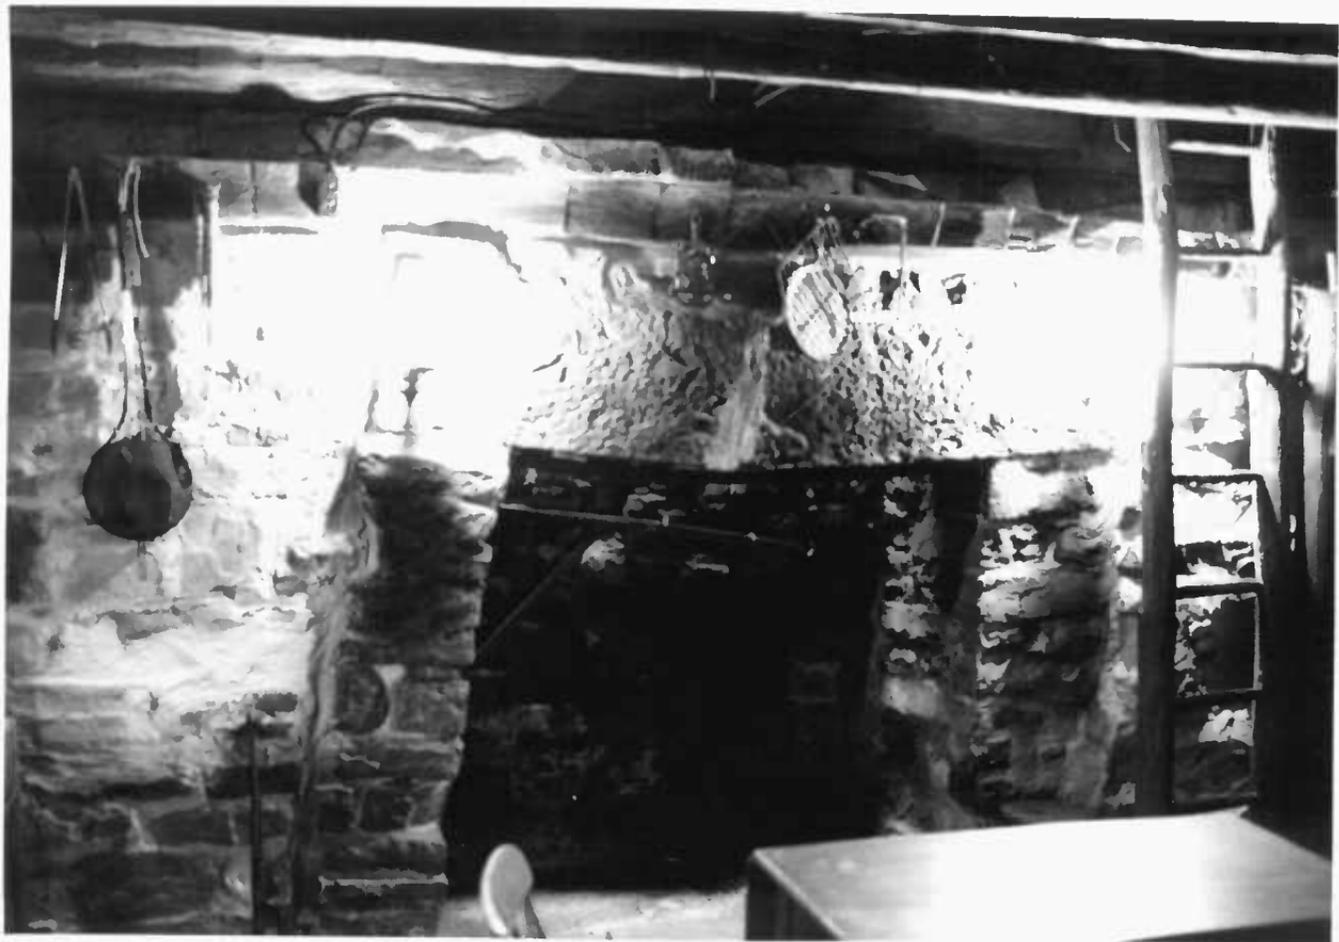
Washhs. fireplace, S wall

The interior of this building is divided into two rooms: cooling room to the W, washroom to the east. The rooms were originally divided by a board partition, which the current owners have replaced with a stone wall. The floors are stone. The stone-lined fireplace in the washroom has the original lintel, how cracked and mended, and its original iron crane and wash pot. A dutch door in the south wall of the washroom opens to the outside. In the washroom the hand hewn rafters are still visible, while in the cooling room they have been covered with a board ceiling. According to the current owners, this building was originally two stories tall, with a carpentry shop in the frame second floor. This shop burned, and the roof was simply placed on the stone first floor.
