G-II-C-332

Henry Wagner Farm  
Grantsville  
Private

INVENTORY FORM FOR STATE HISTORIC SITES SURVEY

Henry Wagner Farm

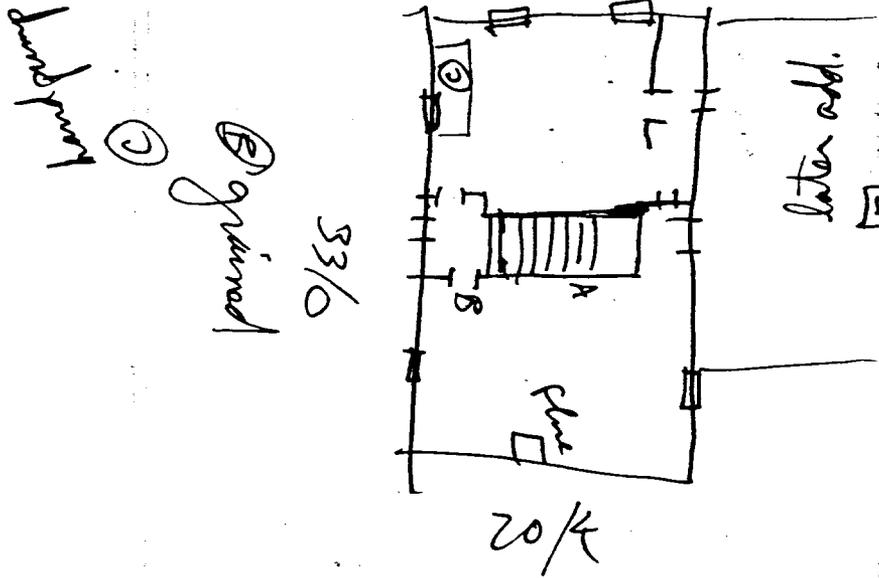
wire nail

planks 2" x 10" - 1/1  
 sill continued to support porch floor

A. plain chain rail & base bd.

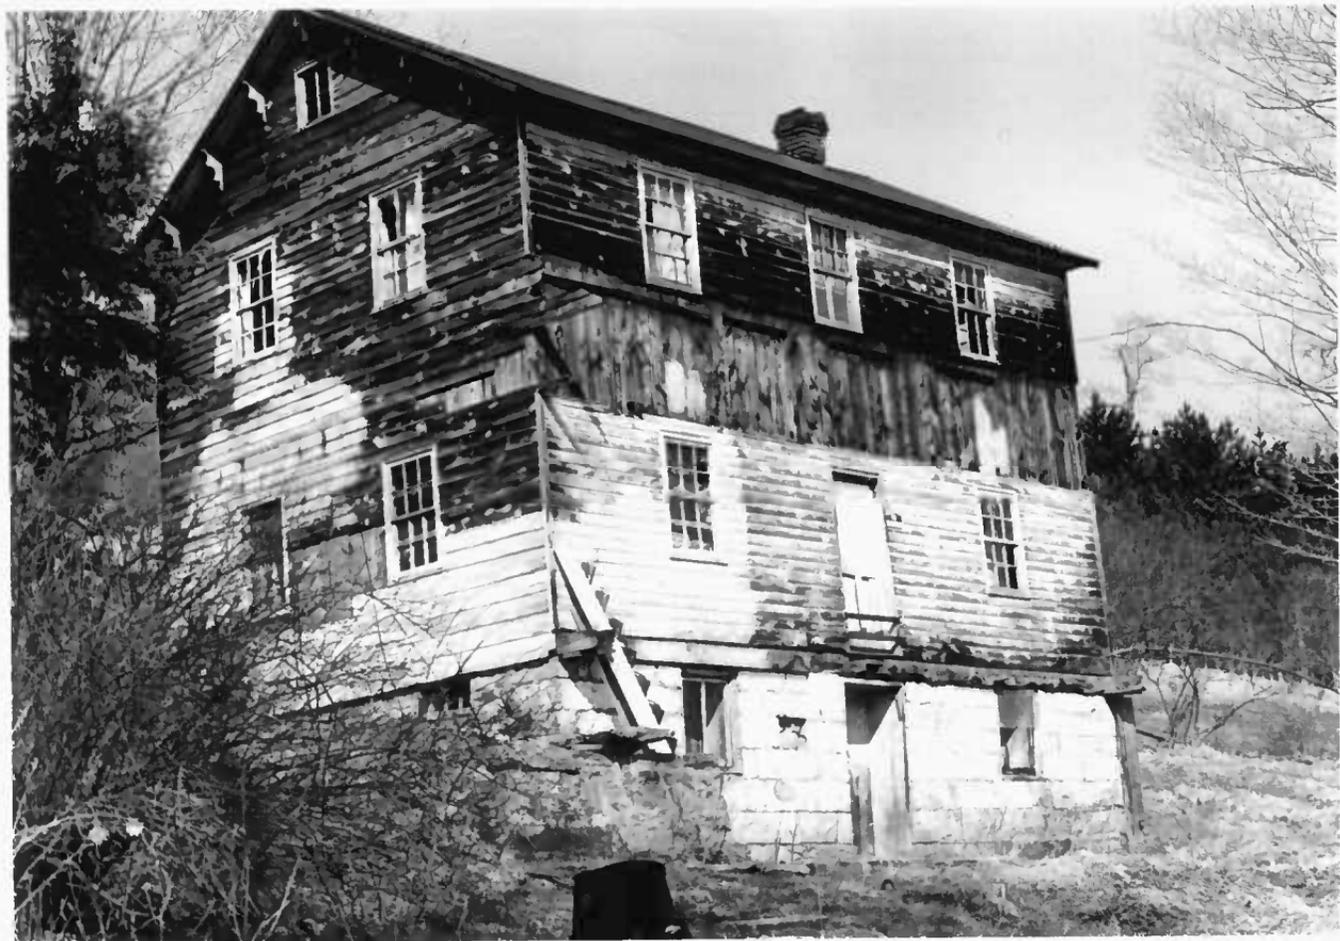
W & S elevation

The south-facing vertical-plank farmhouse measures three bays wide by two bays deep. A rear ell and a front porch have been removed. The gabled structure's facade includes a central entrance containing a four panel door. The exposed coursed ashlar cellar on this side also features a central entrance, in which a batten door appears. Two entrances containing tapered, beveled batten doors occupy the two westernmost bays on the rear. 6/6 sash windows framed in narrow boards light the house. Either end of the attic is lit by a four-pane window. Two-pane windows appear in the cellar.

Corrugated sheet metal covers the roof. Jigsaw brackets support the eaves. The walls are sheathed in tongue and groove lapped weatherboards.

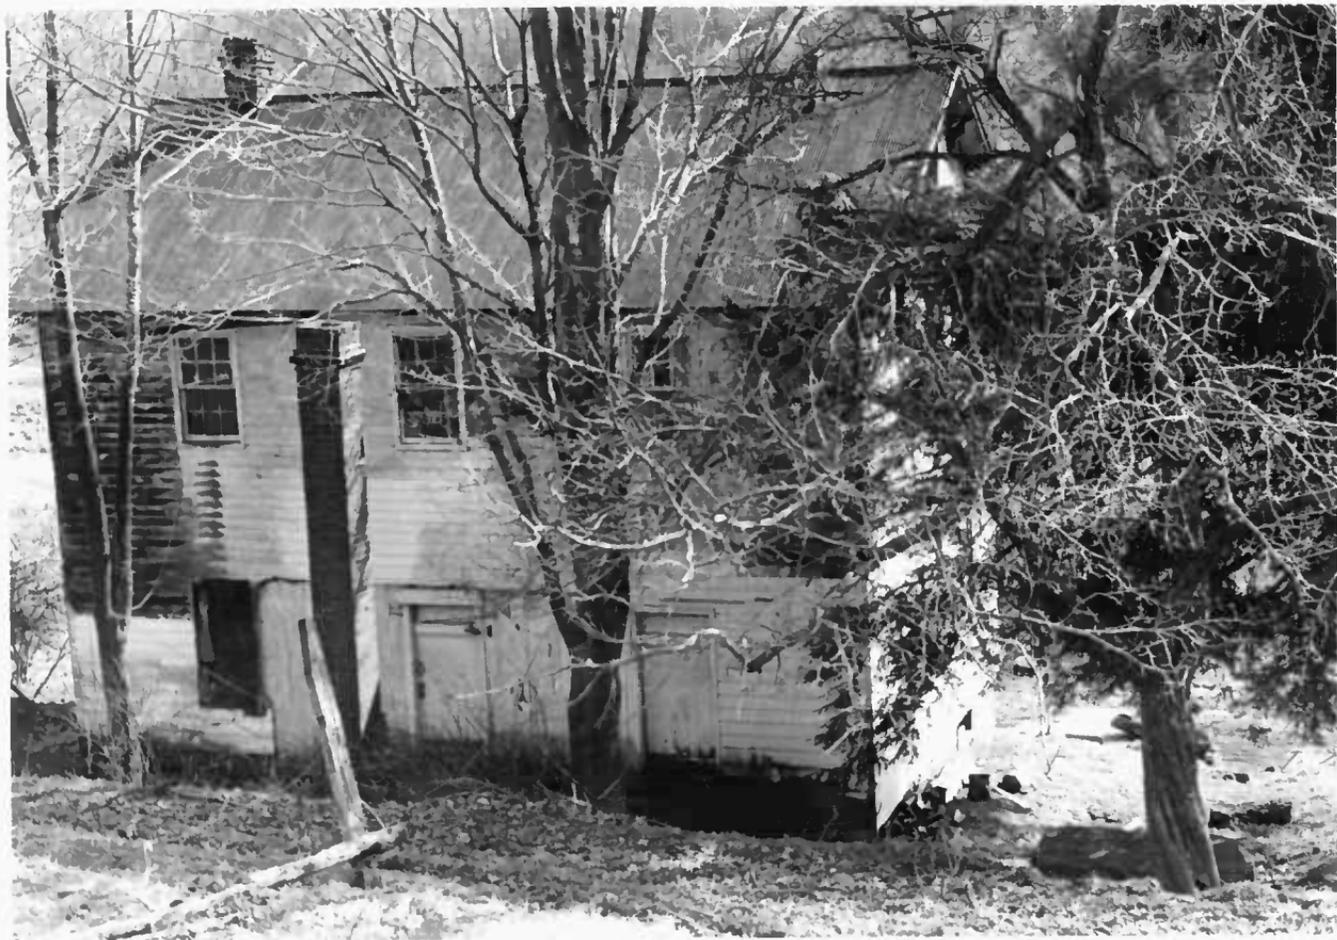
N & W elevation

An interior brick chimney heats the east end. A stove pipe is located at the west end.

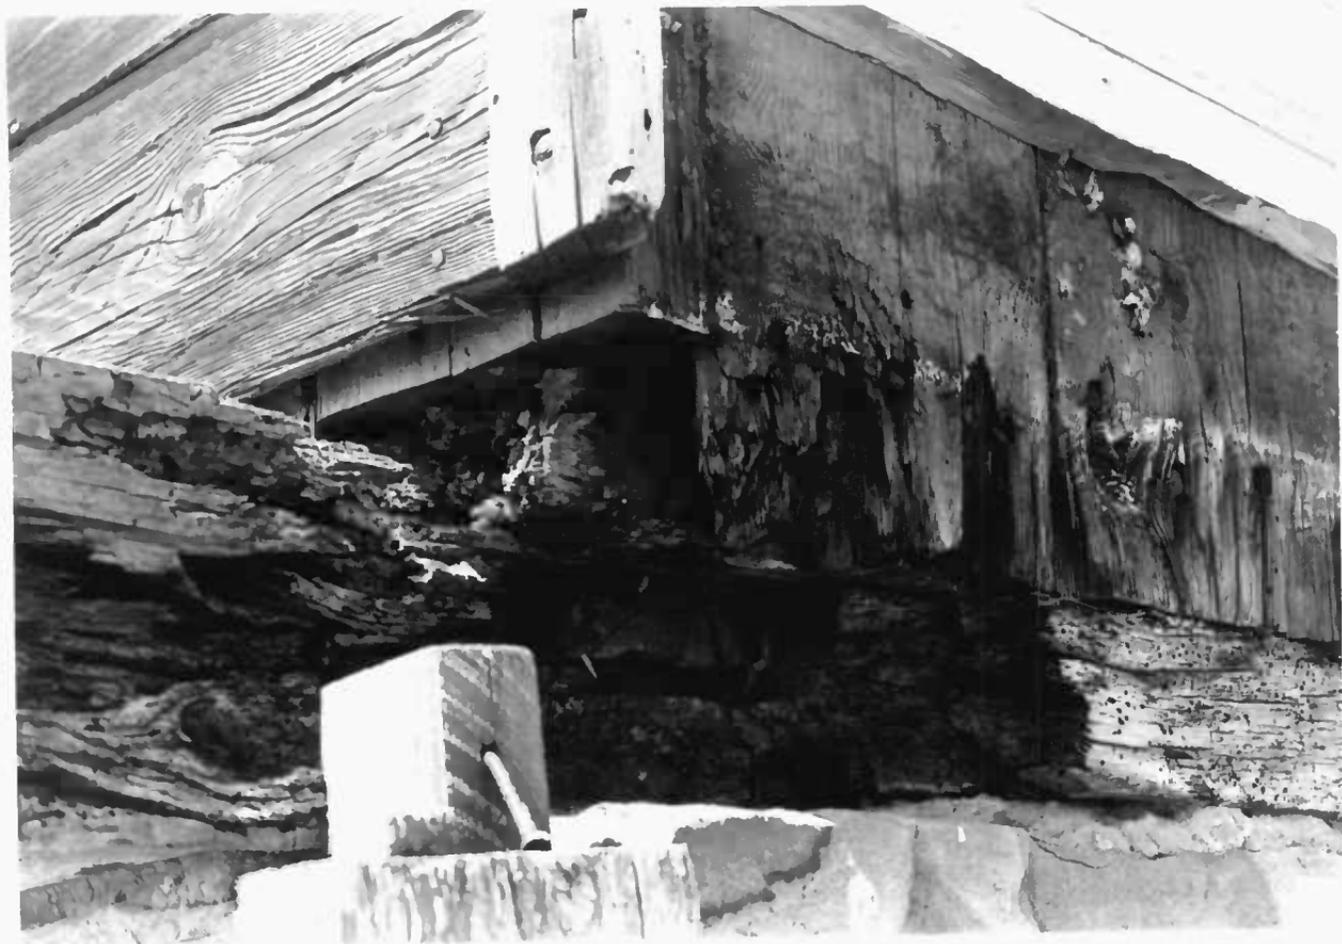
Construction SE corner

This building is constructed with 2" thick by 10" - 1'1" wide vertical planks, which appear to be pine. The 8" by 12" hewn sills are rabbeted to receive the planks, which are nailed into the 4" sill ledge with cast iron spikes. The sill extension now broken off, originally provided support for the southern porch. Wire nails hold the weatherboards. The corner boards are fastened with cast iron spikes.
