INVENTORY FORM FOR STATE HISTORIC SITES SURVEY

HISTORIC Livezey Farm House
 AND/OR COMMON Herbert Harlan's House

HA - 132

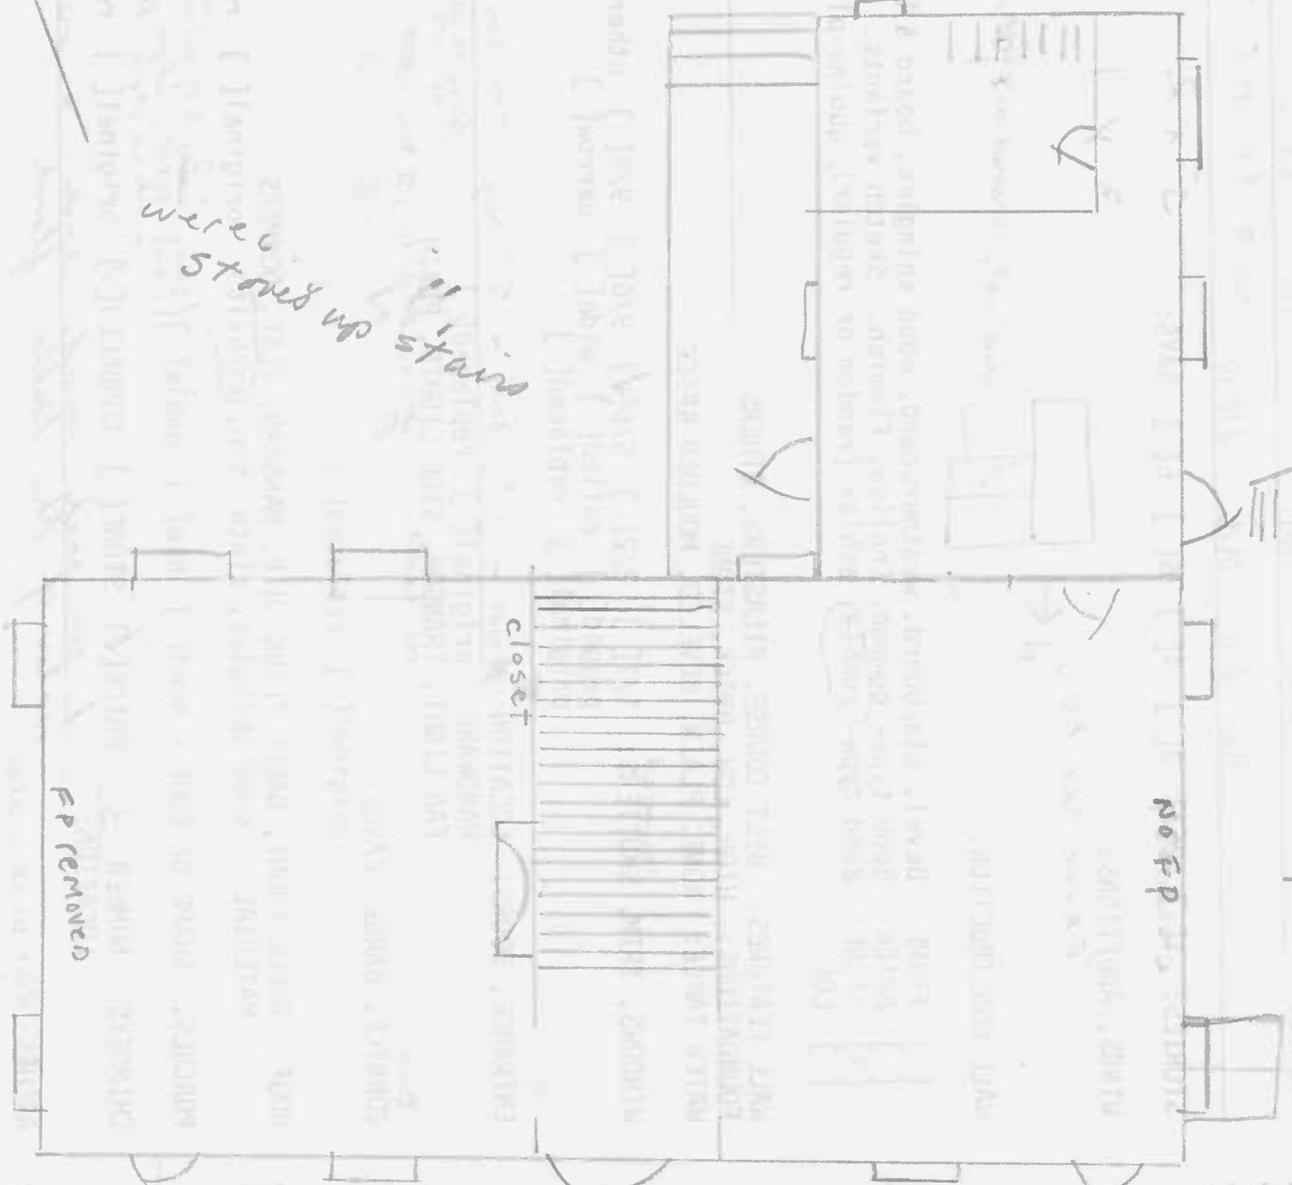
Brick FP
clean
up stairs section

water, privy, and
stove
were
stored
up
stairs

semi elliptical
brick arches

Attic
window
6/6

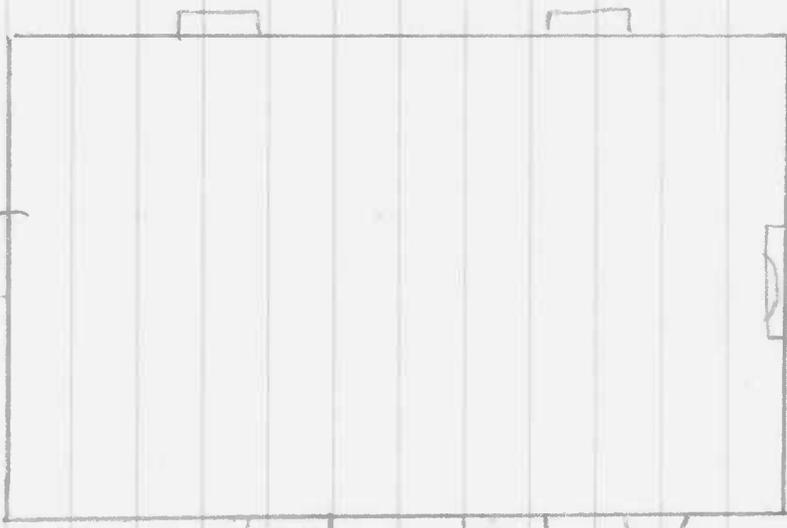
2 story
Stone fireplace
large, cooking type

Attic window
6/6
cooled brick
chimney

Quions
gable flank, tin roof
wide eaves

Stone
chimneys

Second floor
2 windows the
on N + S side

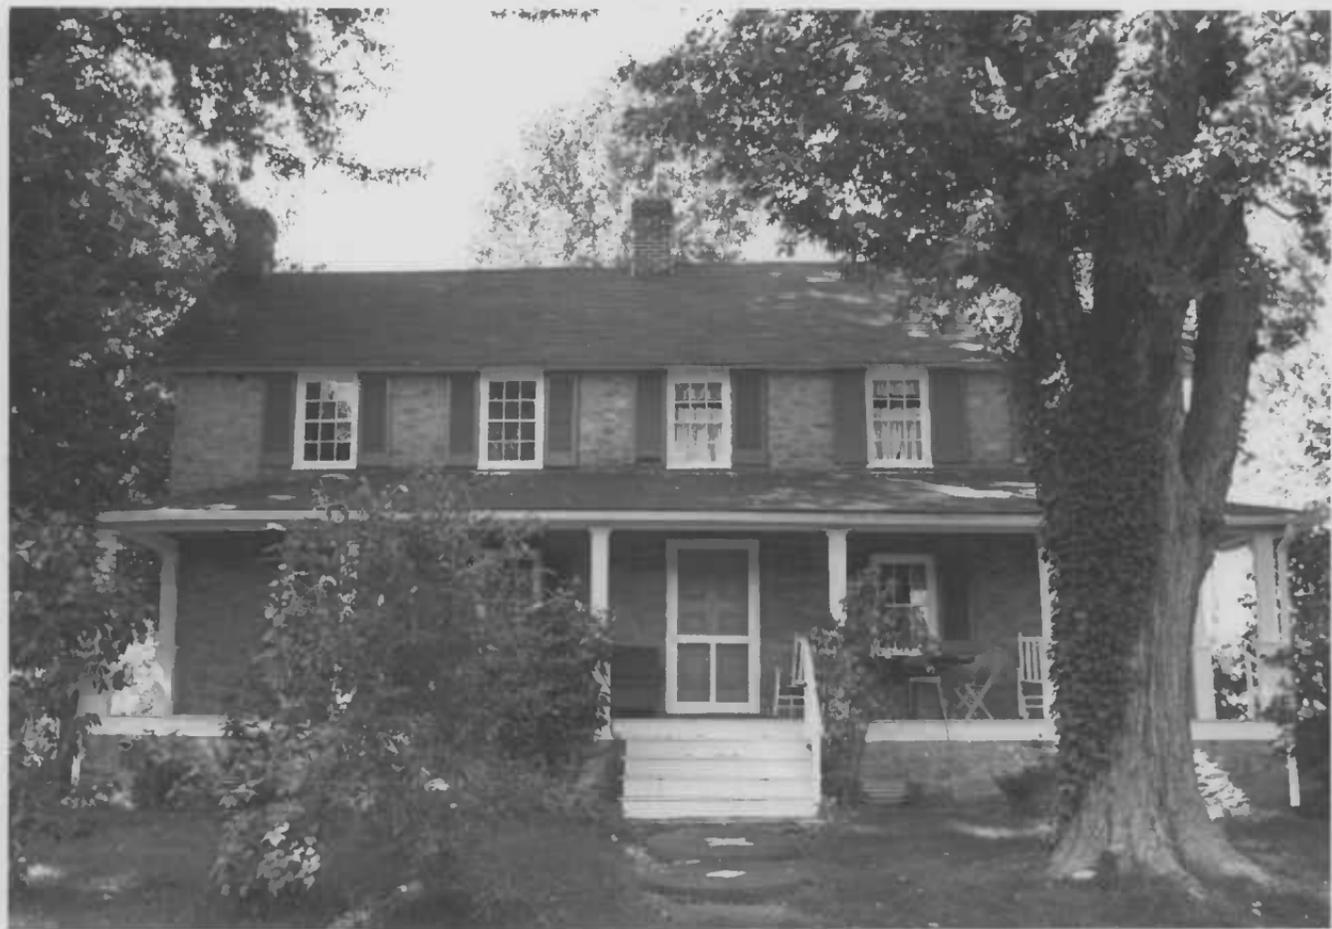
Harlan-Livezey Farmhouse HA-132
Churchville, MD
Susan M. Deeney 9/76
East

This house is located far off the public road, Thomas Run Road, and shares a lane with Medical Hall. The house faces east. The two story house consists of two sections.

Section 1 is uncoursed rubble stone and is actually two different sections built at two separate times. The original house was a small, almost square structure, 2 bays by 2. It included the south end of this section. This was extended to make the house 5 bays by 2. There are three corbeled brick chimneys in this section; one on each of the inside gable ends and one almost in the center of the gable flank roof. The roof has box cornices. There are three doors on the east side. These are located in the first, third, and fifth bays. The center door is very wide and has six moulded panels. Windows are 6 lights over 6 and have louvered shutters. Flat brick arches are above all first floor windows and doors on this section. A five bay, hip roofed porch is located on the east side. It is one story high and has stone foundations. There are five pedestaled, square columns with chamfered edges. The porch has wooden steps. The rafter ends are visible on the eaves of the porch roof.

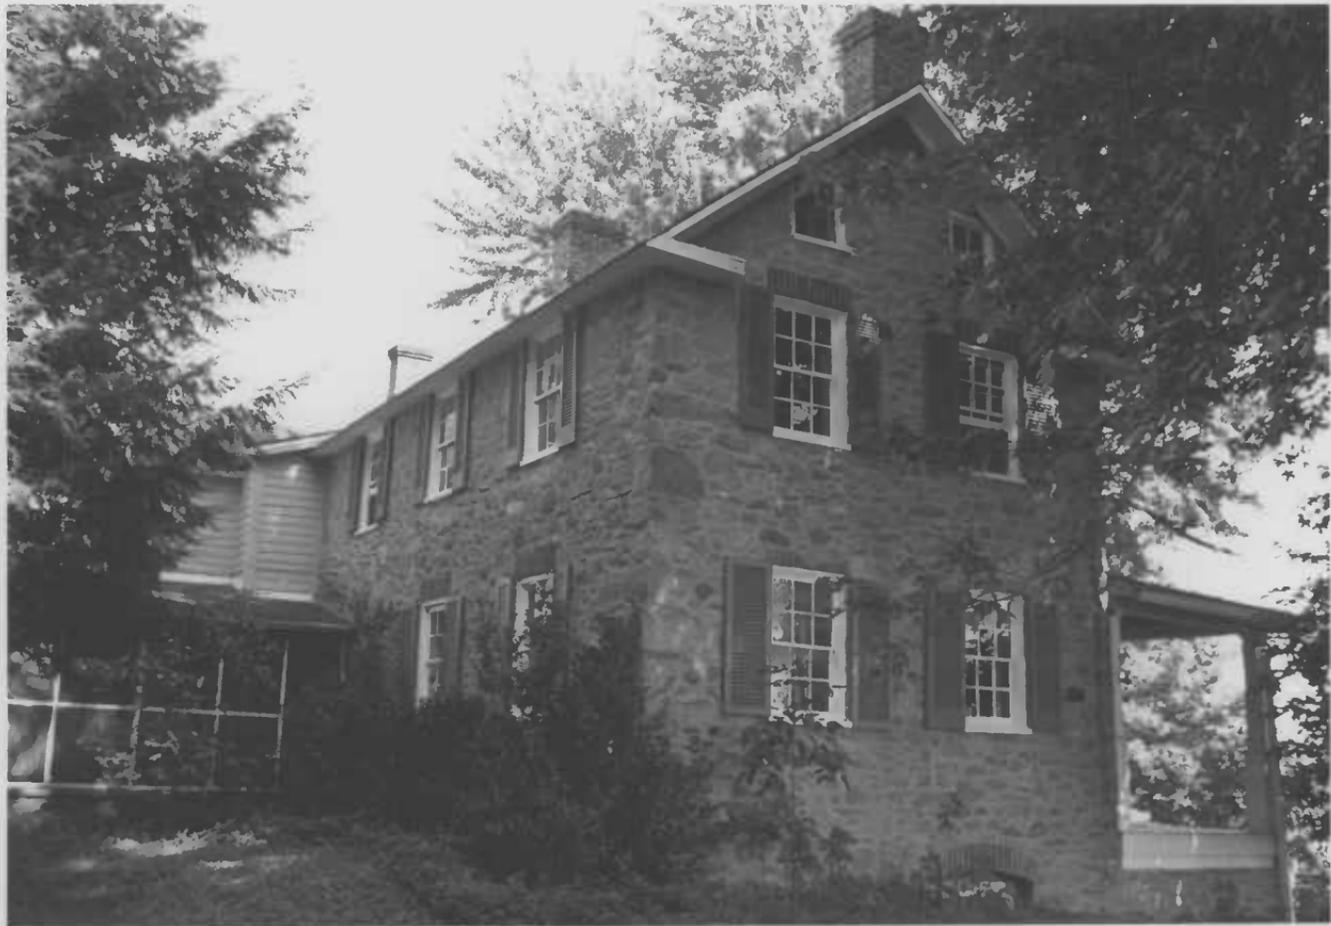
Harlan-Livezey Farmhouse HA-132
Churchville, MD
Susan M. Deeney 9/76
Southwest

The frame section is 3 bays by 1. It is two stories high. The foundations are probably stuccoed brick. An entrance is located in the northeast bay of the north side as well as in the southeast bay of the south side. Windows are 6 lights over 6. A one bay entrance porch is located on the north side. It has a gable front roof and plain, pedestaled, rectangular columns. A shed roofed, screened in porch runs almost the length of the addition on the south side. It is built onto brick foundations and has three brick steps. Doors and windows in the frame addition have been re-arranged and this is apparent in the broken lines of the clapboard covering.

Inside, a narrow stairway is at the west wall. The owner thinks that this was added. He speculates that originally a ladder was used to gain entrance to the second floor and pointed out a specific break in the clapboard where an entrance had been boarded up at the south west corner of the south side. Mr. Harlan also said that the frame section was constructed approximately 100 years ago.

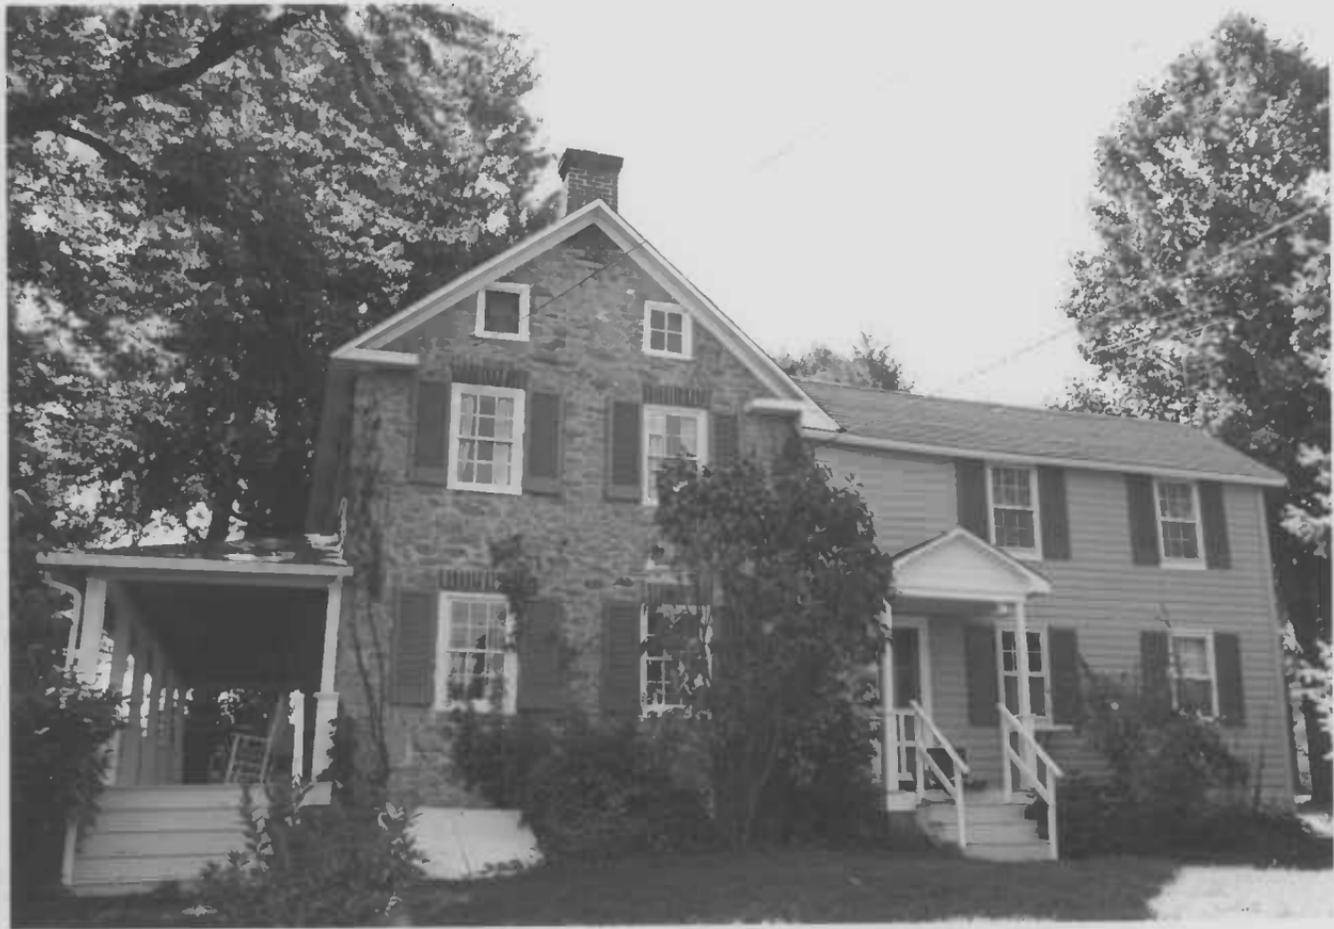
Harlan-Livezey Farmhouse HA-132
Churchville, MD
Susan M. Deeney 9/76
North

To the north of the house is a large, two story, uncoursed rubble stone building, 3 bays by 1. It has a gable flank, tin covered roof with wide eaves. Large, plain quoins are at each corner of the stone structure. Stone lintels are above each window. There is an entrance on the east facade. It is of plain wood plank and is located on the north east bay. Windows are 6 lights over 6. On the south gable end are large, double hung, wood plank doors with large iron strap hinges. These doors were used as a carriage entrance, and have a large, semi-elliptical brick arch above them. A corbeled brick chimney is located at the north inside gable end. This services a large, stone, cooking fireplace. Attic windows at each gable end are 6 lights over 6 and on the north they flank the chimney.

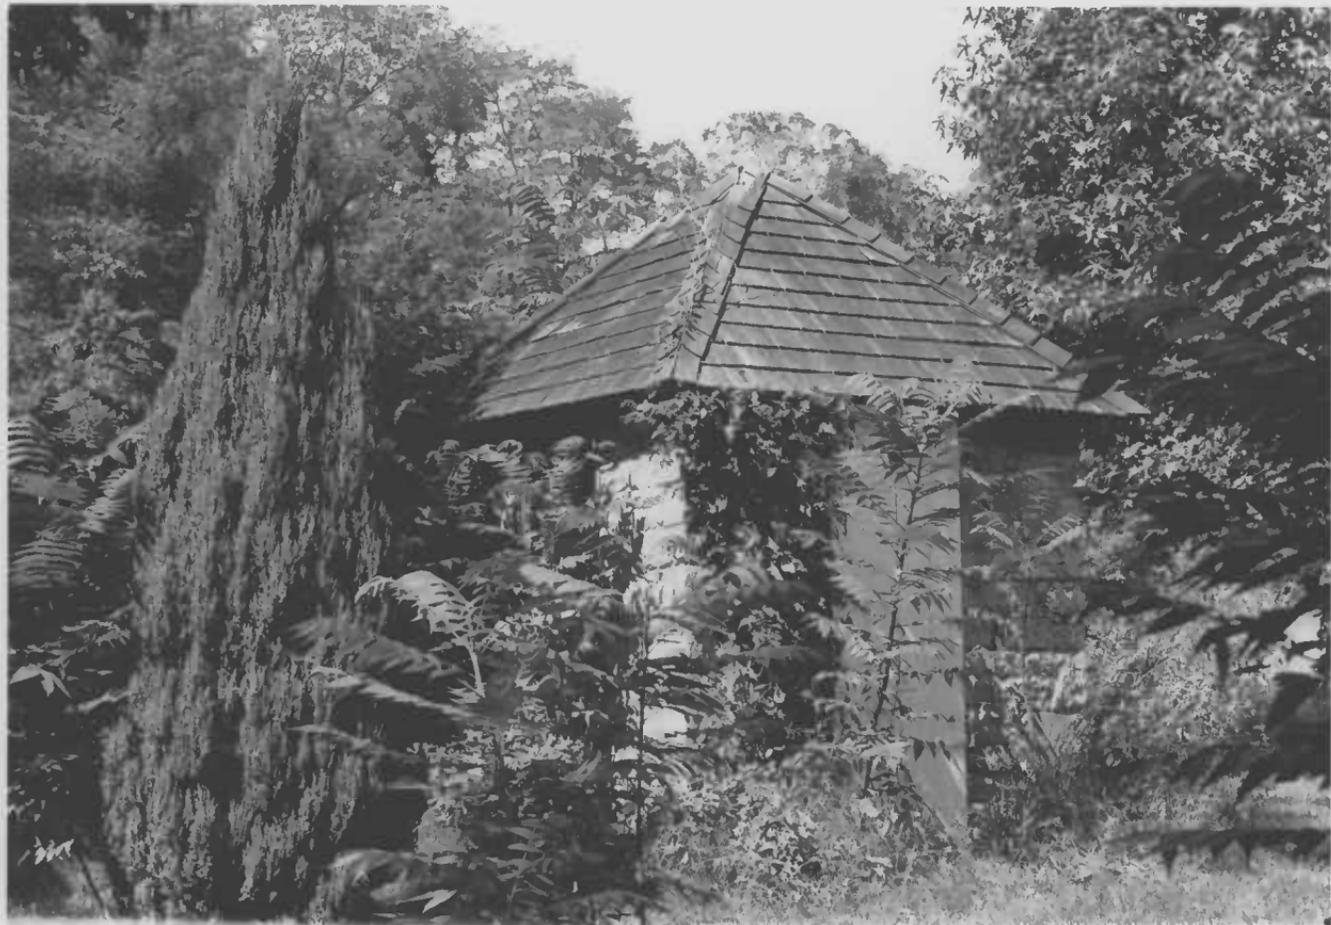
Harlan-Livezey Privy HA-132
Churchville, MD
Susan M. Deeney 9/76
East

A privy is located south west of the house. It is a one story, square, rubble stone structure. It has a wood shingle hip roof. There is one small window on the south side and a wood plank door in the center of the east facade. The door has two iron strap hinges. The sitting board has been removed, but Mr. Harlan said that it was either a three or four seat privy.

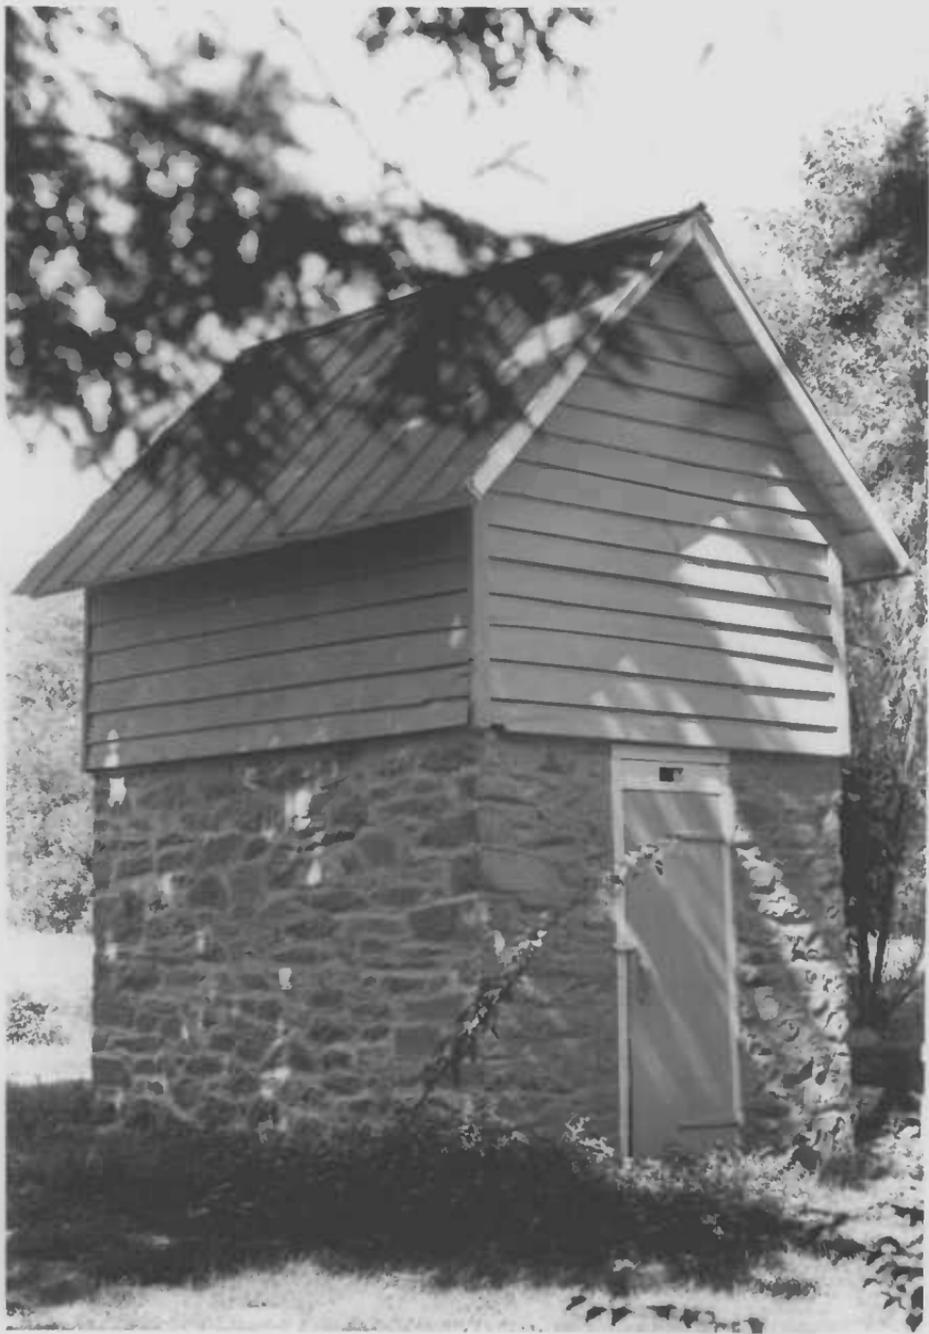
Harlan-Livezey Smokehouse HA-132
Churchville, MD
Susan M. Deeney 9/76
Southeast

A smoke house to the west of the frame addition has a gable front, slate covered roof. The eaves are wide. The first elevation is rubble stone and the second is frame. There are no windows and the door is located in the center of the east wall. The large wood plank door has 2 iron strap hinges.
