HA-286  
Woodlawn  
3214 Harmony Church Road  
Darlington, Maryland 21034

INVENTORY FORM FOR STATE HISTORIC SITES SURVEY

HISTORIC Woodlawn

INVENTORY NO. HA-286

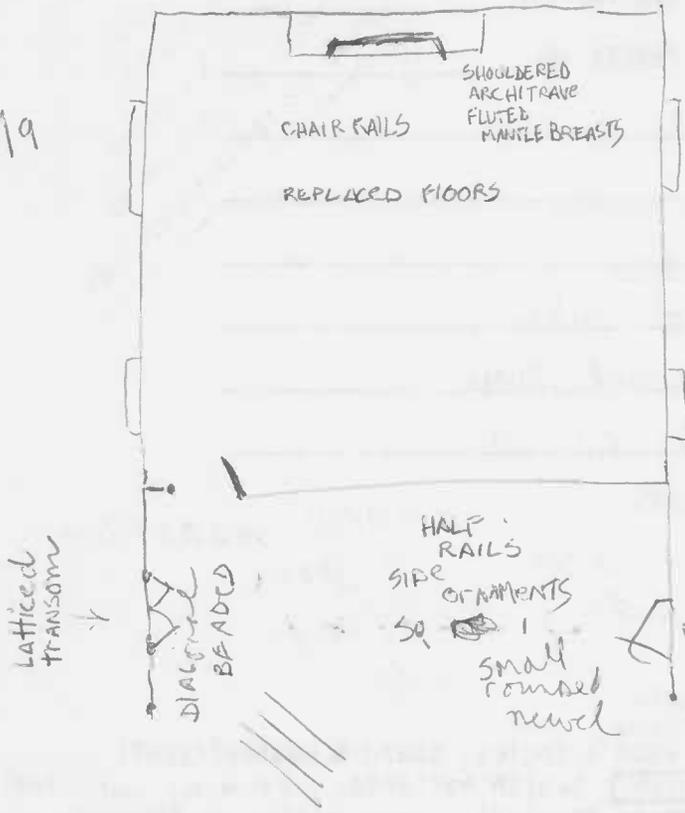
Wood lawn HA-286

OTHER MANTLE VERY PLAIN

OTHER MANTLE  
PILASTER-  
GROG  
MOULDED MANTEL  
BREAST

FIRE PLACE

WEAVER CLOSED OFF KITCHEN  
FP (had been cooked in).  
CHAIR RAILS  
THROUGHOUT

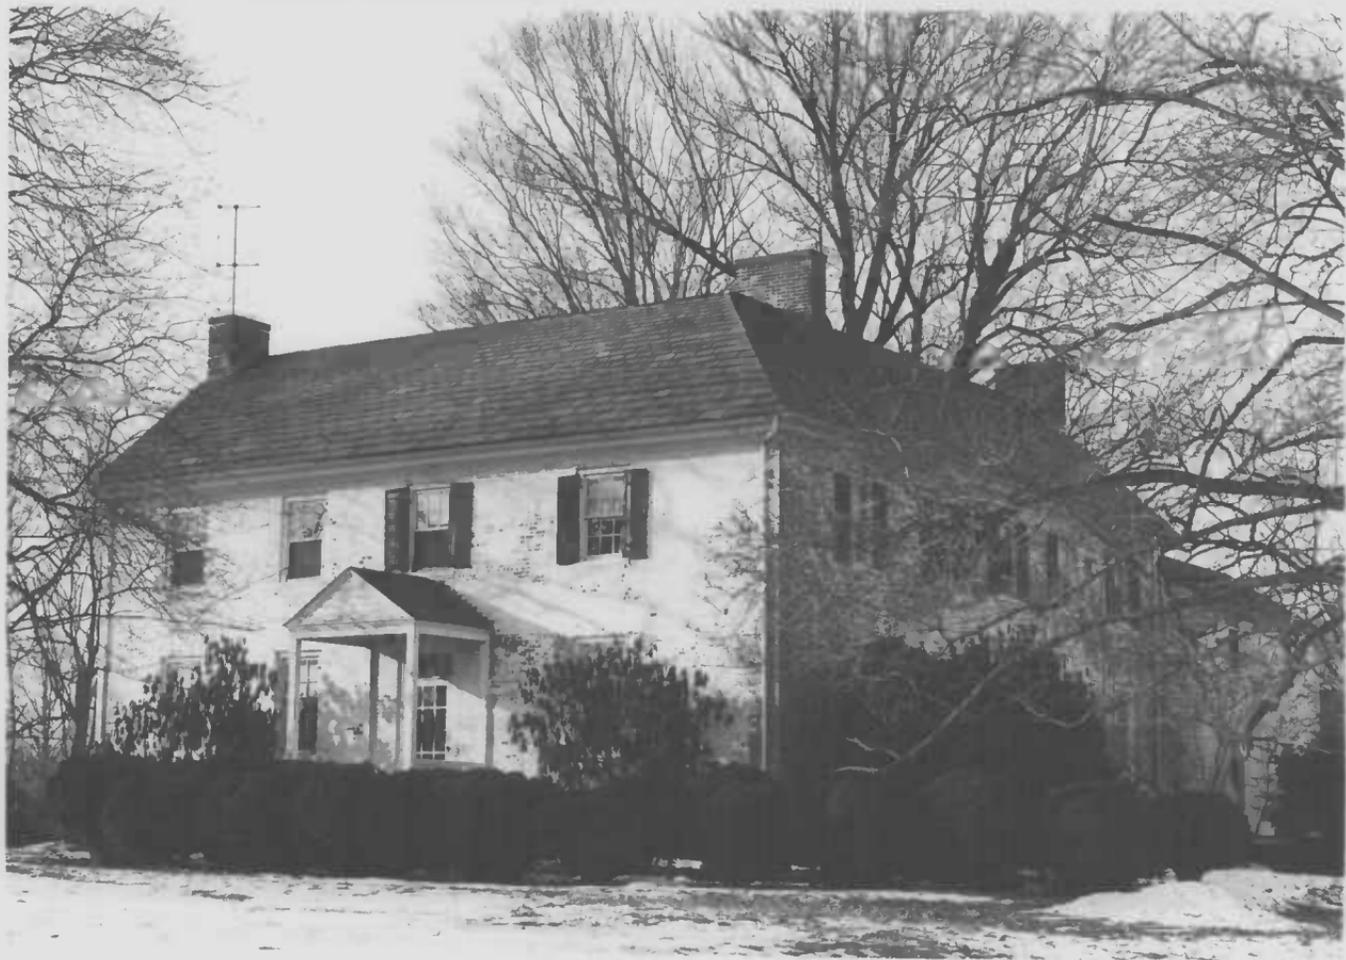
South

The principle facade is four bays long while the el is five bays. Each is two bays wide. Windows on the first elevation are six lights over nine. On the second elevation they are six lights over six. Louvered shutters are at most windows. The main entrance is located in the second bay of the south facade. The double hung doors are of diagonal, beaded board. A lattice work transom is overhead. This forms a through hall and the corresponding door on the north facade is a very wide six panel door. A one bay entrance porch on the south shields the main entrance, while another porch, running the length of the el's west facade shields the north entrance to the through hall.

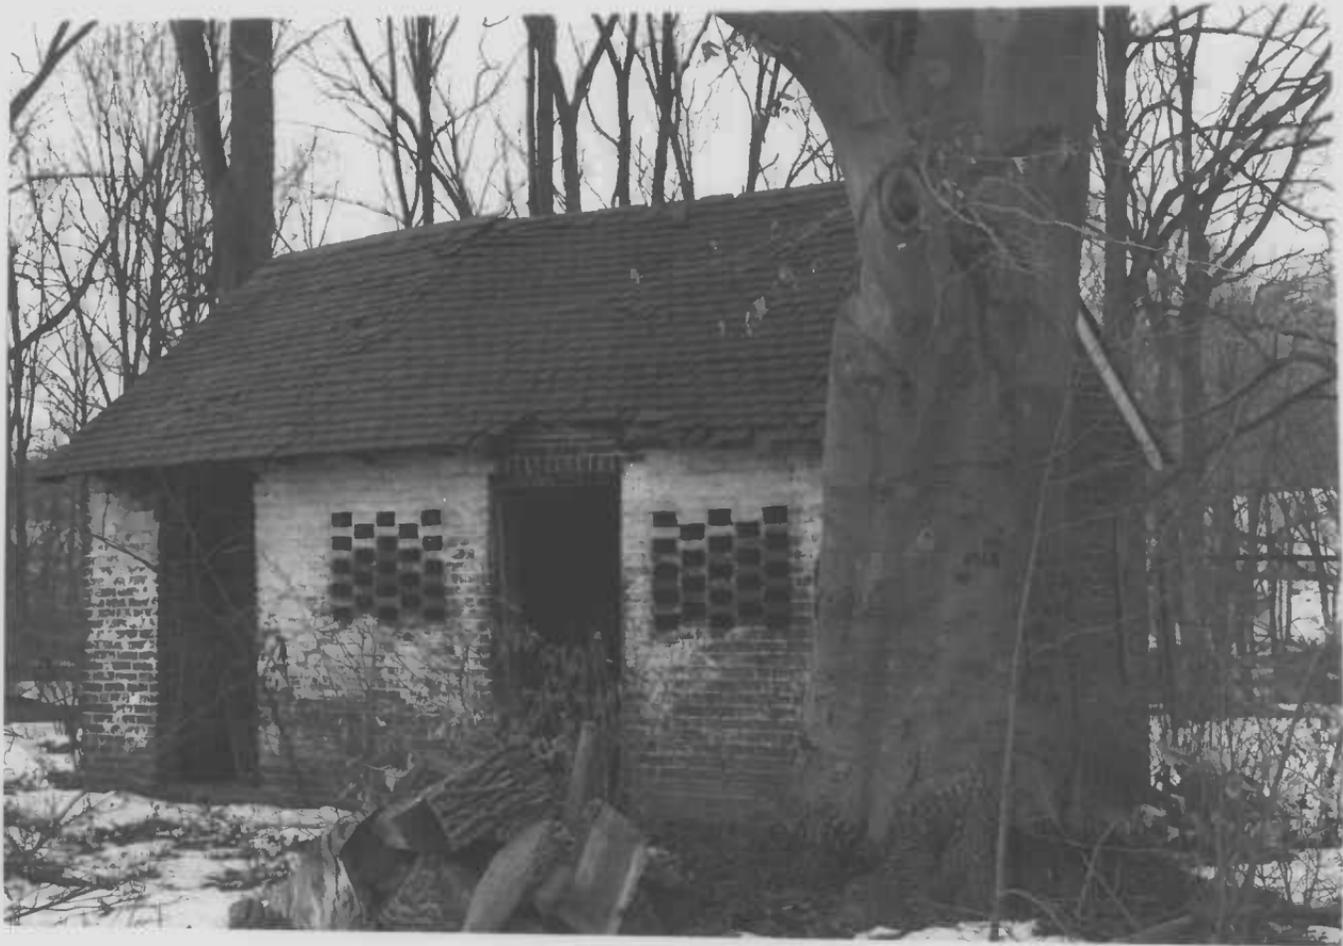
Woodlawn HA-286  
Darlington, MD  
Susan M. Deeney  
January 1978  
South
