HA-1161 and HA-1162
KLAIR HOUSE AND SHEAFFER HOUSE
Havre de Grace, Md.

INVENTORY FORM FOR STATE HISTORIC SITES SURVEY

Klair House

611 Franklin Street

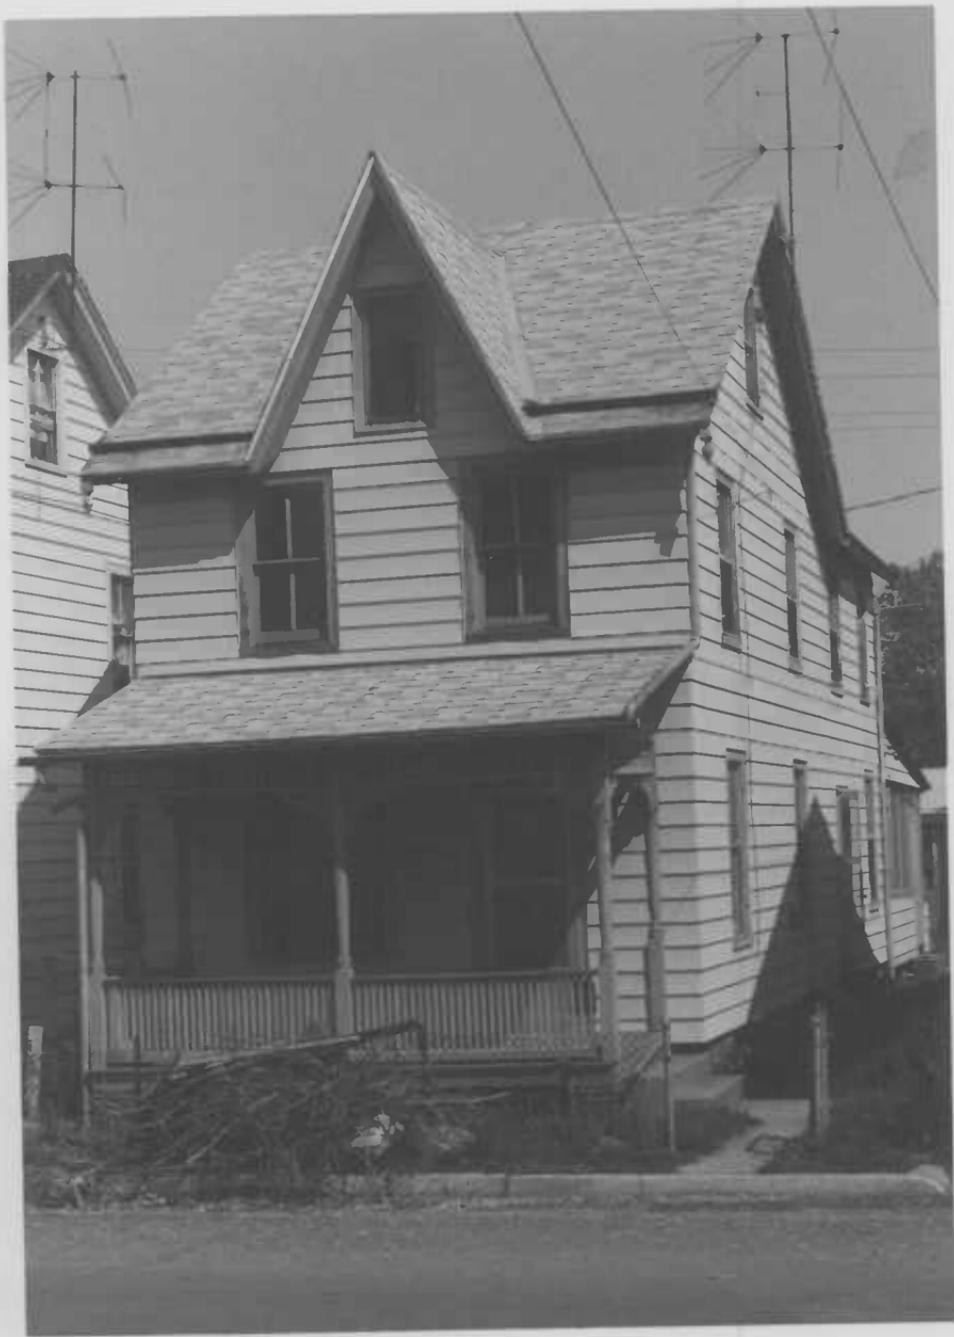
HA - 1161

611 Franklin Street is a two and a half story two bay wide frame dwelling with a gable flank roof, having a center gable on the front. Sided with aluminum, the house is yellow with brown trim and has a two story wing on the rear. A brick foundation underlies the main section and the wing. The structure faces south on Franklin Street with the Cameron-Currier Livery Stables (HA-1104) on the east and a house almost identical to it on the west side.

South Facade

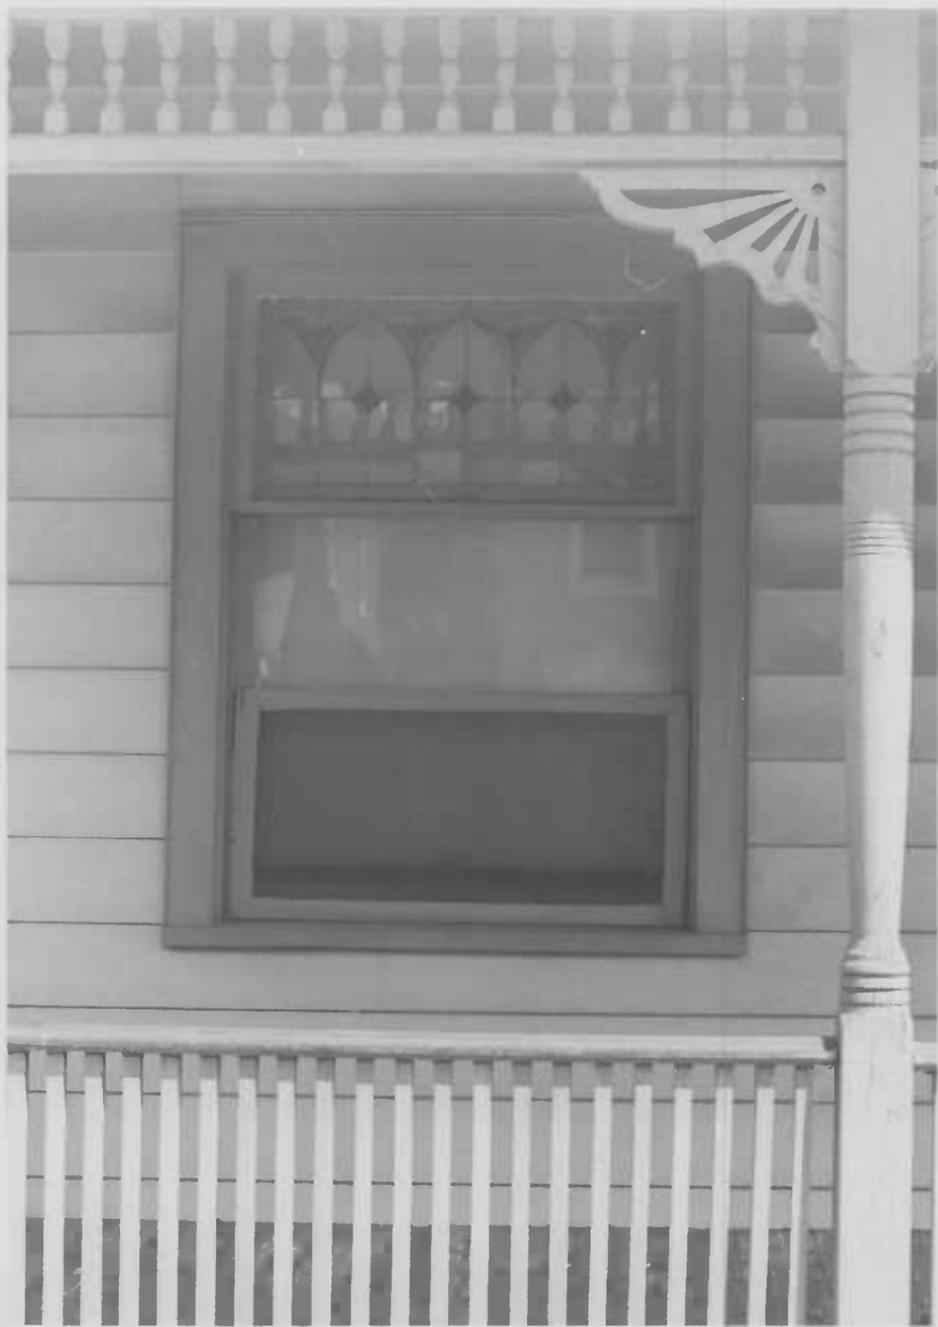
HA-1161

Extending across the front is a two bay Eastlake style porch with a shed roof. Butterfly wing scroll brackets flank the turned posts which support the roof. Having a plain fence railing, the porch is entered from the east side.

A large rectangular 1/1 light double hung sash window with a delicately executed stained glass transom is in the west bay, south elevation. On the second floor, the windows contain 2/2 light double hung sash with wide board enframements, consistent on all elevations.

porch + window detail
