HA-1165
LAWDER APARTMENTS
Havre de Grace, Md.

INVENTORY FORM FOR STATE HISTORIC SITES SURVEY

Lawder Apartments

568 Congress Avenue

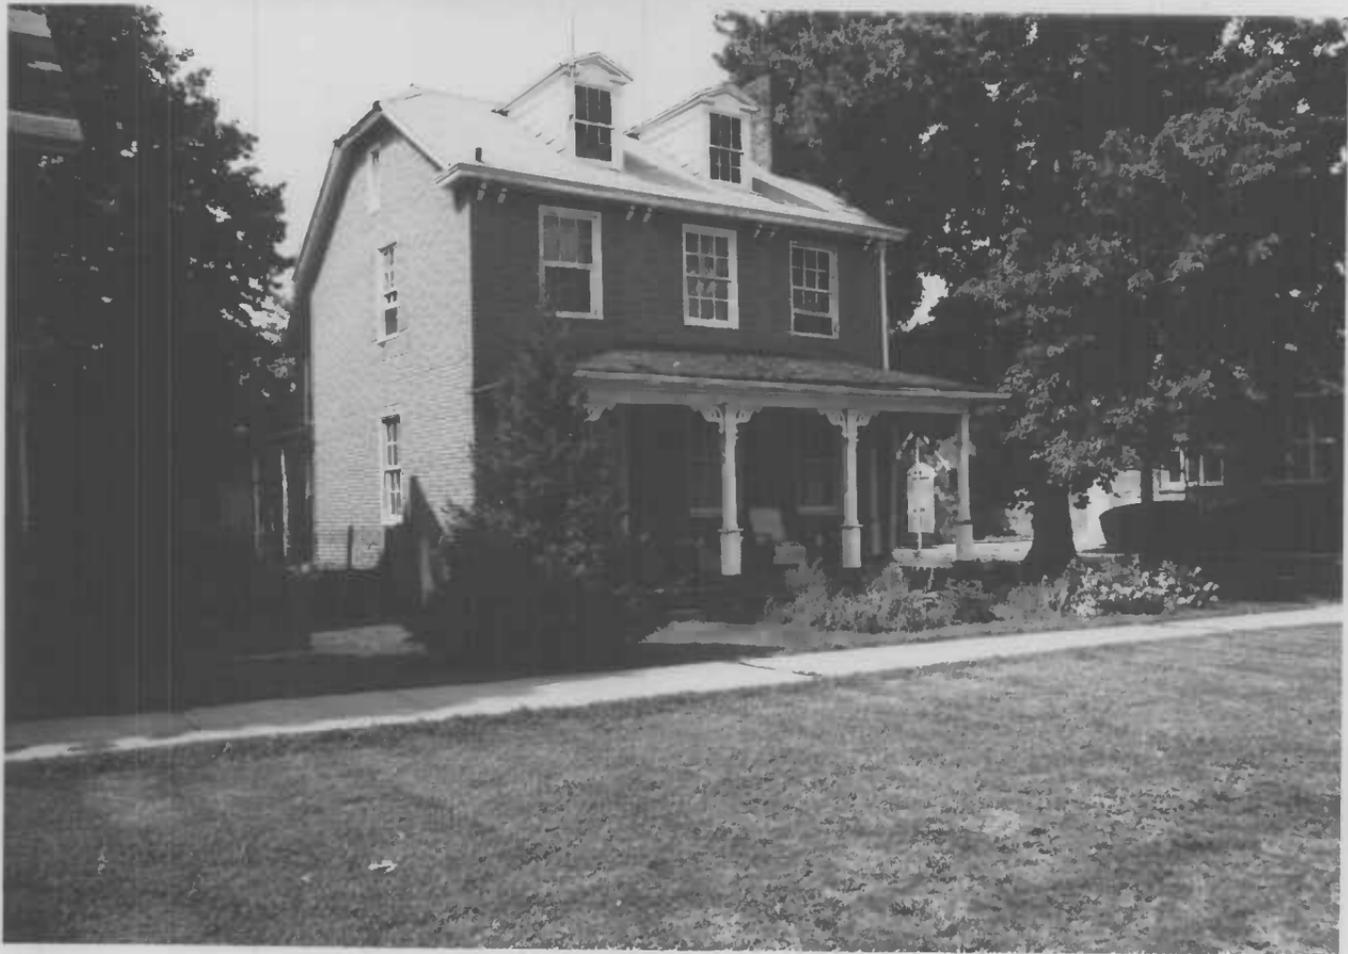
N. Facade

The main entrance is located in the east bay, north elevation. A door containing deeply molded pentagonal and rectangular panels is formed by a three light transom and two sidelights. Both transom and sidelights are divided into diamond shaped sections by metal strips or wood muntins. The door in the south side of the bay addition west elevation, has glass in the upper half.

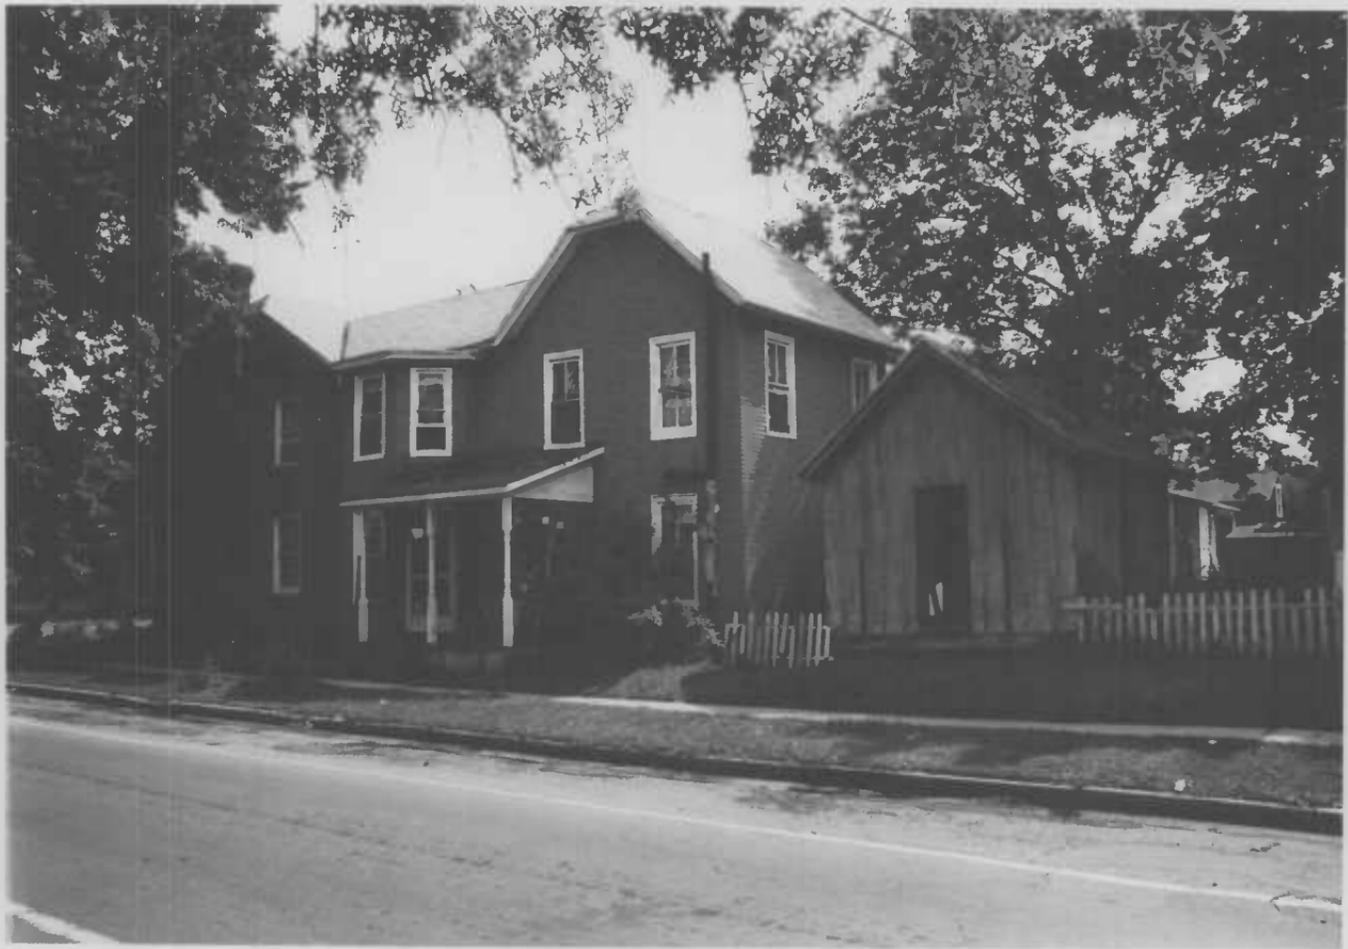
W. Elew.

A three bay porch with a hipped roof, shingled with wood, extends across the front elevation. It is supported by scroll bracketed chamfered posts. On the west elevation a two bay porch with a flat roof supported by turned posts shelters the door in the south side of the bay addition and the window south of it. In addition, a two bay porch with a flat roof supported by turned posts is on the east elevation of the wing.
