HA-1457

Dr. Benjamin Smith House
309 S. Main
Bel Air
Private

INVENTORY FORM FOR STATE HISTORIC SITES SURVEY

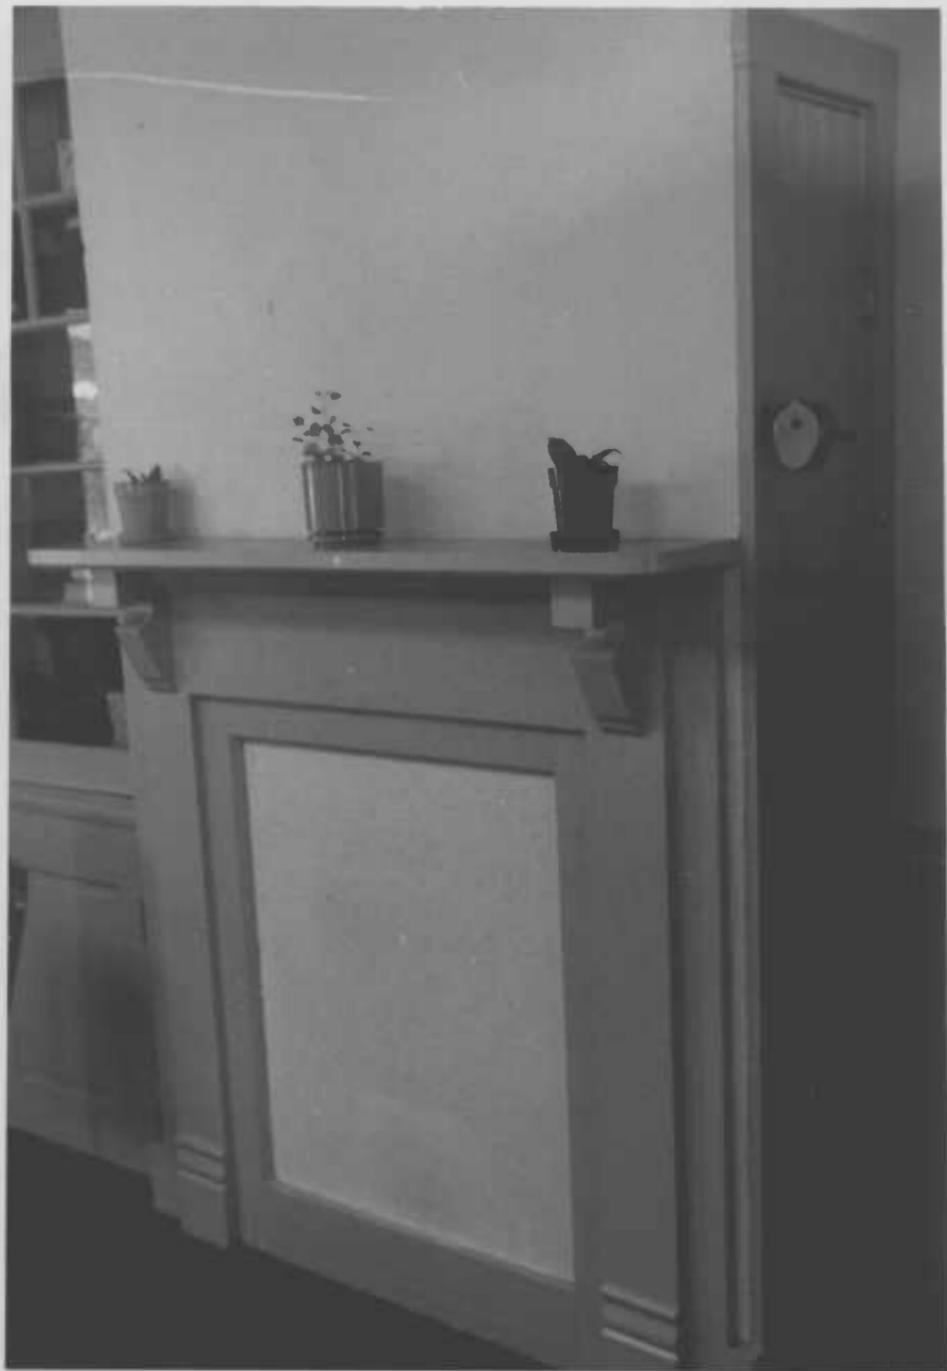
d. n. mantle, looking east

The woodwork inside the dining room is plain. The mantel against the east wall is plain but elegant, a plain wooden surround on molded blocks. The plain shelf is supported on thick cut-out brackets.
