HA-1467

John Keith House
30 E. Pennsylvania Avenue
Bel Air
private

INVENTORY FORM FOR STATE HISTORIC SITES SURVEY

John Keith House

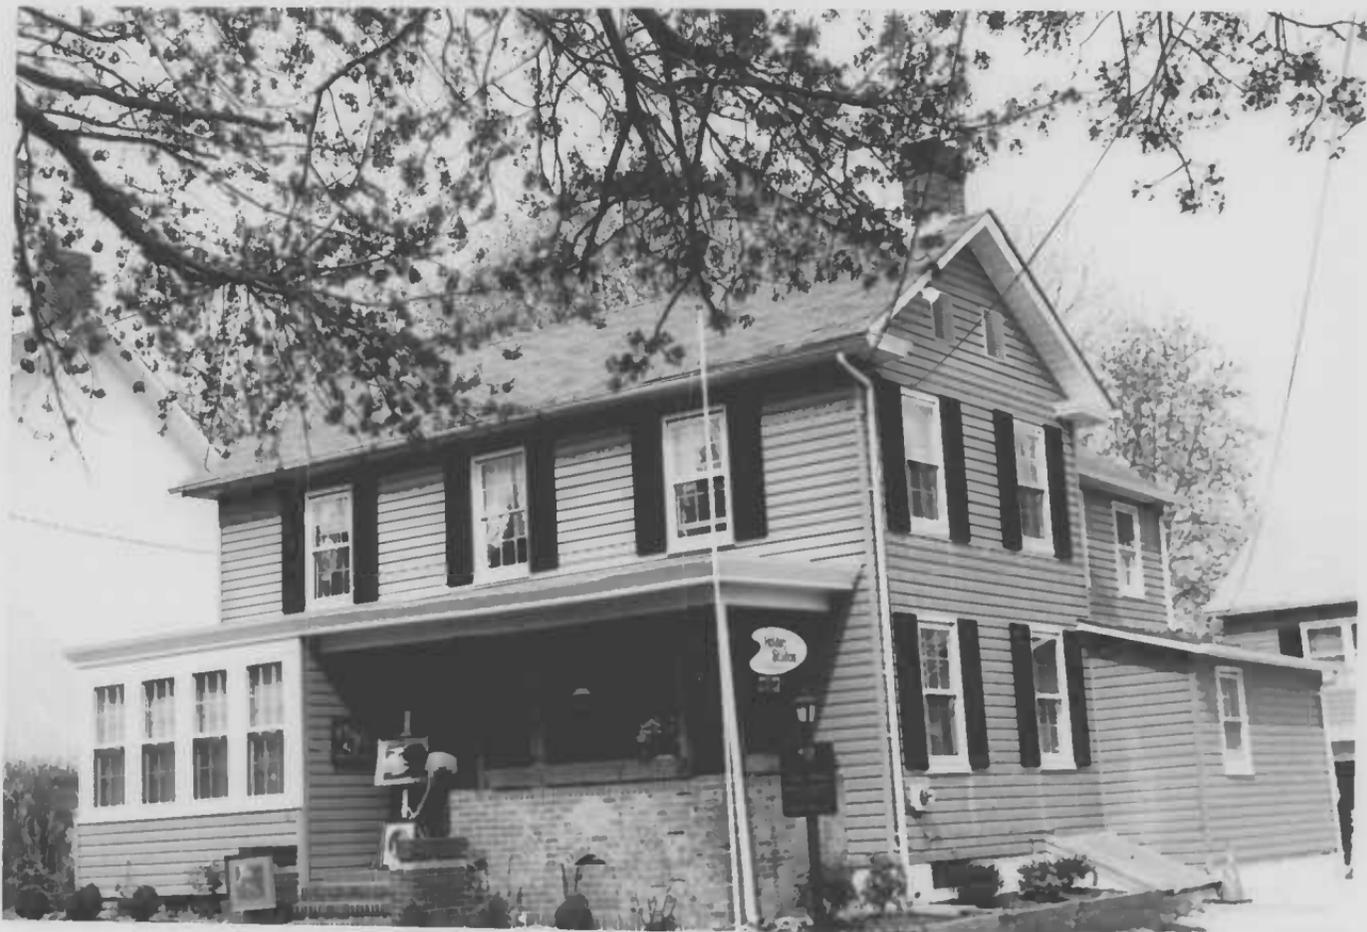
s. + e. elev

This two-story aluminum-sided L-shaped house with a gable roof is at 30 East Pennsylvania Avenue in the Town of Bel Air, Harford County, Maryland. Originally a single pile house with a front porch, the house has been expanded at least twice, first with the addition of a two-story ell to the north containing a kitchen downstairs and a room and a bath upstairs. This addition had a shed porch on the east elevation. This porch has been enclosed. The gable roof of the ell shows that the bay to the west was added to the back later. It contains one room down and a sunporch up.

Old pictures show the former porch to be a wide Victorian veranda with posts and decorative brackets. The entry is in the center of the three bays. The windows in the main block are 6/6 double hung sash flanked by louvered shutters on the front (south) and east. The windows in the ell, with the exception of those in the sunporch, are 4/4 double hung sash. The sunporch windows are modern aluminum sliding panels. The western half of the front porch has been enclosed and shows 6/6 double hung windows, too, two on the west side and four on the south side. The rest of the porch, tiled floor, brick wall and wrought iron posts, is also recent. The Holdens are planning to remove most of the brick and enclose the east half of the porch in glass to provide a showcase for their photography. An inside end chimney with a corbelled cap rises in the eastern gable end.
