HA - 1571

INVENTORY FORM FOR STATE HISTORIC SITES SURVEY

AND/OR COMMON Log Tenant House (Holdaway's)

East side of Deth's Ford Road north of Harmony Church Road

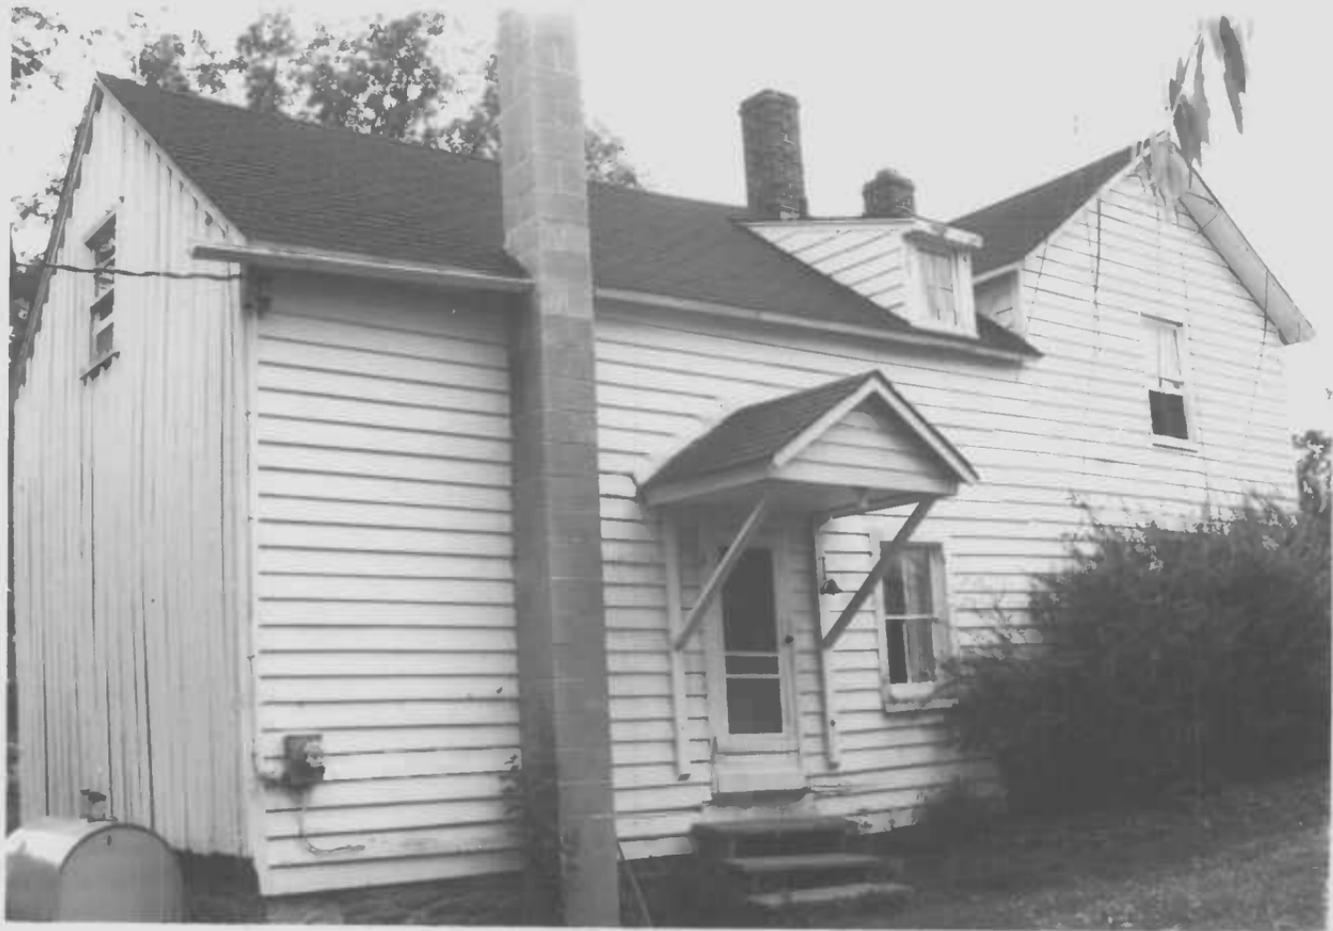
north elevation

The opposite side, the north facade shows evidence of an earlier porch which ran its full length. There is a central door with an added hood and a single 2/2 window in the west side. The east bay is blind and contains a modern stove flue. The shed dormer on the side is added and the clapborads are of course later material.

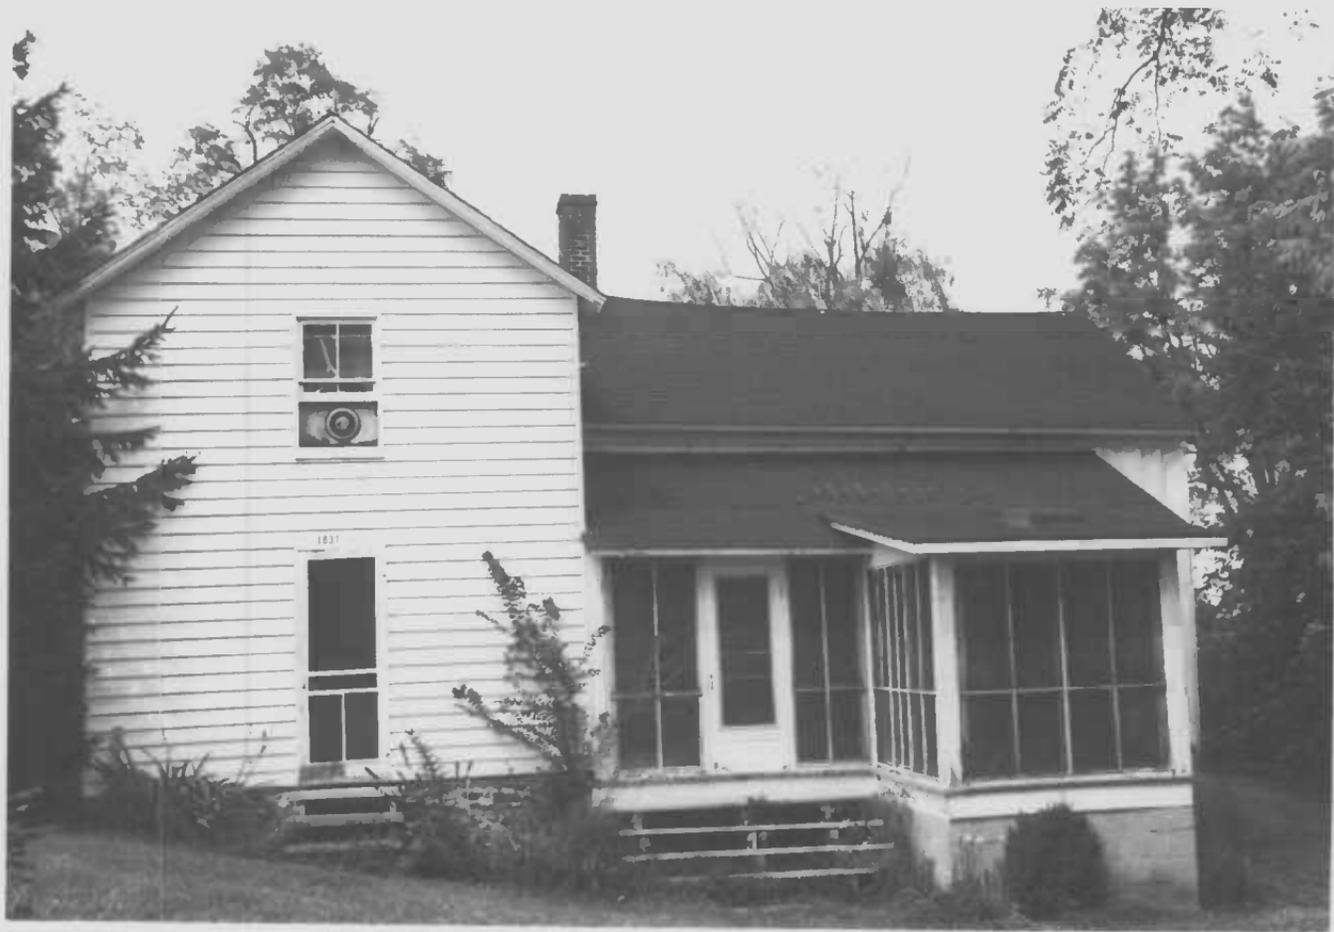
South Elevation

The south facade has two lower windows and an off center door inbetween. The upper level does not exhibit the expected knee windows but is covered by both siding and the shed roof of the porch on this side. This porch is probably added; it is supported by chamfered columns.

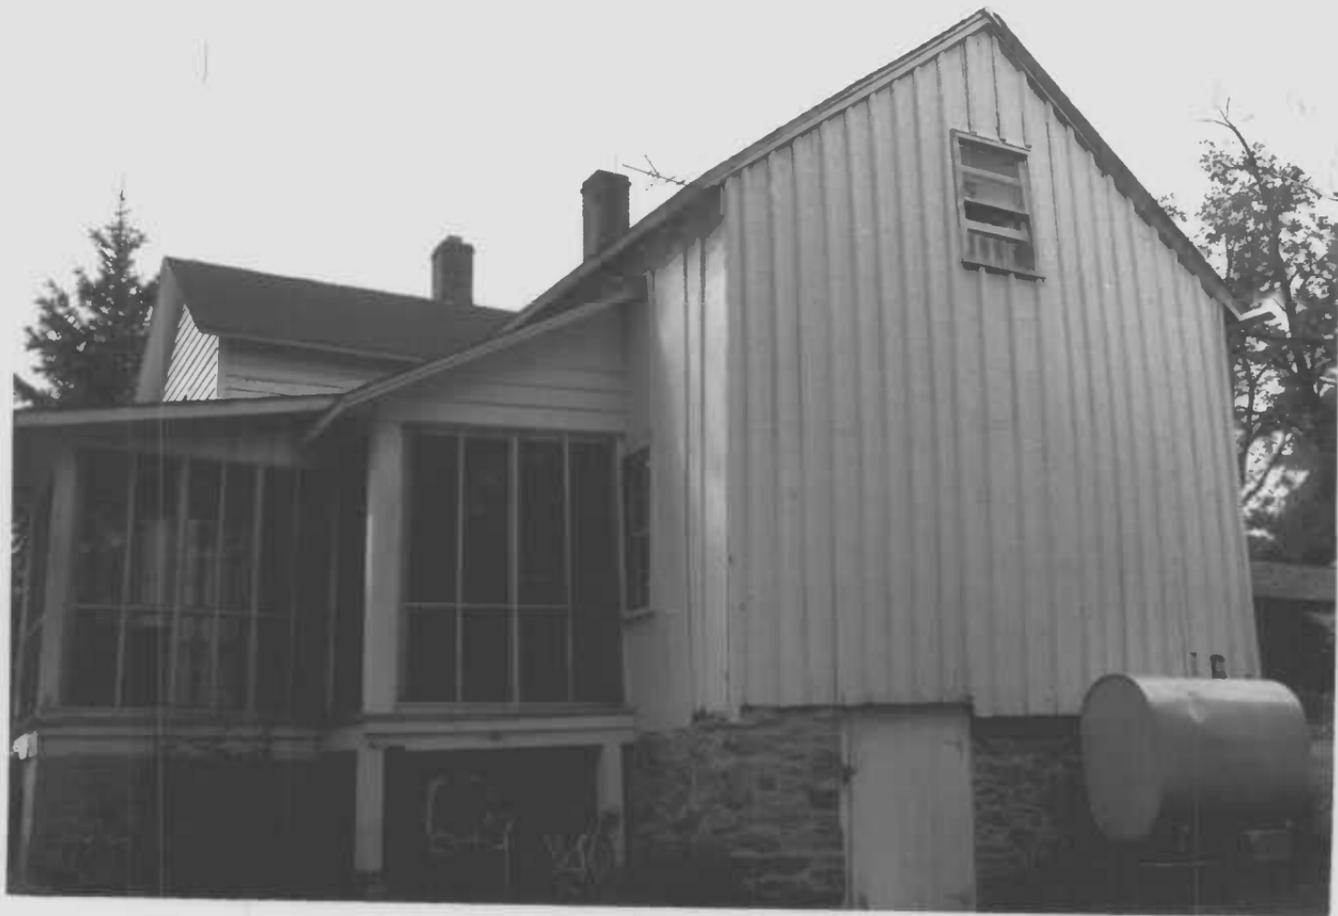
Wayne Nield
East elevation

The east side or end is covered with the board and battens. The single upper window was cut through later. The cellar is entered by a small doorway on the south east corner.
