HO-29  
ARLINGTON  
Private  
Columbia

## MARYLAND HISTORICAL TRUST WORKSHEET

NOMINATION FORM  
for the  
NATIONAL REGISTER OF HISTORIC PLACES, NATIONAL PARKS SERVICE

ATTACHMENT #1  
ARLINGTON  
HO-29  
TAX MAP #30

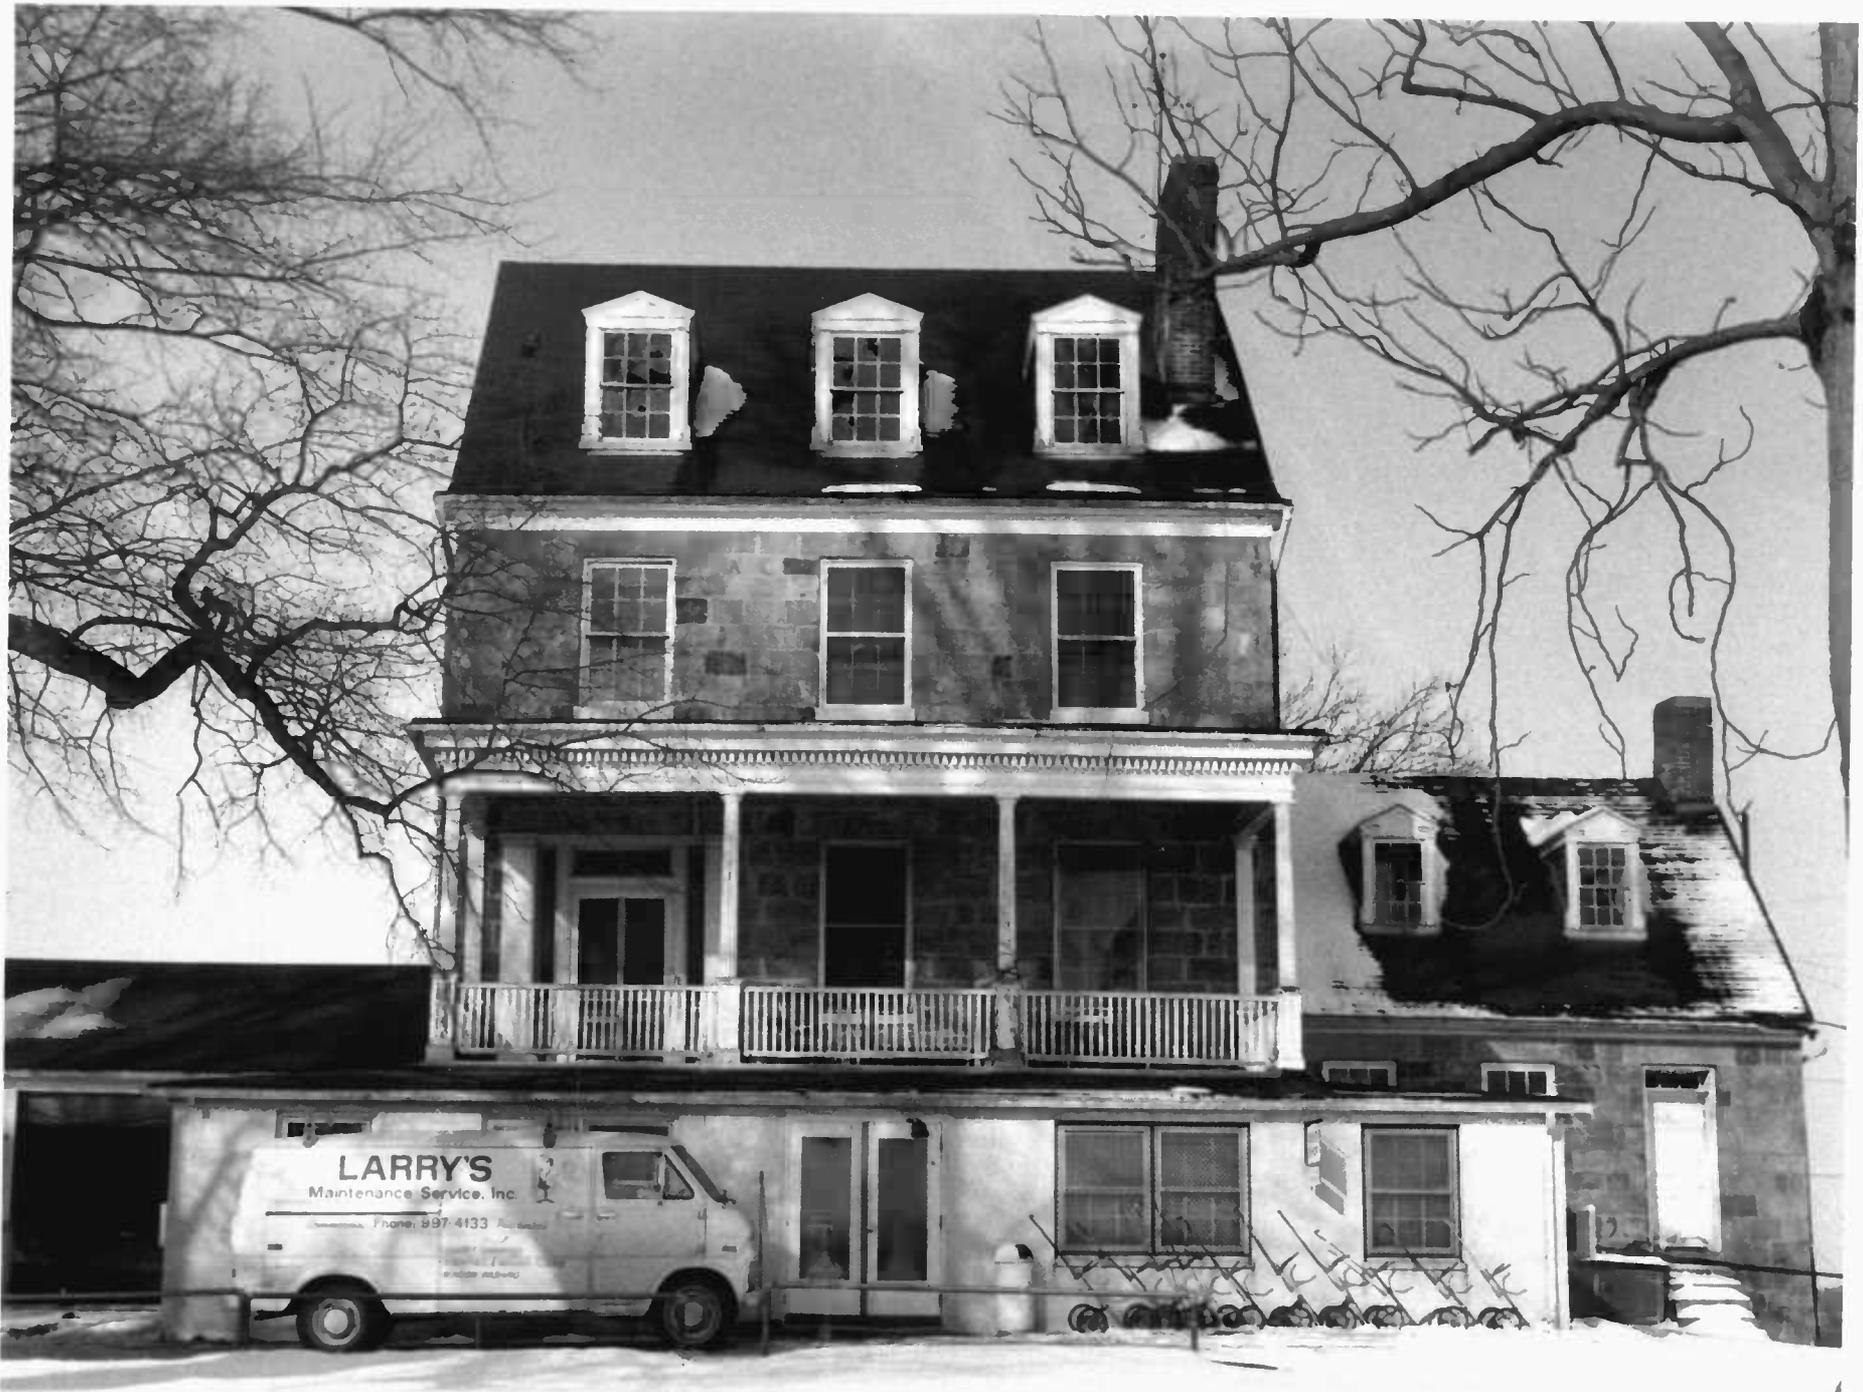
HO-29

It is three bays wide and two bays deep, of granite block construction featuring rectangular double-hung windows decorated with flat stone lintels and flat wooden sills and holding six-over-six lites. All fenestration is symmetrical and proportionally scaled. The double paneled rectangular second floor wooden entrance door located in the south bay faces east and is surmounted by a four lite transom and flanked by flat pilasters and four side lites. The east facade is covered by a flat roofed porch which is crowned by a cornice decorated with a row of dentils and supported by four slender fluted wooden doric columns resting on square wooden posts and two pilasters attached to each corner of the east facade which act as connectors to the wooden ballustrade which runs along the perimeter of the second floor front porch.

ARLINGTON  
(EAST)
