HO-109

Ann B. Dunn's Log House
Woodbine
Private

INVENTORY FORM FOR STATE HISTORIC SITES SURVEY

Attachment I
H0-109
Ann B. Dunn's Log House
Tax Maps 20 and 21

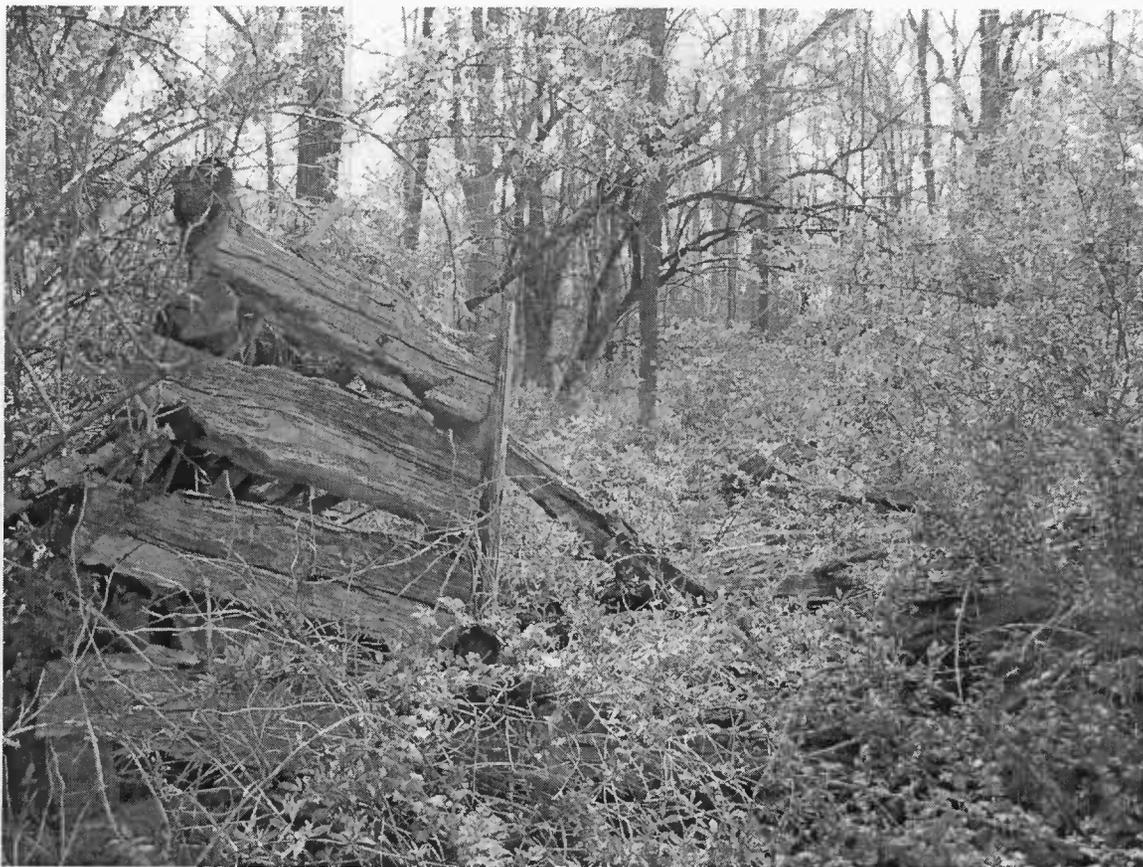
This small log house is now in ruins. The roof is gone, and only two of the walls are standing (west and north). The west elevation (towards Daisy Road) had a central door flanked by two window openings, and smaller square windows above that, just below the eave line.

HO-109
Ann B. Dunn's Log House, ruin
Daisy Road north of Jennings Chapel Road, east side
Woodbine
Jennifer K. Cosham
April 21, 2004
Digital color photo on file at MHT

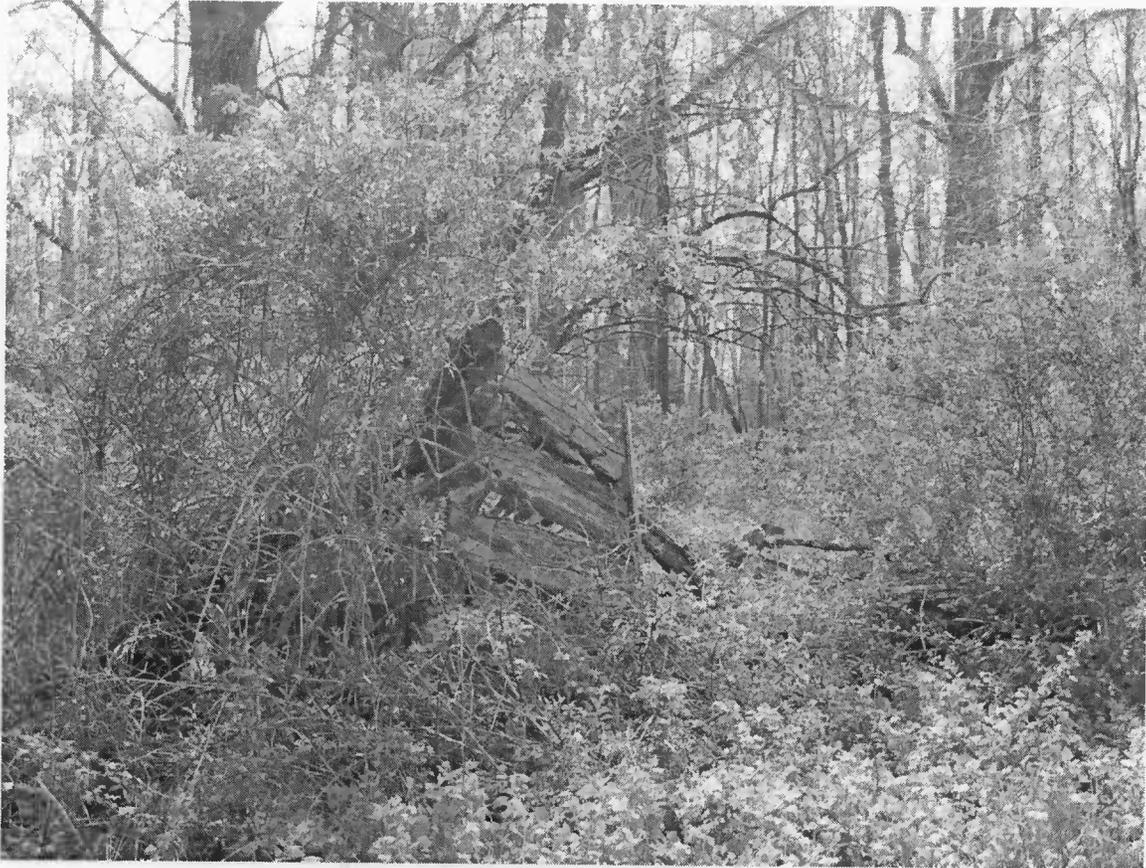
HO-109
Ann B. Dunn's Log House, ruin
Daisy Road north of Jennings Chapel Road, east side
Woodbine
Jennifer K. Cosham
April 21, 2004
Digital color photo on file at MHT

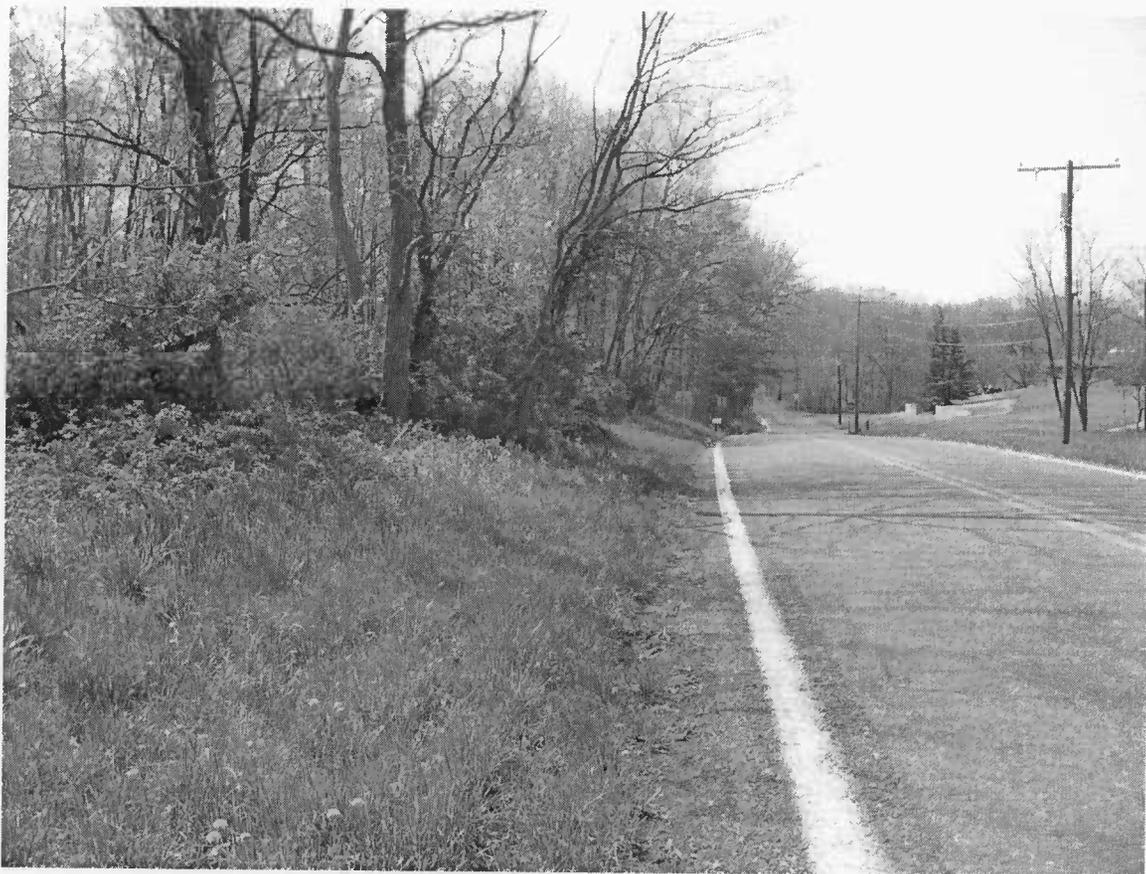
HO-109
Ann B. Dunn's Log House, ruin
Daisy Road north of Jennings Chapel Road, east side
Woodbine
Ruin on left, intersection on right, looking south
Jennifer K. Cosham
April 21, 2004
Digital color photo on file at MHT

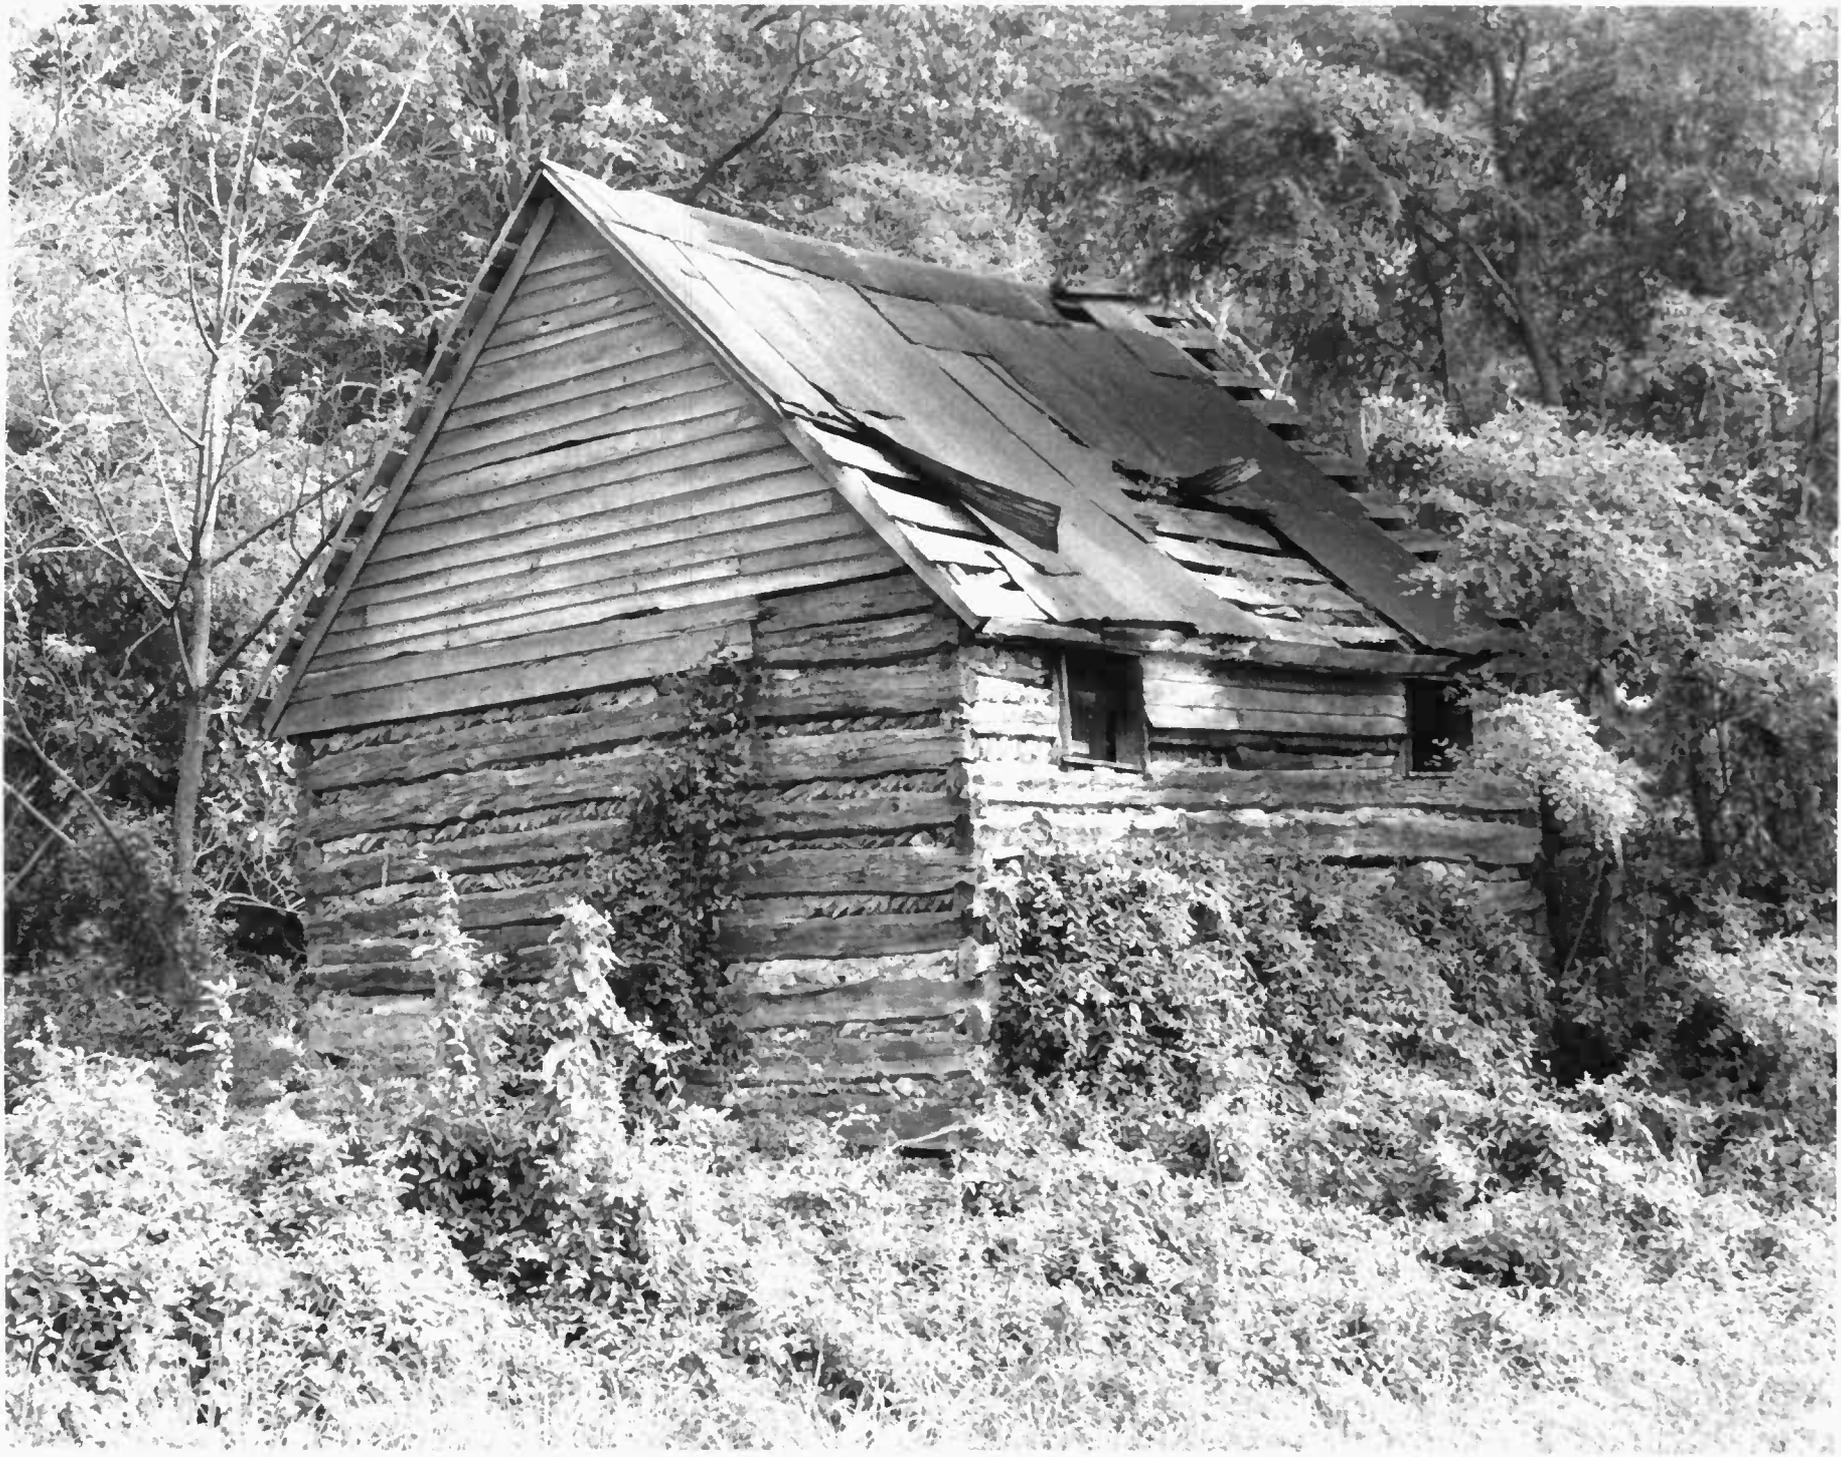
HO-109
ANN B. DUNN'S LOG HOUSE
SOUTH WEST

The south elevation holds two rectangular apertures with two square second floor windows above, all of which have no sashes. A central door is located on its north wall with a window to its west, and two square second floor windows above. An additional entrance is located on its east wall with a square second floor window centered above. The west wall holds no apertures. The building is composed of hand hewn logs, separated and filled with thin stone slabs and mortar chinking. The roof appears to be of a later period than the log house with six inch boards (running east-west) covered with tin sheets of varying sizes.

The log house was at one time covered with clapboards which have been removed except in the A's formed by the gables. The house has settled considerably on its north elevation and is in a state of disrepair with no window sashes. It appears, however, quite intact and sound otherwise and should be considered for rehabilitation and future reuse with required modernization.
