**MARYLAND HISTORICAL TRUST
DETERMINATION OF ELIGIBILITY FORM**

Property Name: The Daisy Trading Post Inventory Number: HO- 258

Project: Verizon - Daisy Cell Site Agency: FCC

INVENTORY FORM FOR STATE HISTORIC SITES SURVEY MAGI# 1402585611

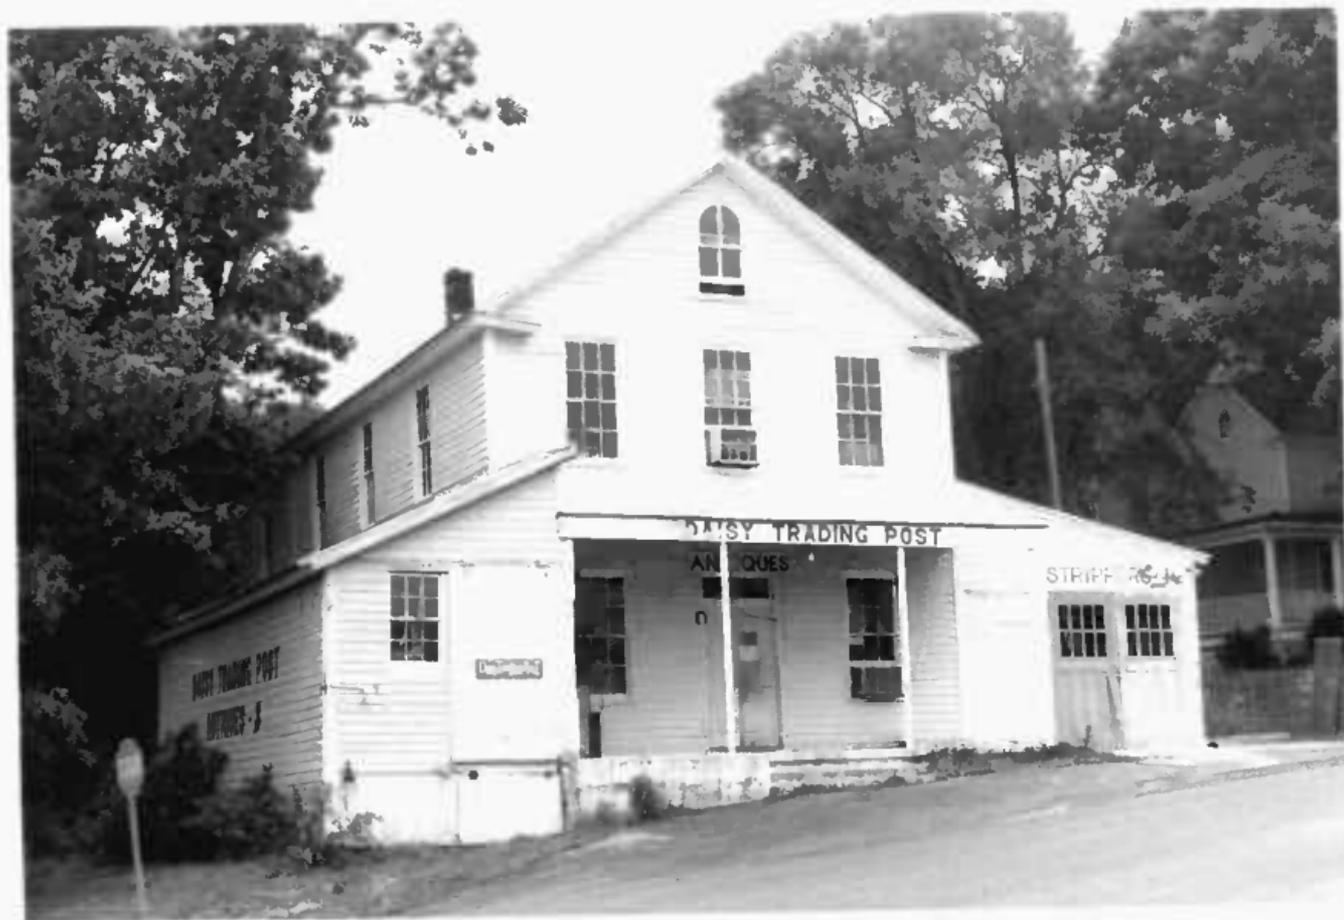
HO 258

Daisy Trading Post

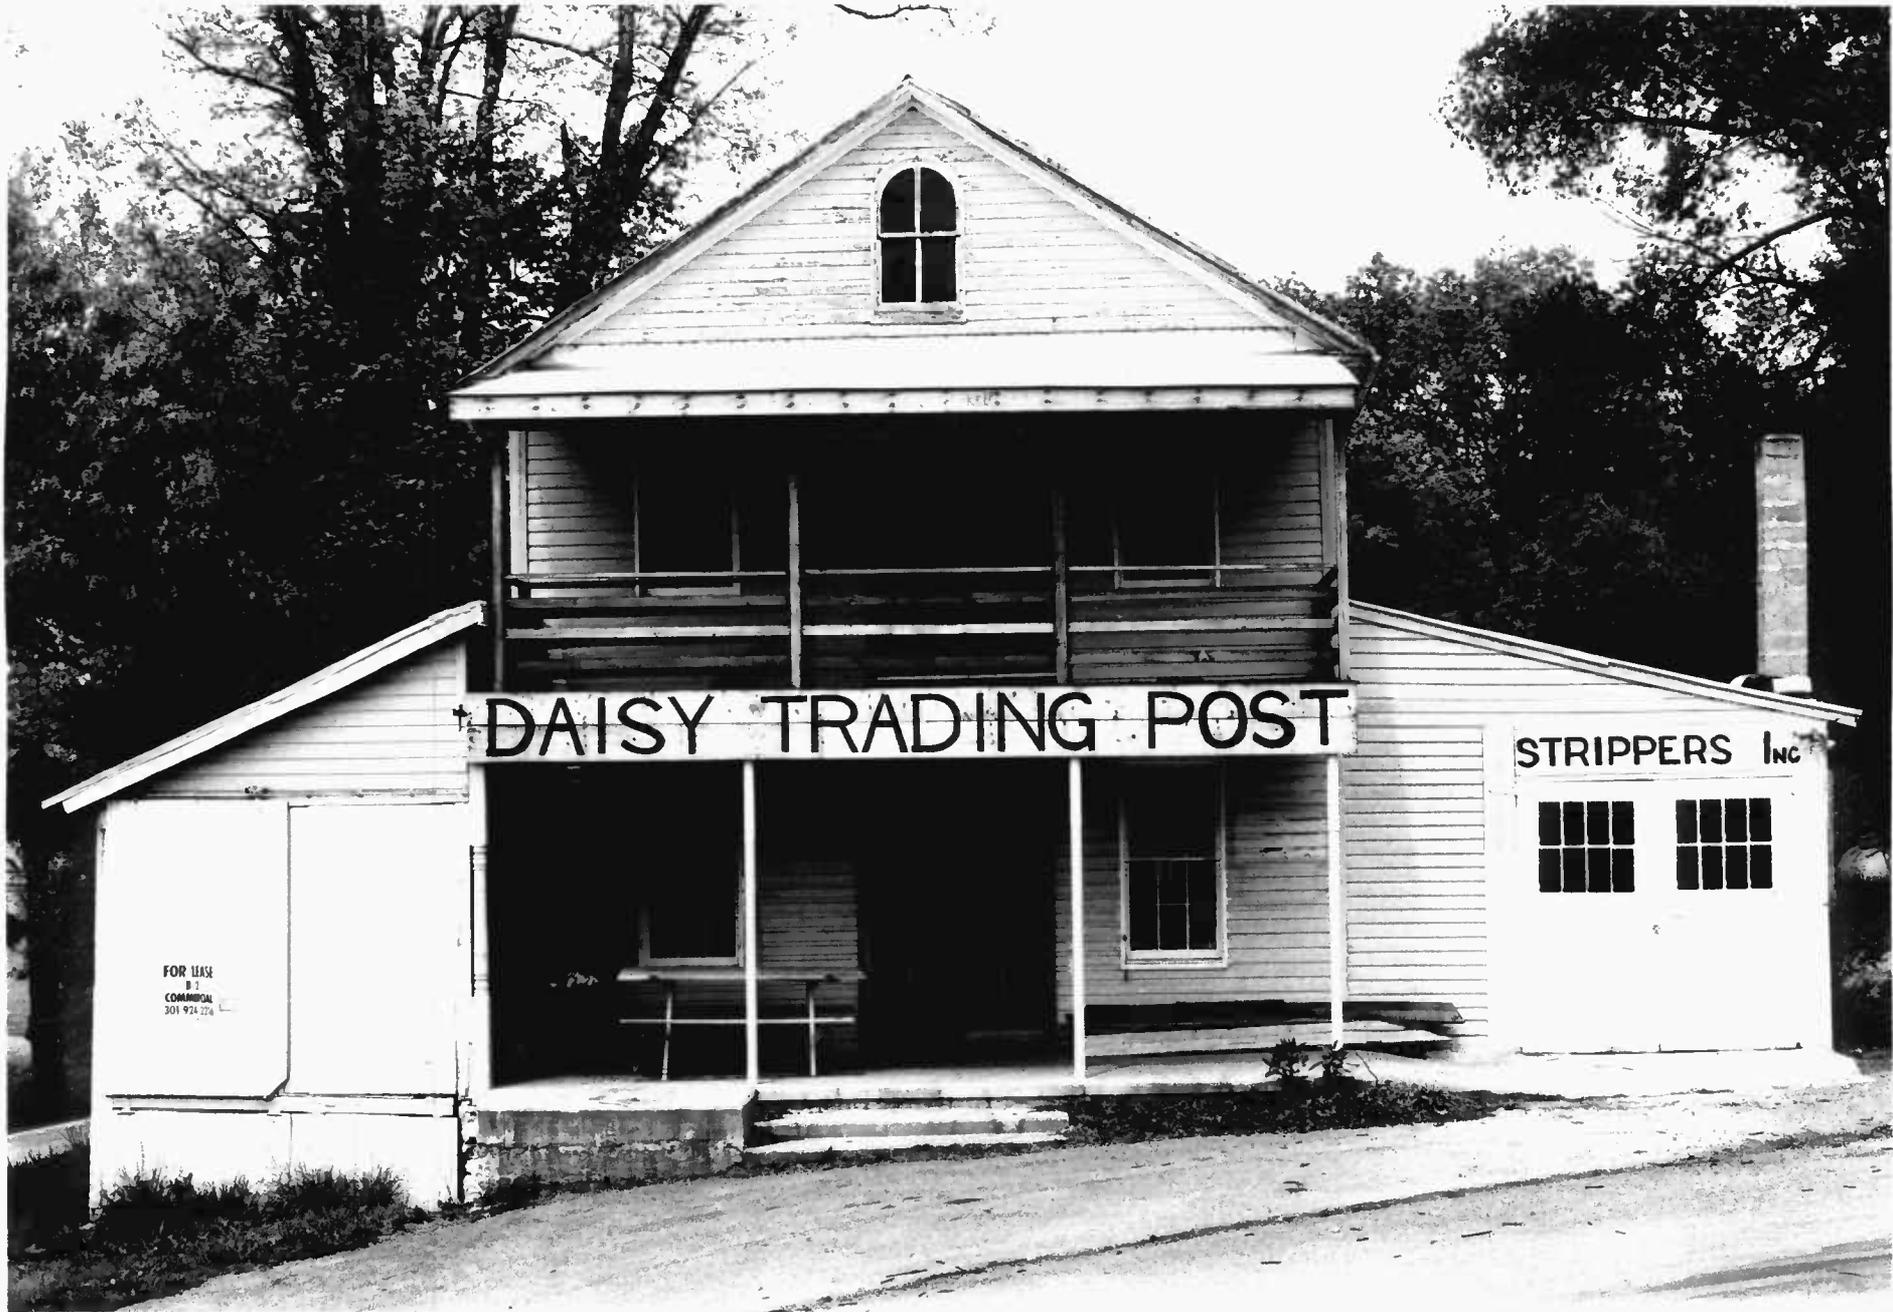
Name: HO-258
Daisy Trading Post
Location: 15948 Union Chapel Road
Woodbine, Maryland
Photographer: Cleora B. Thompson, A.I.C.P.
Date of Photograph: May, 1980
Negatives in possession of the Maryland Historical Trust
View: South elevation
Photographer looking: North
Photograph number: 1 of 1

DAISY TRADING POST
