HO-557  
Mount Misery  
Ellicott City  
Private

INVENTORY FORM FOR STATE HISTORIC SITES SURVEY

HISTORIC Mount Misery

STREET & NUMBER 8469 Hill Street

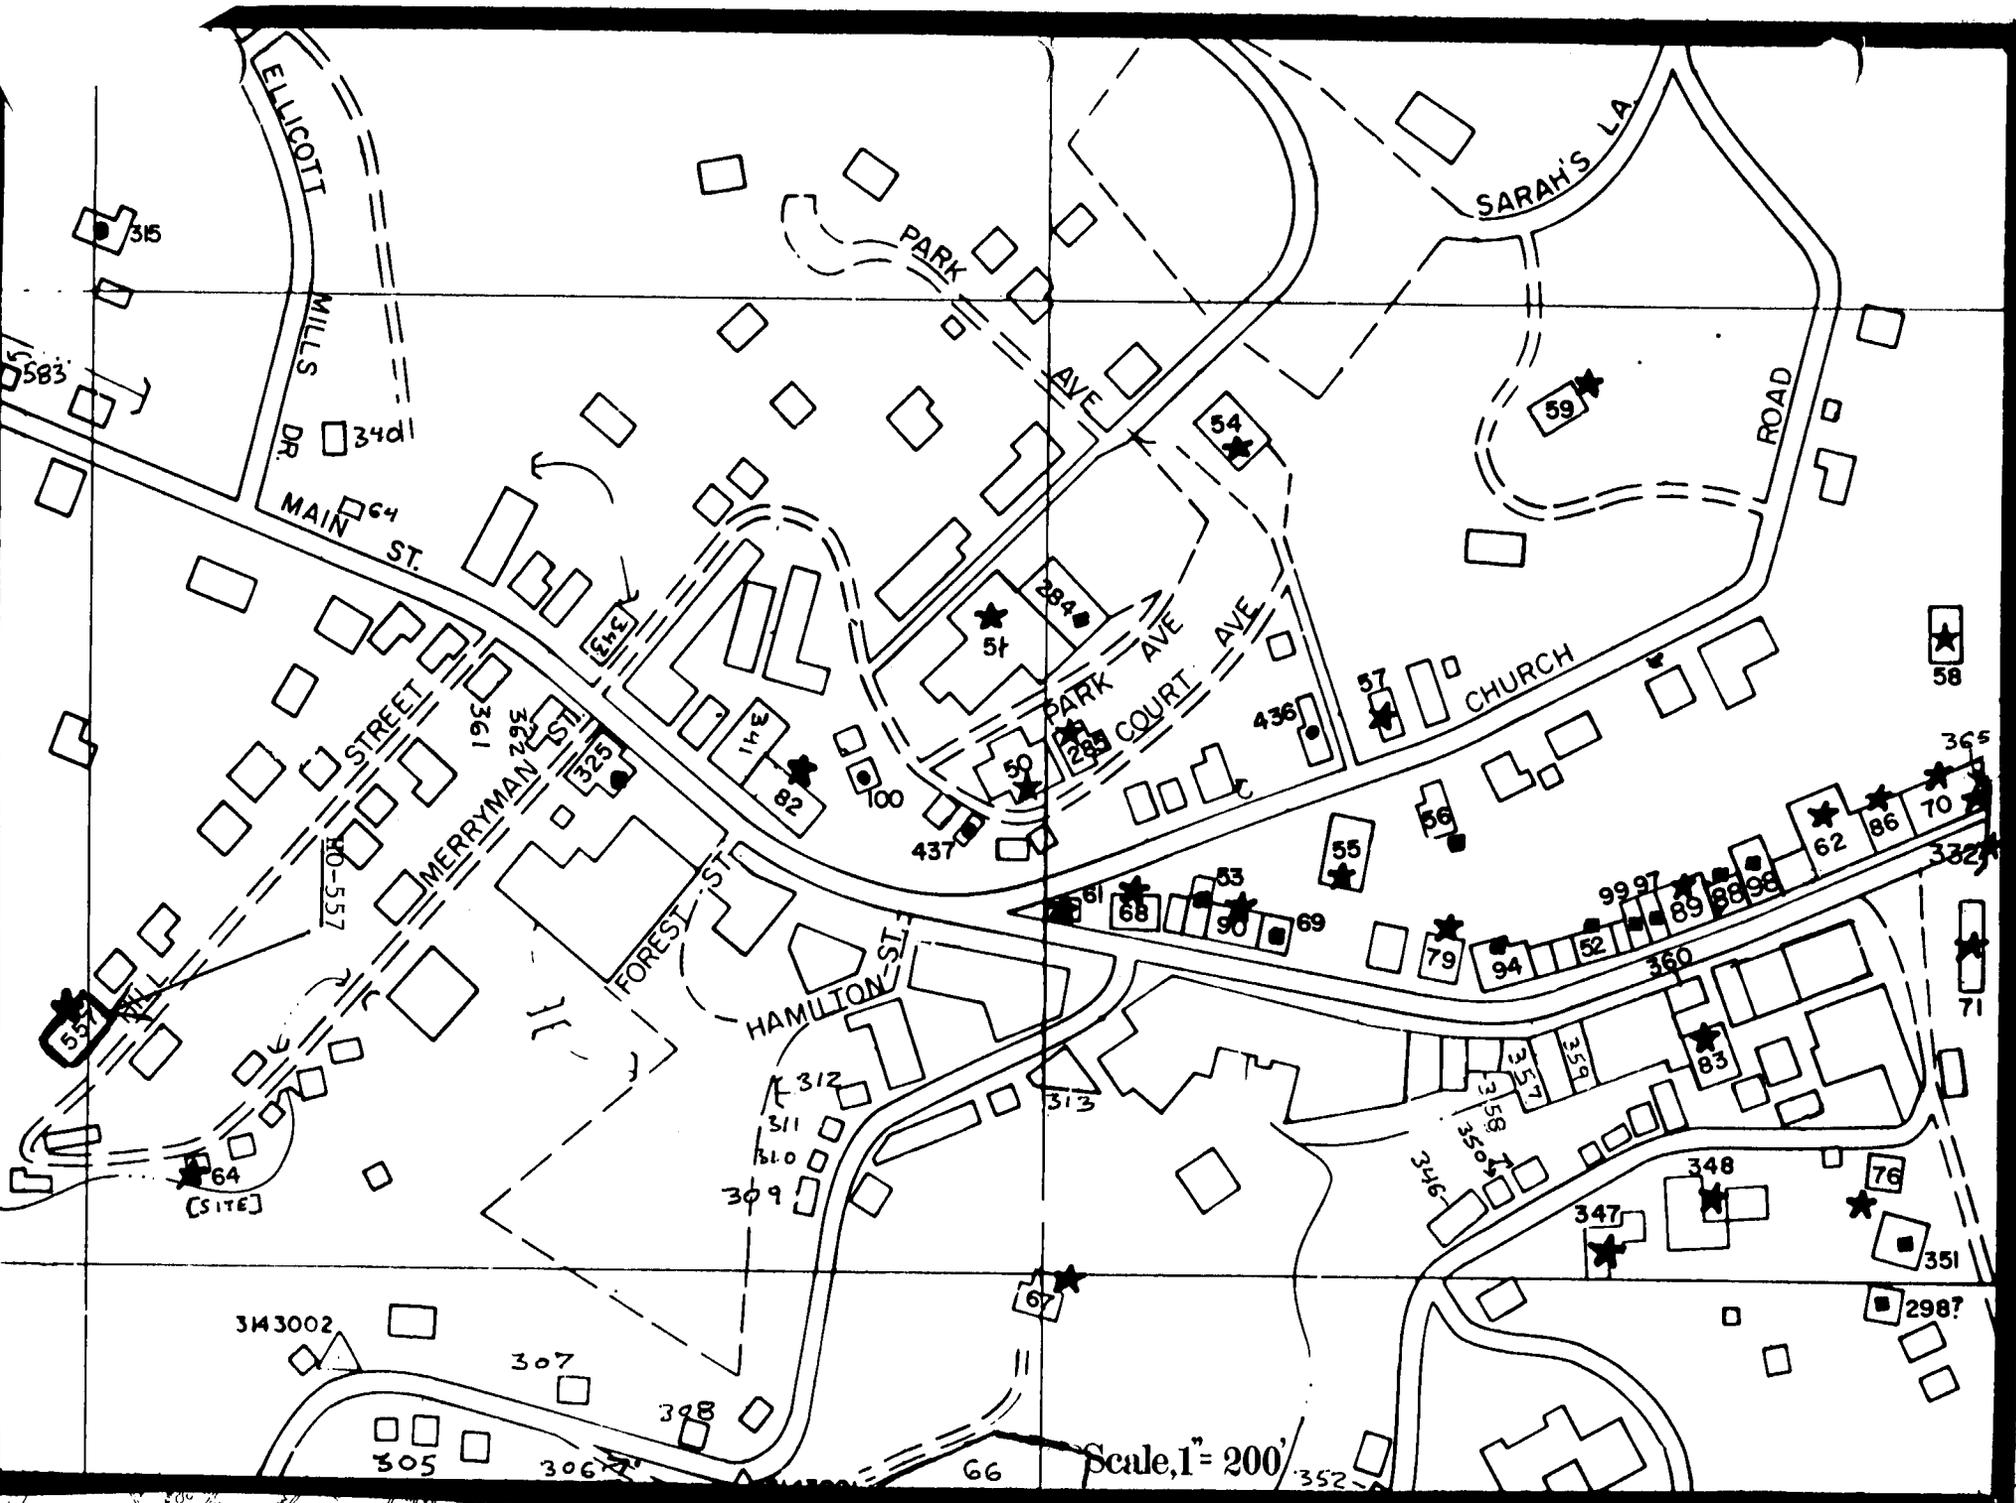
Mount Misery, 8469 Hill Street, Ellicott City

Mount Misery faces east on the west side of Hill Street, before it descends a steep hill south and turns north on to Merryman Street.

It is a four bay wide, two bay deep, two-and-a-half story high, gabled roof (running north-south) granite block house, resting on a granite block foundation and set into the slope of a steep hill, with wide, brick chimneys set into its north and south walls.

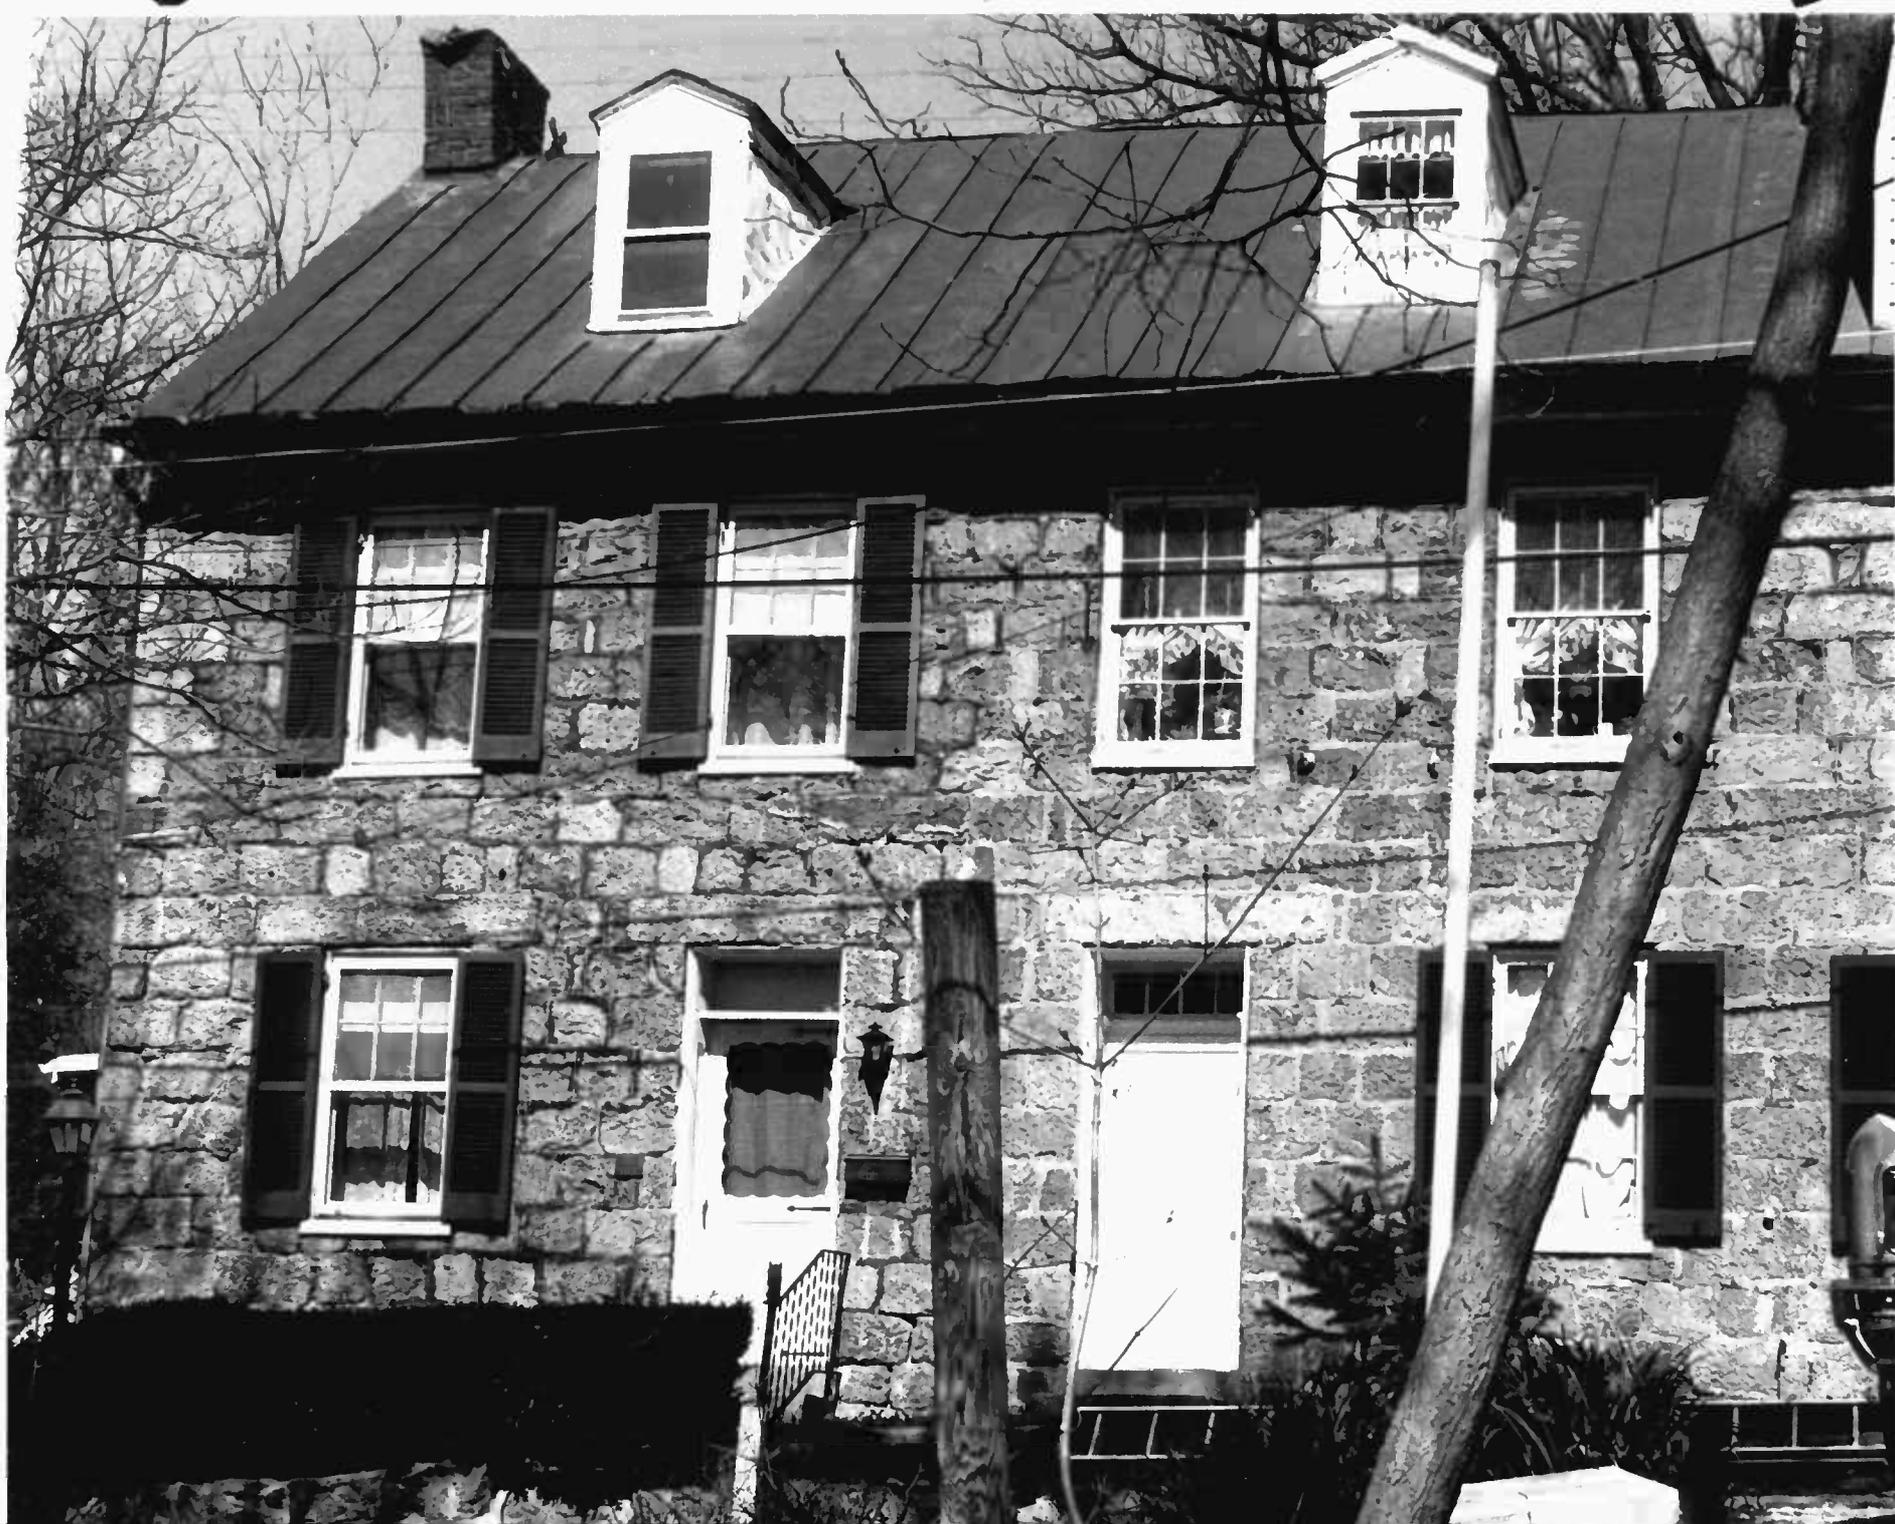
Name: HO-557  
Mount Misery  
Location: 8469 Hill Street  
Ellicott City, Maryland 21043  
Photographer: Cleora B. Thompson, A.I.C.P.  
Date of photograph: April, 1980  
Negatives in possession of the Maryland Historical Trust  
View: East  
Photographer looking: West  
Photograph number: 1 of 1

The east facade of the building features vertically aligned and proportionally scaled fenestration, with two central bay, rectangular entrance doors, surmounted by four light transoms (that in the south central bay now holds only one light, but features the original pegged window frames), and flat stone lintels. These windows are double-hung, retaining their original, pegged mortise and tenon sashes, but holding six-over-one lights on the south half of the house and six-over-six lights on the north half. Windows are underlined by flat wooden lintels, and decorated with shutters.

Two gabled roof, dormer windows are placed in the roofline at this elevation. They hold rectangular windows, flanked by fluted pilasters. The window on the south side holds one-over-one lights and that on the north side six-over-six lights. Excellent stone work is exemplified by the fine stone quoining and flat stone lintels, surmounting the doors and windows, as well as the choice of squarely cut stones for the east facade.

Two stone retaining walls have been constructed along the east elevation, one around the southeast corner of the building, and the other constructed along the west side of Hill Street as it slopes northward up the hill. Still another stone retaining wall runs along the west elevation of the building, creating a patio area west of the house.
